Fukushima Nuclear Accident
Investigation Report
(Interim Report – Supplementary Volume)

December 2, 2011
The Tokyo Electric Power Company, Inc.

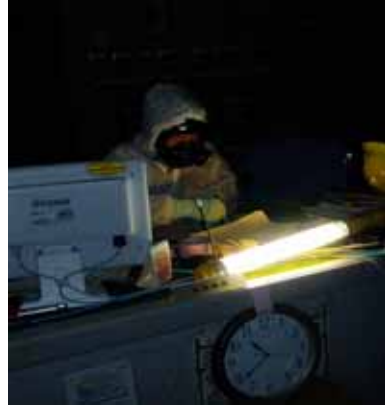
Monitored by the Assistant Shift Supervisor

The Assistant Shift Supervisor at the desk monitored plant data and information wearing a full face mask in the total darkness.

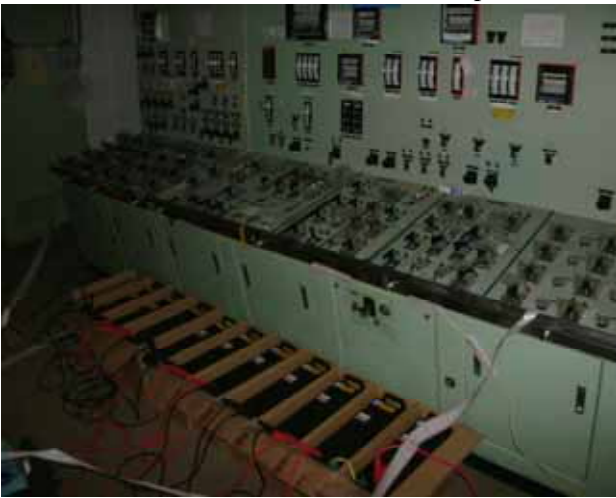
Temporary Instrument Power

Temporary batteries were connected to power control room instruments due to loss of power.

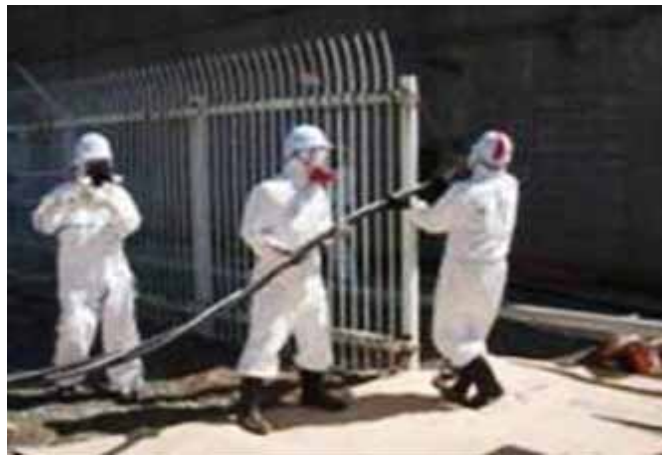
Installing Temporary Power

Workers who are not working for electrical system were called out to manually lay the power cables

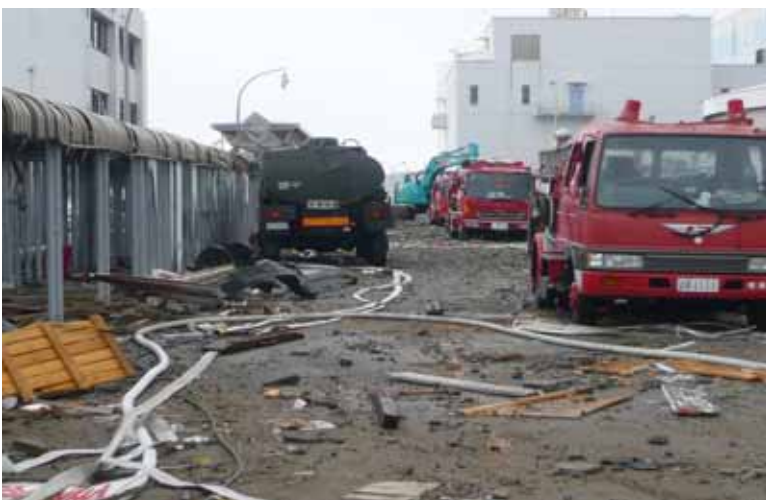
Obstacles on access routes

Fire hoses caused detour for access. After the explosion, debris and damaged fire engines become additional obstacles.
