Response to the accumulated water containing radioactive materials that was found in the trench at Fukushima Daiichi Nuclear Power Station (Interim report)

January 6, 2011
Tokyo Electric Power Company

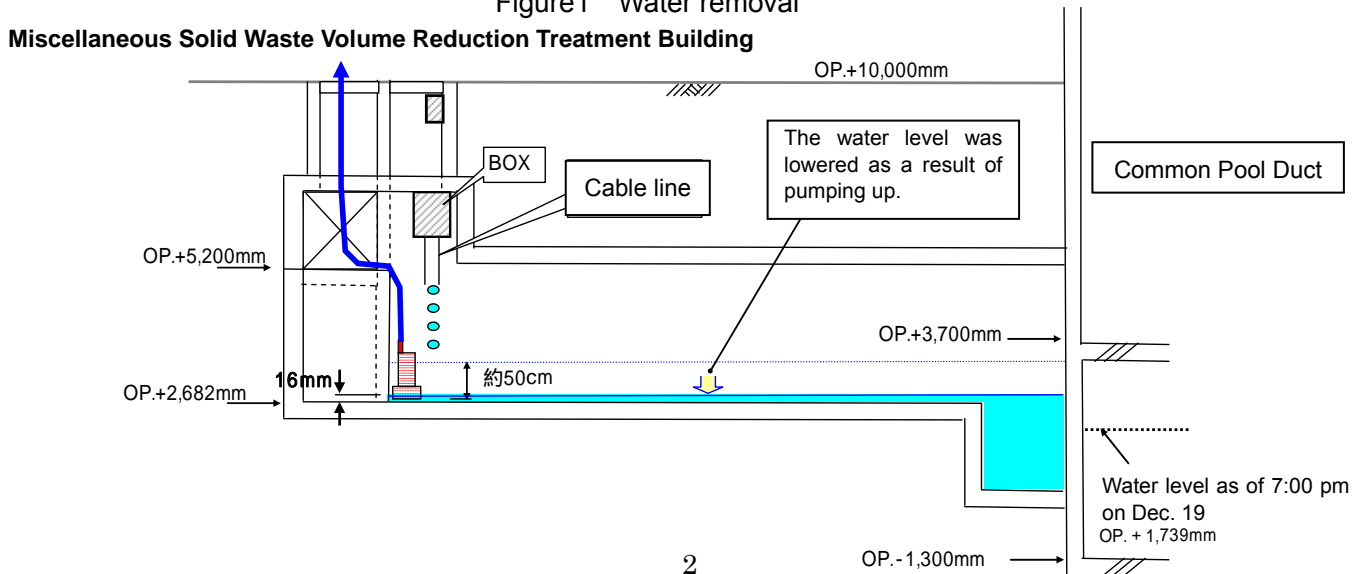
Figure1 Water removal

The transfer of the accumulated water was executed by setting an underwater pump near the opening hatches on the trench floor as the Diagram1 shows, since it was difficult to move farther into the trench due to the high concentration of radioactive materials in the accumulated water. Out of the accumulated water, 16mm (220 m³) on the trench floor because of the pump capacity, approximately 120 m³, have been transferred this time.

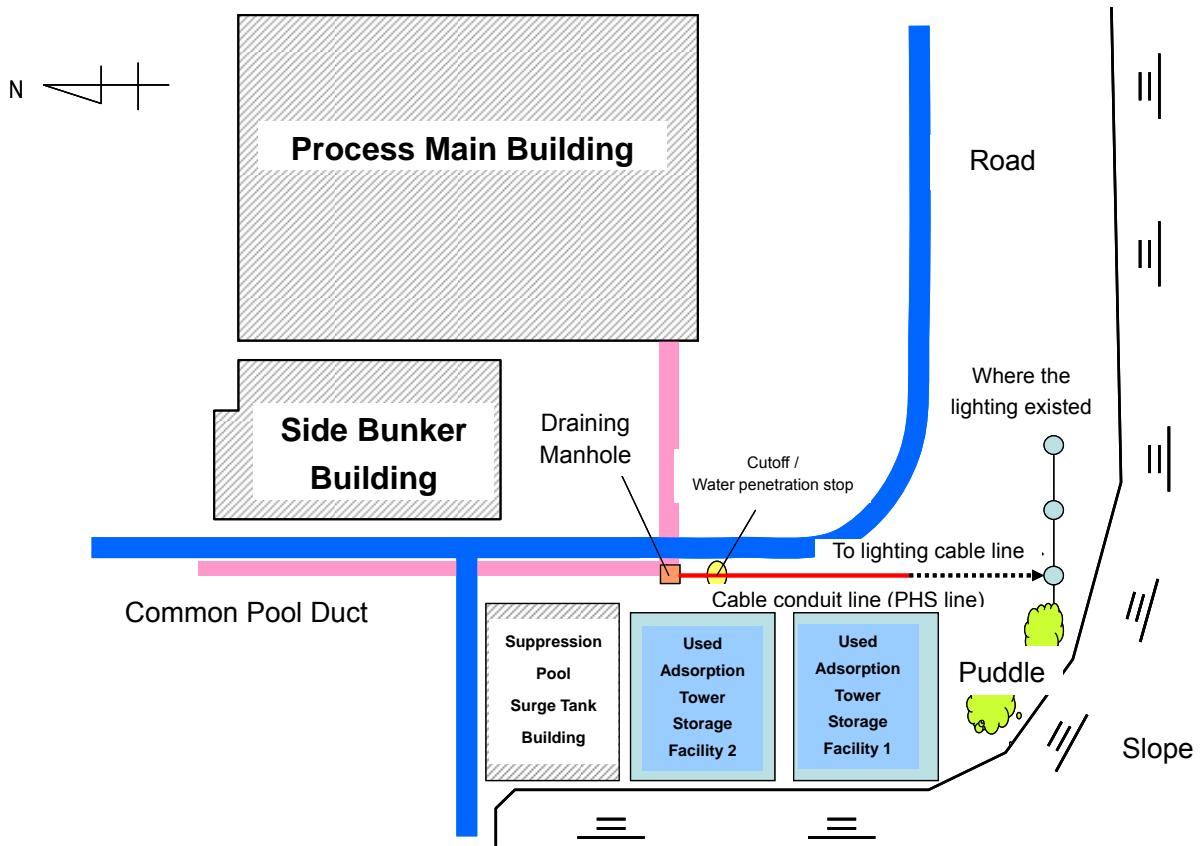
Figure2 Position of cable conduit line

The water (3 tons/day) of relatively low concentration flows into the Common Pool Duct through the cable conduit line. The conduit line is buried directly under the soil, the diameter of which is around 20 mm.

We cut off the cable conduit line as the Figure2 below shows, and stopped the water leakage by using sealing materials at the intake and outlet of the conduit line. On January 6, we confirmed the result of no water incursion from the conduit line located at the trench.

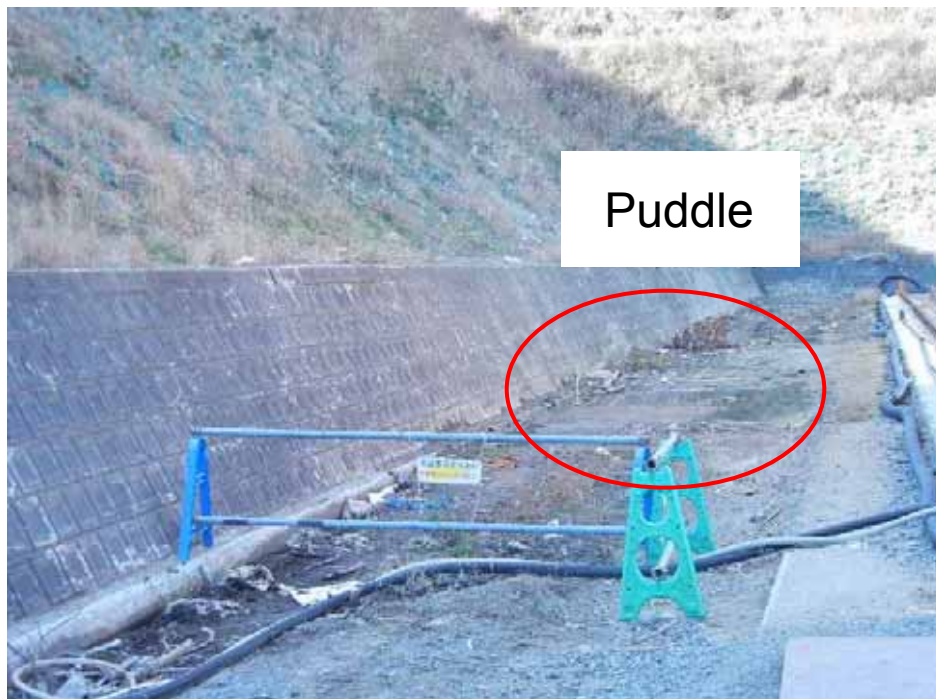
Figure3 Water incursion to cable conduit line

As we could not check the drawings of the conduit line, we interviewed our affiliated companies. As a result, it was found that we had installed a similar conduit line at a power source work carried out about ten years ago to build a PHS relay station. As this conduit line diverges from the lighting power source, and as an opening mouth developed due to the damage incurred to a panel light the Figure 2 below illustrates, the water seems to have moved in through the opening. According to the radioactive concentration we analyzed on January 4 at a puddle on the damaged part of the light, the Cs concentration was almost the same as that which dripped down from the cable conduit line. (Diagram2)

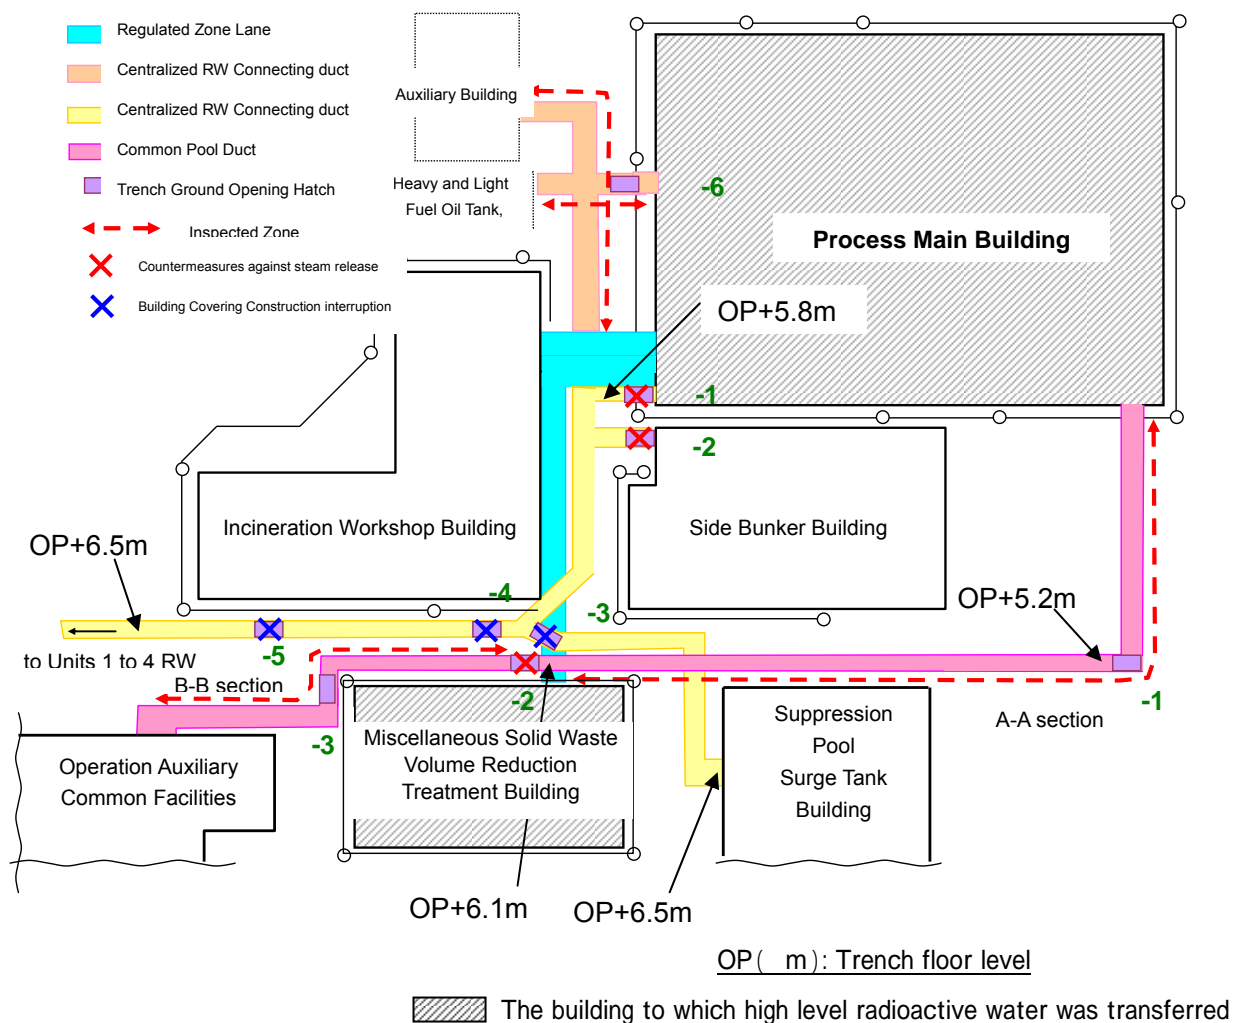
Figure6 Inspected area

In response to the accumulated water containing radioactive materials found at the Common Pool Duct that is connected to the Process Main Building, we will inspect the Common Pool Duct, Centralized RW Connecting duct, Regulated Zone Lane, all of which are connected to the Process Main Building and Miscellaneous Solid Waste Volume Reduction Treatment Building. (Figure6)

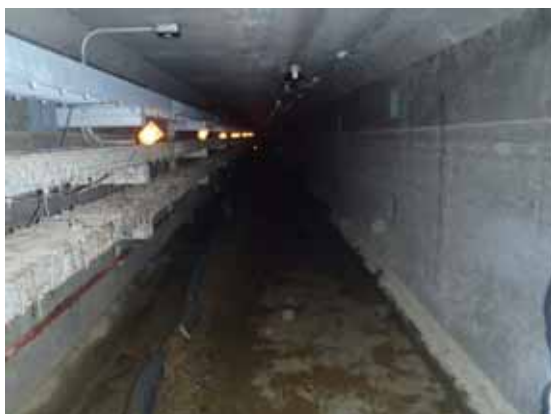
No accumulated water.

【Photo 1】 Situation in the trench (No accumulated water)

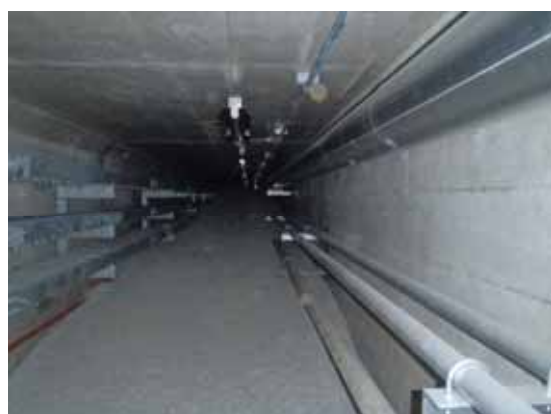
【Photo 2】 Situation in the trench (No accumulated water)

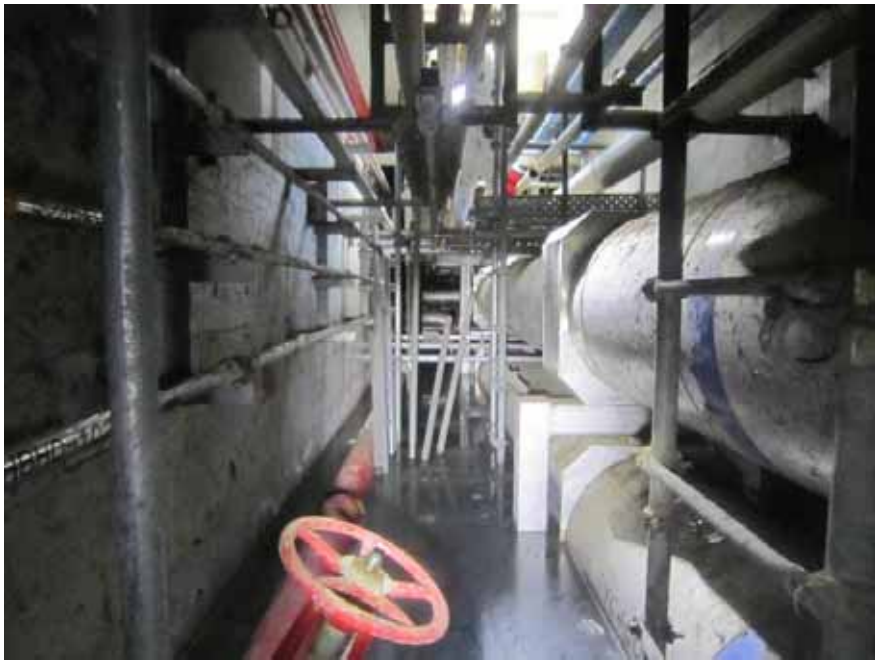
On the other hand, the accumulated water of approx. 142m³ was found at the Centralized RW Connecting Duct (Appendix-3). As shown in the table 4, the radioactive concentration of the accumulated water was low. Therefore, it is assumed that the accumulated water resulted from rain water etc., entering in from the opening hatch located at the upper trench rather from the leakage of the highly concentrated contaminated water that was transferred to the Process Main Building.

- There is accumulated water. The amount of water was approx. 142m³.
- Result of Nuclide Analysis :

【Photo 1】 Situation of accumulated water in the trench

The water level of the accumulated water and radioactivity concentration of the Common Pool Duct (A-A section) and Centralized RW Connecting Duct will be checked periodically (tentatively once a week). As for the centralized RW connecting duct , we are planning to implement preventive measures for rain water at the opening hatch of the upper duct.

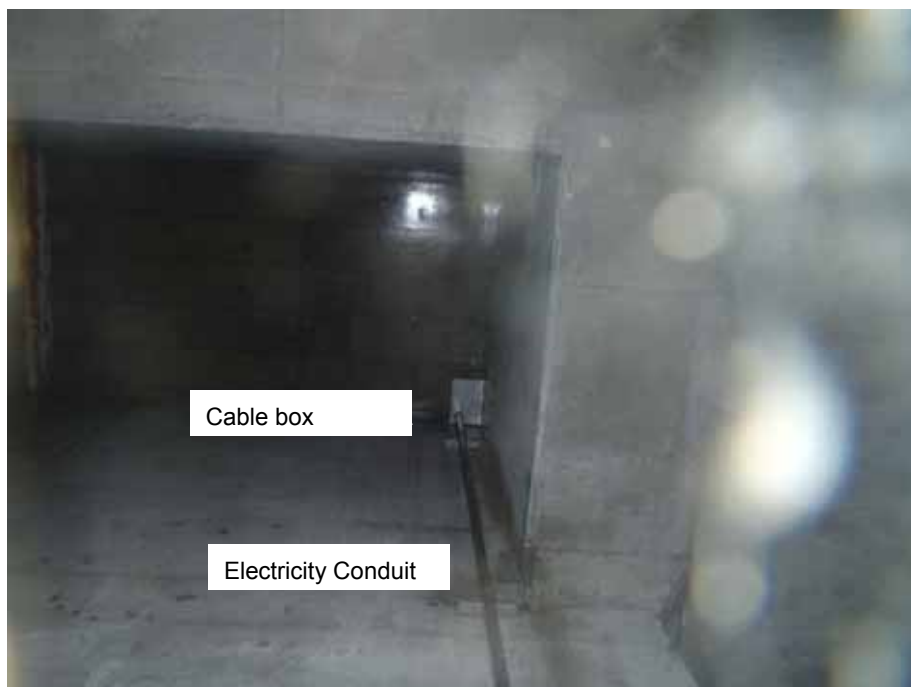
- There is accumulated water. The amount of water is approx. 220m³
- Result of Nuclide Analysis :

【Photo 1】 Situation of accumulated water in the trench

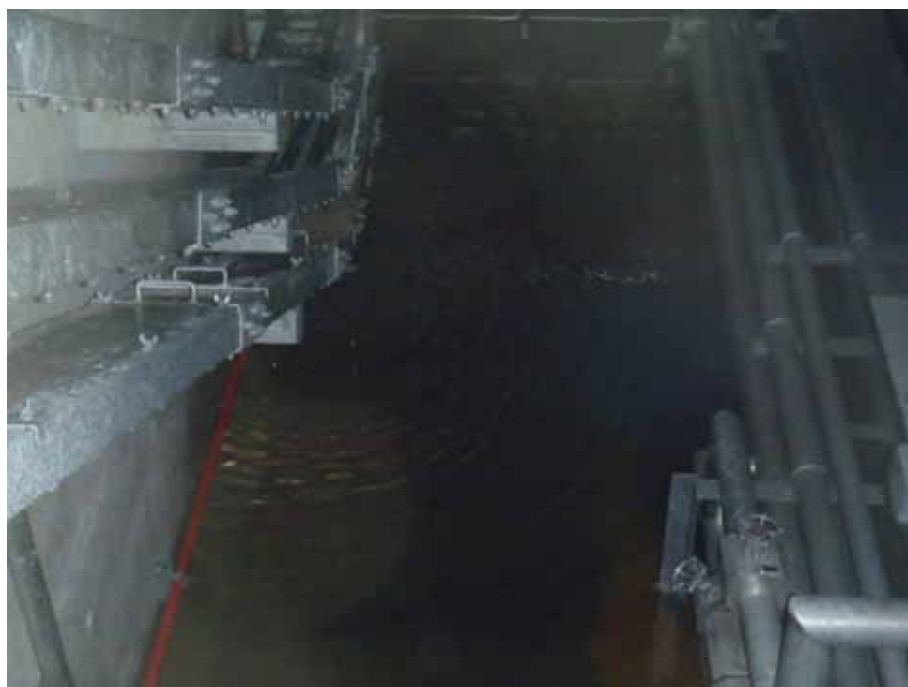
【Photo 2】 Situation of accumulated water in the trench
