The Current Statuses of Unit 1-4 Emergency Diesel Generators (D/G): 12 units

Recovery work for Unit 1 D/G (A, H) flooded due to Tsunami

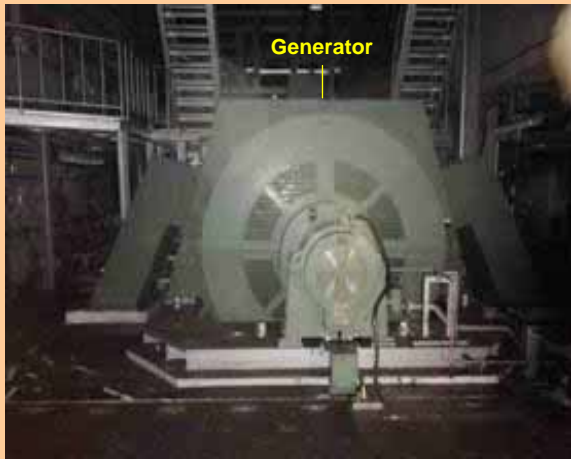
Flooded condition of Unit 1 D/G (H)
(Photo taken on March 20, 2011)

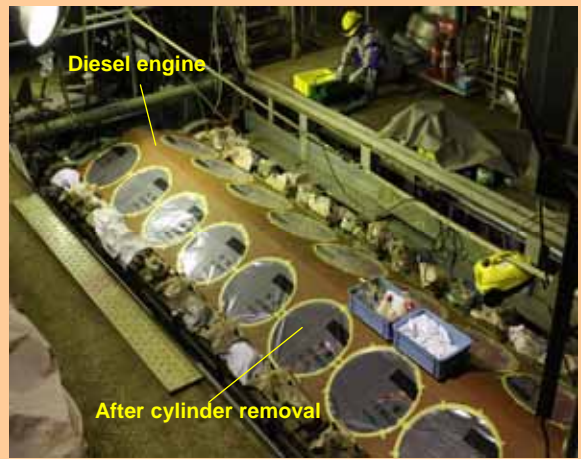
Recovery work for Unit 1 D/G (H)
(Photo taken on April 17, 2012)

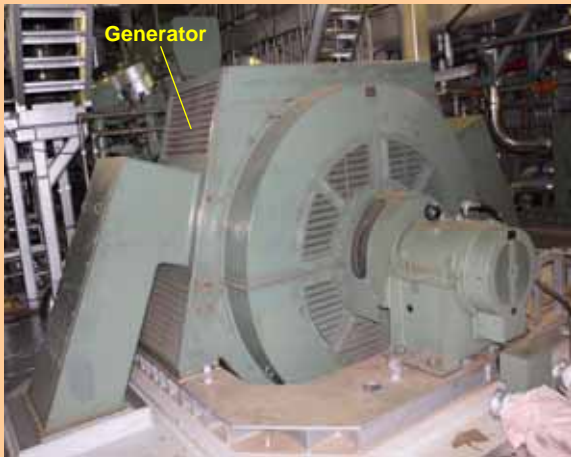
Unit 1 D/G (B) (Photo taken on April 20, 2012)

D/G was flooded due to Tsunami and became unavailable.
It has been recovered on July 15, 2011 and is now in standby state.

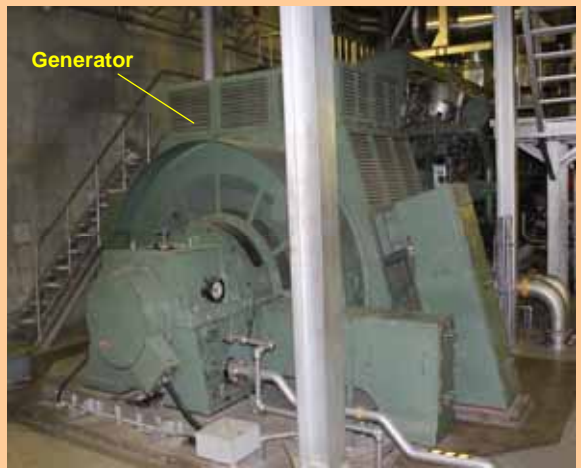
Unit 2 D/G (A) (Photo taken on April 20, 2012)

Though D/G itself was not flooded, it became unavailable right after the Tsunami with other equipments (such as the power panel in the Seawater Heat Exchanger Building and auxiliary pump) being flooded.
It has been recovered on August 8, 2011 and is now in standby state.

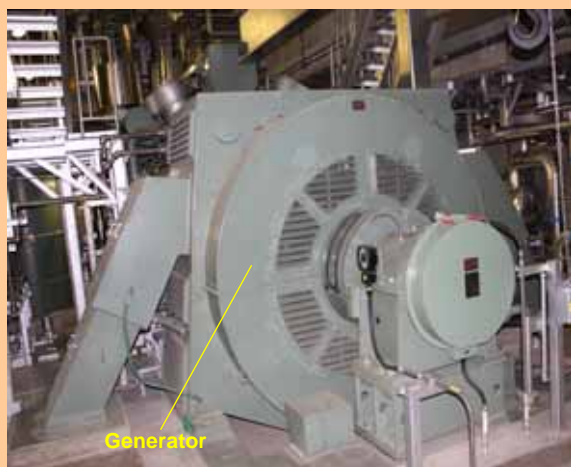
Unit 3 D/G (A) (Photo taken on April 17, 2012)

Though D/G itself was not flooded, it became unavailable right after the Tsunami with other equipments (such as the power panel in the Seawater Heat Exchanger Building and auxiliary pump) being flooded.
It has been recovered on August 31, 2011 and is now in standby state.

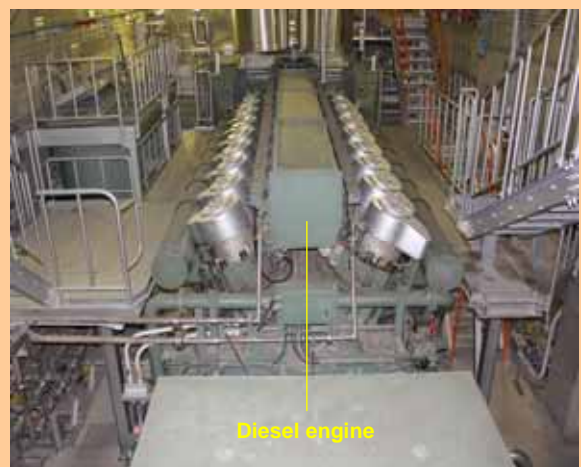
Unit 4 D/G (A) (Photo taken on April 17, 2012)

Though D/G itself was not flooded, it became unavailable right after the Tsunami with other equipments (such as the power panel in the Seawater Heat Exchanger Building and auxiliary pump) being flooded.
It has been recovered on August 3, 2011 and is now in standby state.
