List of Documents concerning the Response Status at
Fukushima Daiichi Nuclear Power Station and
Fukushima Daini Nuclear Power Station (June 2012 version)

Fukushima Daiichi Nuclear Power Station

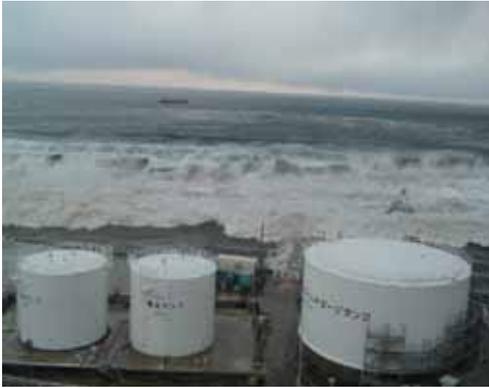
Tsunami destroys 10m high seawall and pushes inland

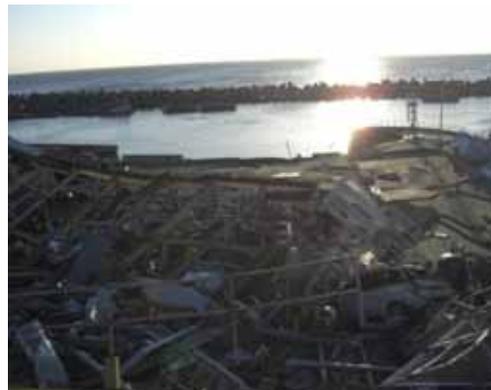
Conditions on sea side after tsunami arrival

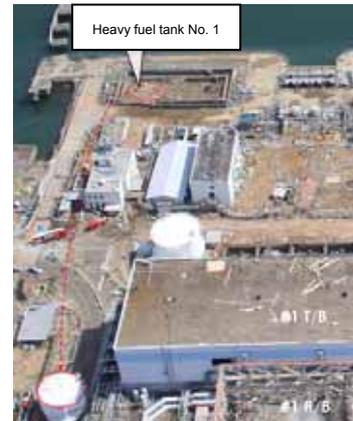
The heavy fuel tank was carried to the north side of the Turbine Building by the Tsunami

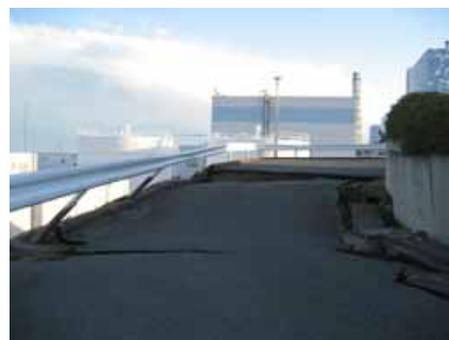
Site road cracked and impassable

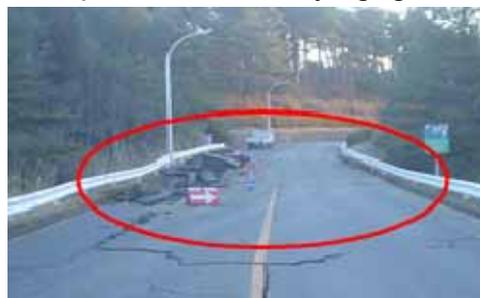
Damage to the access road to Unit 5, 6
(After restoration, the asphalt on one side was stripped off and gravel and rocks underneath were used to restore the other side.)

In addition to the gravel loaded into the dump truck, gravel and rocks exposed from beneath cracked asphalt on the side of the road that was impassable was also used for restoration purposes. The backhoe was used to make the other side of the road flat again.

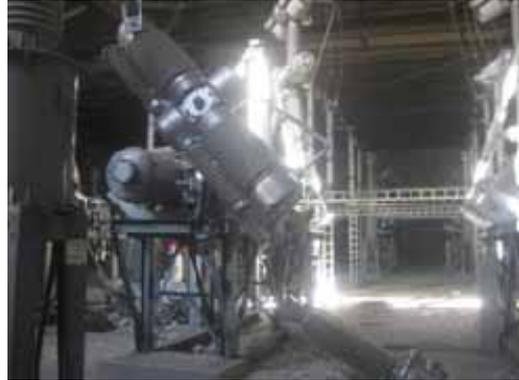
some equipment had fallen. Switchyard circuit breaker damaged by the earthquake and some equipment had fallen.

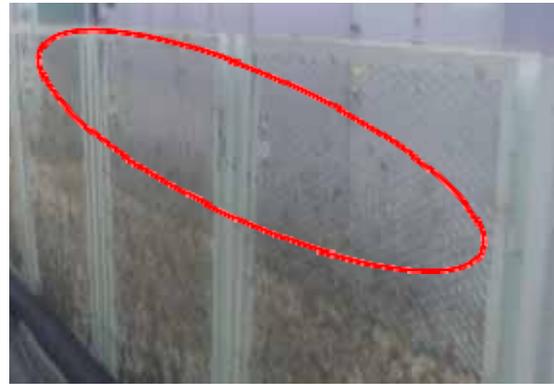
Sand and seaweed was adhered to the 6.9kV high voltage power panels (M/C) and 480V low voltage power panel (P/C)

Conditions in Unit 1 1st floor turbine building M/C

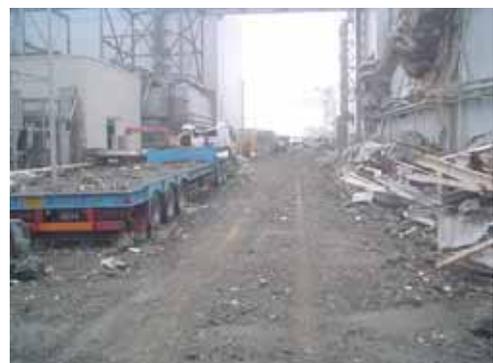
Conditions at Unit 3/4 transformer area after debris and tractor trailers had been pushed aside (photographed days after the disaster)

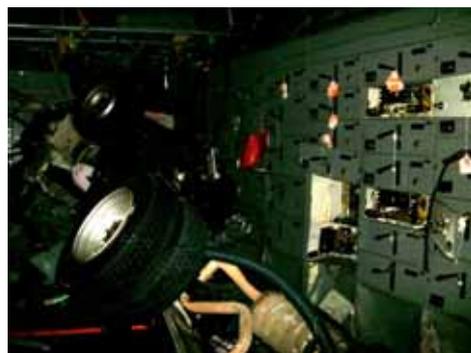
Truck that had been stuffed into the back of the Unit 4 truck bay (photographed in the days after the disaster)

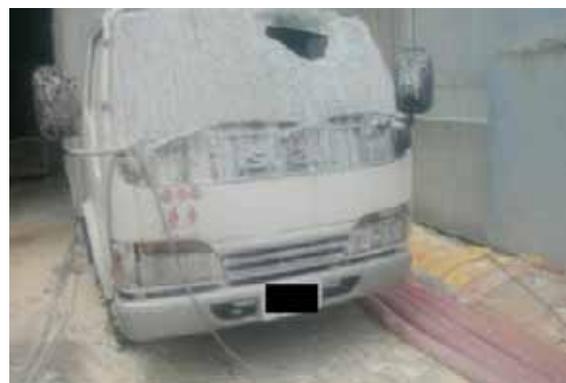
Truck that had been placed in front of the Unit 4 truck bay (photographed days after the disaster)

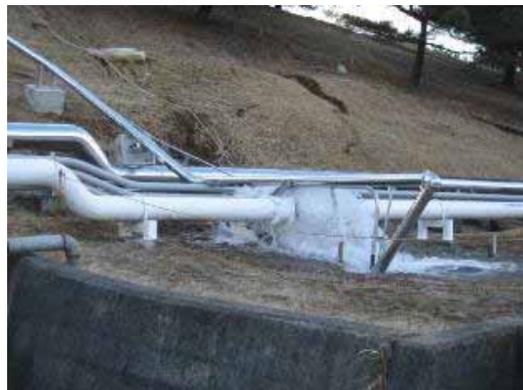
Transformer FP pipe leakage

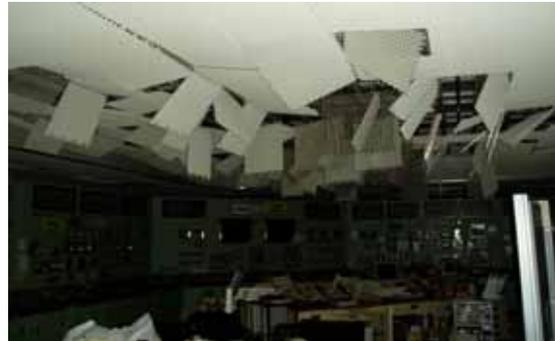
Situation of MCR after explosion

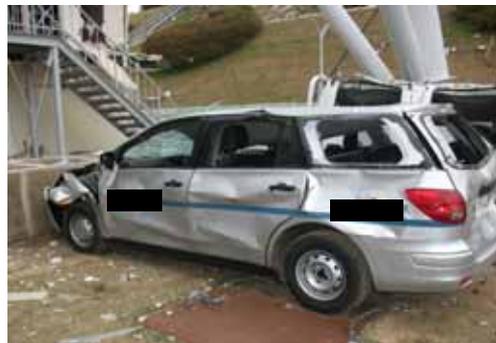
Car damaged by blast winds

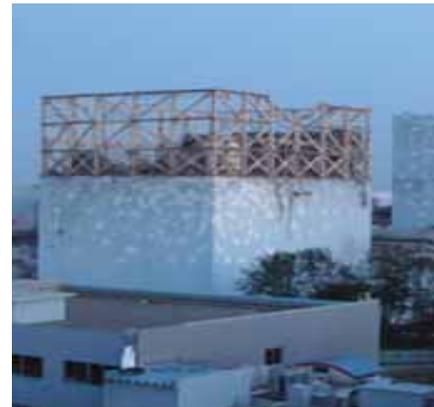
Unit 1 R/B after explosion

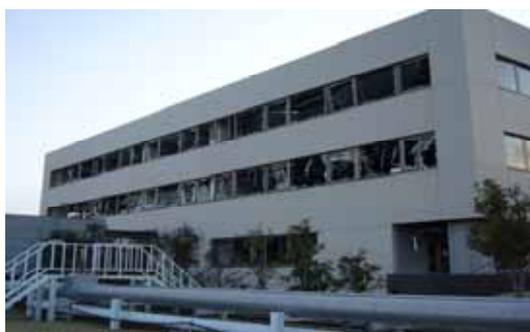
Main office, where windows were broken by blast winds

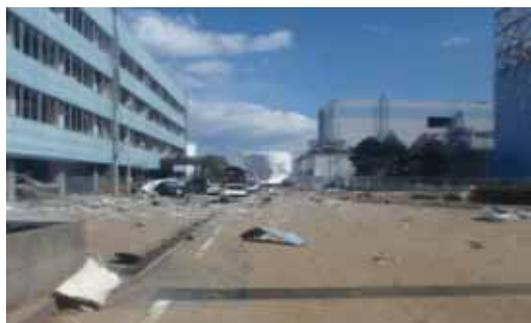
Former main office, where windows were broken by blast winds (Unit 1 can be seen to the right)

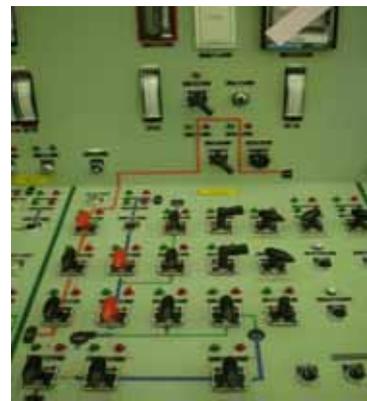
HPCI control panel (photo taken at later date)
At the time, all condition indicator lamp were off

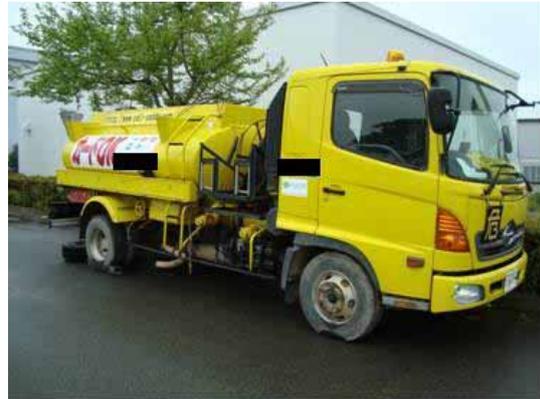
Fuel supply truck with flat tire (photo taken at later date)

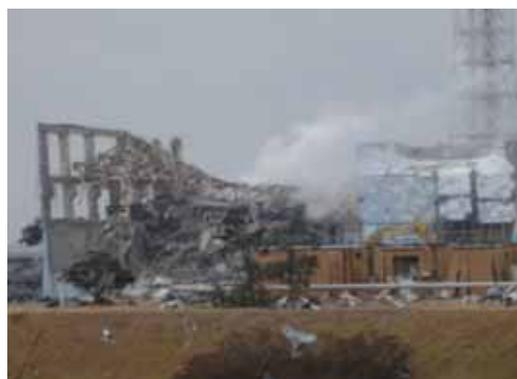
Unit 4 damage (on right side of photo)
(Unit 2 is on left side of photo)

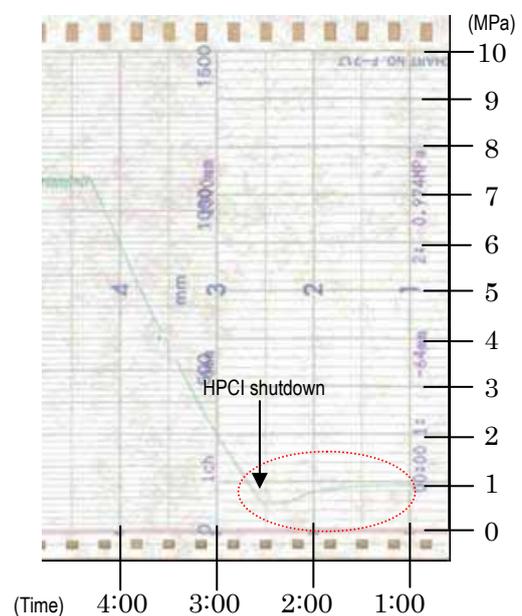
Reactor pressure chart
 (Was stable at approx. 1MPa, but began dropping around 02:00, eventually going below 0.69MPa.)

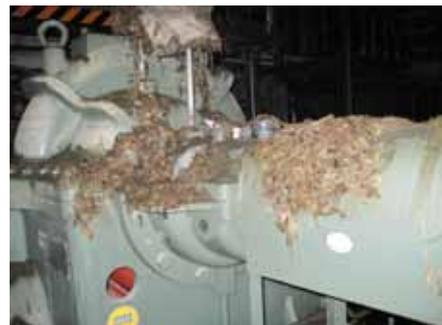
Water damaged cooling water pump
(photo taken at later date)
