Current Conditions of Unit 1-4 Seawater Heat Exchanger Building

Restoration status of the equipments in Unit 4 Seawater Heat Exchanger Building based on the restoration plan

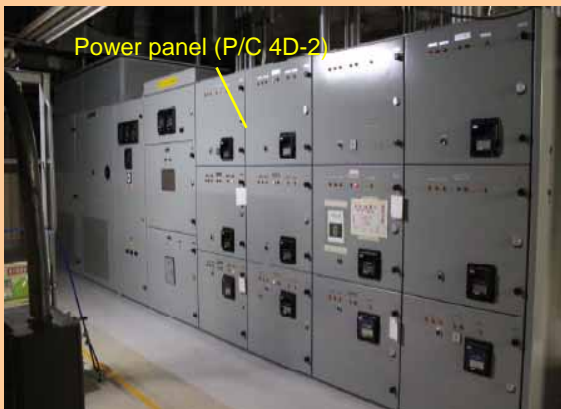
Power panel (P/C 4D-2)
(Photo taken on June 18, 2012)

The power panel damaged by the Tsunami was replaced with a newly manufactured power panel (P/C 4D-2). Restoration completed on May 16, 2012.

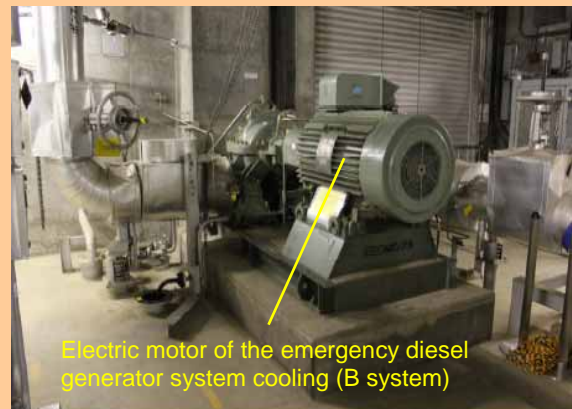
Electric motor of the emergency diesel generator system cooling (B system)
(Photo taken on June 18, 2012)

The power supply for the emergency diesel generator system cooling (B system) was switched from a temporary power supply to the permanent power panel (P/C 4D-2). Restoration completed on May 16, 2012.

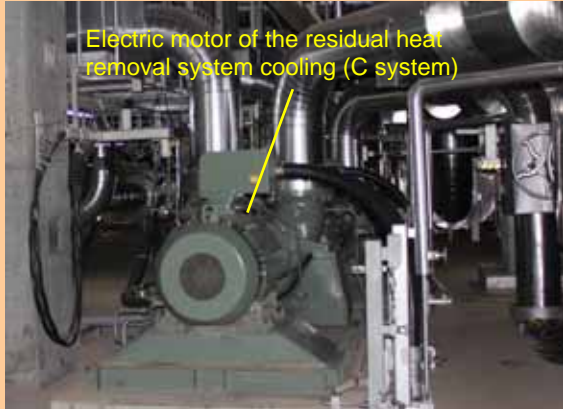
Electric motor of the residual heat removal system cooling (C system)
(Photo taken on June 7, 2012)

The power supply for the residual heat removal system cooling (C system) was switched from a temporary power supply to the permanent power panel (P/C 4C-2). Restoration completed on May 15, 2012.

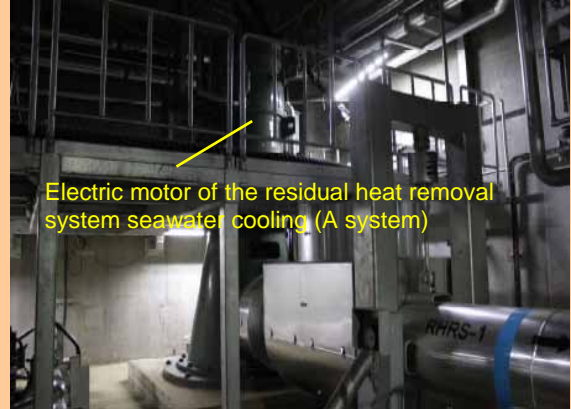
Electric motor of the residual heat removal system seawater cooling (A system)
(Photo taken on June 18, 2012)

The power supply for the residual heat removal system seawater cooling (A system) was switched from a temporary power supply to the permanent power panel (P/C 4C-2). Restoration completed on May 15, 2012.

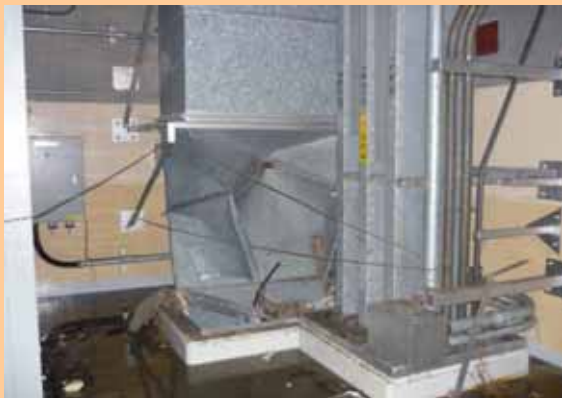
Air conditioning duct on the 1st floor of Unit 1 Seawater Heat Exchanger Building
(Photo taken on March 16, 2011)

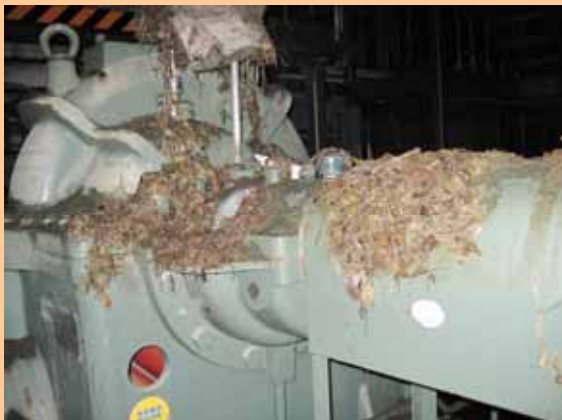
Reactor component cooling system pump (B) on the basement of Unit 4 Seawater Heat Exchanger Building
(Photo taken on March 23, 2011)

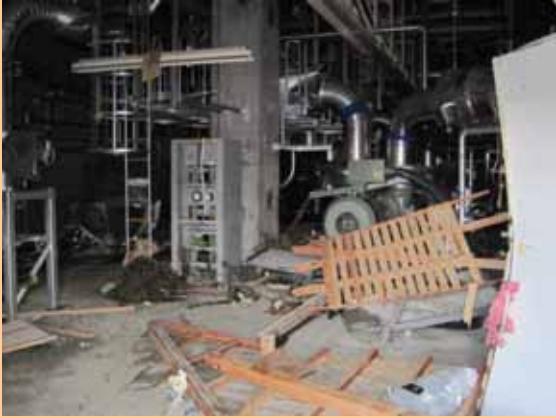
Unit 4 residual heat removal system cooling (C system) on the 1st floor of Unit 4 Seawater Heat Exchanger Building (Photo taken on March 13, 2011)

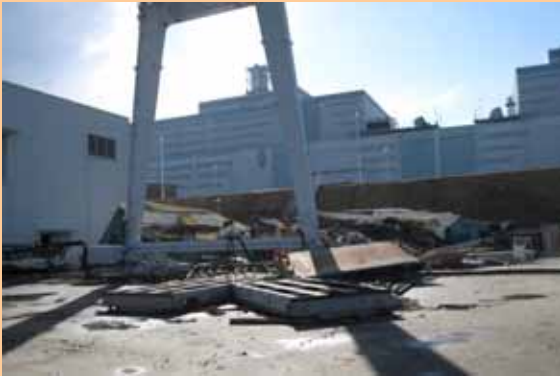
Between Unit 3-4 Seawater Heat Exchanger Buildings (Outside) (Photo taken on March 16, 2011)

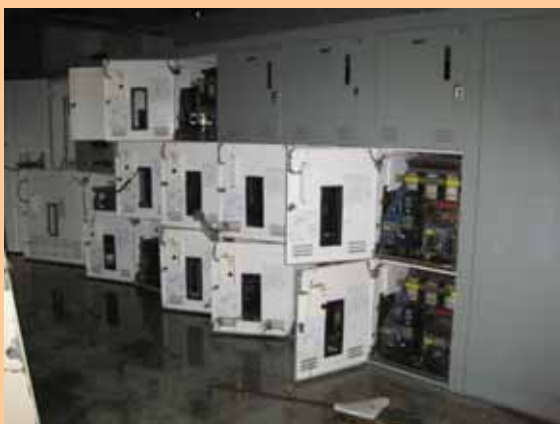
Unit 1 power panel (P/C 1D-2) on the 1st floor of Unit 1 Seawater Heat Exchanger Building (Photo taken on March 13, 2011)
