Impact of Tsunami on the monitoring posts and the current situations

Impact of Tsunami on the monitoring posts and the current conditions (Chart)

MP6 exposed to the Tsunami

MP-7 washed away by the Tsunami

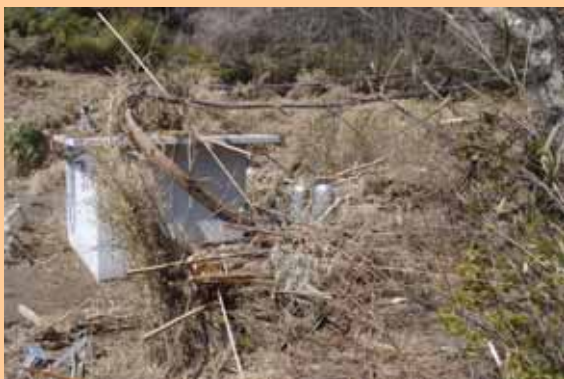
1. MP-6 after the earthquake
(Photo taken on April 3, 2011)

The detectors and equipments installed in the building were partially exposed to the Tsunami.

MP-6 was capable of measurement even after the detectors, control panel and the equipments installed in the building were partially exposed to the Tsunami, as the soundness of equipments was maintained. The equipments were replaced from October 11 to 21, 2011, for the purpose of preventive maintenance.

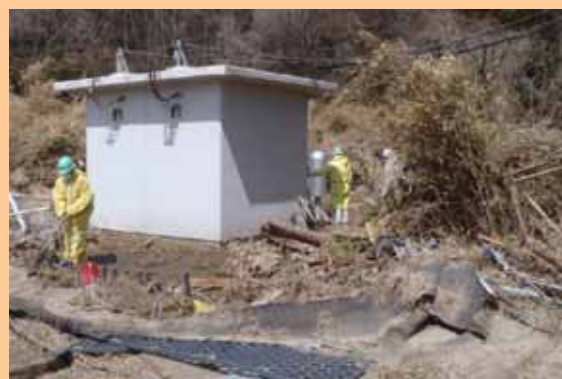
2. Debris removal

Removed the debris brought by the Tsunami.

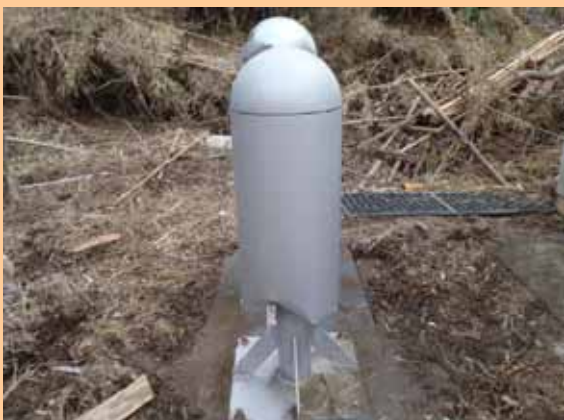
3. Detector after debris removal
(Photo taken on April 4, 2011)

The radiation environment surrounding the detector was changed as a result of debris removal, and MP-6 measurement values went down.

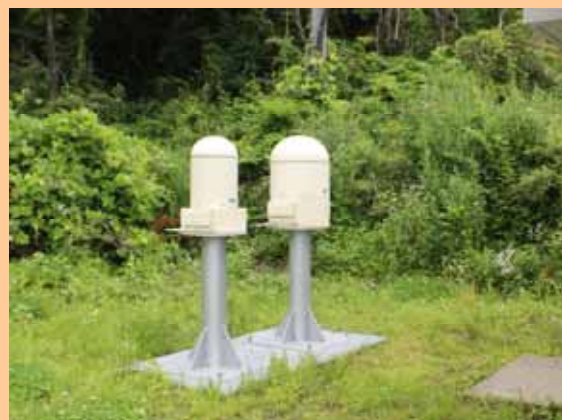
3. Replacement of detectors, etc.
(Photo taken on July 23, 2012)

The replacement of detectors and the equipments installed in the building was completed on October 21, 2012.

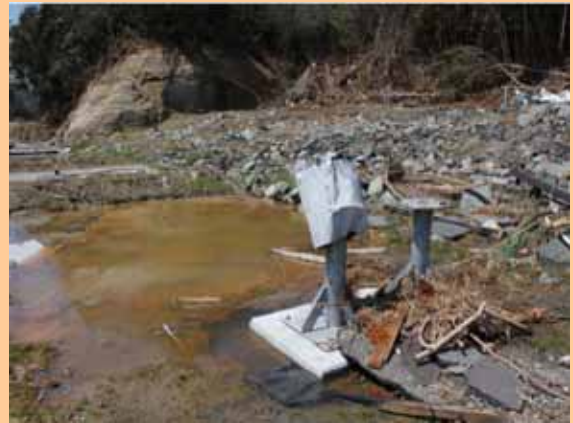
| | Exposure to Tsunami | Operation status right after the Tsunami | Current operation status (July 2012) |
|---|---|--|--|
| MP - 7 | Yes (The detectors and the equipments were washed away by the Tsunami) | Not operable (Washed away by the Tsunami) | OK (Permanently installed on December 21, 2011) |

2. The detectors and the building washed away by the Tsunami
(Photo taken on April 24, 2011)

Since MP-7 was washed away by the Tsunami, measurement utilizing a portable monitoring post was started on March 21, 2011. Detectors were then installed and measurement utilizing a temporary monitoring post was started on June 13, 2011. The permanent installation was completed on December 21, 2011 allowing for measurement by the new monitoring post.

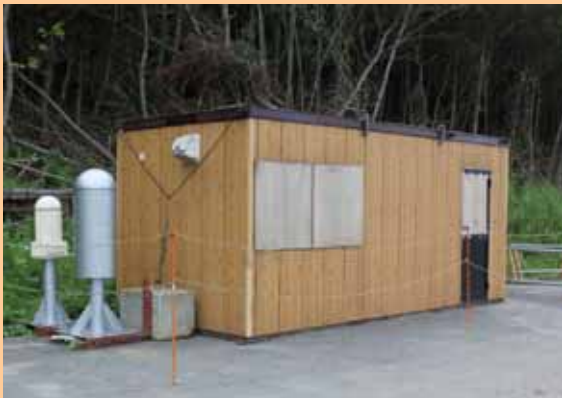
3. Temporary MP-7
(Photo taken on August 26, 2011)
Measurement utilizing the temporary monitoring post was started on June 13, 2011.

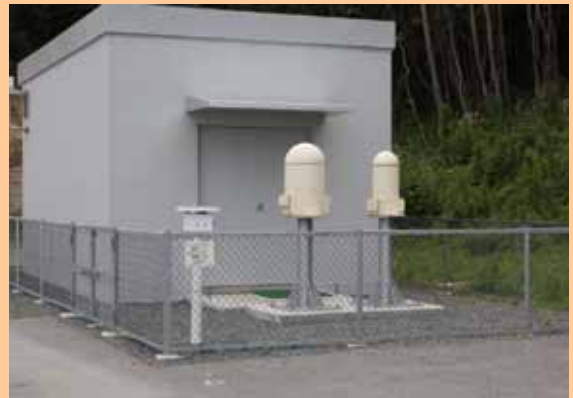
4. Newly installed MP-7
(Photo taken on July 24, 2012)
The permanent installation was completed on December 21, 2011.

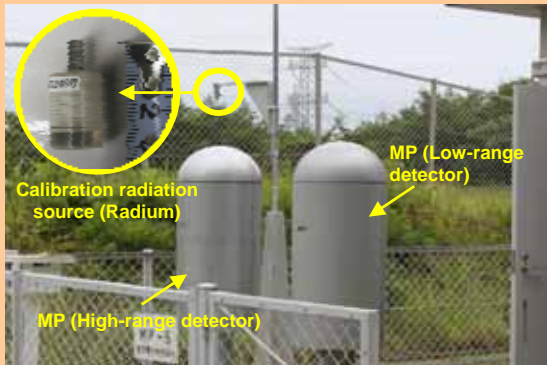
Irradiate the monitoring post with a calibration radiation source (of a very low radiation dose which is harmless to humans) to confirm that the detector functions properly. Check the measurement values acquired during the irradiation on the monitoring panel in the building to see if the values are within the criteria.

1. Irradiate the monitoring post with a calibration radiation source

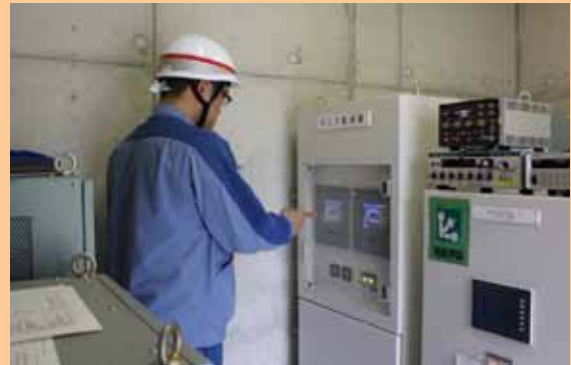
Check the measurement values on the monitoring panel.

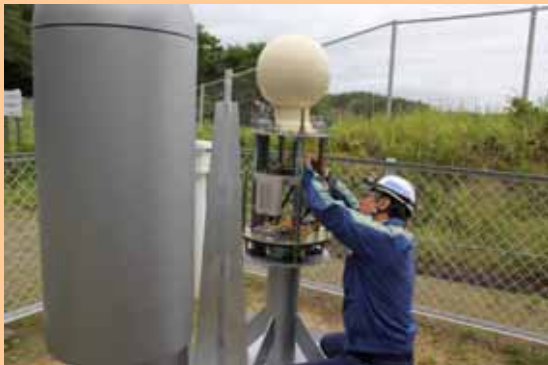
Remove the cover from the monitoring post and clean the inside of it.

Cleaning the inside of the monitoring post

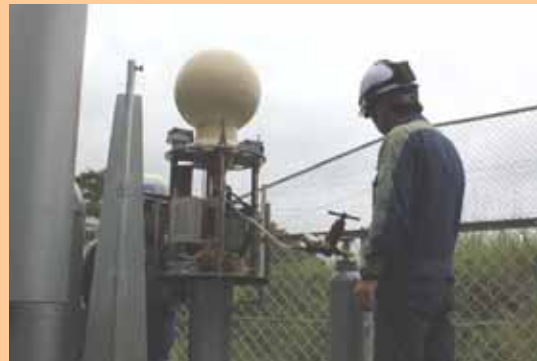
Inject nitrogen gas in order to maintain the consistent humidity level inside the container storing the detector and ensure the detector accuracy.

Nitrogen gas injection

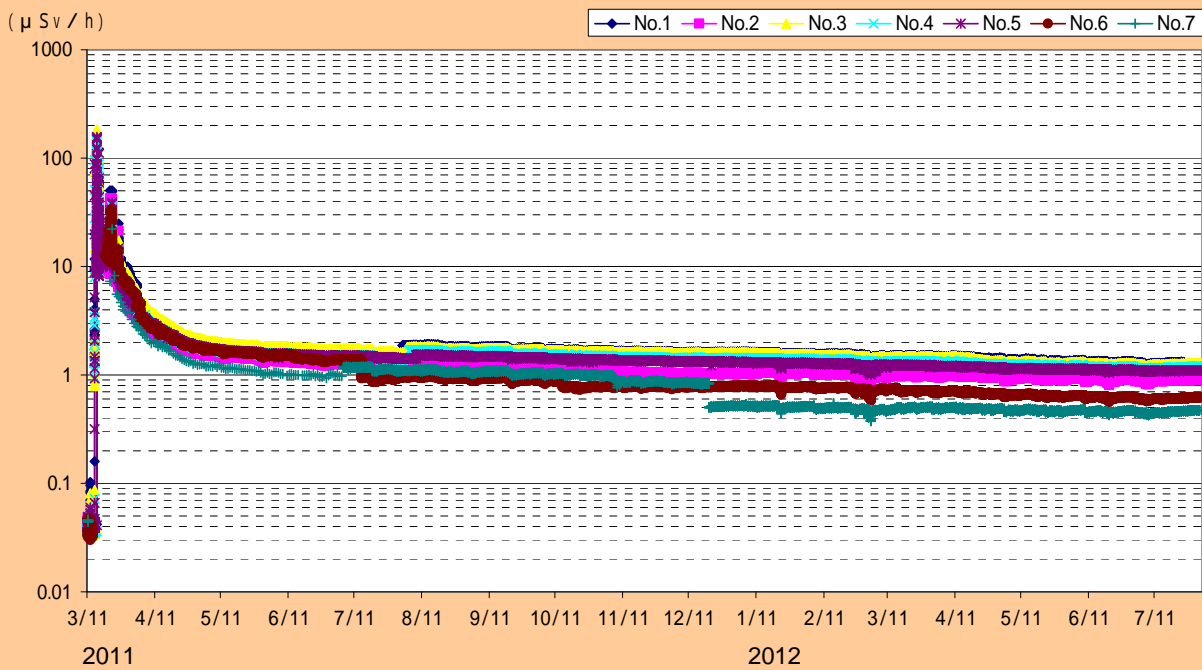
Monitoring post measurement results acquired from March 11, 2011 to July 31, 2012

- The radiation dose on the power station border exceeded $5 \mu\text{Sv/h}$ at 10:07 PM on March 14, 2011 (MP-1) and at 12:12 AM on March 15, 2011 (MP-3), which was judged to be an occurrence of a specified event (radiation dose increase on the site border) according to Article 10 of the Act on Special Measures Concerning Nuclear Emergency Preparedness. However, it was estimated that the specified event was caused by the radioactive materials released into the air due to the accident at Fukushima Daiichi Nuclear Power Station.

- After 9:30 AM on April 3, 2011, the radiation dose detected on the site border decreased to $5 \mu\text{Sv/h}$, and it was judged that the condition had recovered from the specified event stipulated by Article 10 of the Act on Special Measures Concerning Nuclear Emergency Preparedness (radiation dose increase on the site border) at 8:23 AM on April 8, 2011.

- As of July 31, 2012, the range of measurement values acquired by MP-1 to 7 is $0.5\text{-}1.3 \mu\text{Sv/h}$.
