Installation of the emergency diesel generator (A) in Unit 1 Reactor Building Annex (August 31)

As for the emergency diesel generator (A) in Unit 1 Reactor Building Annex which was damaged by the Tsunami, the control panel was removed on August 2. The generators* newly manufactured and repaired were installed on August 31.

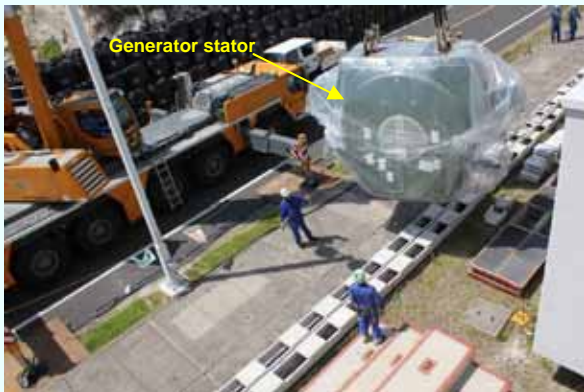
1. Generator stator being lifted up by a crane car (Photo taken on August 7, 2012)

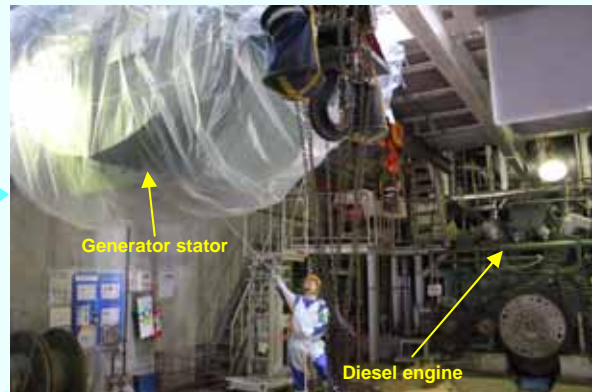
2. Generator stator being lifted down into the building (Photo taken on August 7, 2012)

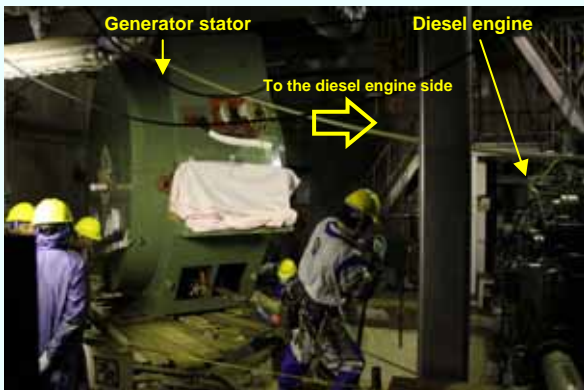
3. Generator stator being moved (Photo taken on August 8, 2012)

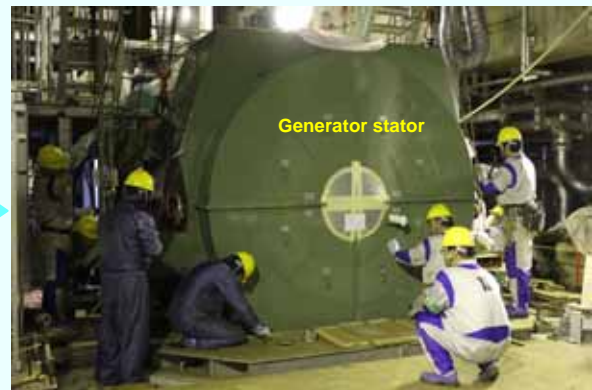
4. Generator stator being installed (Photo taken on August 8, 2012)

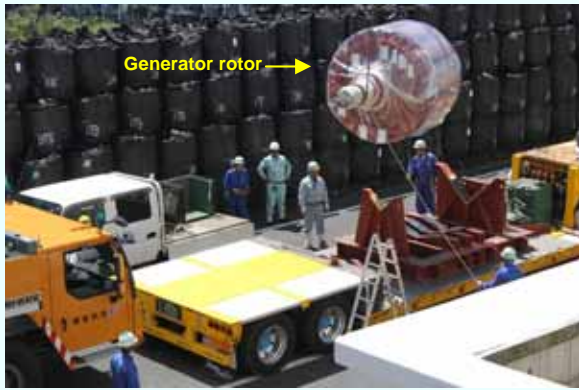
1. Generator rotor being lifted up by a crane car (Photo taken on August 20, 2012)

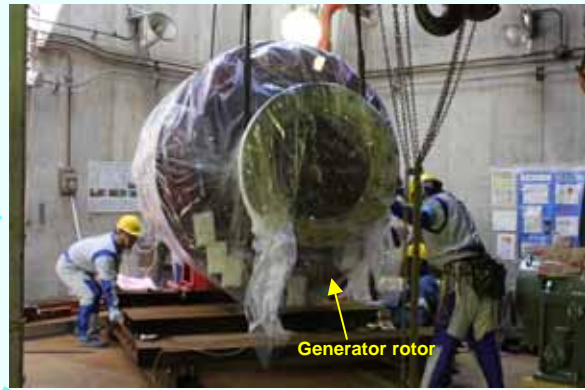
2. Generator rotor being lifted down into the building (Photo taken on August 20, 2012)

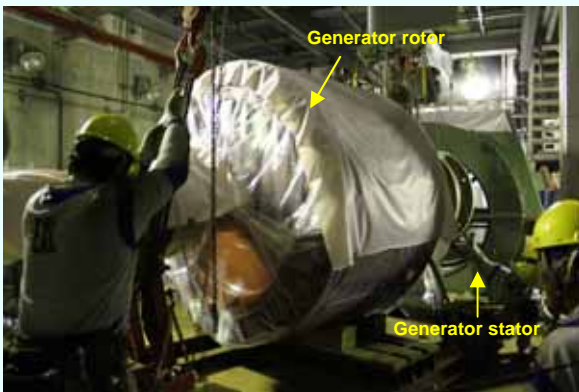
3. Generator rotor being moved (Photo taken on August 21, 2012)

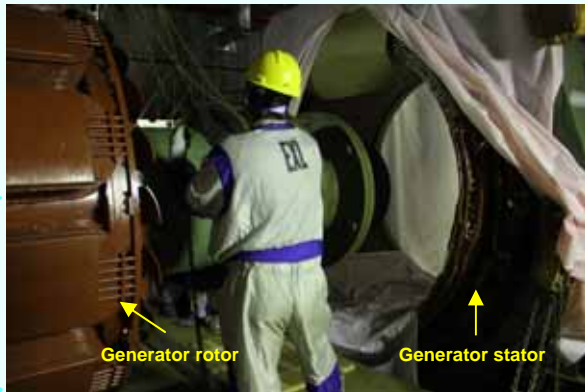
4. Generator rotor being inserted into the generator stator (Photo taken on August 22, 2012)

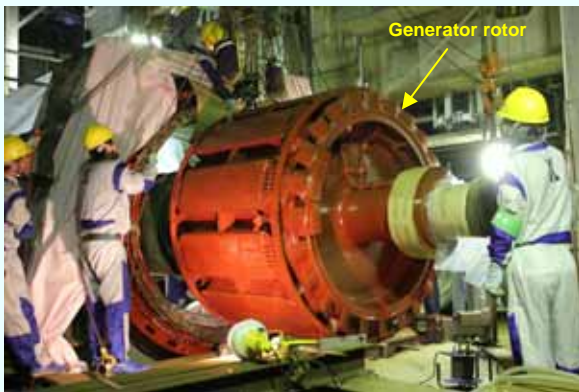
5. Generator rotor being inserted into the generator stator (Photo taken on August 22, 2012)

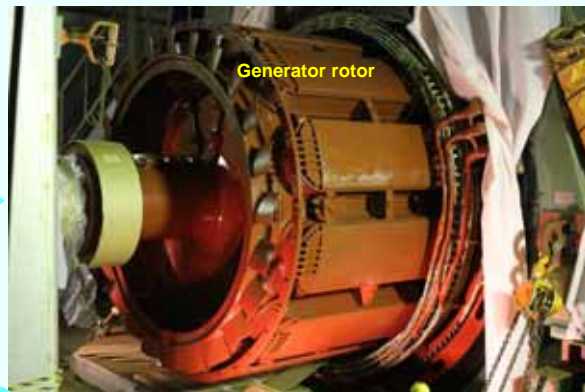
6. Generator rotor being inserted into the generator stator (Photo taken on August 22, 2012)

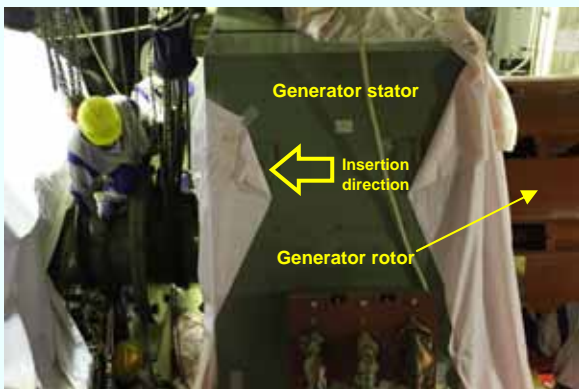
7. Generator rotor being inserted into the generator stator (From above) (Photo taken on August 22, 2012)

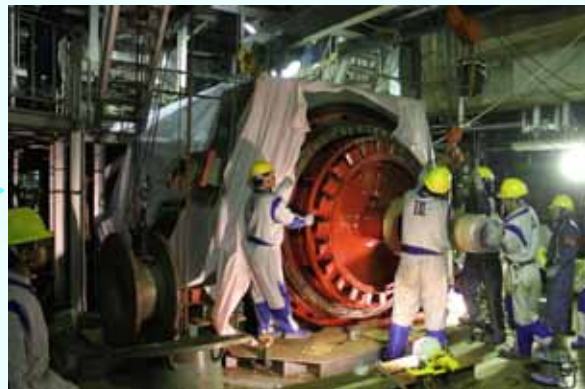
8. Generator rotor being inserted into the generator stator (Photo taken on August 22, 2012)

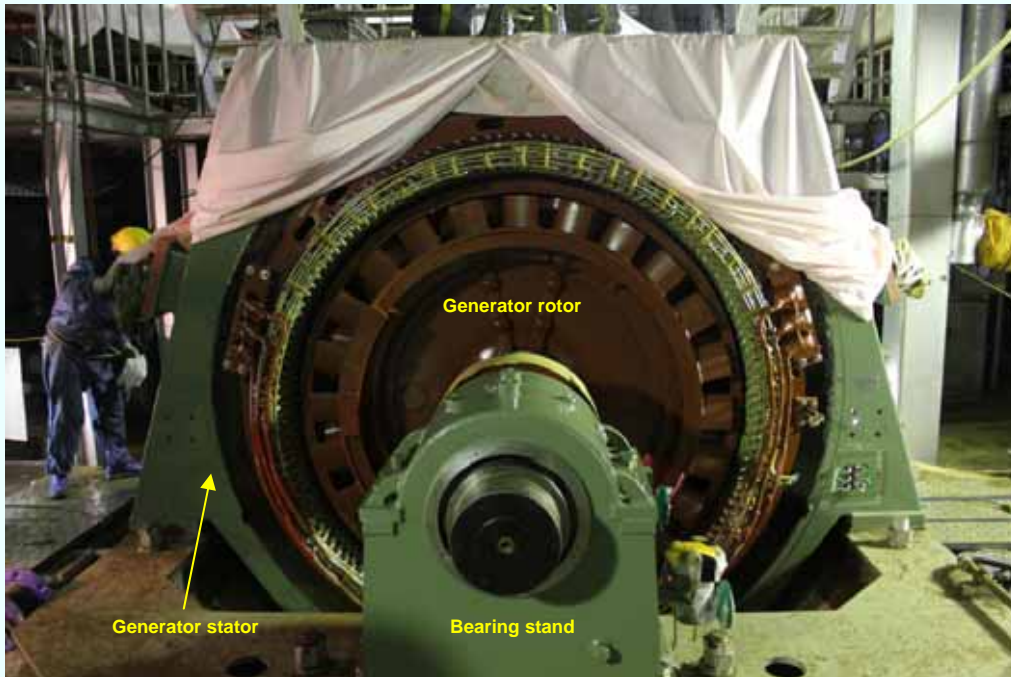
Generator installation completed on August 31, 2012 (Photo taken on August 31, 2012)

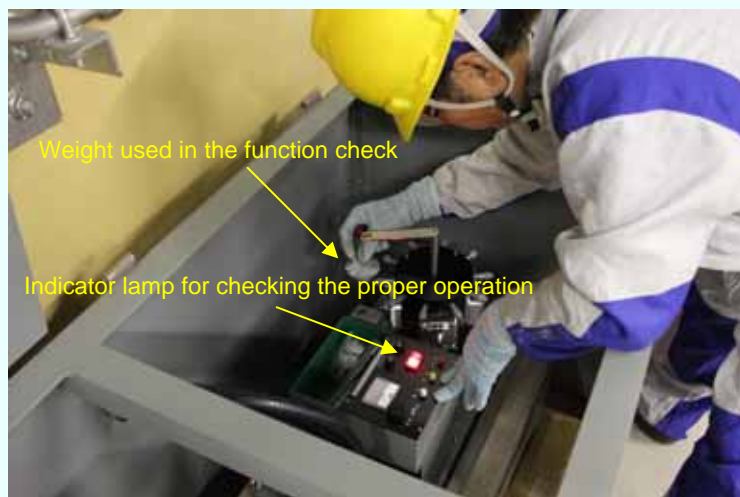
Function check (Second basement of Unit 1 Reactor Building)
(Photo taken on July 25, 2012)

A weight was placed on the seismometers to check for their proper operation.

All the seismometers in Unit 1 Reactor Building (12 including 4 damaged by the Tsunami) newly manufactured by June 13 have been permanently installed after a function check was completed on August 6.

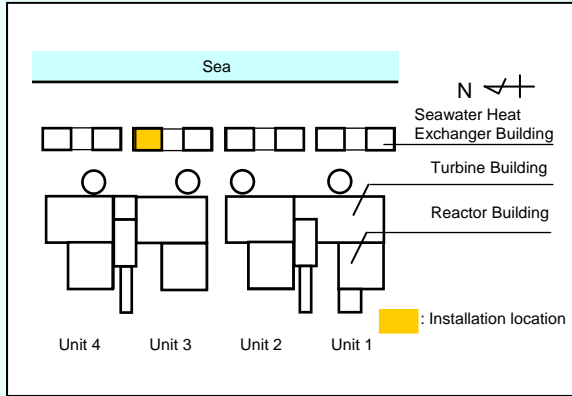
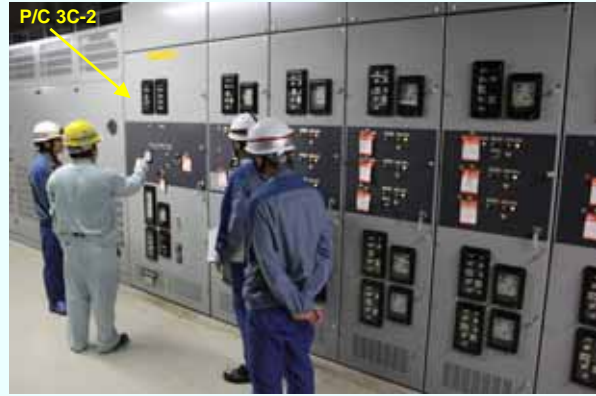
Function check (Photo taken on August 27, 2012)

As for the power panel (P/C 3C-2) in Unit 3 Seawater Heat Exchanger Building which was damaged by the Tsunami, a new power panel was manufactured and installed on January 27. The power panel was permanently installed after a function check was performed on August 27.
