Measures against Radioactive Water Leakage in Unit3 Turbine Building of Fukushima Daiichi Nuclear Power Station

October 31, 2012
Tokyo Electric Power Company

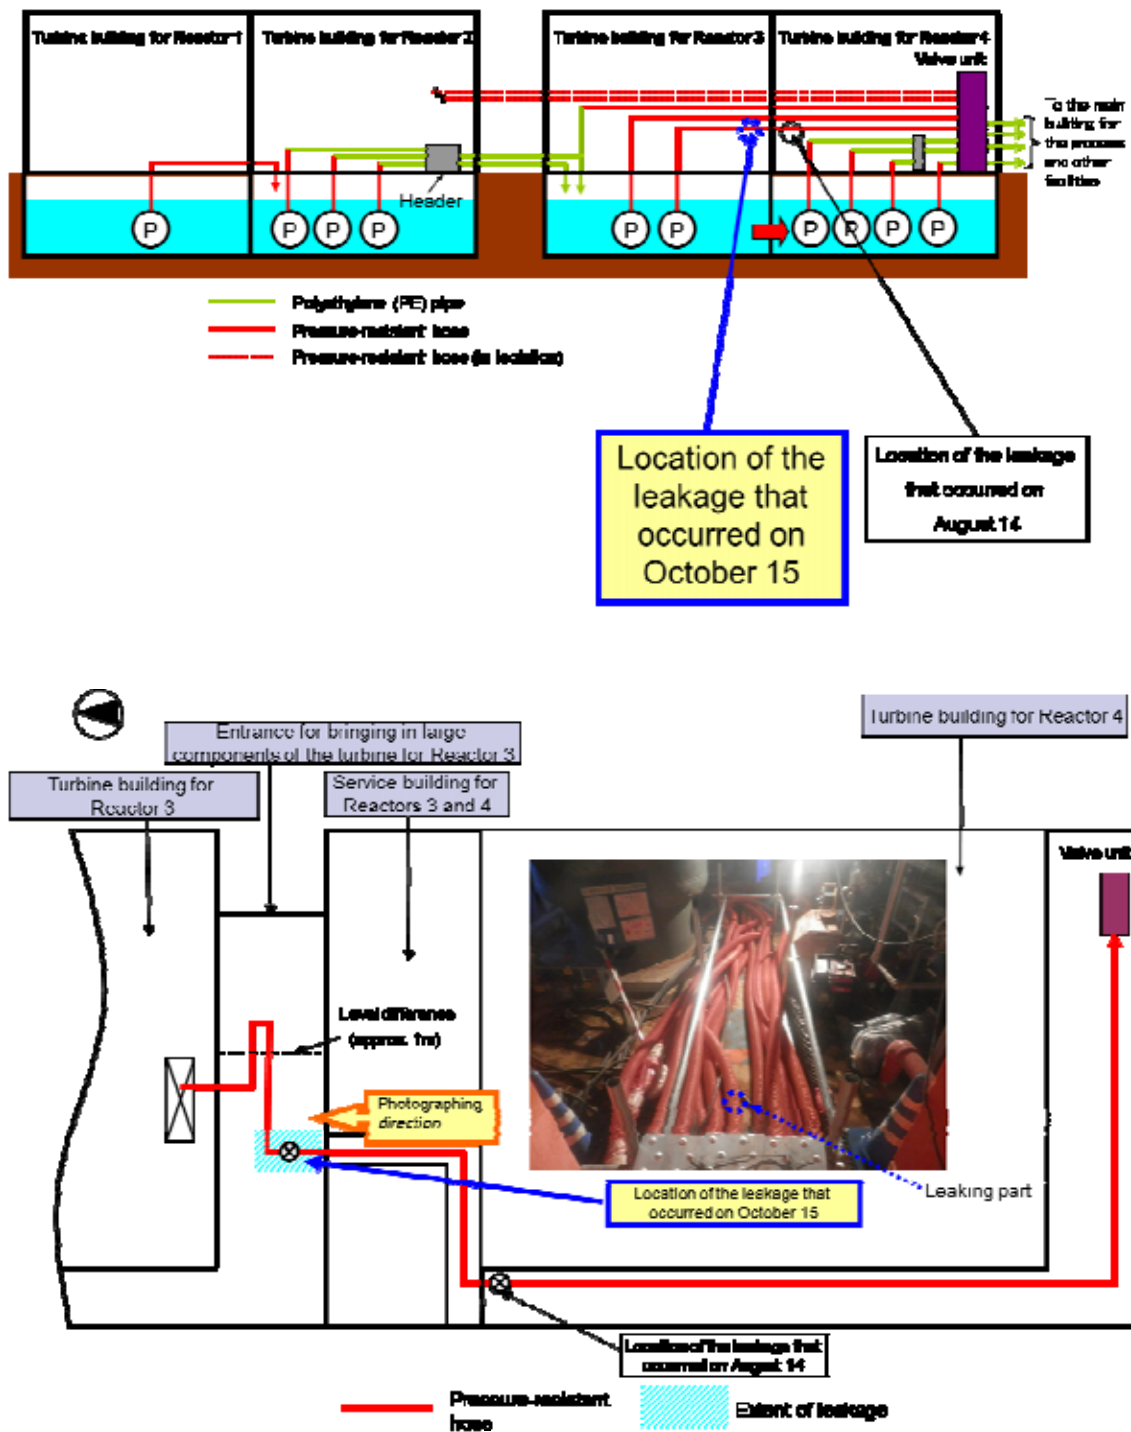
Fig.1 Location of the Leakage in the Turbine Building

At about 10:00 a.m., on October 15, 2012, employees of a subcontracting company at work discovered that water was leaking near the entrance for bringing in large components on the first floor of the turbine building for Reactor 3 of Fukushima Daiichi Nuclear Power Station. They notified employees of Tokyo Electric Power Company (TEPCO) of what they had discovered and the TEPCO employees confirmed at 10:10 a.m. that it was surely a leakage (Fig.1).

Many hoses are installed in the area of the first floor of the turbine building for Reactor 3 in which the leakage occurred. These hoses are installed in such a way that they almost cover the entire area with a width of approx. 1.5m with some of the hoses overlapping (Fig.1).

We ran flushing water through the line in question and confirmed that the leaking part of the pressure-resistant hose was the upper part of the hose located near the entrance for bringing in large components on the first floor of the turbine building for Reactor 3 (Fig.1).

The leaking pressure-resistant hose was laid directly on the floor. There was no other pressure-resistant hose or cable placed on top of the pressure-resistant hose in the vicinity of the leaking section. Many hoses were installed around the location of the leakage in such a way that they almost covered all of an area with a width of approx. 1.5m, but it was possible to walk the vicinity of the location of the leakage without stepping on a pressure-resistant hose because the floor was exposed (Fig.1).

Volume of the pool of the leaked water: approx. 0.09m³ (approx. 3m (length) x approx. 6m (width) x approx. 5mm (depth))

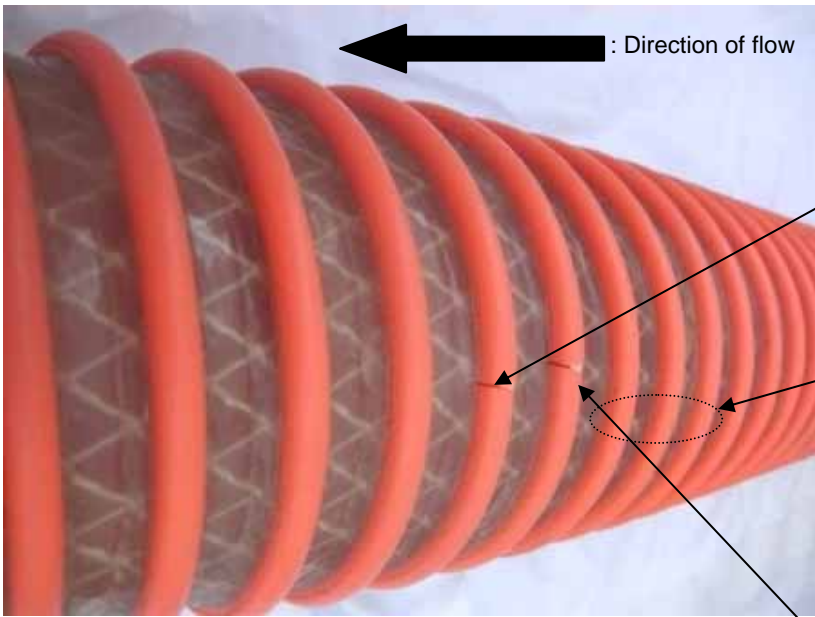
Fig.3 External Surface of the Pressure-resistant Hose from which the Leakage Occurred (the Leaky Part)

Cracks on the hose surface: There were cracks in the upper parts of 5 reinforcement rings on the hose. Of the cracks in the 5 locations, the cracks in 3 locations were cracks inside the reinforcement rings. There was no crack in the lower part of the hose or the lower parts of the reinforcement rings.

We also checked the external surface of the hose around the leaking section. Other than the above-mentioned crack of the leaking section penetrating both the reinforcement ring and the main body of the hose, there were 3 locations where there was a crack in the inner circumferences of reinforcement rings in the upper part of the hose. The cracks at these 3 locations originated from the points where the reinforcement rings are bonded to the main body of the hose, but there was no sign of penetration on the outer circumferences of the reinforcement rings.

Crack in reinforcement ring: one location

Internal crack in reinforcement ring: 3 locations

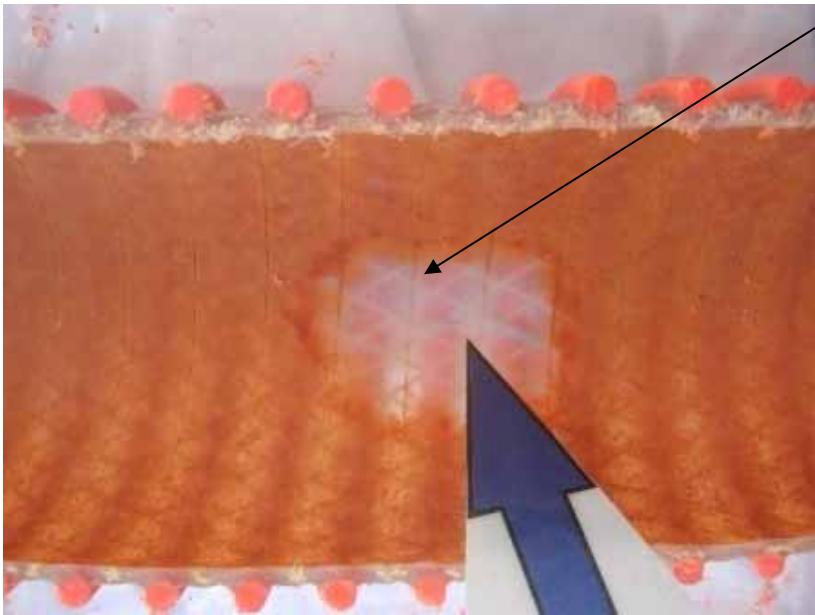
Fig.4 Internal Surface of the Pressure-resistant Hose from which the Leakage Occurred (the Leaking Section)

We located the leaking section of the pressure-resistant hose by running water through the hose. The leaking section was located in the upper part of the hose. We made a detailed examination of the opening and found that the opening was a linear crack penetrating both the reinforcement ring and the main body of the hose. Because the crack in the main body of the hose is longer on the outside of the hose than on the inside, it is considered that the crack developed from the outside to the inside.

(Leaking section)
Penetrating cracks in the reinforcement ring and the main body of the hose: one location

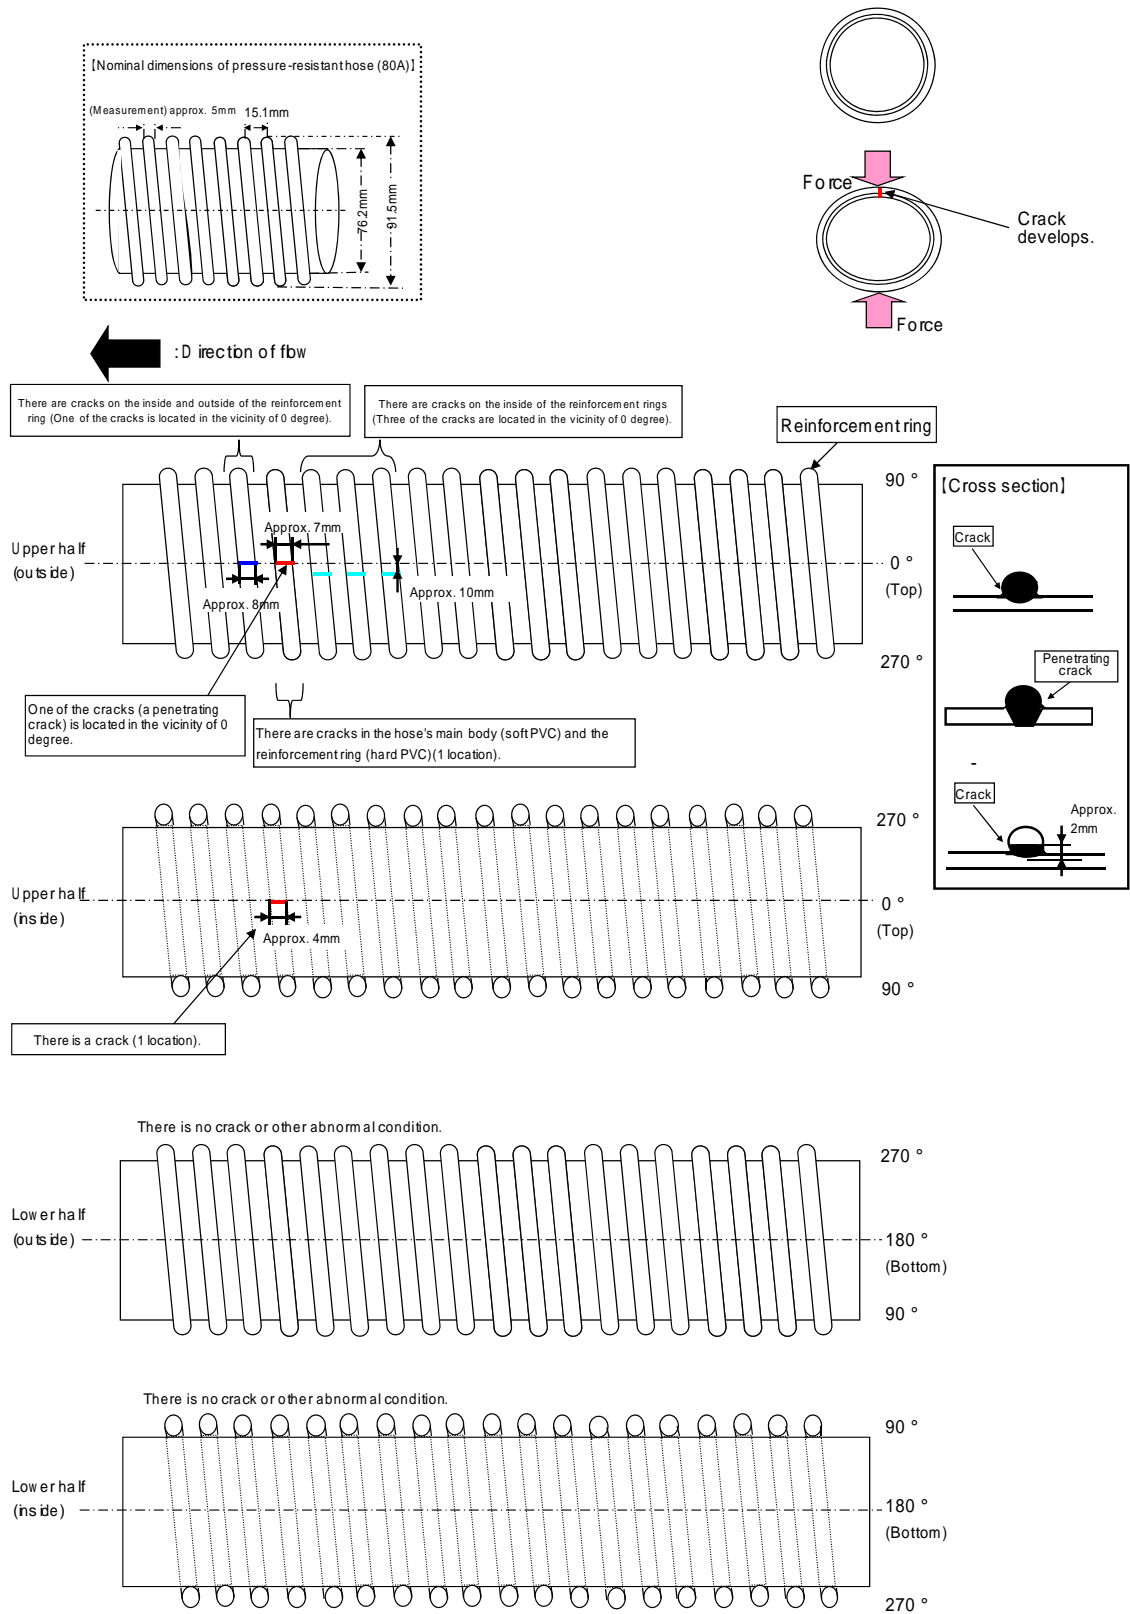
Fig.5 Results of the Inspections of the External and Internal Surfaces of the Pressure-resistant Hose

We visually inspected the external surface of the pressure-resistant hose from which the leakage in question had occurred. The results are as follows (Figs. 3 and 5):

We cut the leaky hose near the leaky part and visually inspected the internal surface. The results of the inspection are as follows (Figs. 4 and 5):

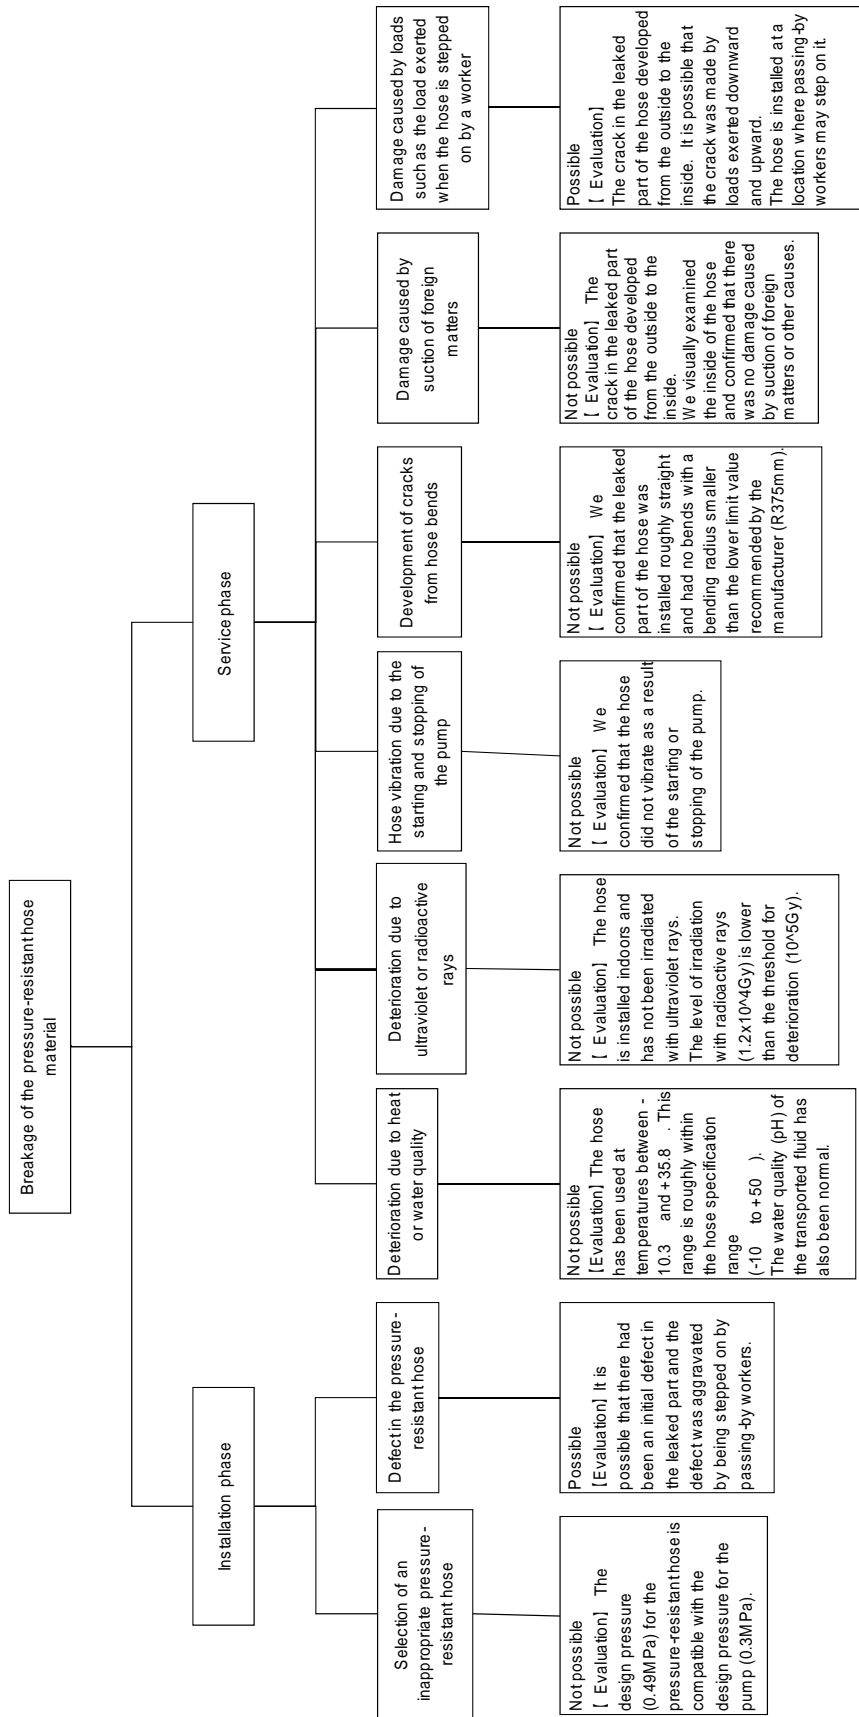
Fig.6 Causal Factors for the Hose Damage

As the leakage from the pressure-resistant hose was through a crack that developed in the main body of the hose, we made evaluations, as described below, of causal factors for the installation phase of the hose and causal factors for the service phase of the hose to identify the causes of the development of the crack based on the results of the inspection of the leaky part (Fig.6).

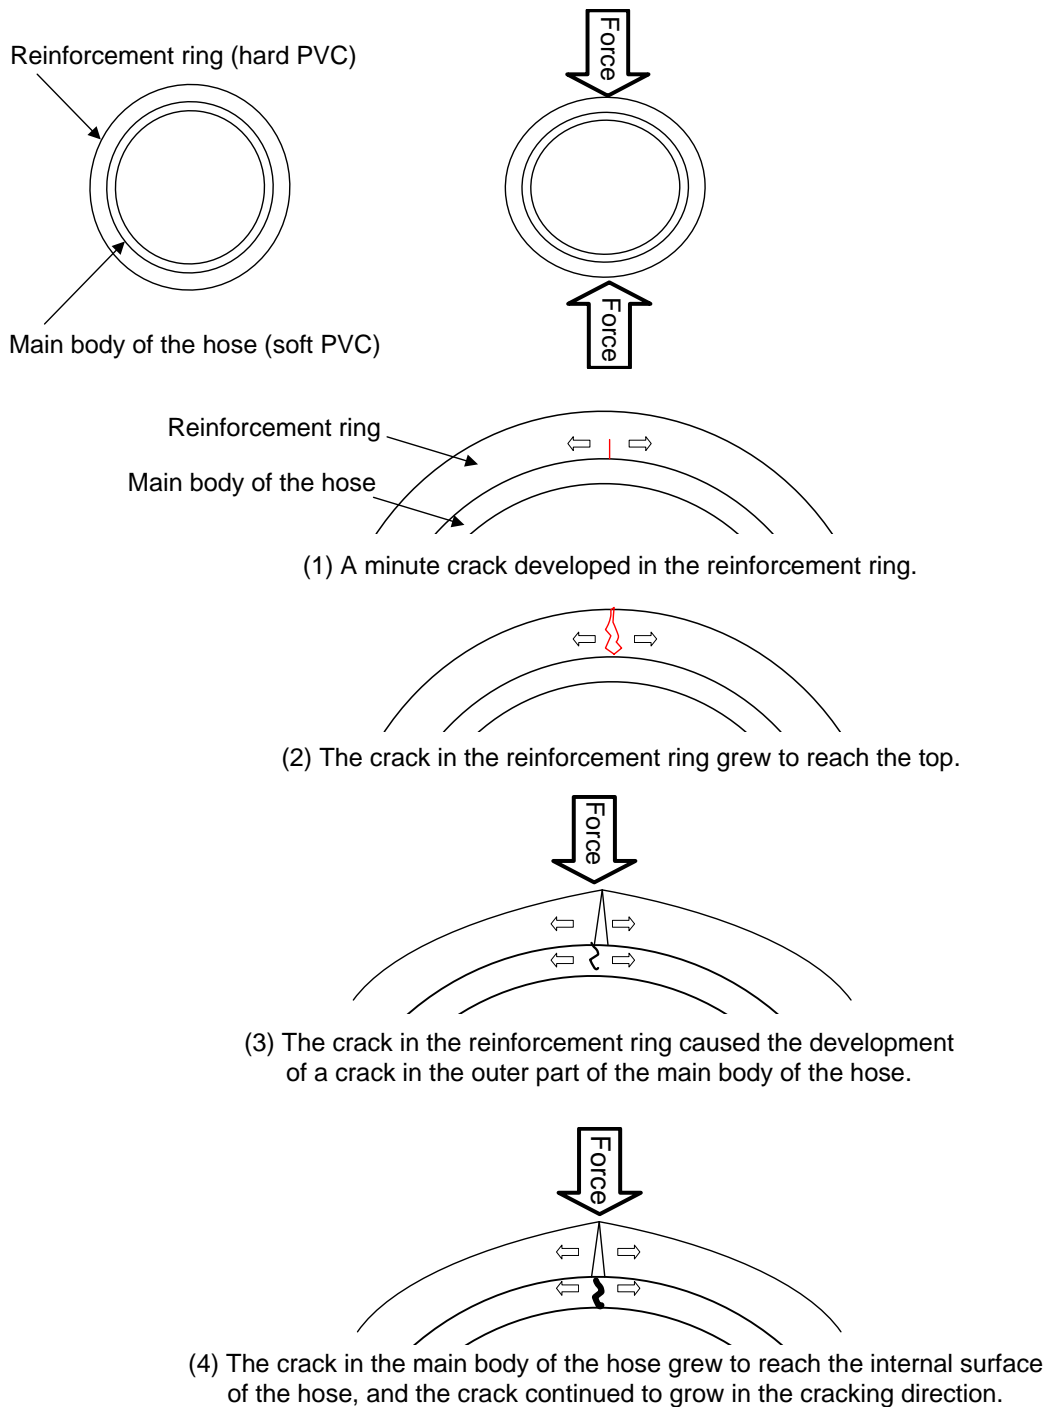
Fig.7 Schematic Diagram of the Development and Growth of the Crack in the Pressure-resistant Hose

From these facts, it is presumed that external forces acted for some unknown reasons on the pressure-resistant hose that compressed the pressure-resistant hose vertically without damaging the external surface, the external forces generated a localized tensile stress in the upper part of the pressure-resistant hose, the tensile stress caused cracks to develop in the reinforcement ring, which are made of hard vinyl chloride, whose elongation is relatively small, from the inner circumferences of the rings, the cracks gradually grew, one of the cracks penetrated a reinforcement ring, and the crack grew further and into the main body of the pressure-resistant hose, which is made of soft vinyl chloride, whose elongation is relatively large (Fig.7).

On the basis of the above-mentioned facts and analyses, we presume that the October 15 leakage occurred as a result of the development of a crack in the pressure-resistant hose due to repeated trampling of the hose by workers before the commencement of implementation of the measures to prevent recurrences of the previous leakage incident and the expansion of the crack due to the pressure imposed by the operation.

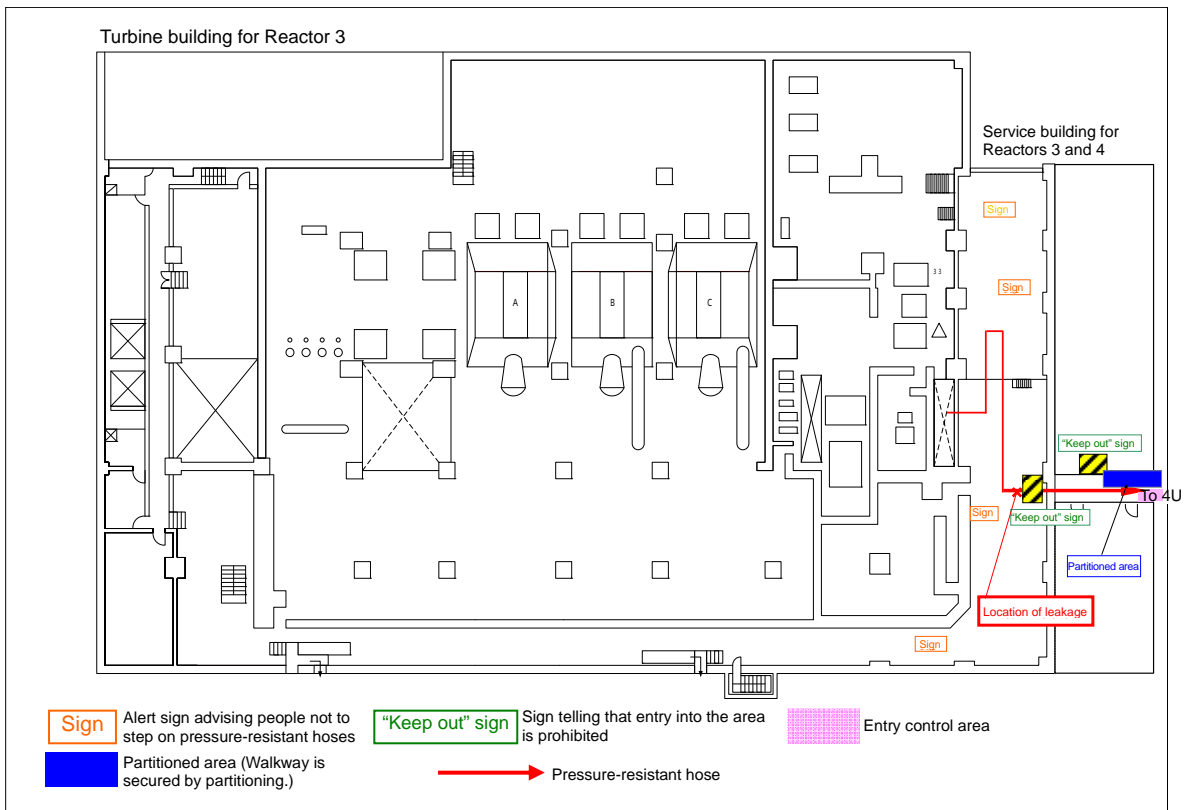
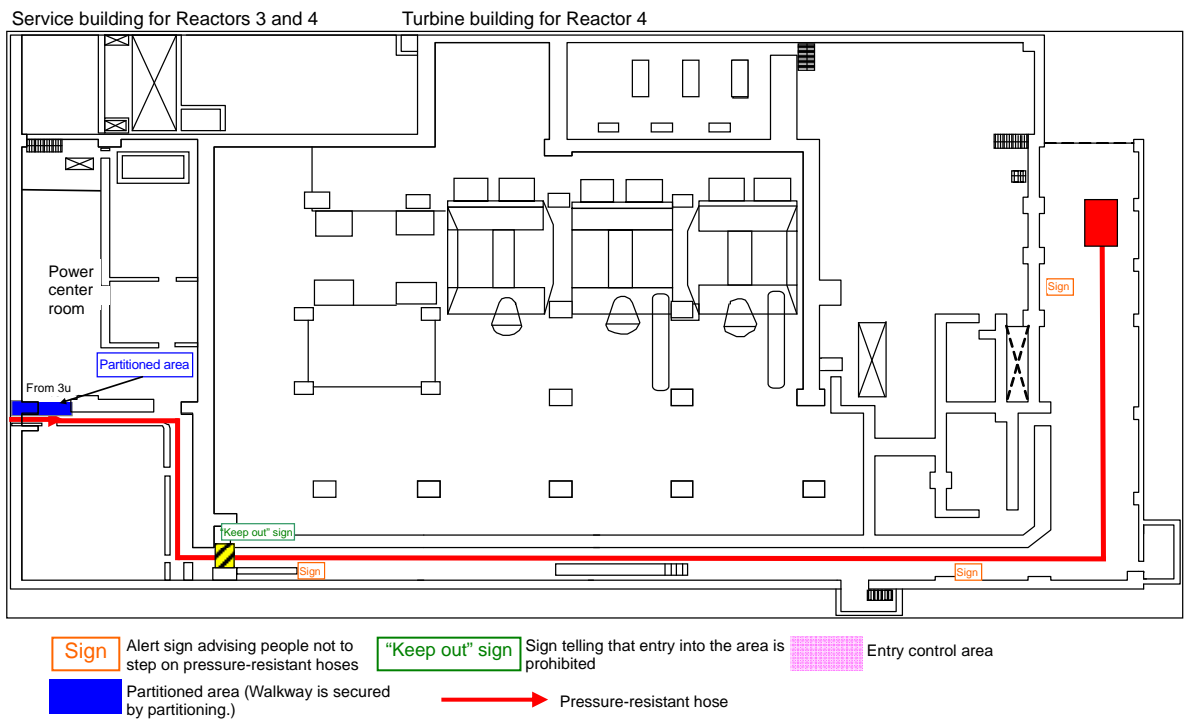
As stated in the statement of the measures to prevent recurrences of the previous leakage incident of the previous report which had been submitted to the Nuclear and Industrial Safety Agency by Tokyo Electric Power Company (see Chapter 3), our employees and subcontracting companies had been instructed not to step on pressure-resistant hoses and efforts were being made to promote consciousness among concerned people of the importance of avoiding stepping on pressure-resistant hoses, including the alerting signs set up in the area around the location of the October 15 leakage (Fig.8).

The following measures were taken to prevent people from stepping on pressure-resistant hoses of the transfer line for Reactors 3 and 4, on which the previous leakage incident had occurred, because it is necessary to use the pressure-resistant hoses until the polyethylene line is completed (Figs. 8 and 9):

- (a) Alert signs to advise people not to step on the pressure-resistant hoses were set up near the entrances of the buildings and near the areas in which many pressure-resistant hoses are laid close to each other. The meaning of these signs was conveyed to our employees and subcontracting companies through our intranet, which is a common electronic bulletin board for TEPCO and the subcontracting companies. The workers involved in converting lines into polyethylene lines near the location of the leakage are instructed not to step on the pressure-resistant hoses by TEPCO employees during the TBM-KY meeting held prior to commencing work.

- (b) As a measure to isolate pressure-resistant hoses through partitioning, the area from the boundary between the turbine building for Reactor 3 and service building for Reactors 3 and 4 to the boundary between the turbine building for Reactor 4 and service building for Reactors 3 and 4, in which pressure-resistant hoses are laid in a manner similar to that in the area in which the August 14 leakage occurred, was designated as an entry control area.
