Evaluation of the situation of cores and
containment vessels of Fukushima Daiichi
Nuclear Power Station Units-1 to 3
and examination into unsolved issues
in the accident progression

— Progress Report No. 1 —

December 13, 2013

Tokyo Electric Power Co., Inc.

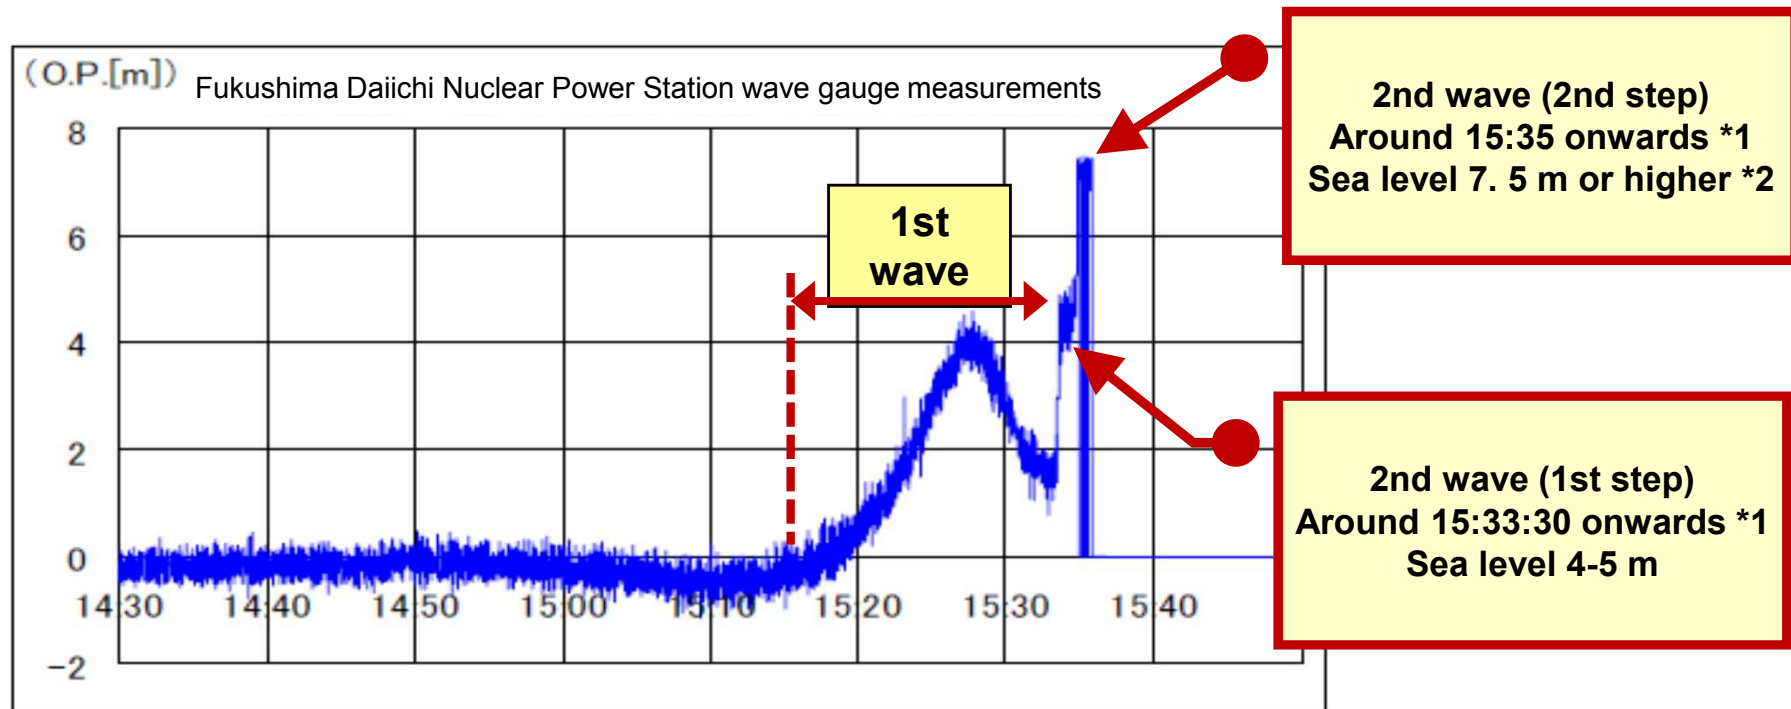
From the recordings made using wave height meter of the tsunami that struck the Fukushima Daiichi Nuclear Power Station, **observations show that the biggest tsunami were made up of the 1st wave & the 2nd wave (1st step), and the 2nd wave (2nd step)**

*1: A problem occurred at around 15:36, resulting in a measured sea level of zero

*2: The observation range of the wave height meter is up to 7.5 m, so levels above 7.5 m are not recorded.

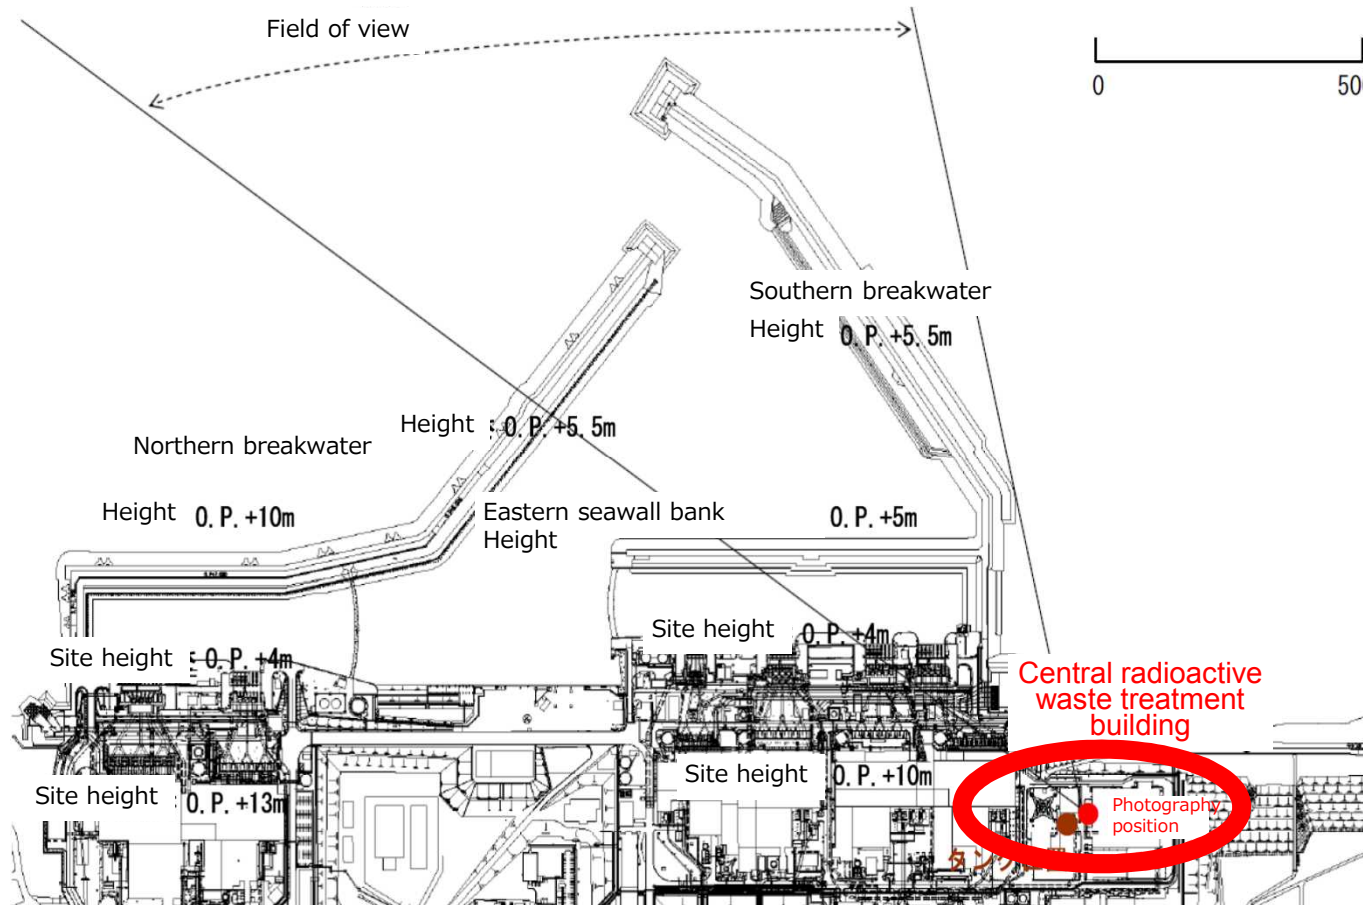
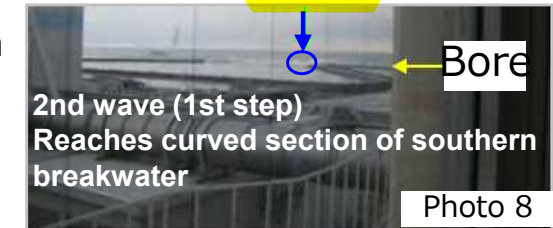
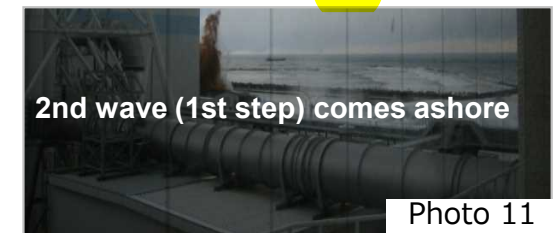
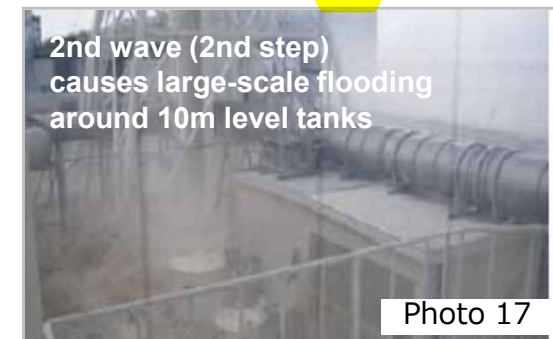
Wave 2, 1st step: At 15:35:40, the wave comes ashore in the site at 4 m above sea level (4 m level); **Wave 2, 2nd step: From 15:36:30 to 15:37**, the wave is estimated to be flowing into the site at 10 m above sea level (10 m level).

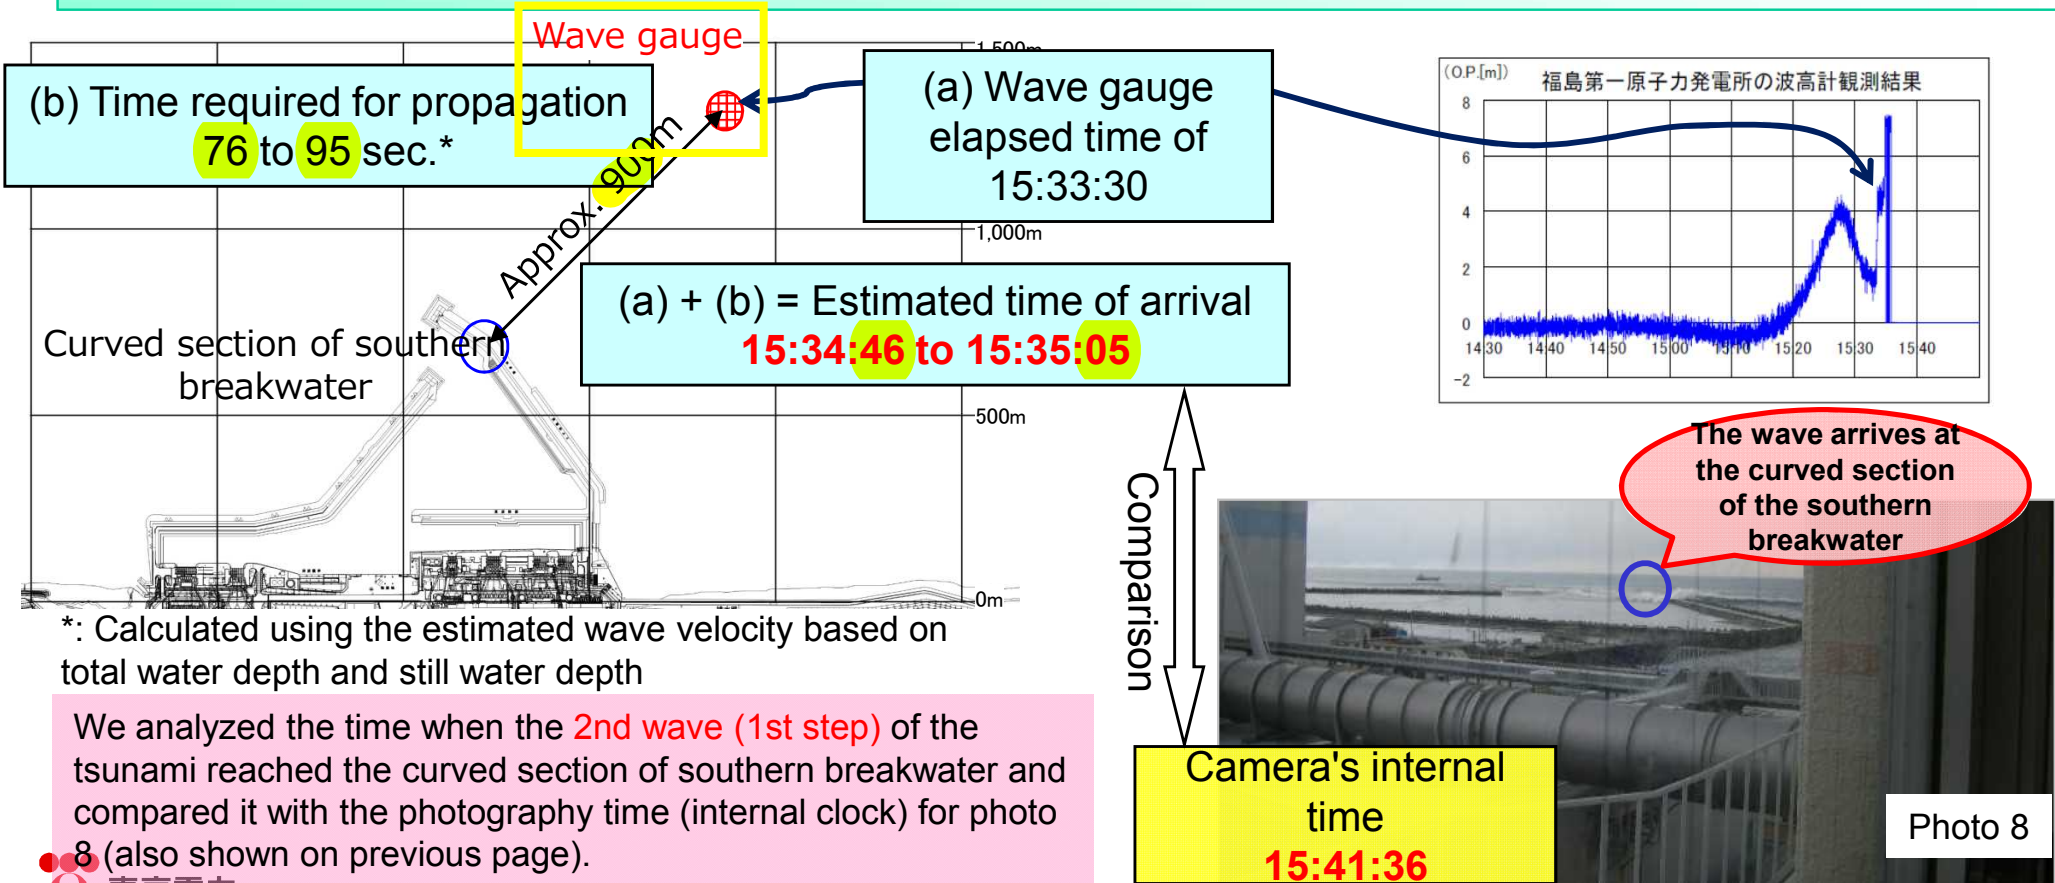
We analyzed the time when tsunami wave 2 (1st step) struck and estimated that the camera's internal clock was fast by between 6 m 31 sec. to 6 m 50 sec. (Hereafter, photography times have been adjusted assuming a median value of 6 m 40 sec.)

We analyzed the time when the **2nd wave (1st step)** of the tsunami reached the curved section of southern breakwater and compared it with the photography time (internal clock) for photo 8 (also shown on previous page).

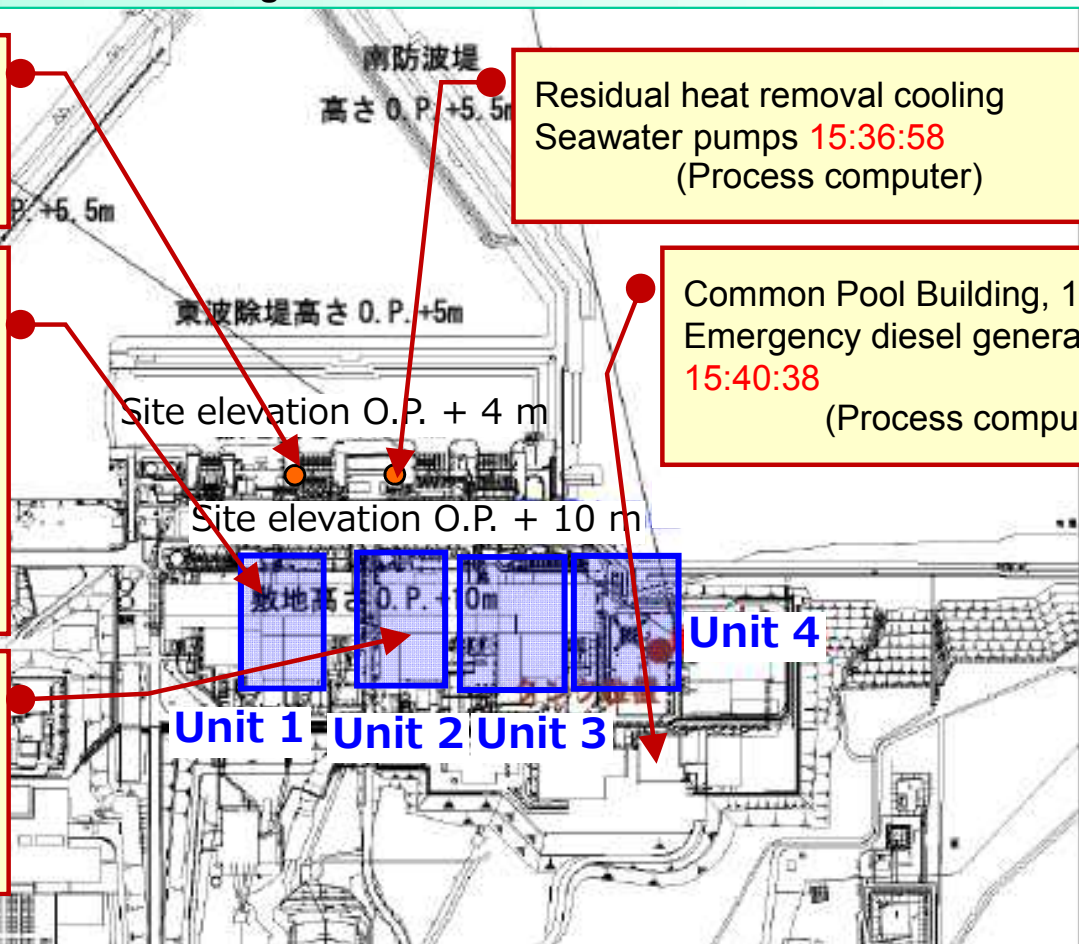
Residual heat removal cooling
 Seawater pumps 15:36:58
 (Process computer)

Common Pool Building, 1st floor
 Emergency diesel generators
 15:40:38
 (Process computer)

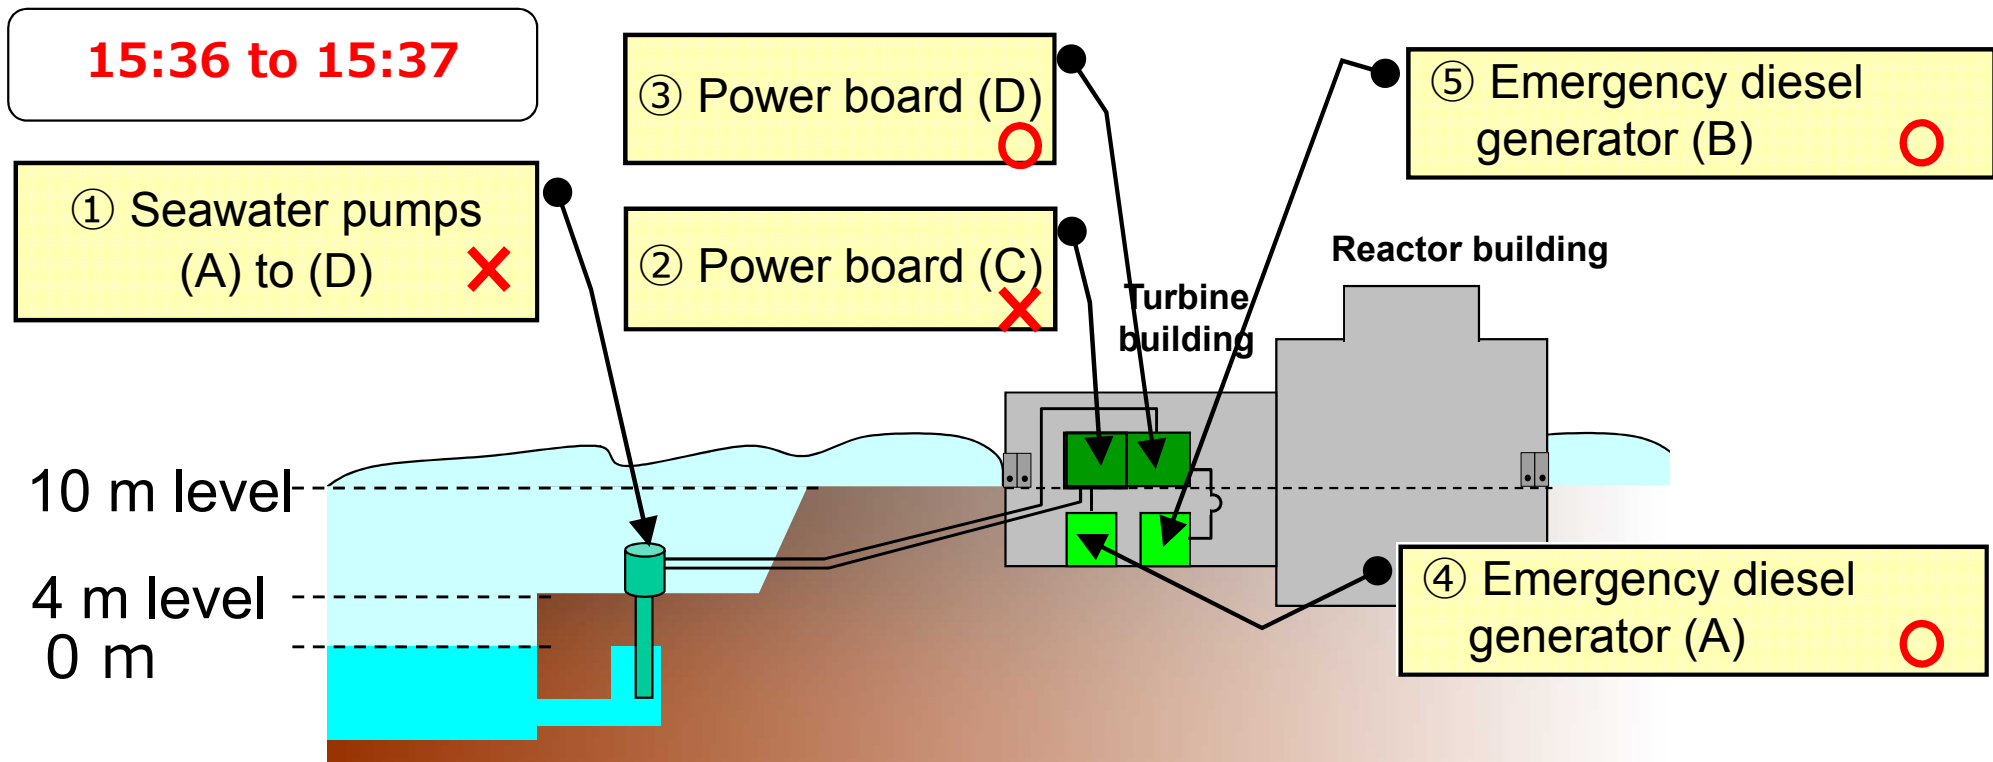
The sequence of function loss in equipment within the site
(function lost sequentially starting from the ocean side)

[15:36] Seawater pump function lost → Bus voltage (C) function lost →

[Subsequently] function lost in bus voltage (D) and emergency diesel generators (A) and (B).

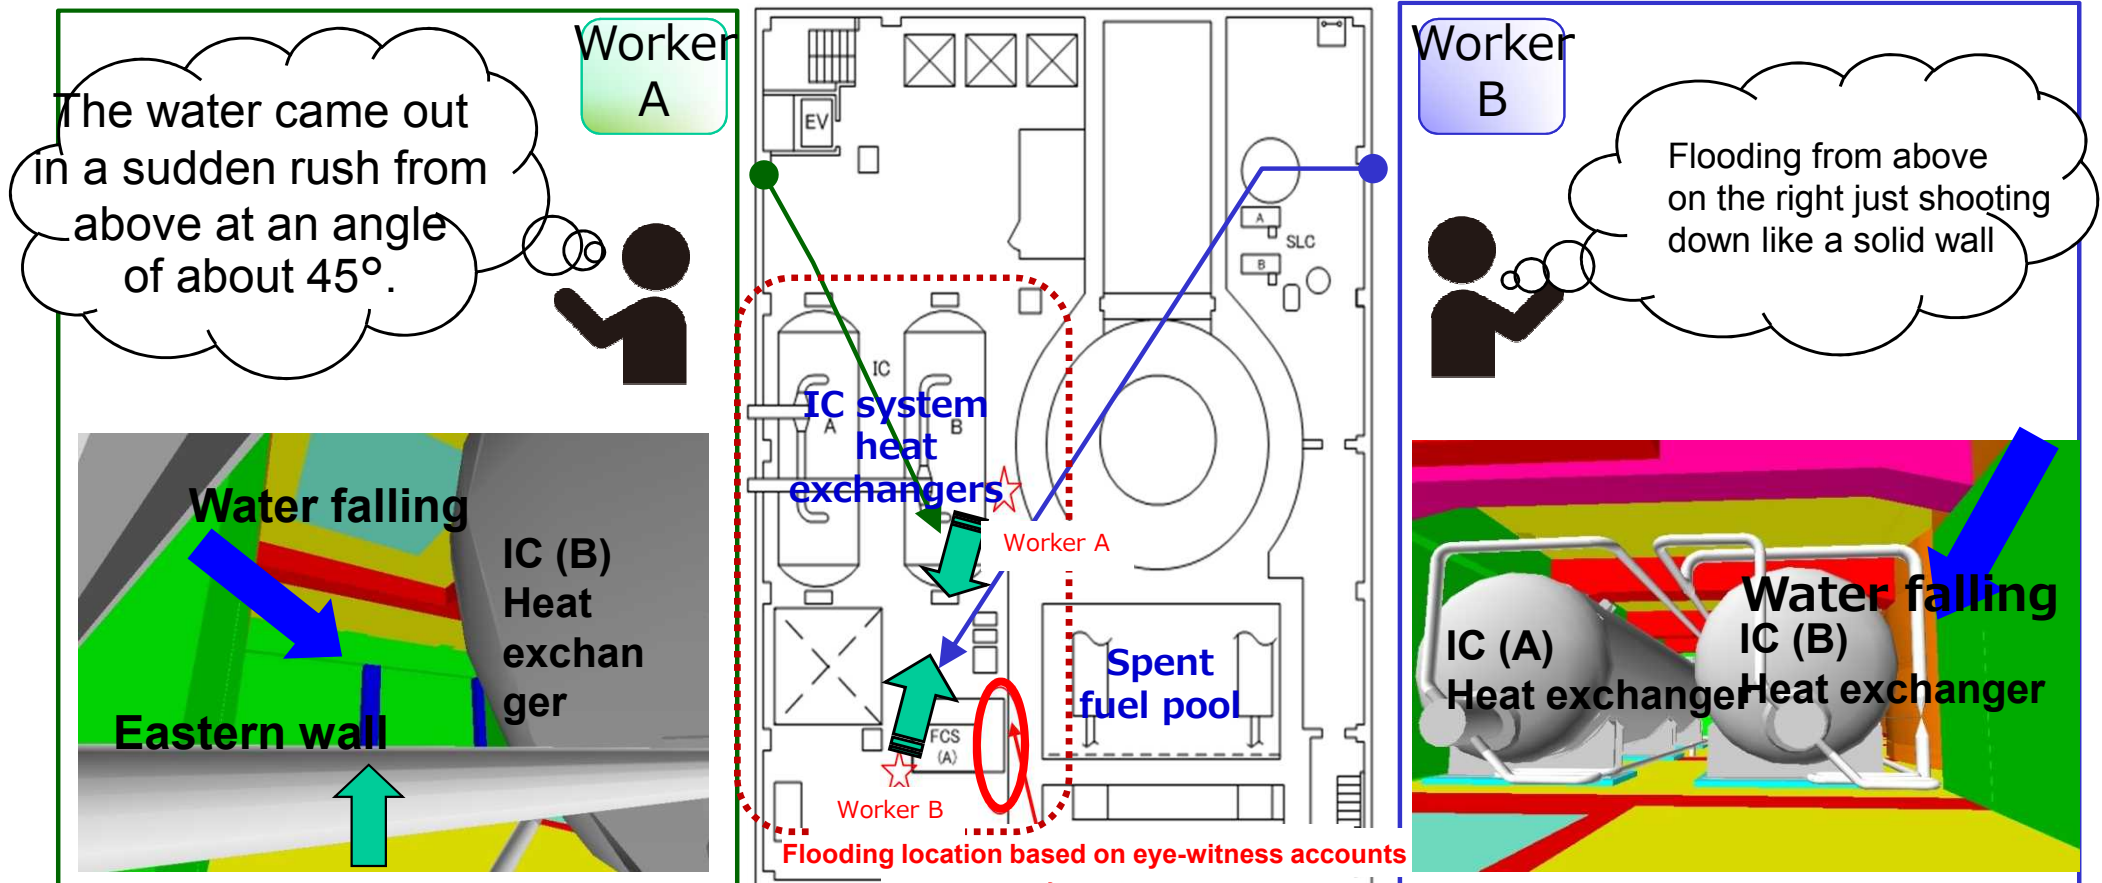
Eye-witness testimony from site workers (2) · Estimation of flooding locations based on images

By matching the eye-witness accounts from both workers, we can estimate that the flooding locations were **in the "overflow prevention chamber"** shown above.

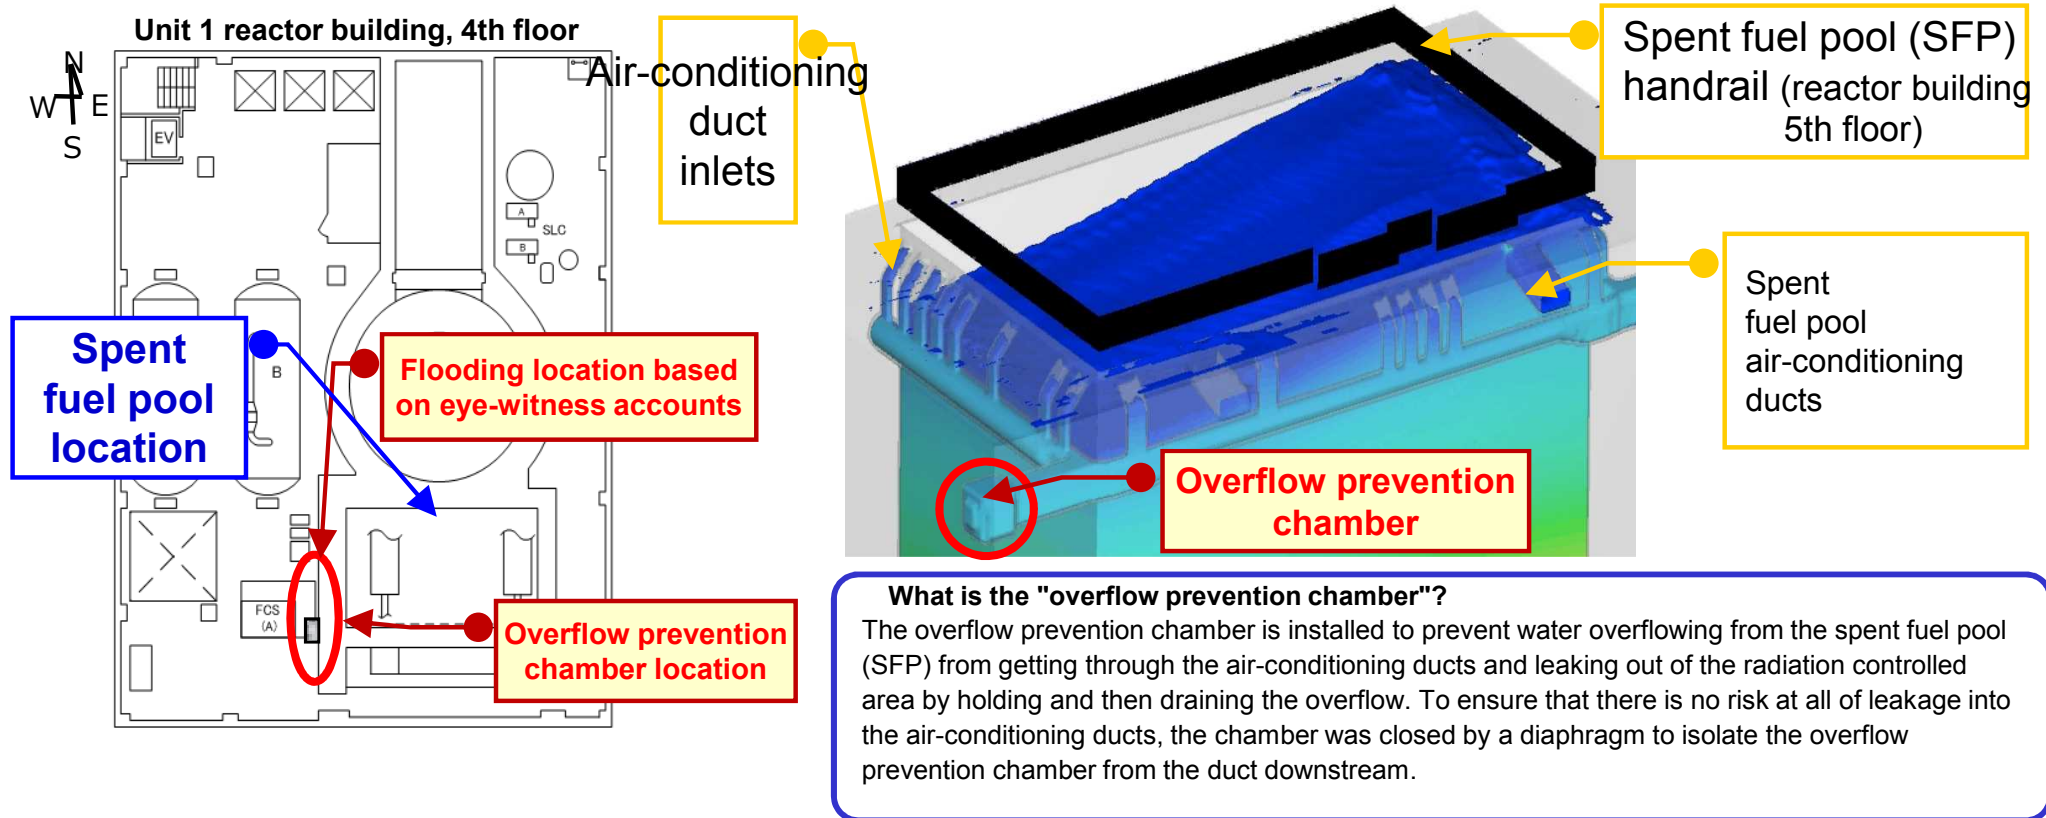
- Studying the drawings made it clear that, apart from this overflow prevention chamber, **there is no other equipment near the flooding location that could cause an overflow** that accords with the eye-witness accounts (see previous page).
- The "Committee on Accident Analysis" of the Nuclear Regulation Authority (NRA) also studied the possibility of flooding from this chamber and concluded that it was highly likely that the flooding was from that location.

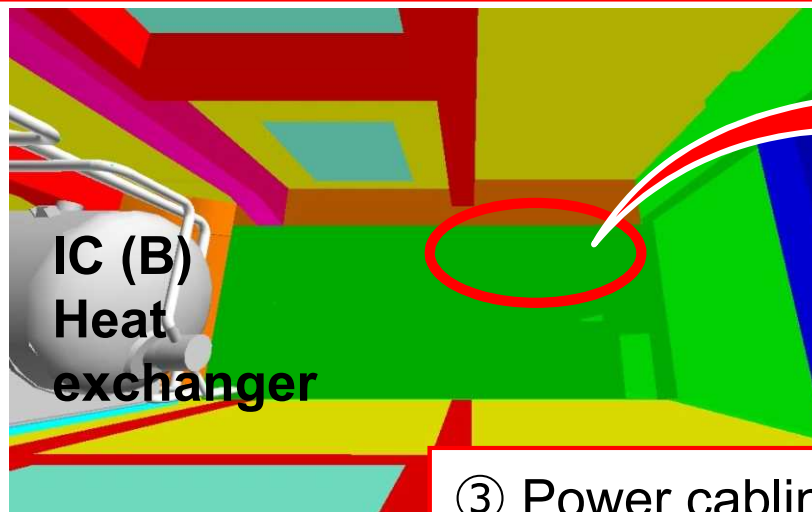
- Site surveys confirmed that, of the equipment and tubing in the vicinity, **water could only have leaked from the overflow prevention chamber.**
- Similarly, site surveys included **visual confirmation of deformation of the chamber itself and deformation or openings in the shutoff plates.**

① **Air-conditioning ducts and overflow prevention chamber**
: **Connected to the surface of the spent fuel pool wall**
Pool water can flow into the chamber during an earthquake

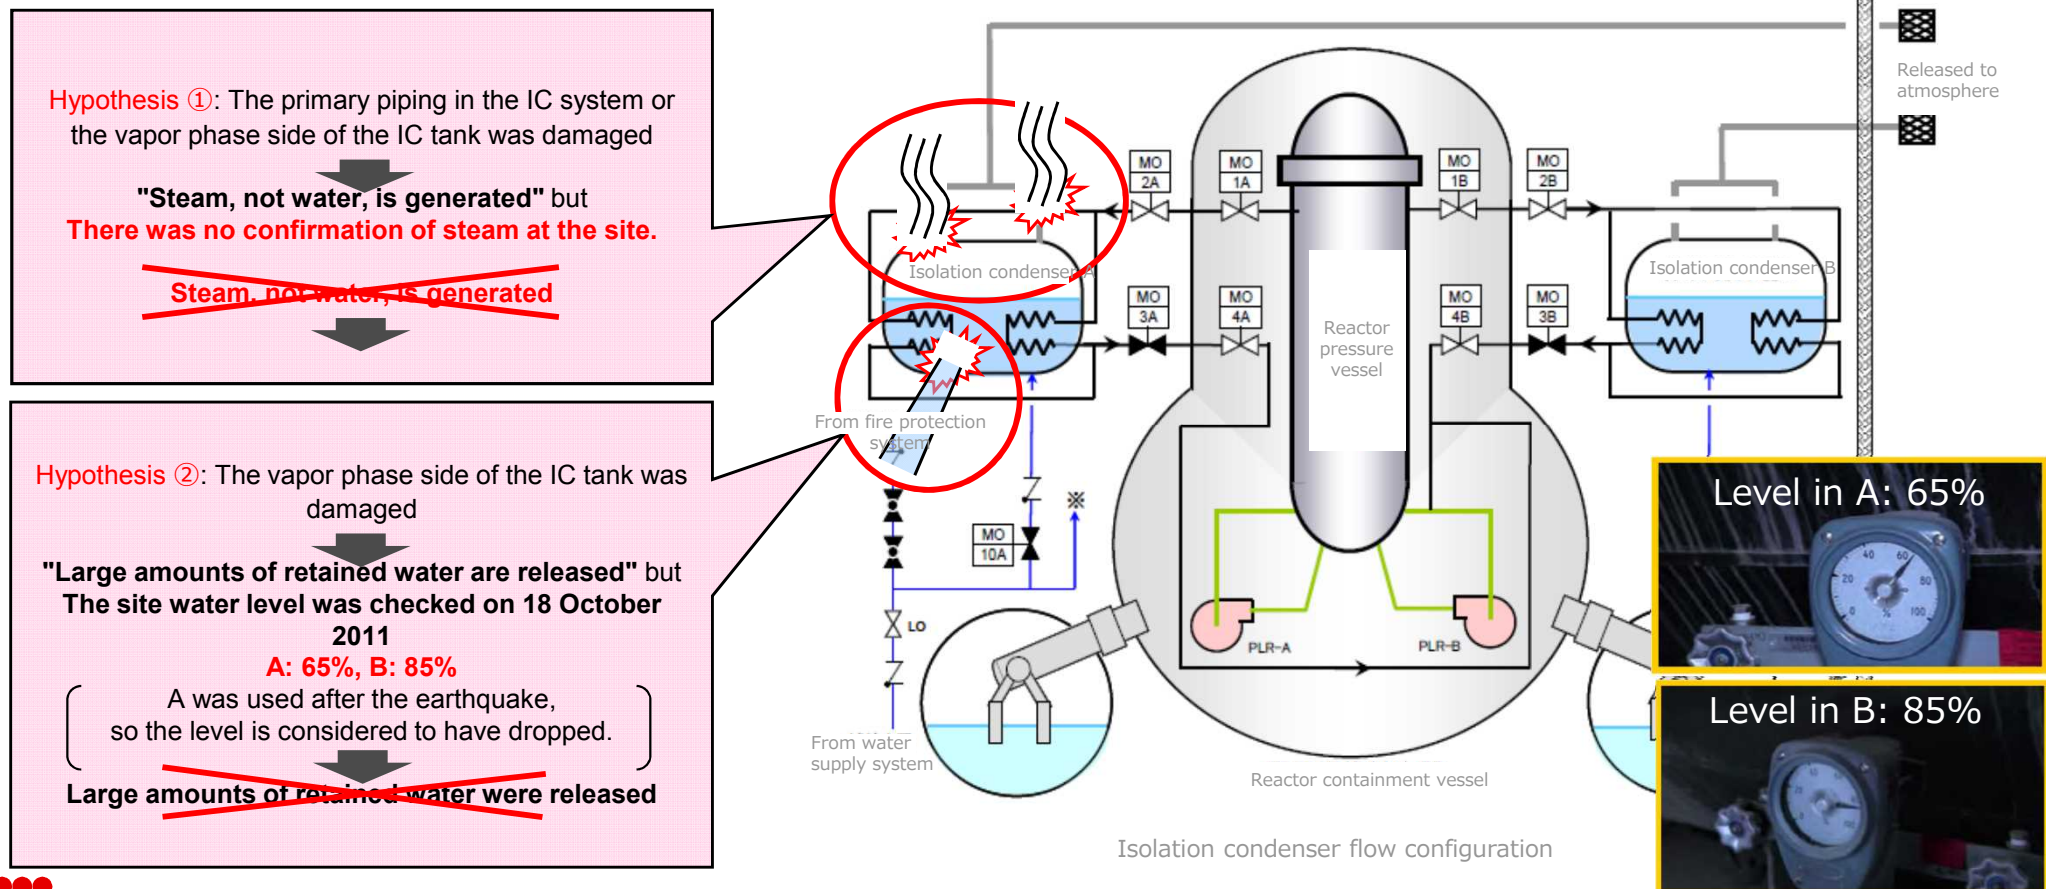
By checking water levels in the isolation condenser (IC) heat exchanger, confirming that there is no damage consistent with water discharge from inside important equipment near the site

- Because there is no confirmation of steam at the site and given that the amount of water remaining in the IC tank can be confirmed (65% in A and 85% in B), it is considered unlikely that any damage occurred that would cause an outflow of water inside important equipment near the site.

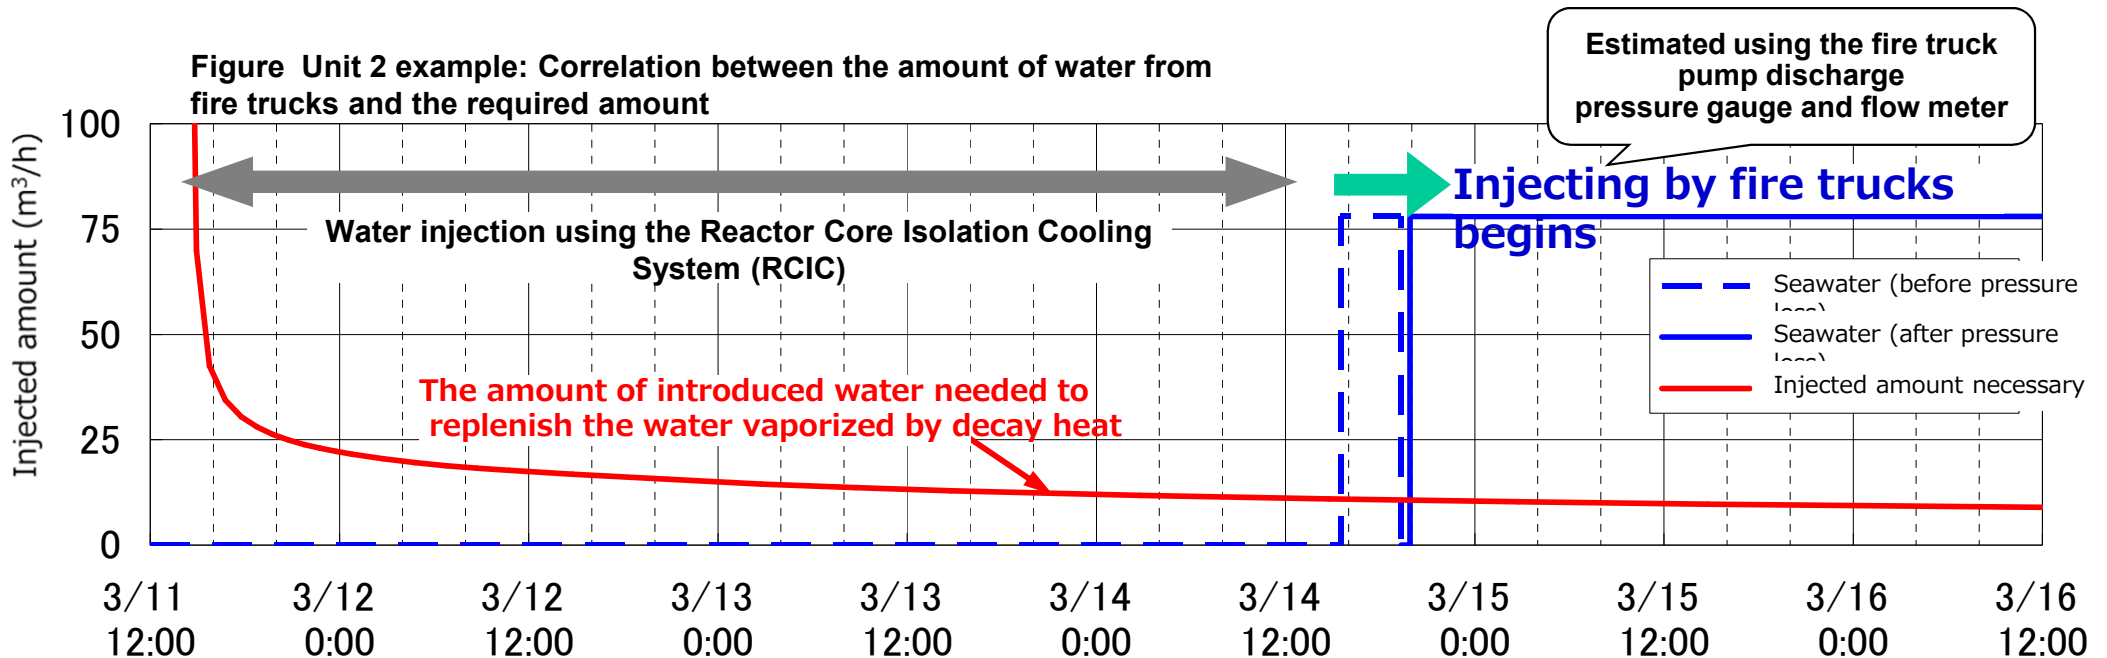
In Units 1-3, the amount of water injected into the reactors by fire trucks was sufficient to replenish the water vaporized by the decay heat

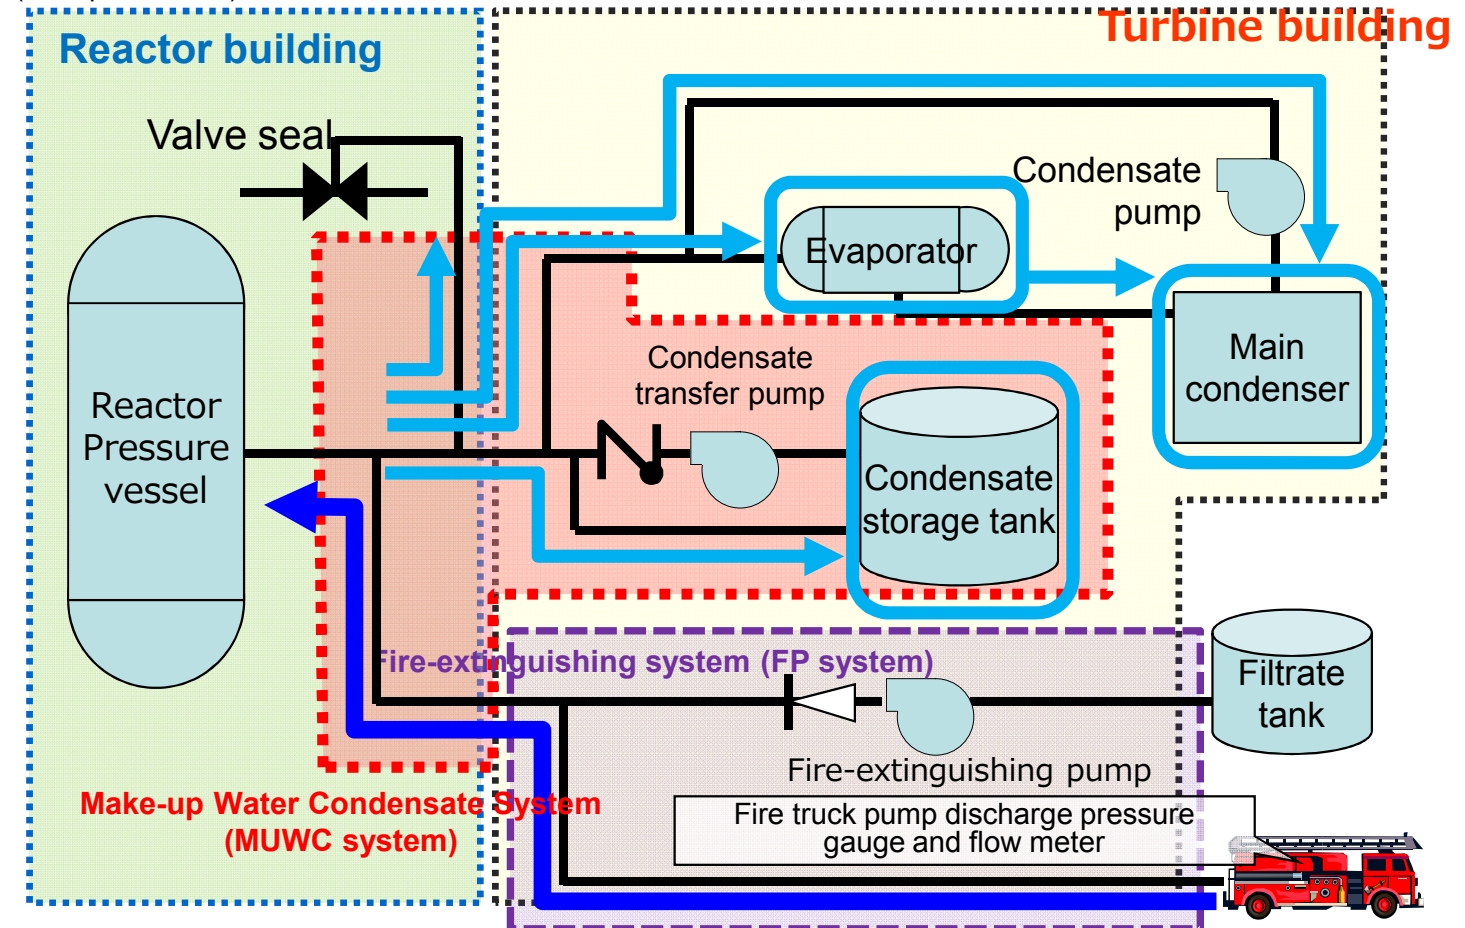
Main paths generating bypass flows (example of Unit 1)

Confirmation from piping drawings that there were paths that would generate bypass flows to the main condenser and condensate storage tank during the accident

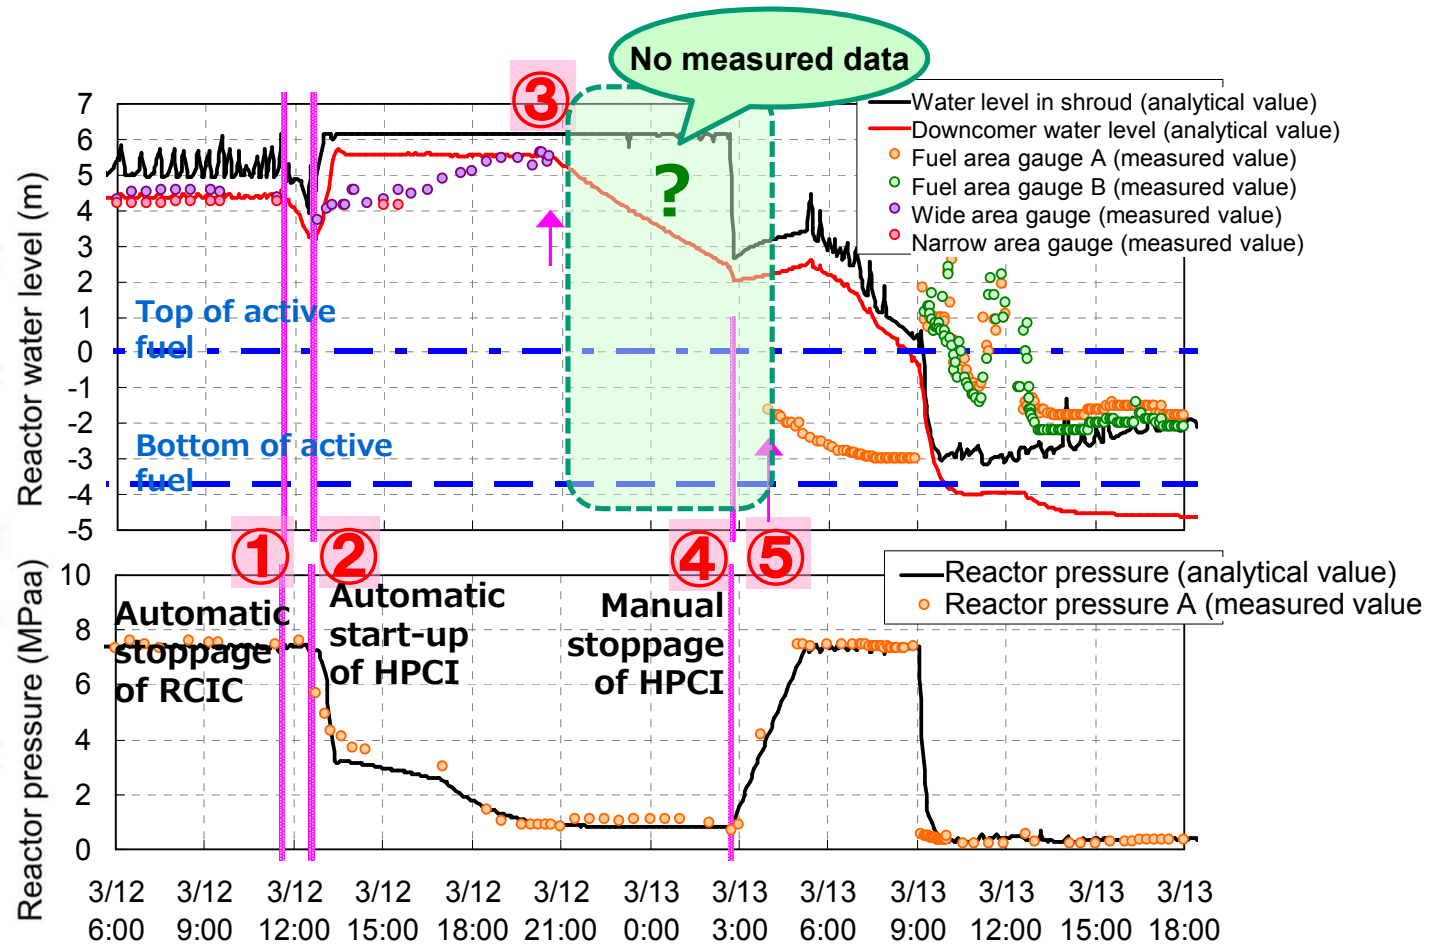
Reactor pressure buildup

Water level measurement already below effective fuel top at this point

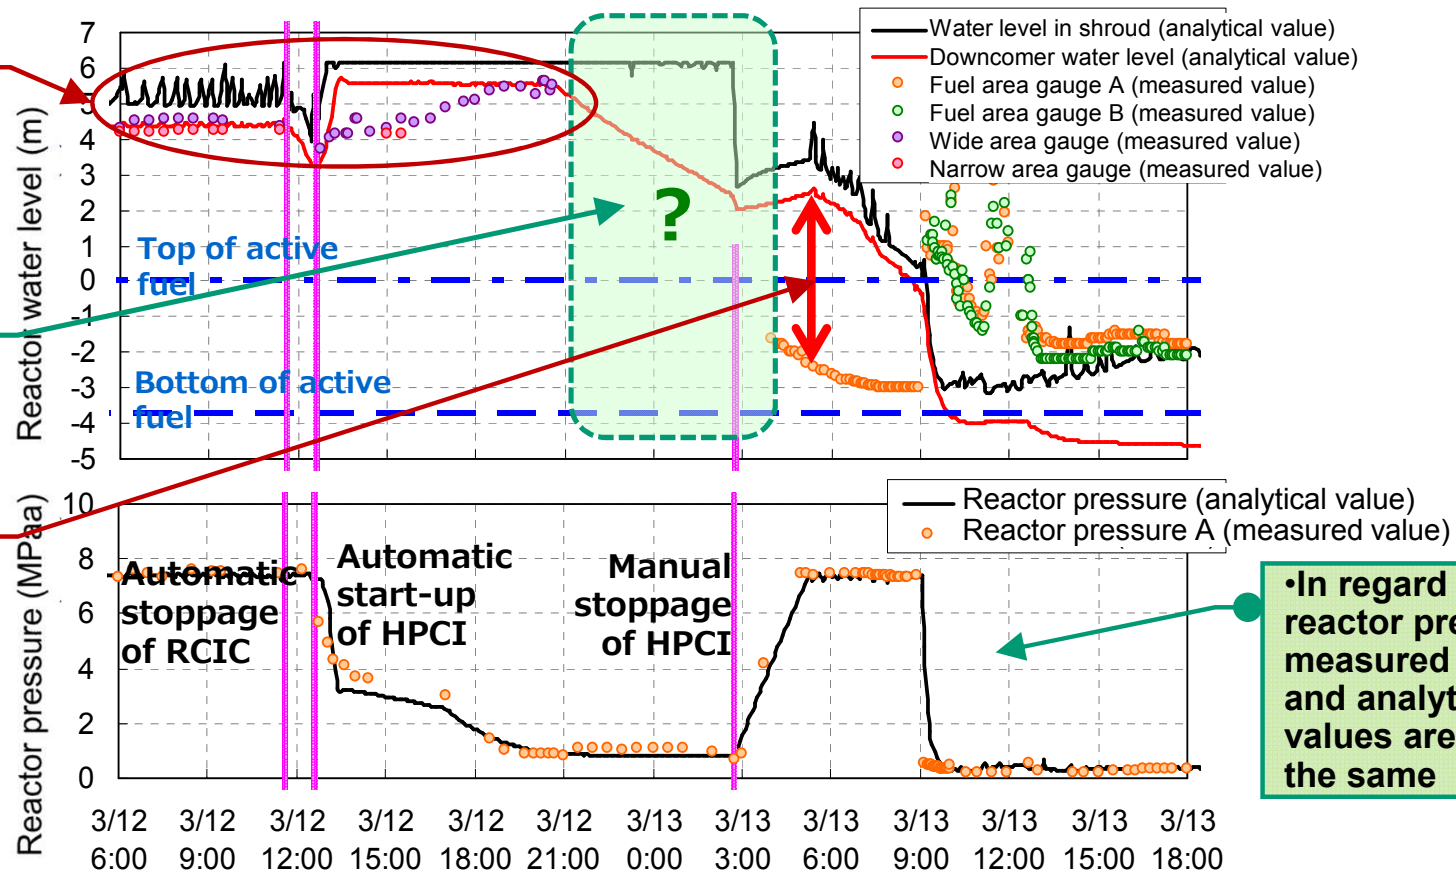
Data is missing during this period

• Measured values and analytical values differ greatly

• In regard to reactor pressure, measured values and analytical values are roughly the same

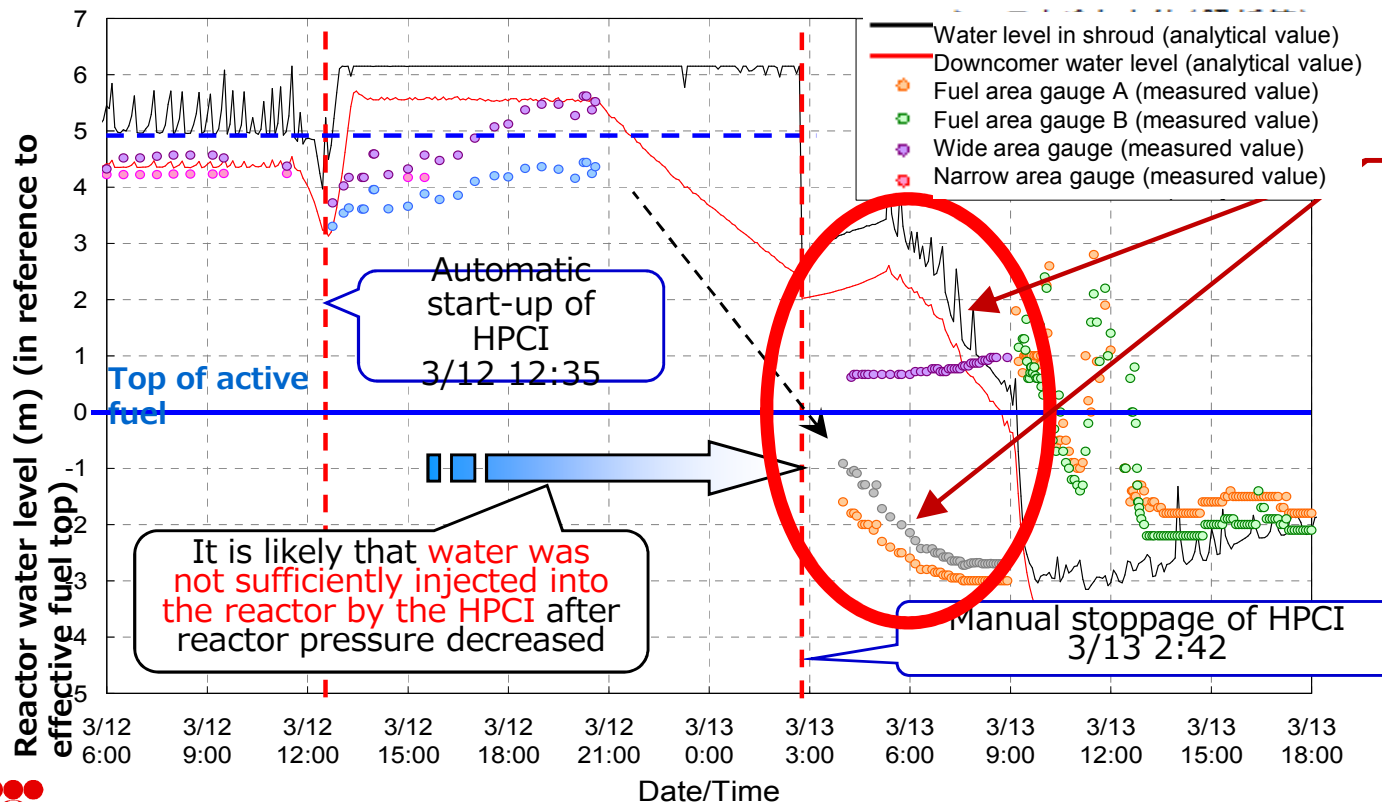
The process through which fuel was exposed and damaged has not been logically explained due to uncertainties in the operational status (actual amount of water injected) of the HPCI system, but **the advancement of core damage in unit 3 will be re-assessed in the future based on the estimated result that water injection to the reactor by the HPCI system was insufficient.**

Analytical water level (black line ν^{ν})
 According to MAAP analysis, the water level was higher than the effective fuel top until 9:00 on March 13

Measured water level (gray circles \bullet)
 The fuel area gauge indicated a water level lower than the effective fuel top at around 4:00 on March 13

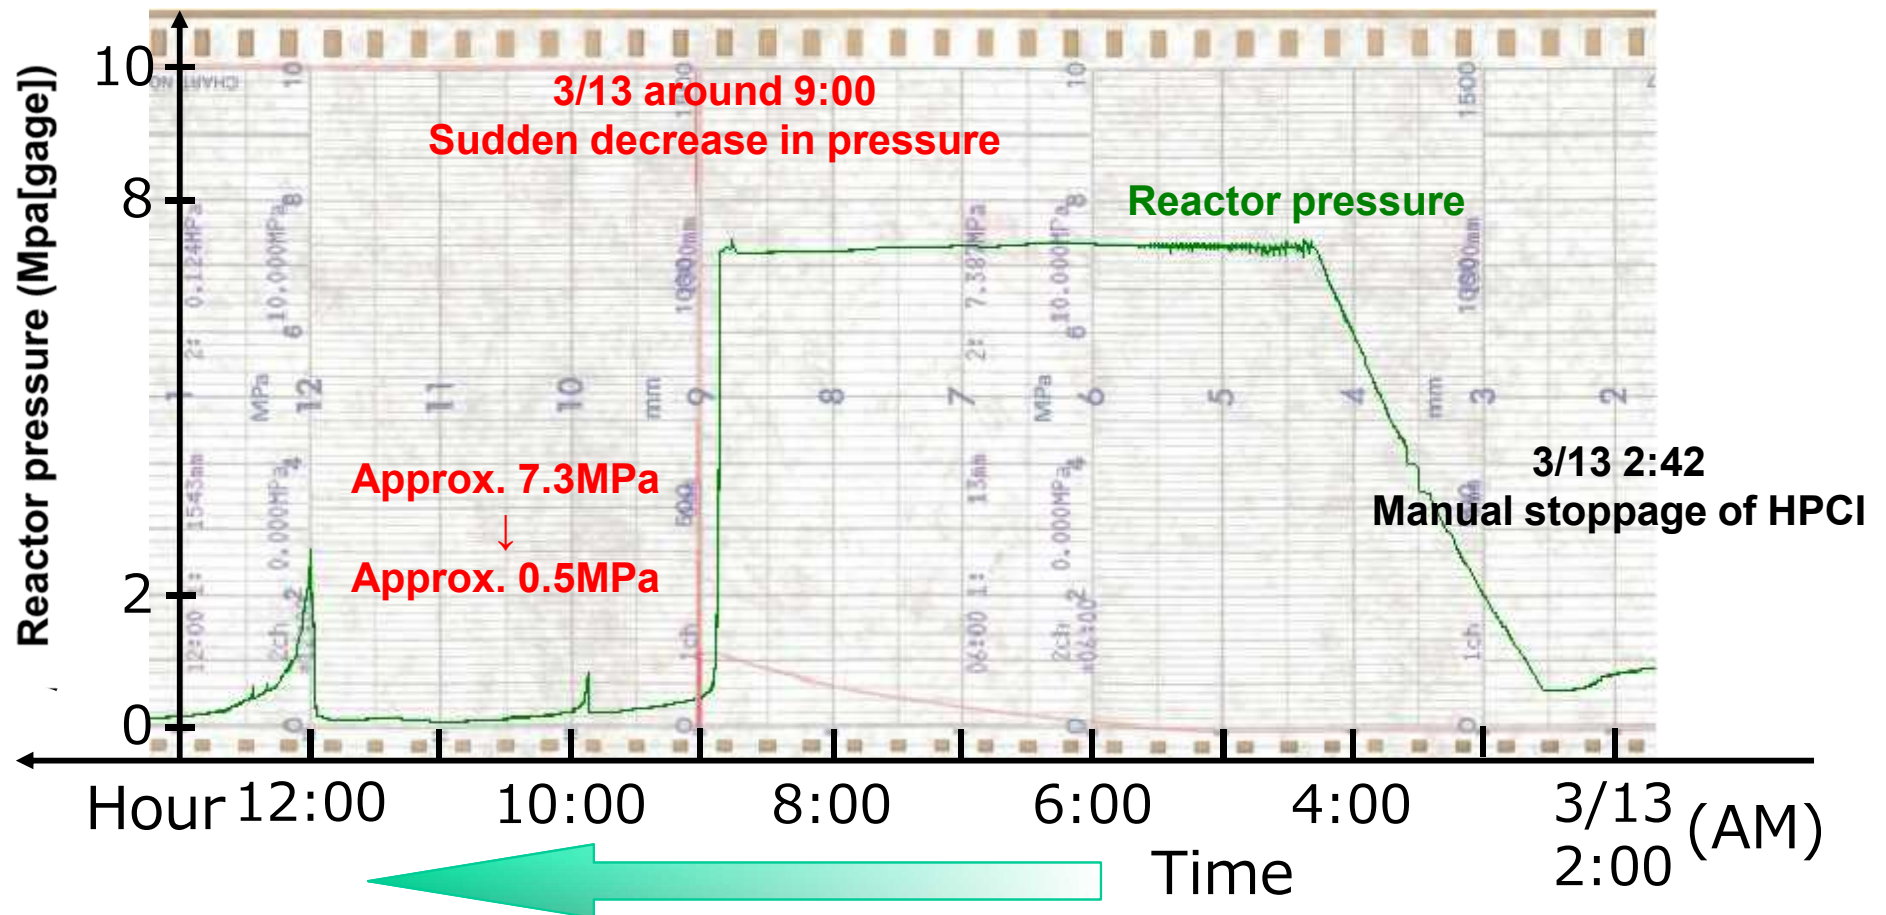
At around 9:00 on March 13, reactor pressure dropped while an operator was preparing for manual depressuring. Depressuring occurred rapidly within 2–3 minutes, while this normally takes around 20 minutes after manually opening the safety relief valves (SRV).
