Evaluation of the situation of cores and
containment vessels of Fukushima Daiichi
Nuclear Power Station Units-1 to 3
and examination into unsolved issues
in the accident progression

— Progress Report No. 1 —

December 13, 2013

Tokyo Electric Power Co., Inc.

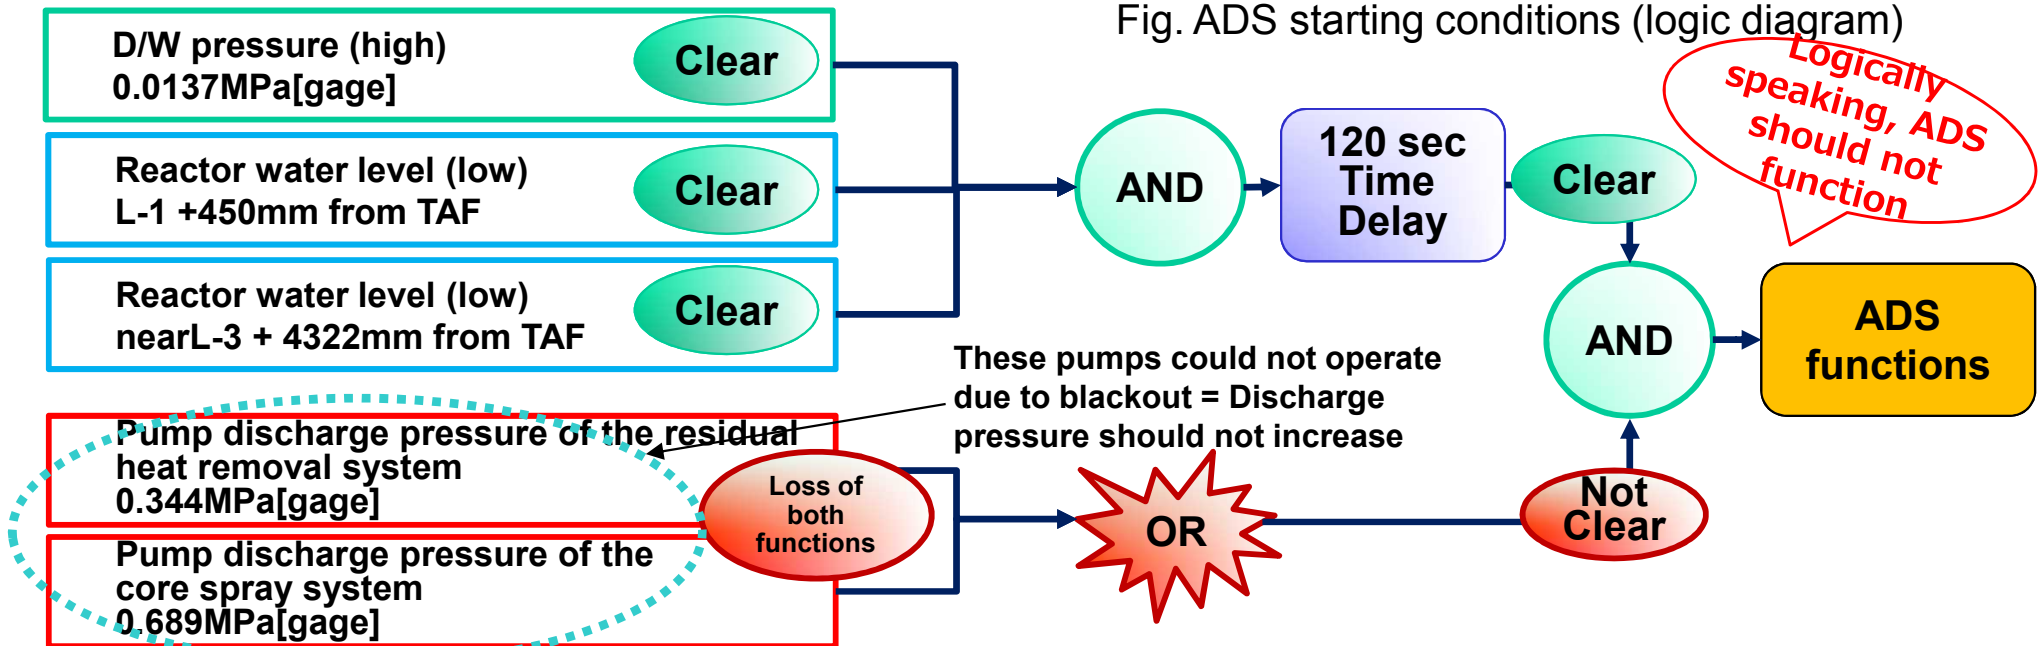
Fig. ADS starting conditions (logic diagram)

It was understood that rapid depressuring is possible if the ADS functions, but it was thought that conditions were not right for the ADS in unit 3 to function.

(*Logically, ADS should not function and perform rapid depressuring, but given the sudden decrease in pressure that actually occurred, the possibility of the ADS having functioned will be examined.)

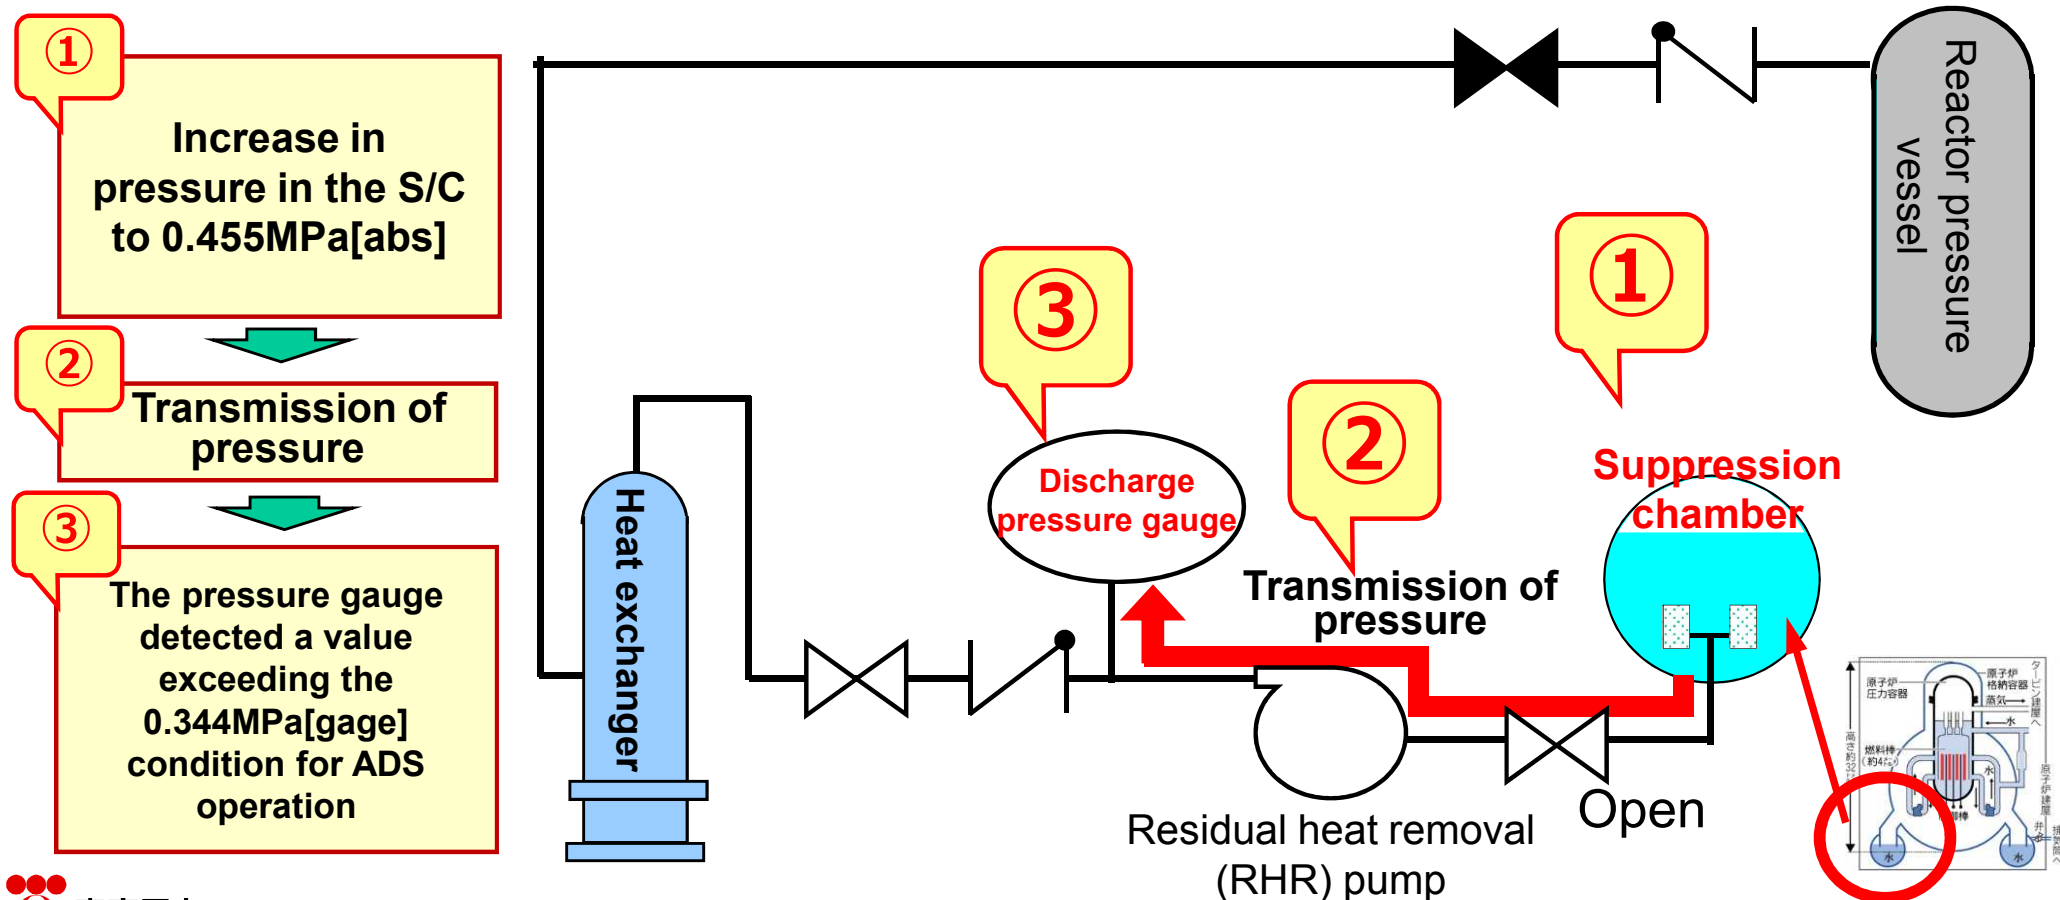
This may have set the conditions for depressuring by the ADS.

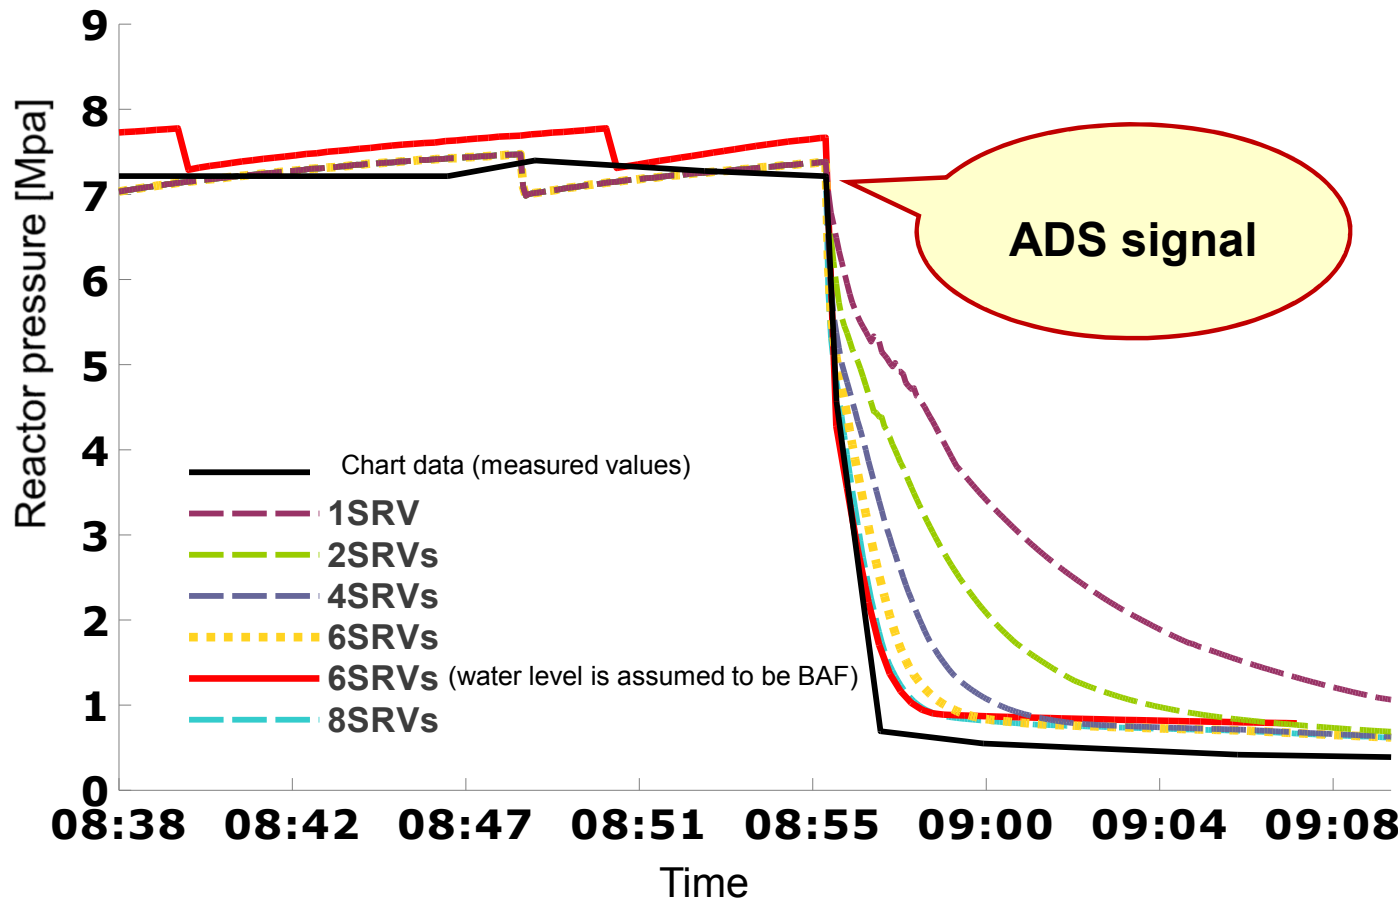
When conditions for the functioning of ADS were analyzed with **6 safety relief valves (SRV) open** and the water level near the fuel bottom as indicated by the measured value, **the actual decrease in reactor pressure could be reproduced for the most part**, so the possibility that operating conditions were right for the ADS to function has been verified.

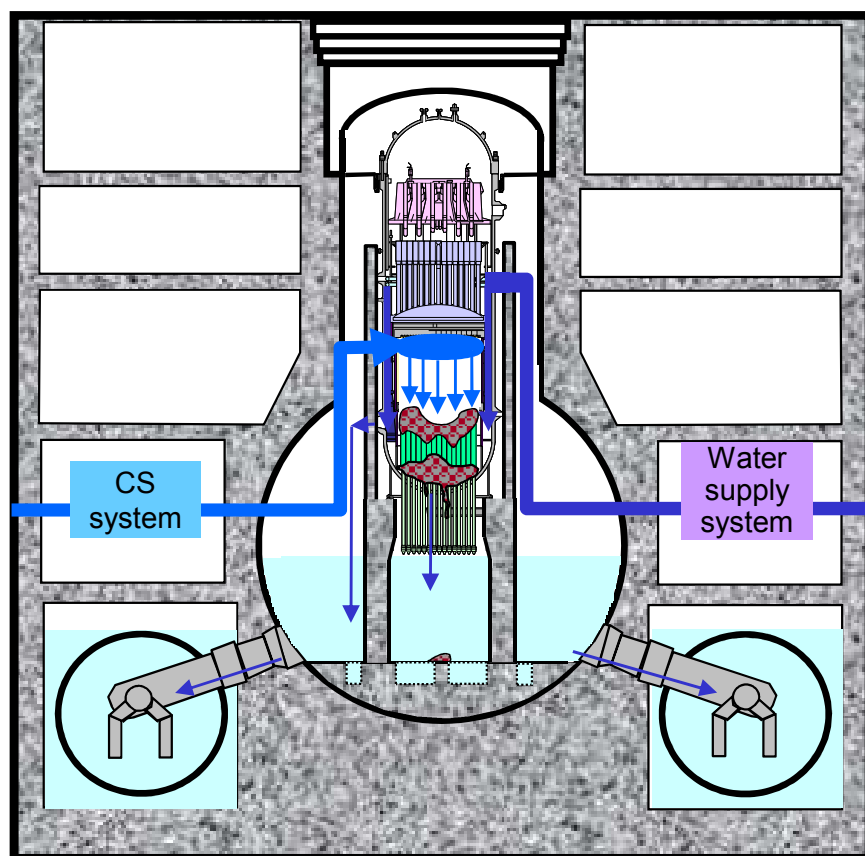
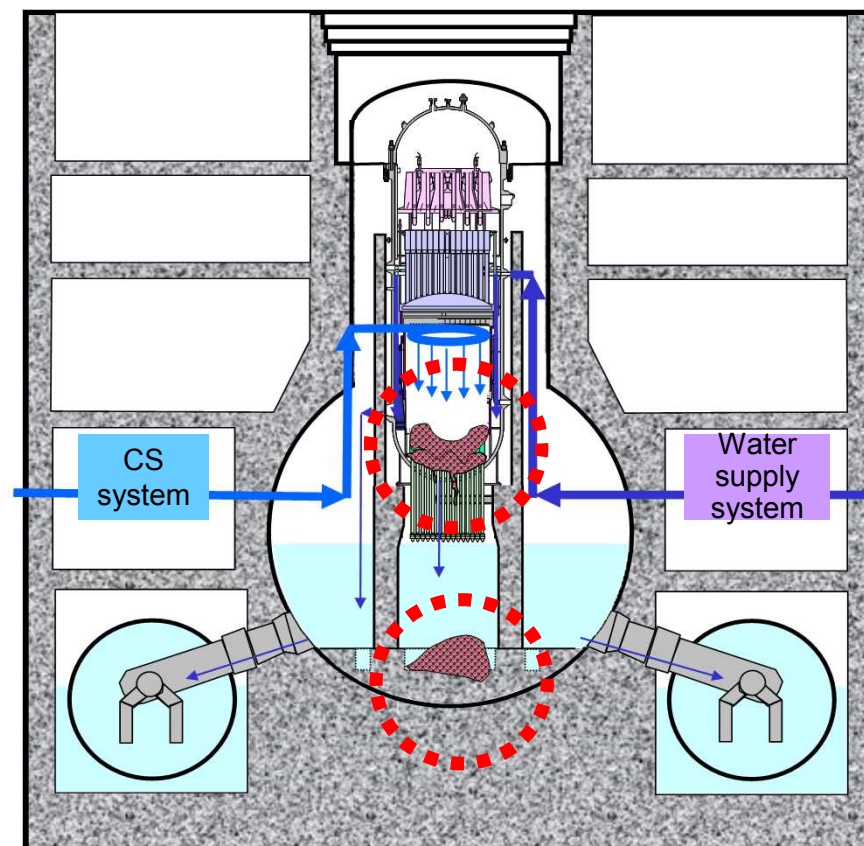
Revise the extent of core damage and core meltdown in consideration of the lack of water injection by the high-pressure coolant injection system (estimate that a larger amount of fuel than initially evaluated has fallen inside the containment vessel).
