Investigations concerning the estimation of core and in-containment conditions

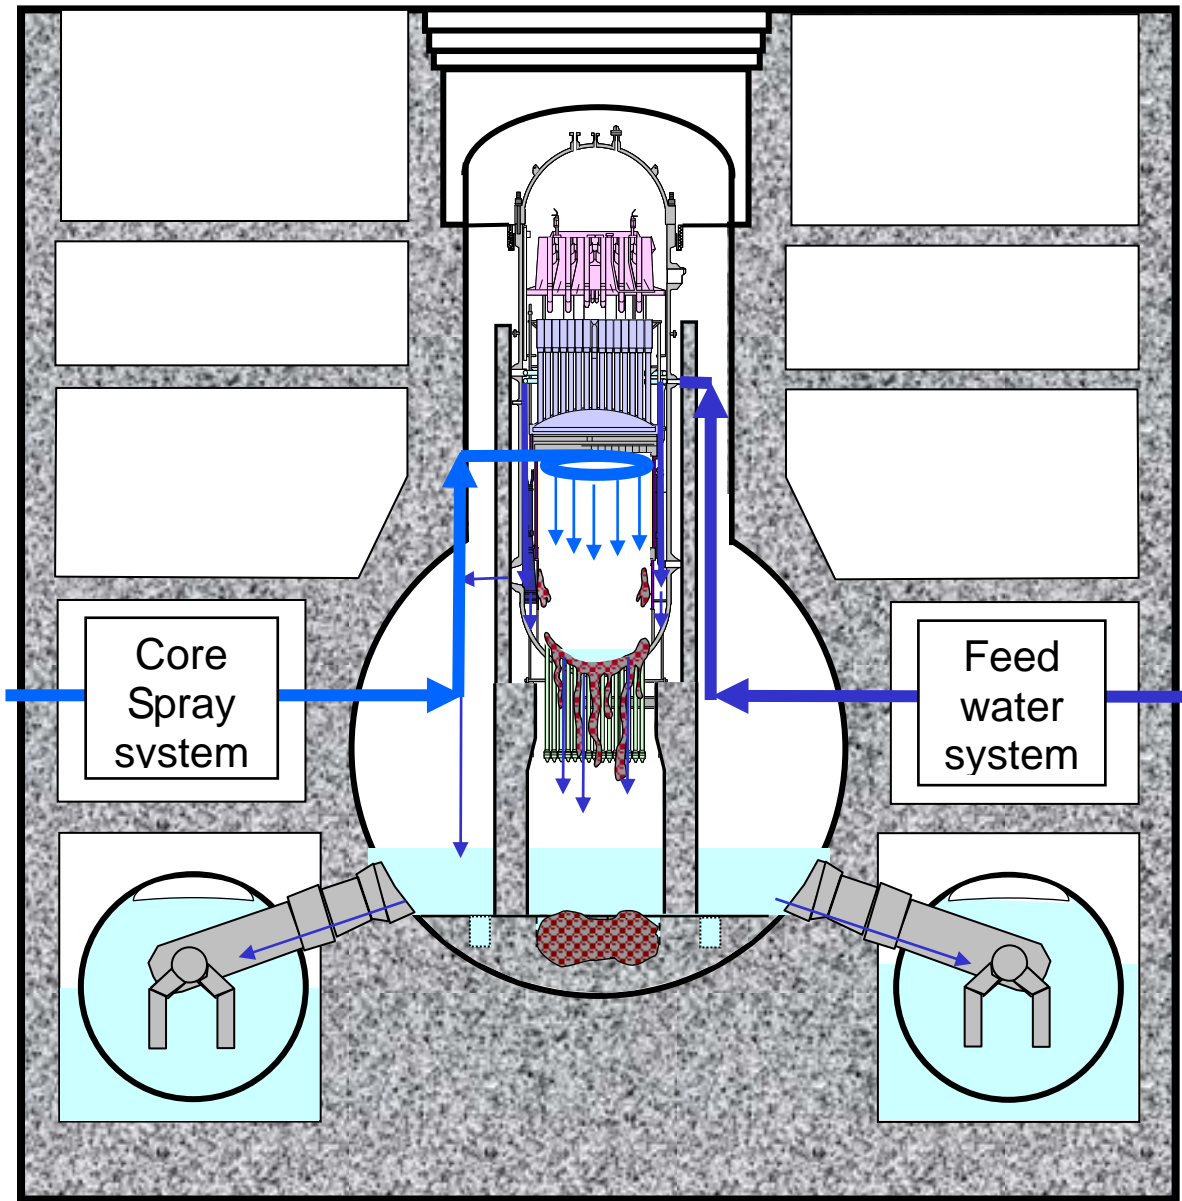
Figure 1-1 Estimated conditions of the core and PCV of Unit-1

(Note) The illustration is not accurately representing a quantitative image for the size, etc. of debris.

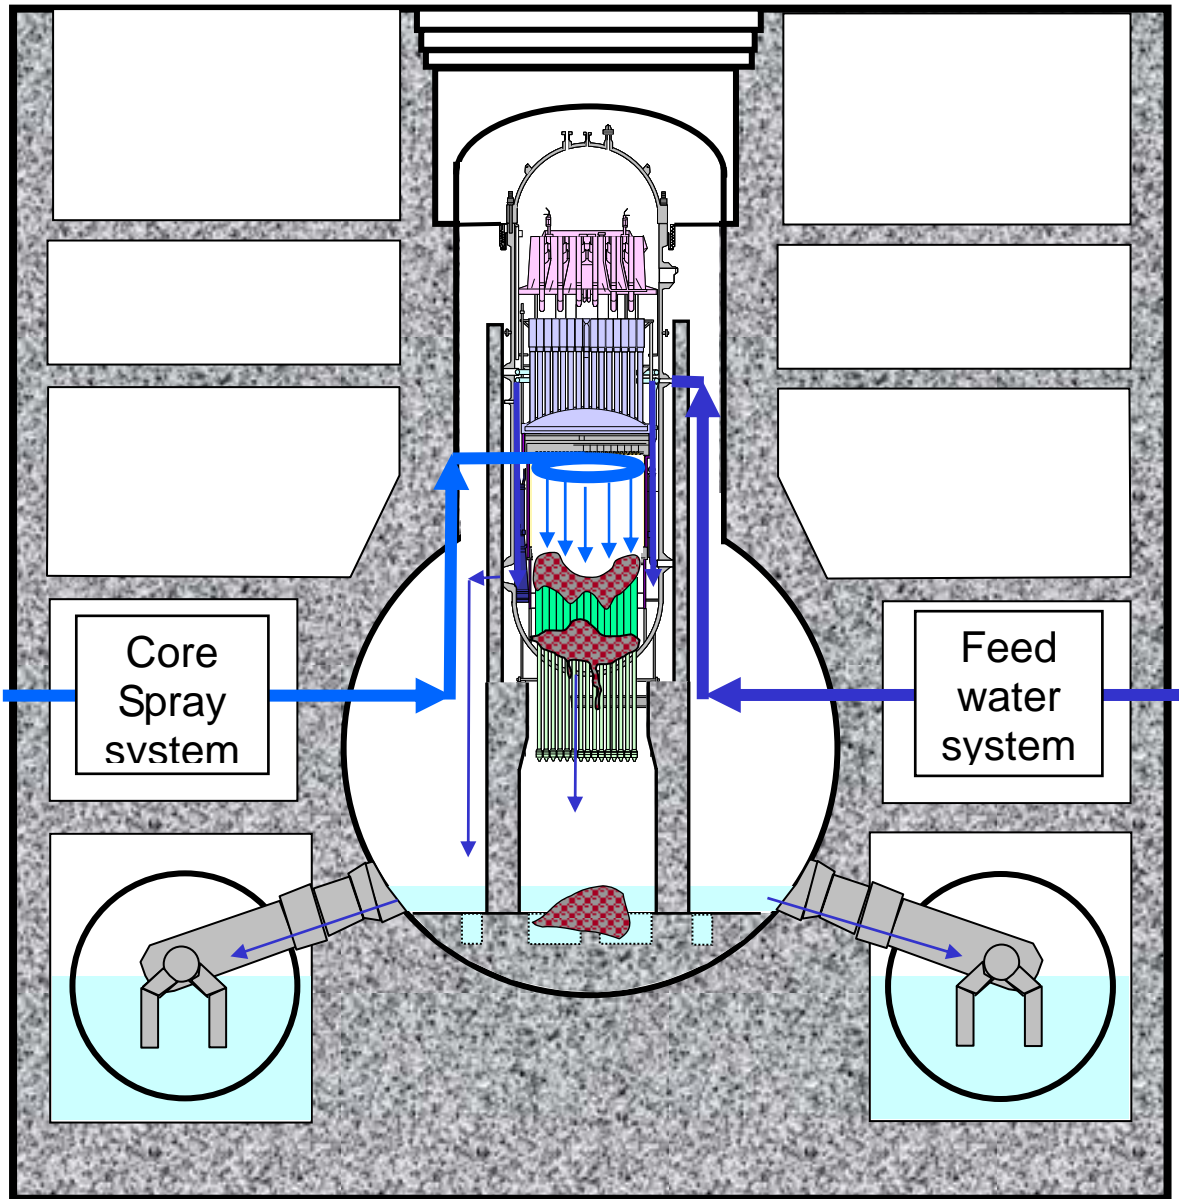
Figure 1-2 Estimated conditions of the core and PCV of Unit-2

(Note) In the earlier figure as of November 30th, 2011, the amount of debris on the PCV pedestal looked small (it was drawn so, because the fractions of fuel that remained in the core region and fell to the bottom or the pedestal of the reactor vessel or PCV had been unknown). The fallen debris on the PCV pedestal was shown as larger this time to avoid the misunderstanding that the reactor vessel had not been ruptured. The illustration is not accurately representing a quantitative image for the size, etc. of debris.

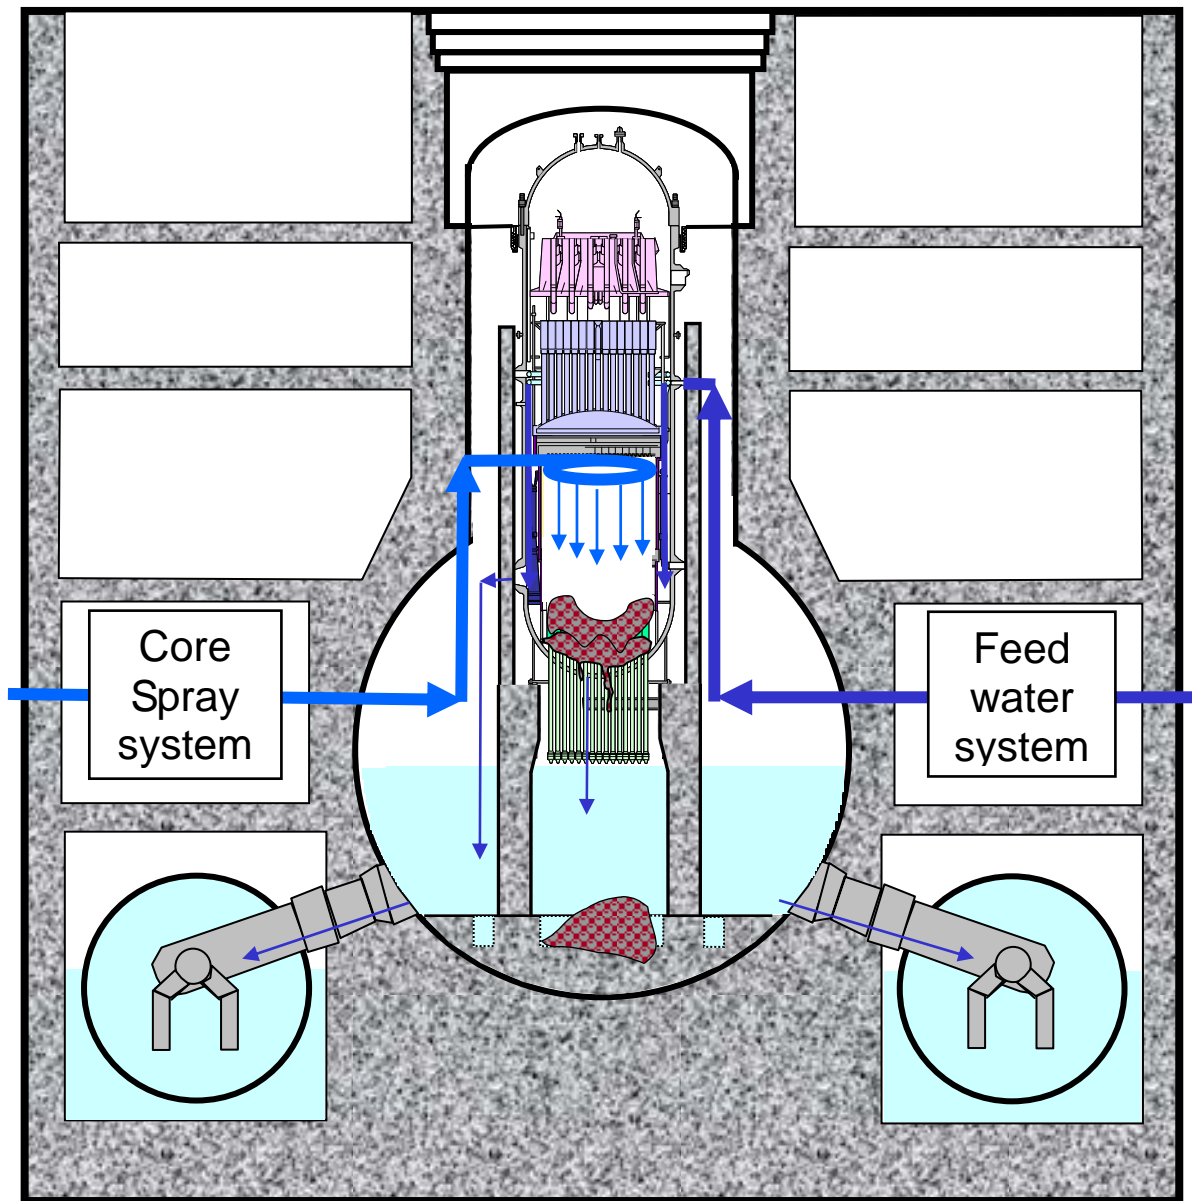
Figure 1-3 Estimated conditions of the core and PCV of Unit-3

(Note) In the earlier figure as of November 30th, 2011, the amount of debris on the PCV pedestal looked small (it was drawn so, because the fractions of fuel that remained in the core region and fell to the bottom or pedestal of the reactor vessel or PCV had been unknown). The fallen debris on the PCV pedestal was shown as larger this time, because it was considered that the accident might have developed faster than predicted before. This was based on the new finding that sufficient water injection to the reactor had become impossible before the operator manually stopped the HPCI. The illustration is not accurately representing a quantitative image for the size, etc. of debris.

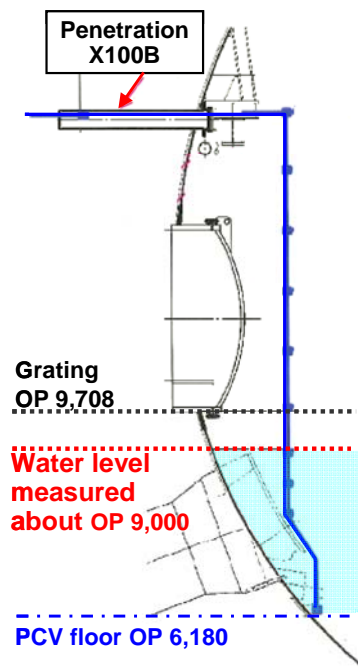
Figure 2-1 Measured level of water retained in Unit-1 PCV

The level of water retained was measured by lowering the CCD camera cable down to the water surface through the grating above in the PCV. The water level was found to be about 2.8m above the D/W floor (as of October 10th, 2012) (Figure 2-1).

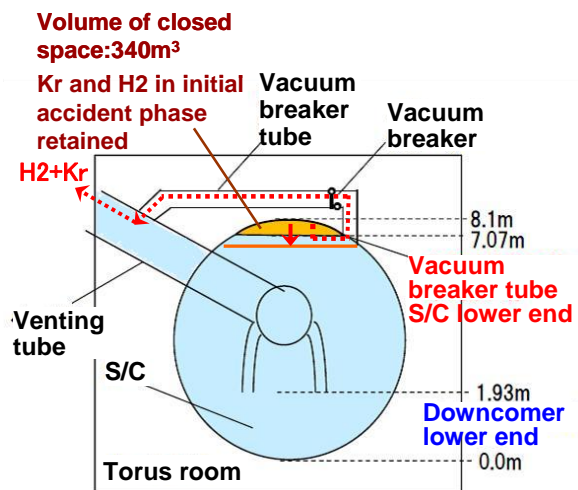
Figure 2-2 Closed space in gaseous phase inside S/C of Unit-1

In September 2012, a nitrogen gas injecting test was conducted into the suppression chamber (S/C), in which the theory was demonstrated that hydrogen gas and Kr-85 generated in the early stage of the accident and retained in the S/C upper space pushed down the S/C water level and were discharged to the D/W through the vacuum breakers. This helped to confirm that the S/C was currently almost filled with water (the level at around the lowest end of the vacuum breaker tube *²⁾ (Figure 2-2).

the following sequence: When the S/C water level drops, residual gas left in the closed space in the upper S/C is discharged to the D/W through vacuum breakers, and then the S/C water level rises and stops the gas discharge. In this hypothesis, Kr-85 is understood to originate in the early phase of the accident, because Kr-85 is a long half-life fission product and its amount cannot be explained as being newly produced by spontaneous fission, etc.

In the test to verify the mechanism hypothesis, the S/C pressure (being monitored by the existing instrumentation) rose after the injection of nitrogen gas started into the S/C, the hydrogen gas concentration and Kr-85 radioactivity monitored by the containment gas control system started to increase, which decreased when nitrogen gas injection was halted. This is interpreted to be that the nitrogen gas injection pressurized the closed space of the S/C upper part, which lowered the S/C water level and formed a gas discharge channel to the D/W through the vacuum breakers, thus the retained gas in the space was discharged together to the D/W by the injected nitrogen gas.

Most of the hydrogen gas retained in the S/C has been purged by continuously injecting nitrogen gas into the S/C since October 2012. Further tests are now underway to verify a mechanism of hydrogen production in the S/C by water radiolysis.

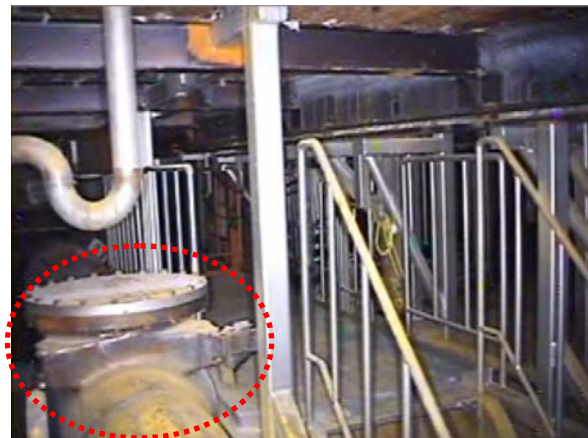
Figure 2-3 Camera photo of an S/C vacuum breaker in the torus room of Unit-1

No water leaking position in the S/C has been located yet. At least, no leak was confirmed on the flange of one of the eight vacuum breakers, as far as the camera photos showed (Figure 2-3).

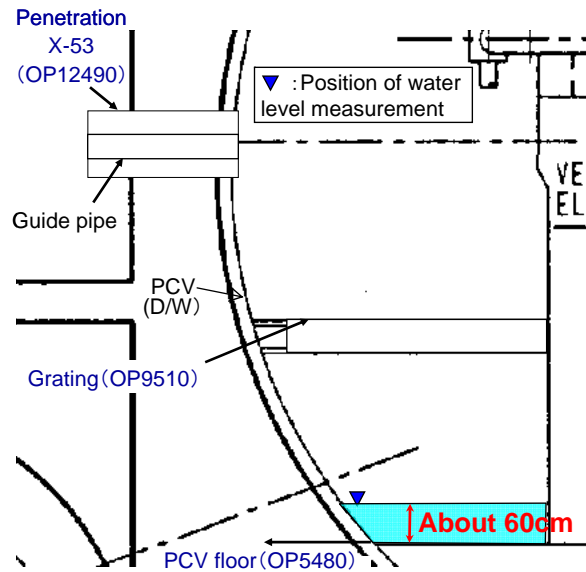
Figure 3-1 Measured level of retained water in Unit-2 PCV

The level of water retained was confirmed to be about 60 cm above the D/W floor by the video image scope (as of March 26th, 2012) (Figure 3-1).

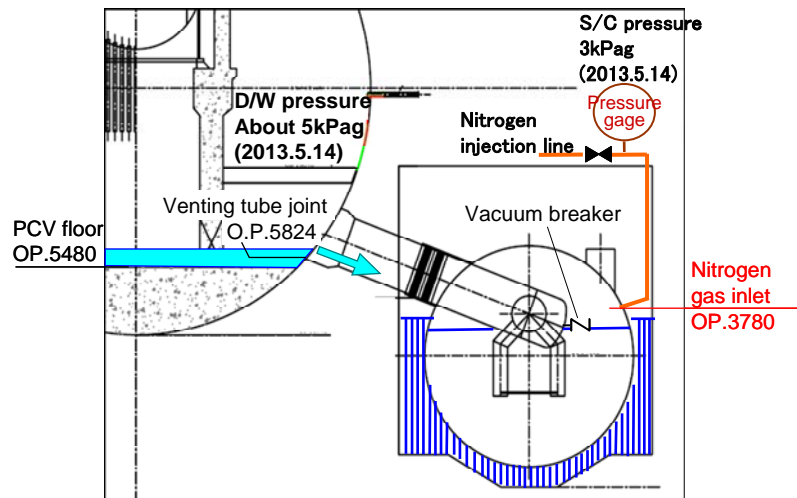
Figure 3-2 Closed space assumed in Unit-2 S/C

The S/C pressure was confirmed to be 3 kPag (as of May 14th, 2013) in a nitrogen gas injecting test into the S/C done in May 2013. The absolute water level in the S/C was not accurately known, but it was confirmed to be approximately on the level of the nitrogen gas inlet (O.P. 3780), because some reasonable pressure due to the water head should exist at the inlet if the S/C were almost filled with water. If the low water level in the

D/W is considered in combination, the water injected into the reactor vessel is considered to have reached the S/C via the D/W and venting tubes. If this hypothesis is correct, the current S/C water level will be on the same level as that of water retained in the torus room*⁵) (Figure 3-2).

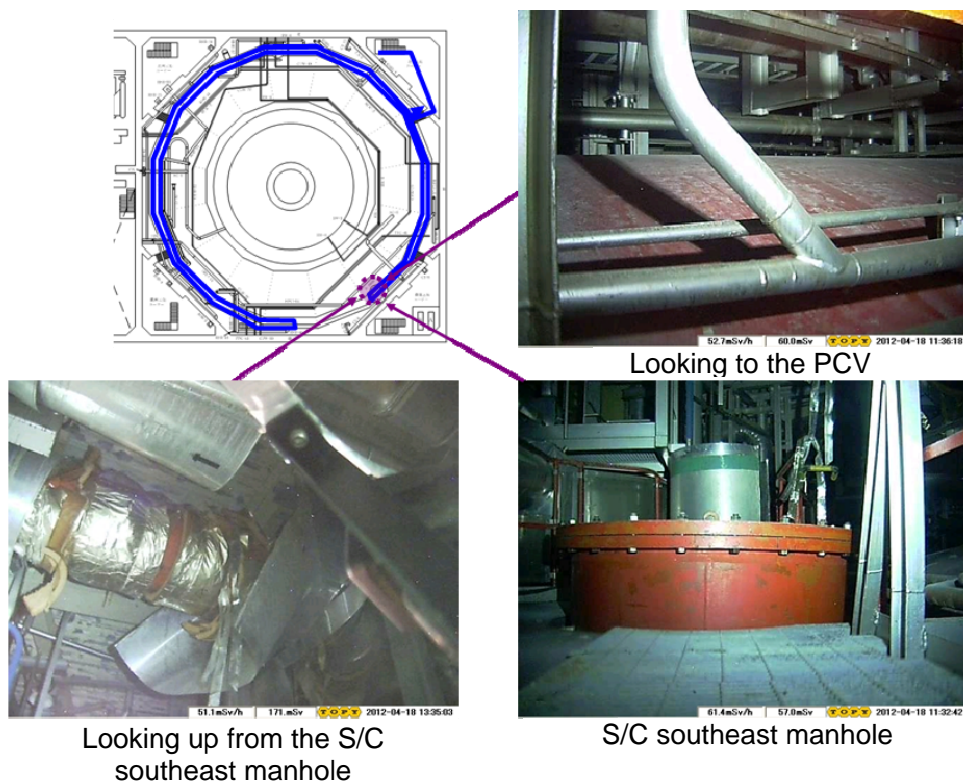
Figure 3-3 Camera photos in the torus room of Unit-2 (part)

No water leaking position in the S/C has been located yet. At least, no leak was confirmed on the flange, etc. of the S/C manholes, as far as the camera photos show (Figure 3-3).

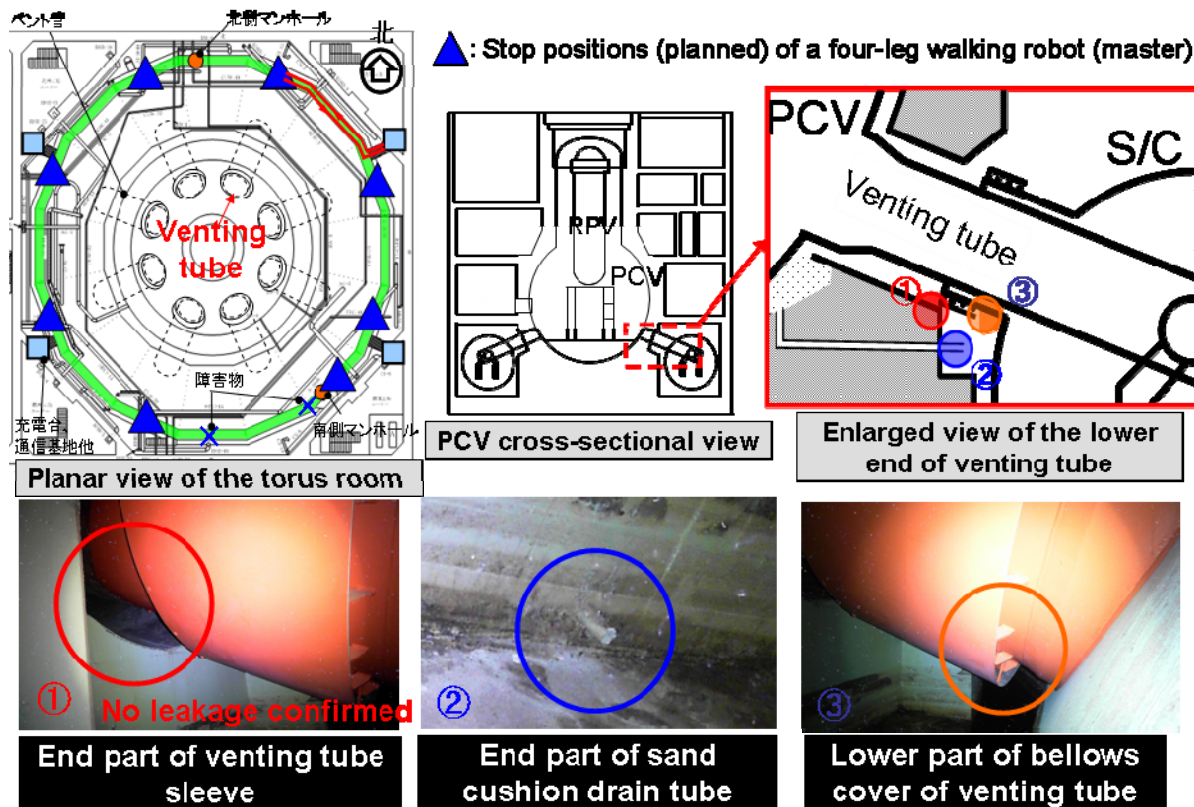
Figure 3-4 Camera photos around the lower end of the venting tube in the torus room of Unit-2 (part)

No water leaking position in the S/C has been located yet. At least, no leak was confirmed from the lower end of venting tubes within the visible range (Figure 3-4).

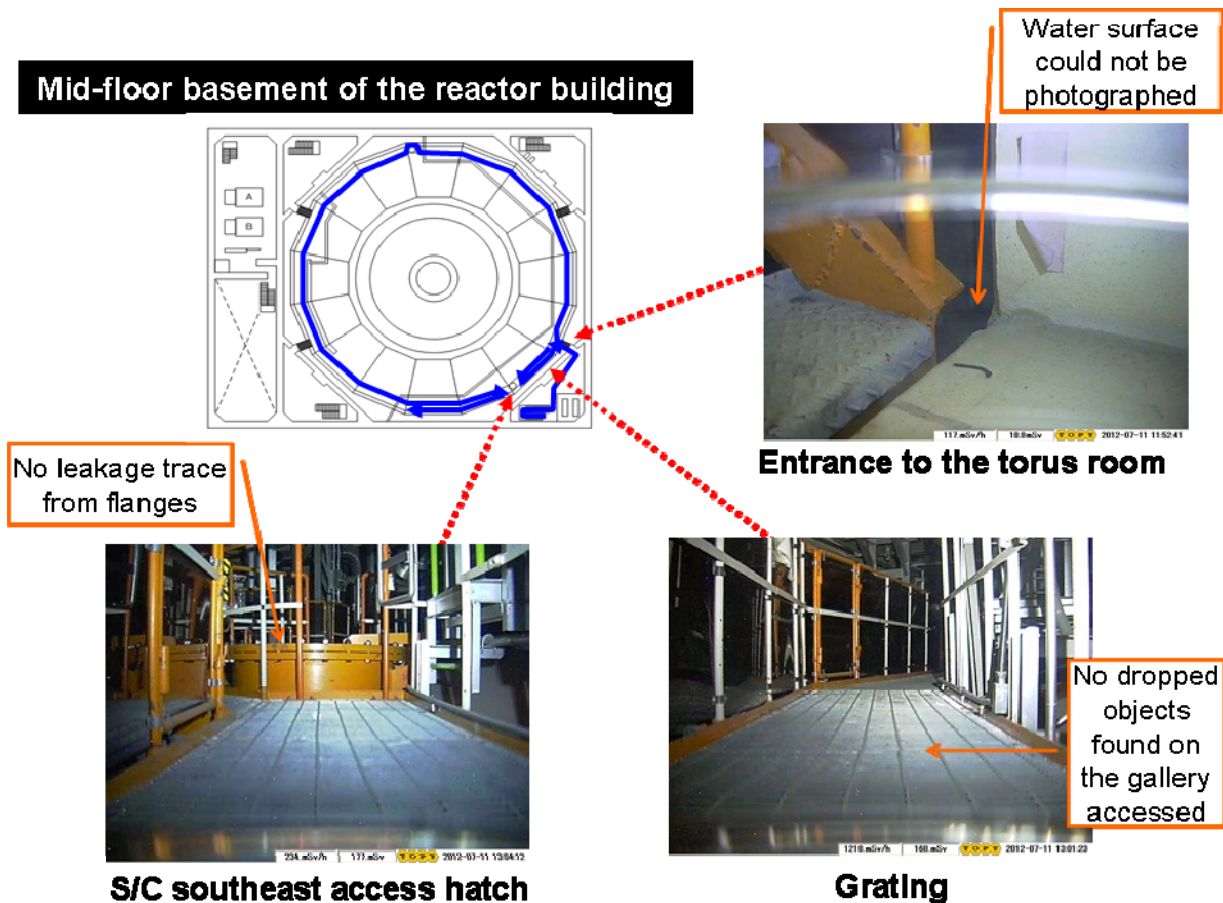
Figure 4-1 Camera photos in the torus room of Unit-3 (part)

No water leaking position in the S/C was located yet. At least, no leak was confirmed on the flange, etc. of the S/C manholes, as far as the camera photos show (Figure 4-1).
