Status of investigation on estimating situation of cores and containment vessels

1. Introduction

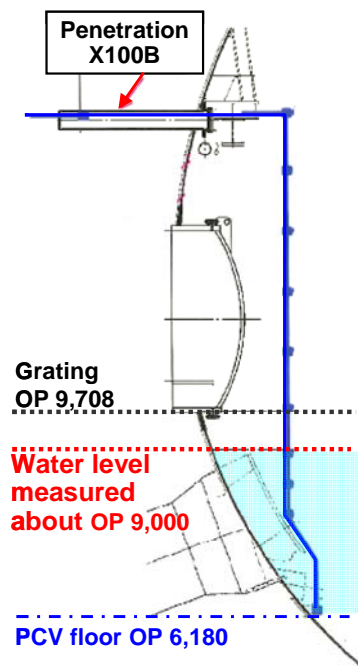
Figure 2-1 Measured level of water retained in Unit-1 PCV

The level of water retained was measured by lowering the CCD camera cable down to the water surface through the grating above in the PCV. The water level was found to be about 2.8m above the D/W floor (as of October 10<sup>th</sup>, 2012) (Figure 2-1).

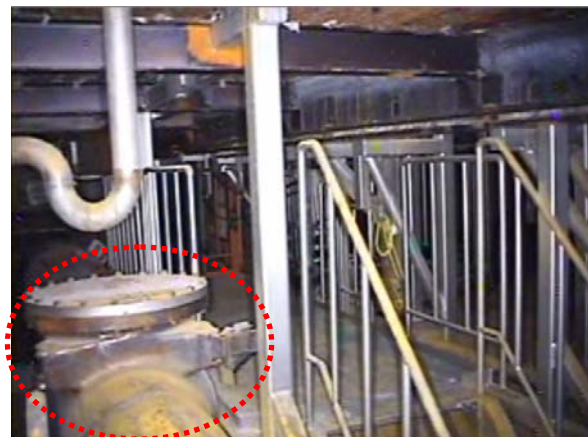
Figure 2-3 Camera photo of an S/C vacuum breaker in the torus room of Unit-1

No water leaking position in the S/C has been located yet. At least, no leak was confirmed on the flange of one of the eight vacuum breakers, as far as the camera photos showed (Figure 2-3).

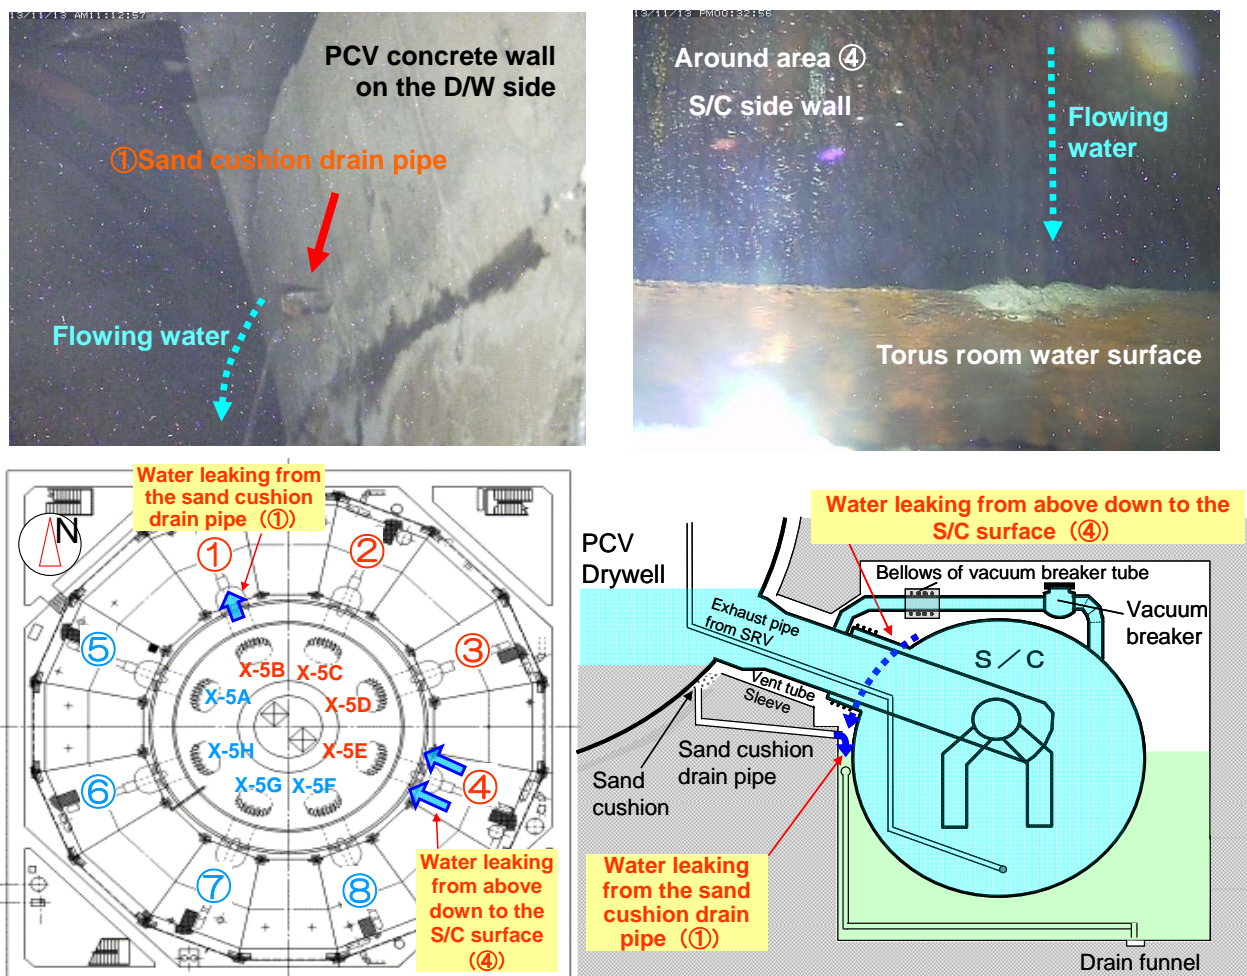
Figure 2-4 Camera images taken below the vent tubes in Unit 1 torus room (part)

Camera imaging confirmed water leaks at the following locations (Figure 2-4).

- Vent tube X-5B (① in the figure): water flowing from the displaced sand cushion drain pipe\*
- Vent tube X-5E (④ in the figure): water flowing down on the S/C surface with 2 streams around both sides of the vent tube

\*Water leaks at ① were confirmed since the vinyl chloride pipe (connecting the sand cushion drain tube and drain funnel with an insertion-type joint) had been displaced. Water leaks could not be confirmed at locations ② to ⑧, since the drain tubes had not been displaced. The concrete seams (joints) below the sand cushion drain piping were observed to be wet all around on the concrete wall.

Water leaks into the sand cushion occur only when water leaks directly from the drywell. The leakage is probably from a low position of the drywell below the water level (for example, the containment vessel shell, pipe penetrations, etc.). The low location of the water leaks in the drywell would indicate the possible influence of molten fuel that fell to the PCV bottom. This information is of critical significance in estimating the conditions of the core and PCV.

Meanwhile, the water leakage down to the S/C surface around both sides of the vent tube X-5E indicates the possibility of water leaks from the vacuum breaker tube (its bellows, for example) immediately above the vent tube. This elevation of the vacuum breaker tube is about the same level as that of the upper limit of PCV water level which was reached in an attempt to flood the PCV by increasing the amount of water injected in May 2011; where the PCV water level was calculated from the injected nitrogen gas pressure. The nitrogen gas pressure was stopped from changing at a specified level, which means the PCV water level was leveled off, i.e., an indication of leak hole existence at the level (Figure 2-5) [5].

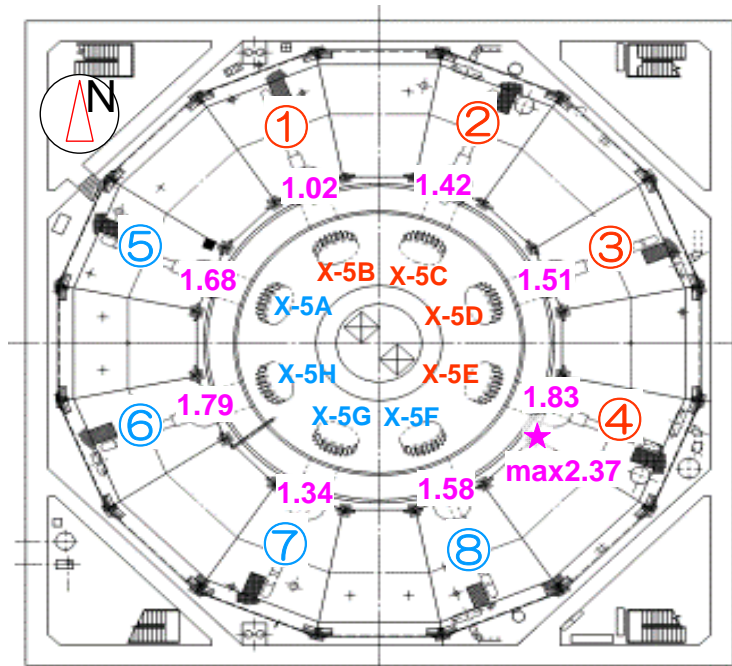
Figure 2-6 Dose distribution measured during the torus room investigation underneath vent tubes of Unit 1

The vertical distribution of radiation doses measured when lowering the instrumentation boat in November 2013 was similar to that measured in February 2013 (in the area surrounding the torus). Dose distribution along the boat traveling route was about 1 to 2 Sv/h, and the highest spots were in the southeast area (Figure 2-6).

In June 2011, steam blown from the pipe penetrations was witnessed at the southeast corner of the first floor of the reactor building. This would mean that radioactive materials carried by the steam were blown to the torus room after the accident and they deposited on the walls and structure surfaces there. The dose distribution in the torus room is considered to be the sum of doses due to these contamination sources. The estimated radiation dose levels on the water surface due to water-retained radionuclides ( $7.3 \times 10^4$  Bq/cm<sup>3</sup> of Cs-134 and  $1.5 \times 10^5$  Bq/cm<sup>3</sup> of Cs-137, sampled on February 22, 2013) are about 100 mSv/h and not a dominant contributor to the 1 to 2 Sv/h dose measured [6].

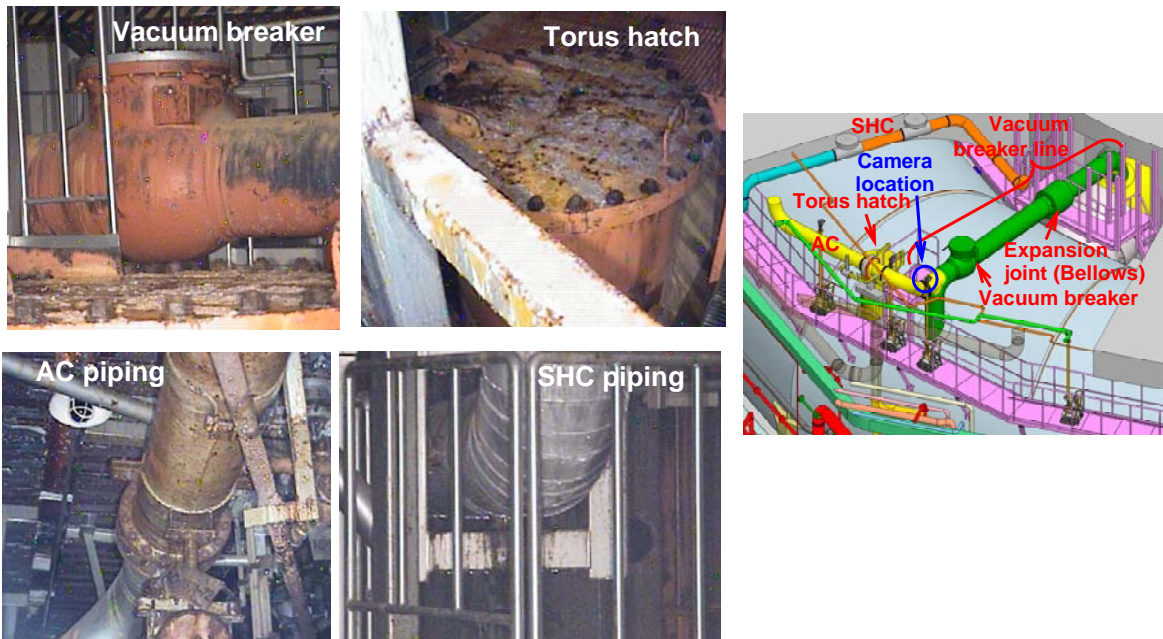
Figure 2-7 Camera images of Unit-1 S/C top area exploration (around vent tube X-5E) (Part)

In May 2014, survey instrumentation robot was introduced through a drilled hole in the northwest area of the first floor of the Unit1 reactor building to explore the S/C top area in order to locate the leak source near the vent tube X-5E, where leaking had been confirmed. By using the outer catwalk, the instrumentation robot made a camera survey around the vent tube X-5E, and the water leak was confirmed to be from the protective cover of the expansion joint on the vacuum breaker line. No leaks were noticed from the vacuum breaker valve, torus hatch, Shutdown cooling system (SHC) piping or Atmospheric control system (AC) piping (Figure 2-7) [7].

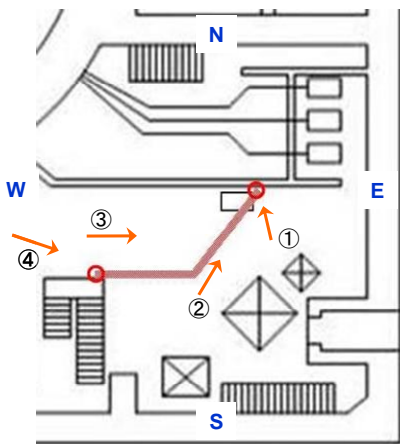
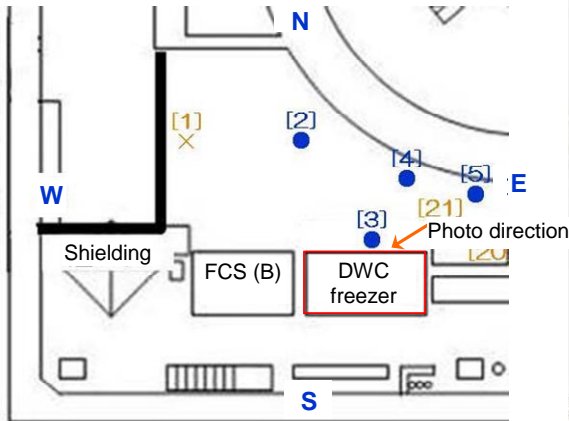
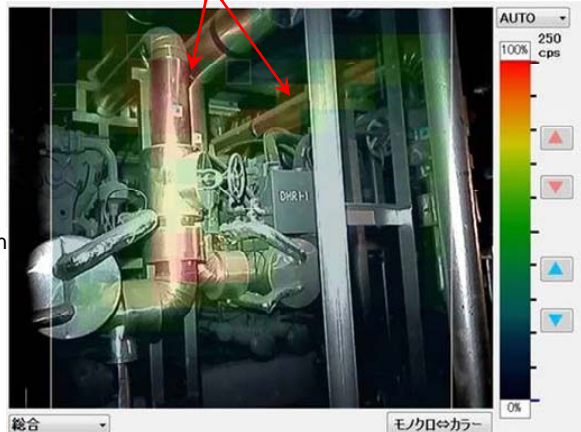
Figure 2-8 Gamma camera images in the southern area of Unit 1 reactor building 1st Floor (part)

In December 2013, contamination was surveyed on the first floor of the Unit-1 reactor building by radiation dose measurements and gamma camera images taken using a robot. It was found that contamination was relatively high on the Atmospheric control system (AC) piping and Drywell humidity control system (DHC) piping (Figure 2-8) [8].

Hot spots confirmed along piping

The AC piping is where the steam passed through when the wetwell (W/W) venting was carried out during the accident. Its high contamination is considered to be due to venting flows, and the situation was similar to that for the area near the standby gas treatment system (SGTS) train entrance room or near the SGTS piping connected to the main stack, where high dose rate had

The DHC piping is connected to the Reactor building closed cooling water system (RCW), and therefore its high dose is considered to be due to the same mechanism as that of RCW piping, where high dose rate had been already confirmed.

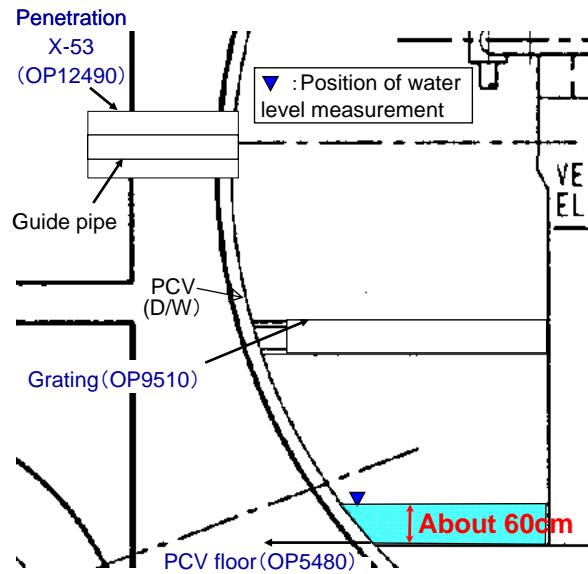
Figure 3-1 Measured level of retained water in Unit-2 PCV

The level of water retained was confirmed to be about 60 cm above the D/W floor by the video image scope (as of March 26<sup>th</sup>, 2012) (Figure 3-1).

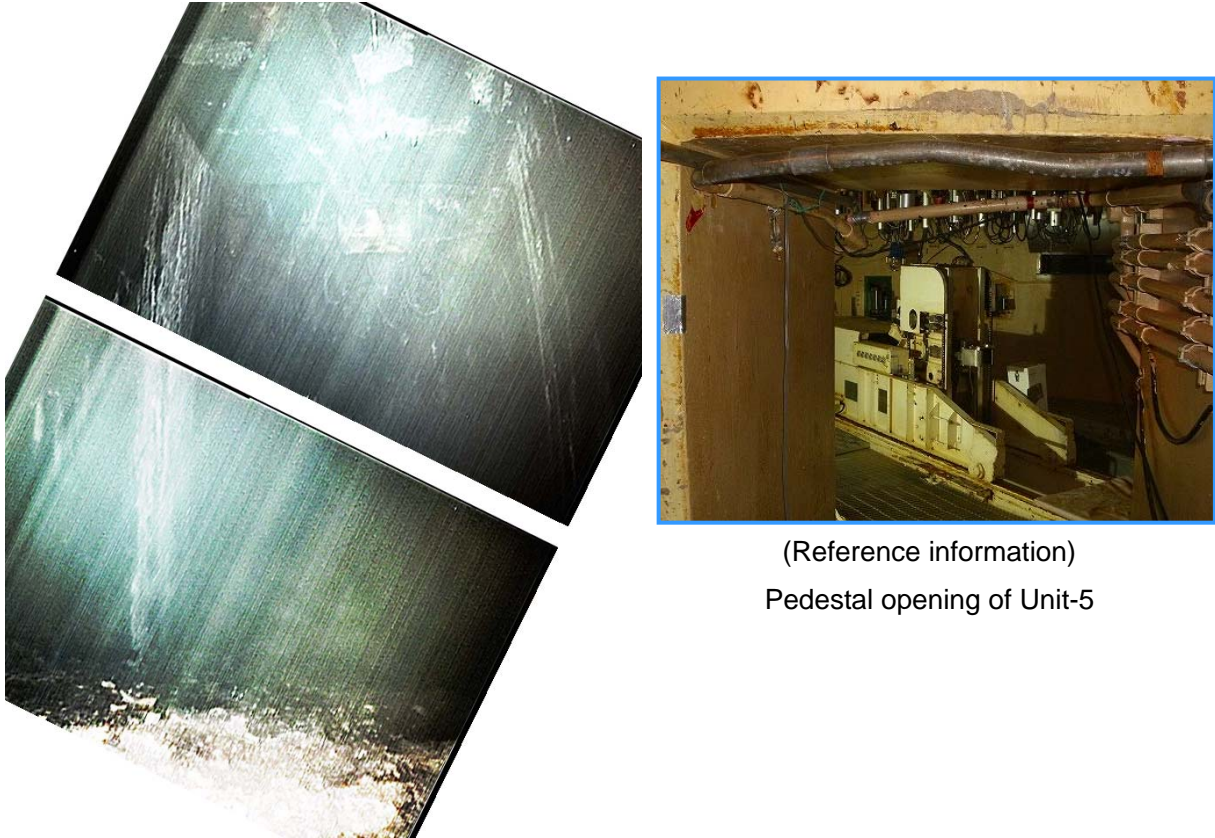
Figure 3-3 Photos inside the PCV pedestal taken at the pedestal opening (processed image)

photo processing for noise and contrast, they confirmed the position of the control rod position indicator probe (PIP) cables in the upper part of the pedestal opening, but no clear information was obtained regarding what was in the lower part inside the pedestal (Figure 3-3).

Dosimeters measured the dose rates as far as the top of the CRD replacement rails. The values were about 45 – 80 Sv/h. As supplementary information, dose rates were estimated from the camera image noises; they were about 30 Sv/h near the landing point in replacement rail and

about 36 Sv/h near the pedestal opening. No clear indication was obtained about gaining access to fuel debris, even via the pedestal opening on the CRD replacement rail because access to fuel debris will result in rapid dose rate increase.

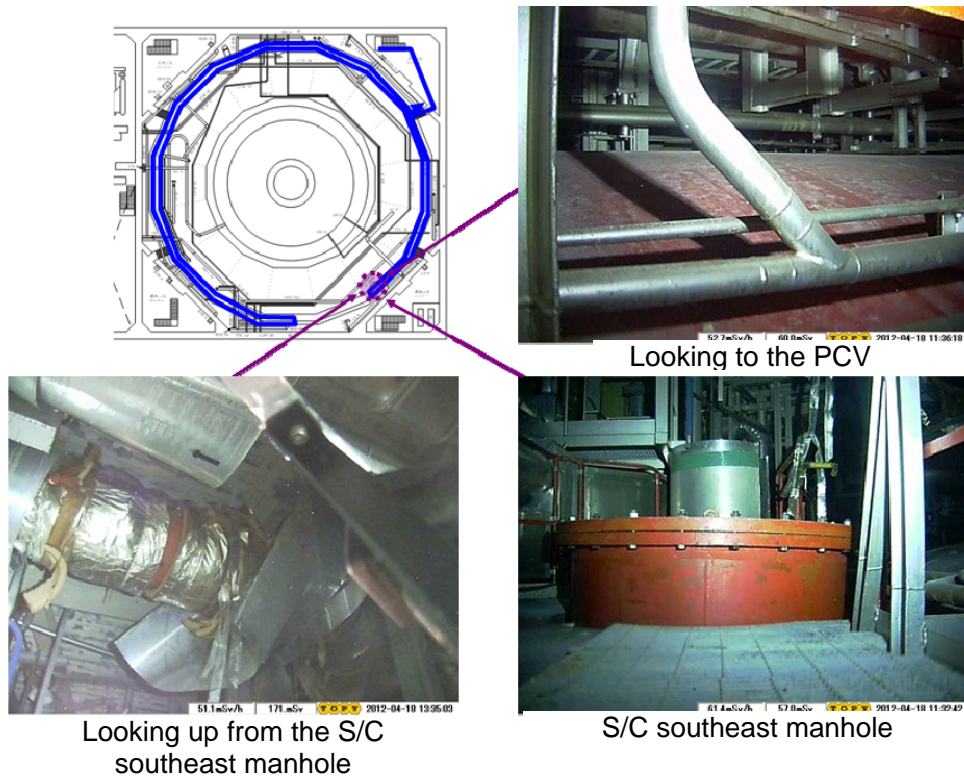
Figure 3-5 Camera photos in the torus room of Unit-2 (part)

No water leaking position in the S/C has been located yet. At least, no leak was confirmed on the flange, etc. of the S/C manholes, as far as the camera photos show (Figure 3-5).

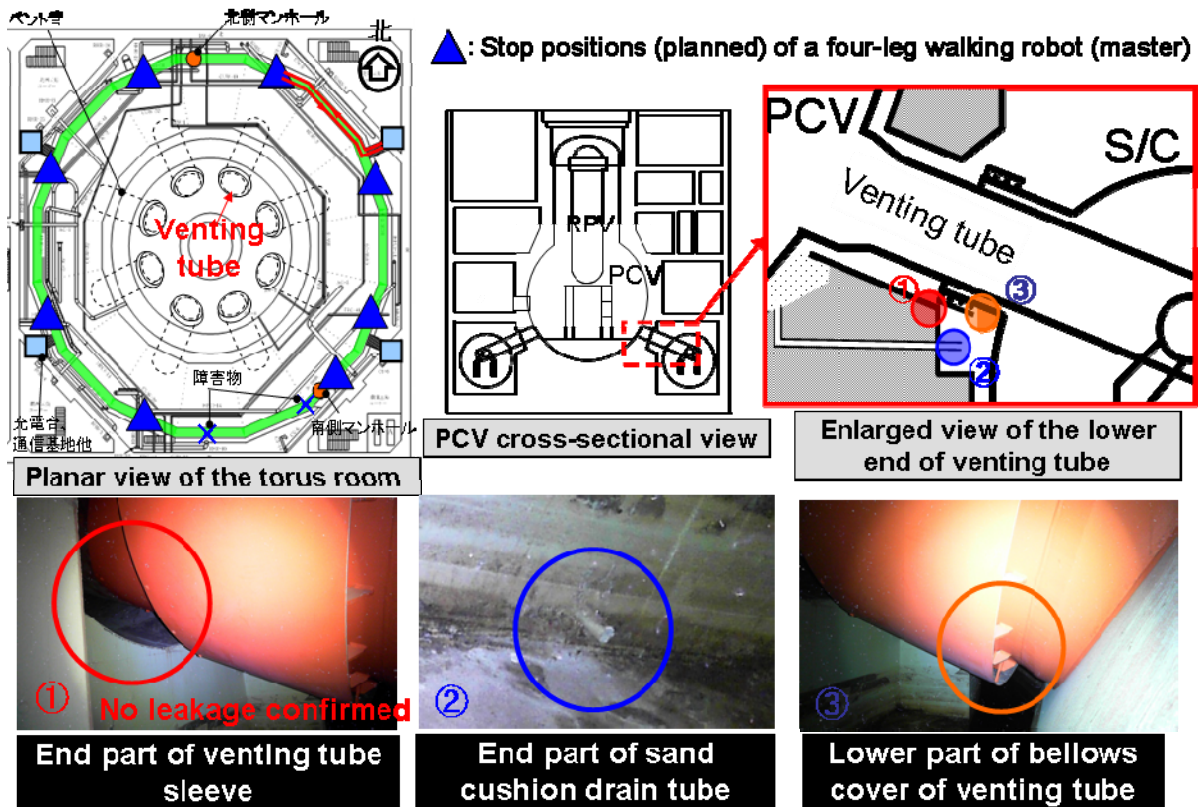
Figure 3-6 Camera photos around the lower end of the venting tubes in the torus room of Unit-2 (part)

No water leaking position in the S/C has been located yet. At least, no leak was confirmed from the lower end of venting tubes within the visible range (Figure 3-6).

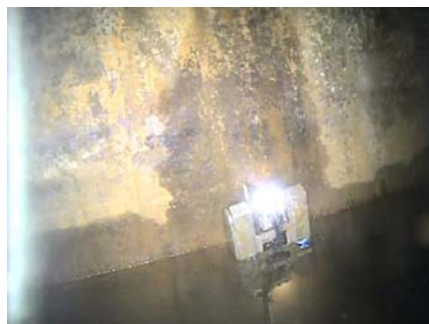
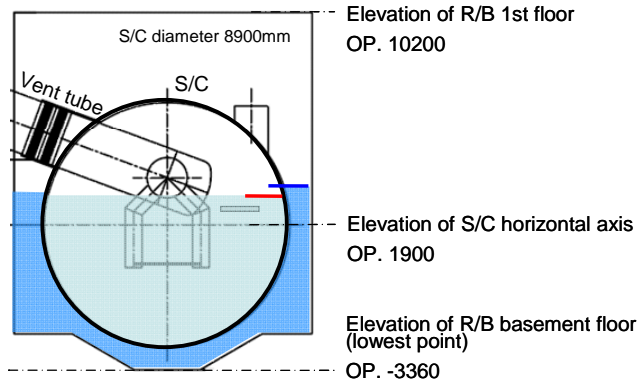
Figure 3-7 S/C water level measurements of Unit-2

In January 2014, the S/C water level was remotely measured using ultrasonic techniques from the chamber outer surface. That is, the ultrasonic waves reflected by the S/C internal structures (as well as the opposite wall) were continuously measured. The water level could be estimated by observing where the reflective waves disappeared (Figure 3-7) [15].

The S/C water level is in correspondence with the level of water retained in the torus room. This is consistent with the water level estimated earlier by the nitrogen gas injection tests. This information confirms that water leaks occurred at the S/C lower position (including piping).

(Note) S/C water level seems to be affected by water level retained in the torus room

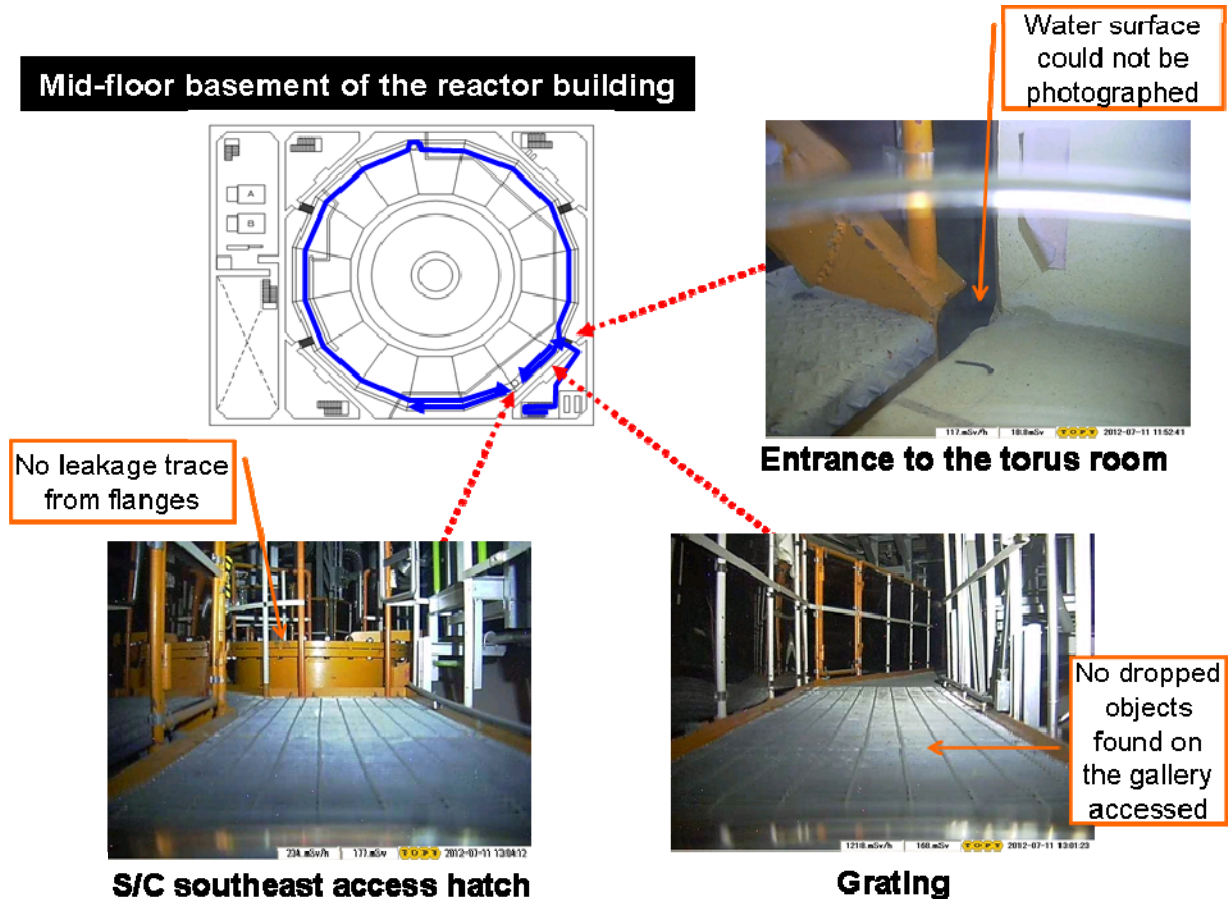
Figure 4-1 Camera photos in the torus room of Unit-3 (part)

No water leaking position in the S/C was located yet. At least, no leak was confirmed on the flange, etc. of the S/C manholes, as far as the camera photos show (Figure 4-1).

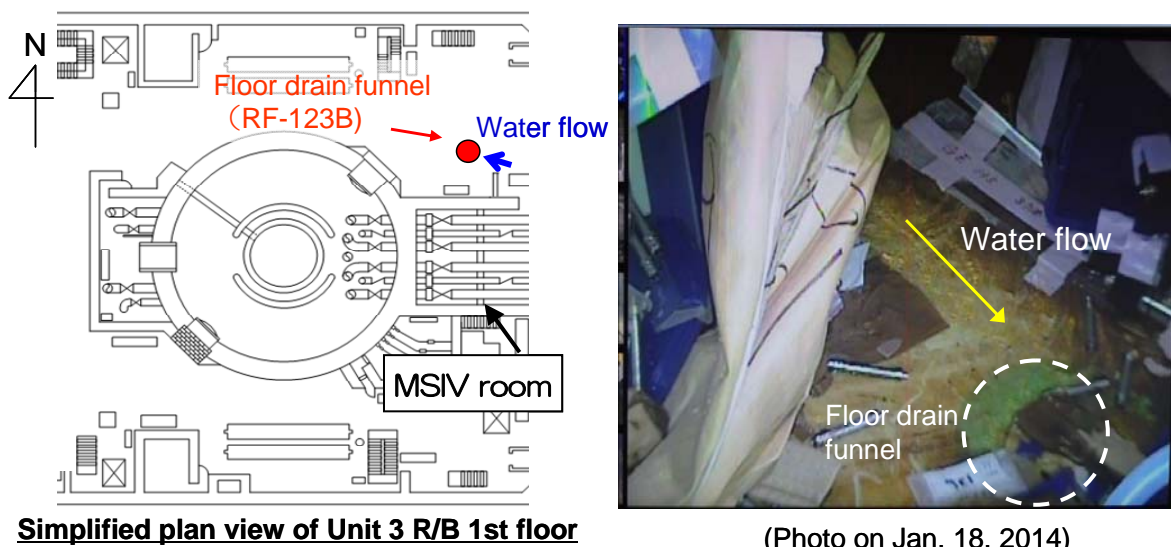
Figure 4-2 Water leak near the MSIV room door of Unit-3

In January 2014, while camera photos taken by the rubble and wreckage removal robot in the Unit 3 reactor building were being checked, water was seen to be flowing from near the main steam isolation valve (MSIV) room door in the northeast area of the reactor building first floor. The water was flowing towards a nearby floor drain funnel (Figure 4-2) [18].

The water level in the PCV is estimated as about OP.12m (about 2 m above the reactor building first floor) by converting the S/C pressure obtained by the existing pressure indicators to water head. This elevation is on the level of PCV penetrations for main steam lines, thus indicating the possibility of water leaks from the PCV penetration in the MSIV room as the source of the water flow. In consideration of this possibility, instrumentation was inserted into the MSIV room from the HVAC system room on the floor above, in April and May 2014, and photos were taken and dose rates were measured in the room, in order to locate the water flows in the room. Water leaks were from near the expansion joint of main steam line D. It was concluded [19] that the leakage had occurred only from the main steam line D, based on: (1) confirmation of no leaks from the main steam lines A, B and C, and their main steam drain pipes; and (2) the flow directions of leaked water on the floor.
