Report on the Investigation and Examination of
Unconfirmed/Unclear Matters
on the Development Mechanism of the Fukushima Nuclear Accident
Progress Report No.3

May 20, 2015

Tokyo Electric Power Company, Inc.

Progress Report No.3

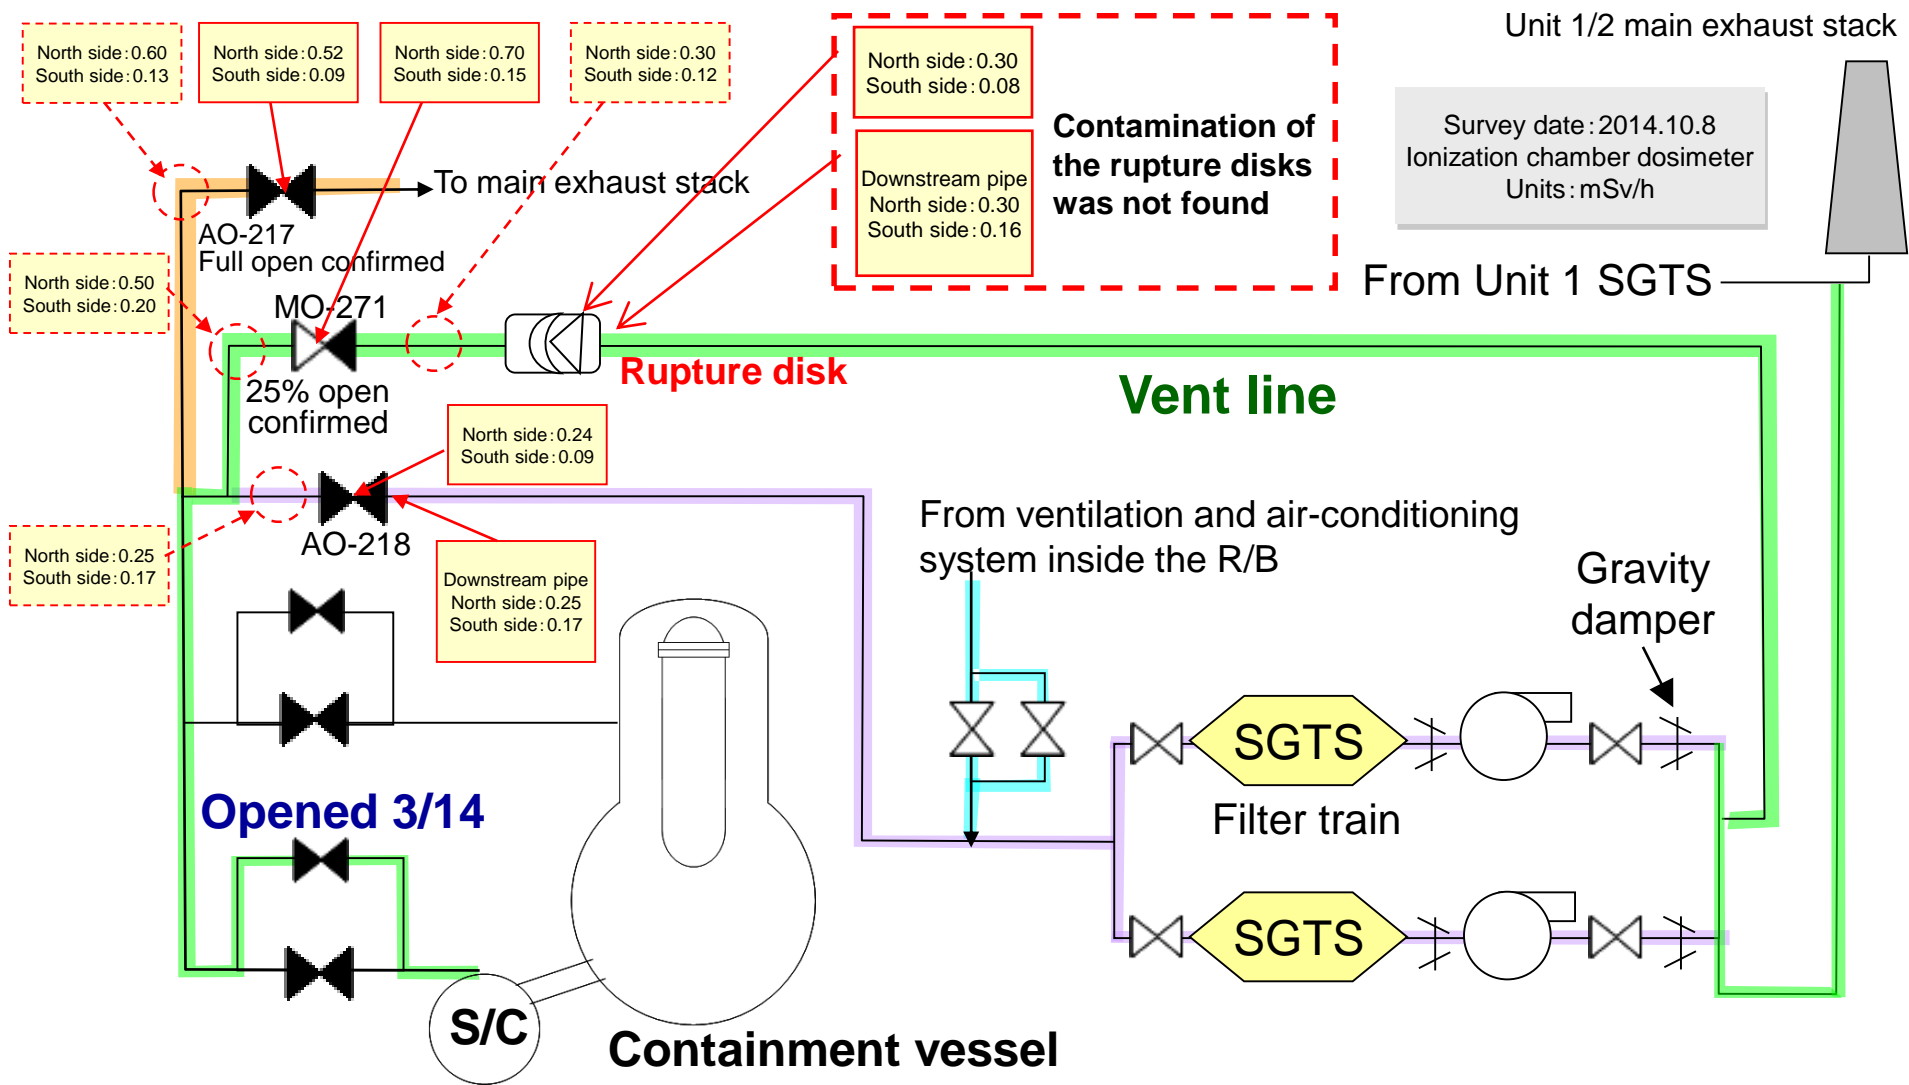
(3) Dose survey results ~ Around rupture disks ~

★The “north side” of the pipe surface dose refers to the dose measured from the SGTS filter side. “South side” values are lower due to shielding by the pipes. This means that doses from the SGTS dominate and that contamination of the pipes cannot be detected

No contamination was found near the rupture discs.

⇒ It is highly likely that the rupture discs did not function

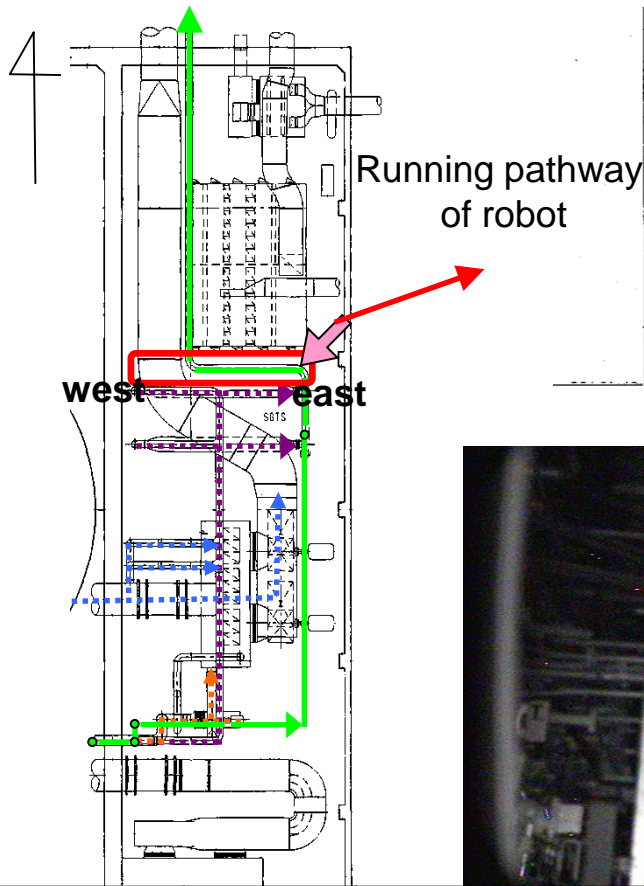
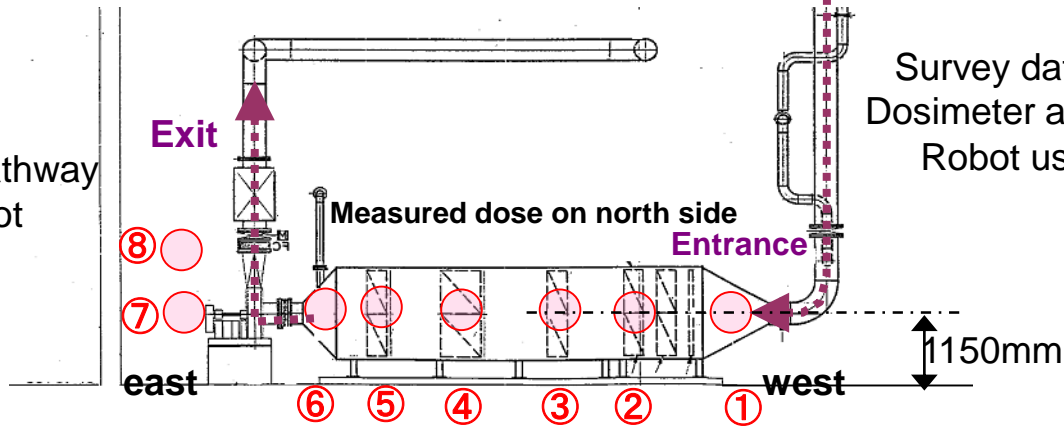
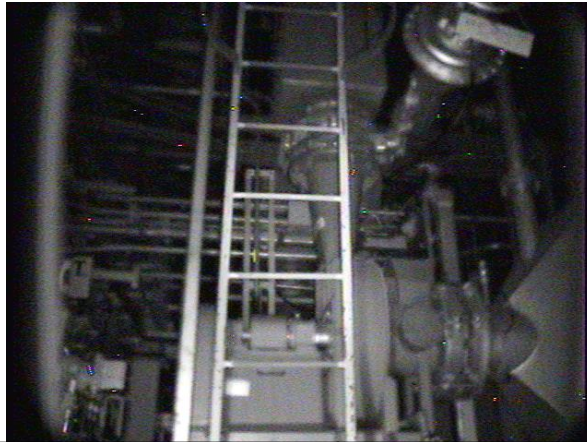
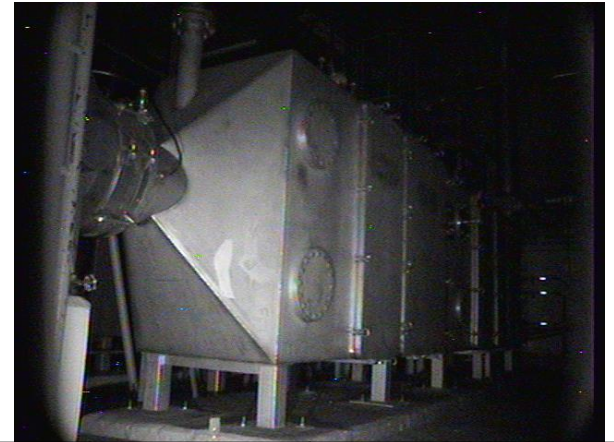
(4) Dose survey results ~ SGTS filter train (A) ~

Survey date: 2014.11.12
 Dosimeter attached to robot
 Robot used: PackBot

Measurement location	⑧-A	⑦-A	⑥-A	⑤-A	④-A	③-A	②-A	①-A
Measurement location	Outlet pipe	Outlet pipe	Outlet	HEPA filter	Charcoal filter	HEPA filter	Pre- filter	Inlet
Measurement height	2170mm	1150mm	1150mm	1150mm	1150mm	1150mm	1150mm	1150mm
Dose rate	79mSv/h	85mSv/h	400mSv/h	1Sv/h *	460mSv/h	220mSv/h	140mSv/h	69mSv/h

* Dose rate measured at a location approximately 20 cm away from the surface of the filter train (approximately 65 cm from the center of the filter)

High levels of contamination were found on the SGTS filter (downstream side)
⇒ It is possible that gases containing radioactive materials flowed back into the SGTS. This may have been caused by the following factors.

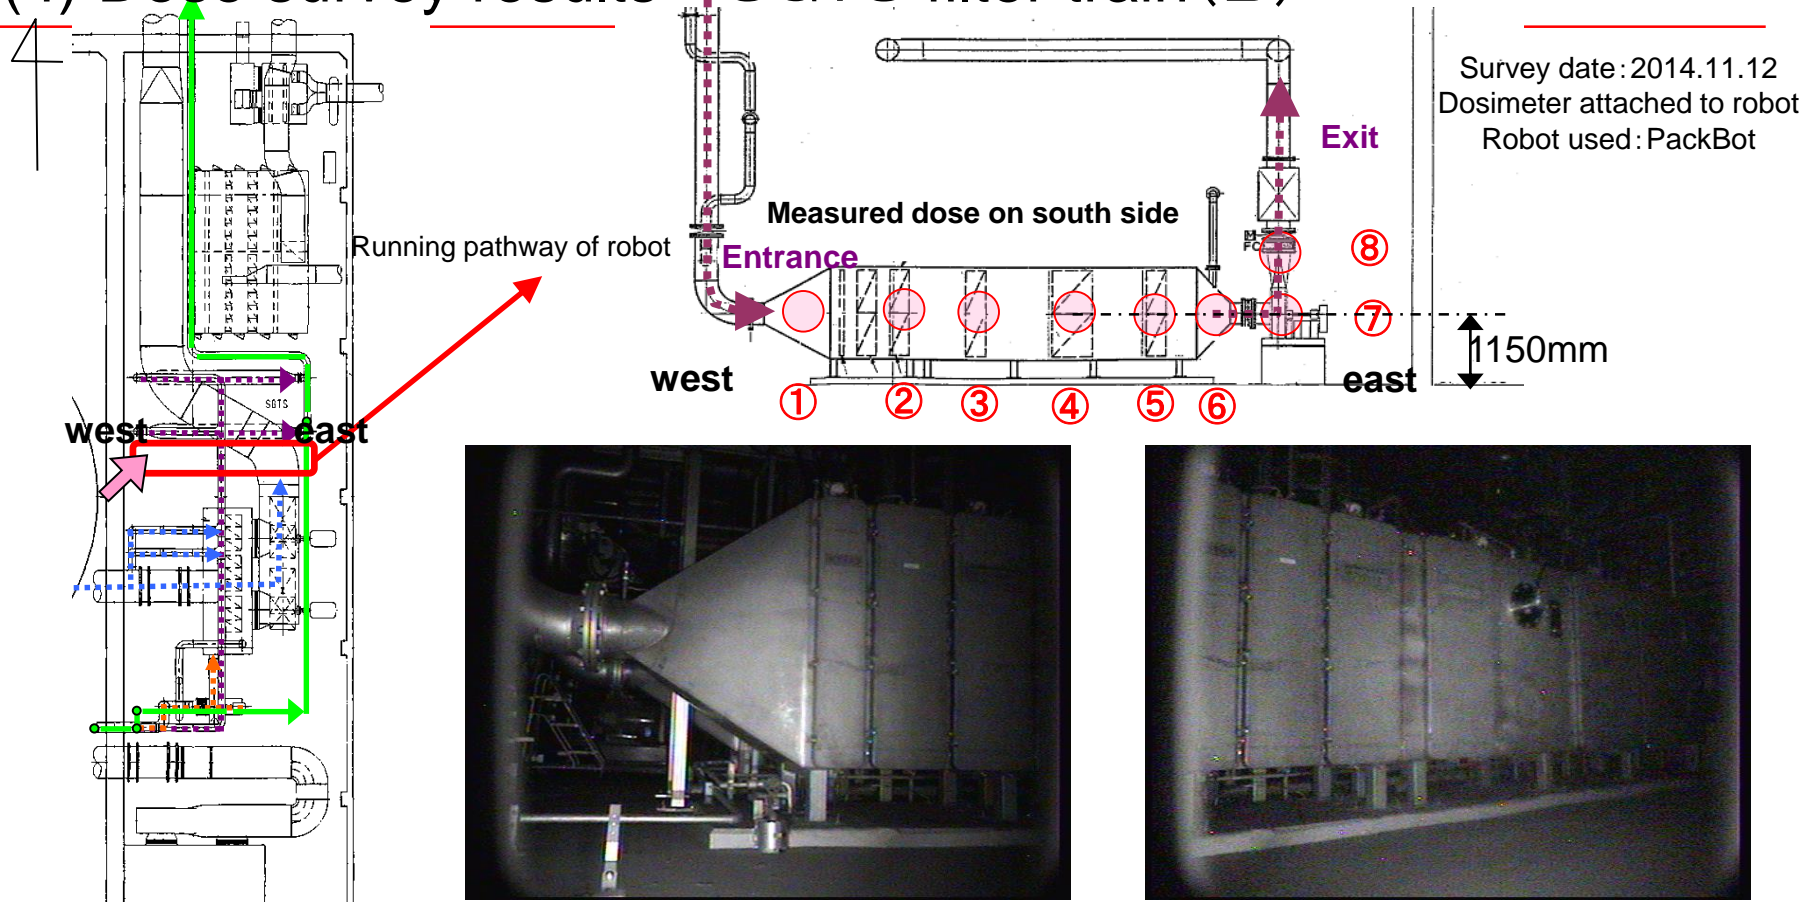
(4) Dose survey results ~ SGTS filter train (B) ~

Measurement location	①-B	②-B	③-B	④-B	⑤-B	⑥-B	⑦-B	⑧-B
	Inlet	Pre-filter	HEPA filter	Charcoal filter	HEPA filter	Outlet	Outlet pipe	Outlet pipe
Measurement height	1150mm	1150mm	1150mm	1150mm	1150mm	1150mm	1150mm	2170mm
Dose rate	15mSv/h	29mSv/h	44mSv/h	160mSv/h	850mSv/h *	500mSv/h	210mSv/h	120mSv/h

*) Dose rate measured at a location approximately 20 cm away from the surface of the filter train (approximately 65 cm from the center of the filter)

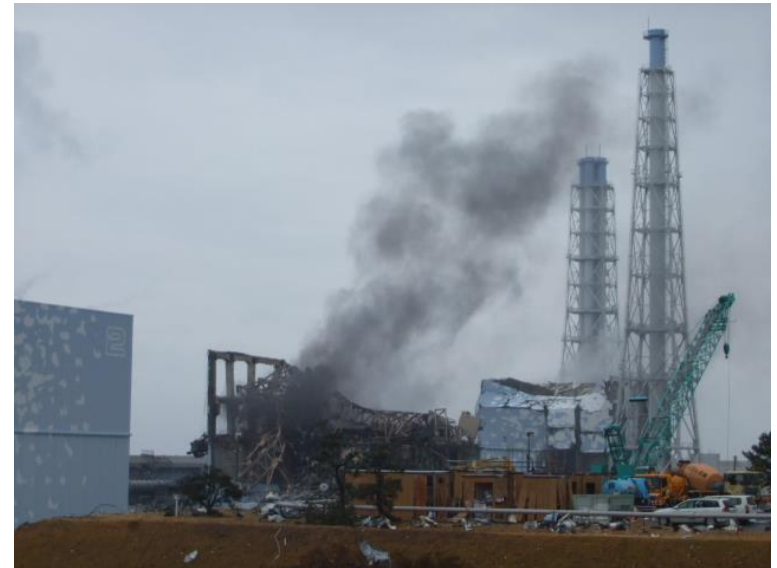
Unit 3 (March 21, 2011)

Black smoke was seen emanating from the southeast side of the Unit 3 R/B at around 4 PM on March 21

However, it was assumed that this was caused by the ignition by some means of oil in the PLR pump speed controller on the fourth floor of the reactor building. Since the unit was in operation at the time of the accident there were very few flammable materials inside the power station so it is quite possible that the aforementioned clause is accurate.

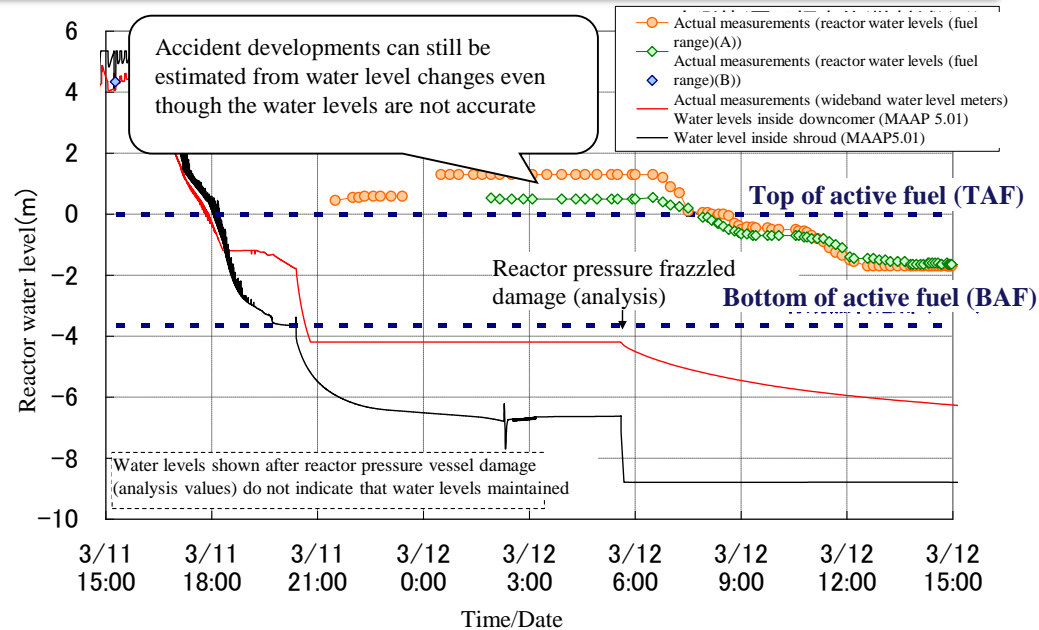
Unit 1 reactor water level changes

The results of the analysis performed in (2) suggest the possibility that the location of leak ② was not the main steam relief safety valve (SRV), but rather the top of the containment vessel

- ① 3/11 6:50 PM
Beginning of fuel damage, beginning of the generation of hydrogen, small-scale leak from reactor pressure vessel to containment vessel (D/W)
- ② 3/11 8 PM to 9 PM
Leak from reactor pressure vessel to containment vessel (D/W)
- ③ 3/11 11:24 PM to 12:30 AM
Melted debris flows into bottom of plenum (small scale)
- ④ 3/12 1:05 AM to 2:30 AM
Melted debris flows into bottom of plenum (large scale)
- ⑤ 3/12 around 6 AM
Damage to bottom head of reactor pressure vessel

- A leak at the top of the containment vessel means that containment vessel containment function was lost in conjunction with an increase in temperature ⇒ Containment vessel rupture prevention countermeasures implemented.
- DC power sources have been enhanced and spare storage batteries readied as reactor water level monitoring enhancement measures
- Thermometer installed in water level meter condensate tank (Enables the reliability of readings to be confirmed)

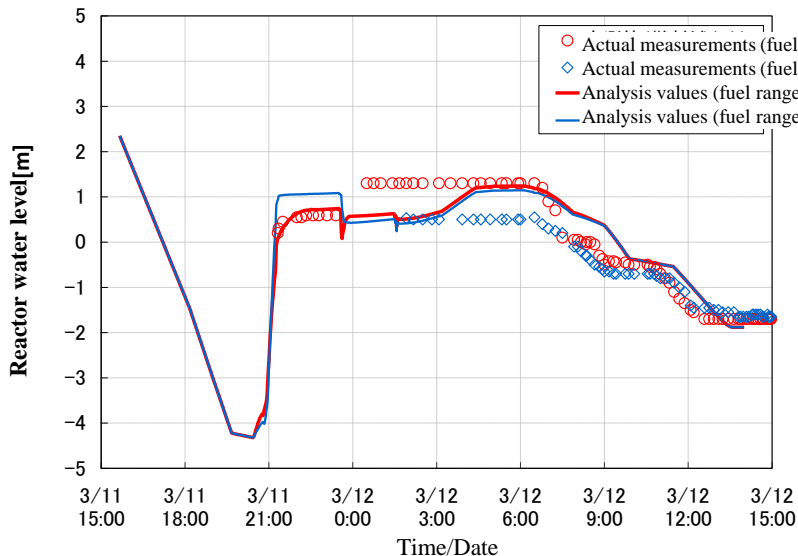
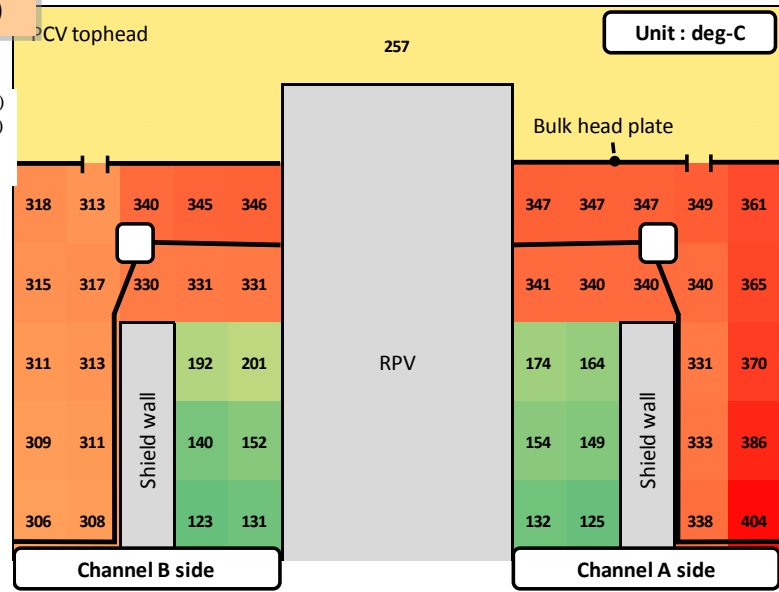
【Case 1】Leak location : Near bottom of Containment vessel (SRV)

The analysis showed that the temperatures inside the containment vessel increased evenly by and large, and the water level differences between System A and System B indicated by the actual measurement data were not seen.

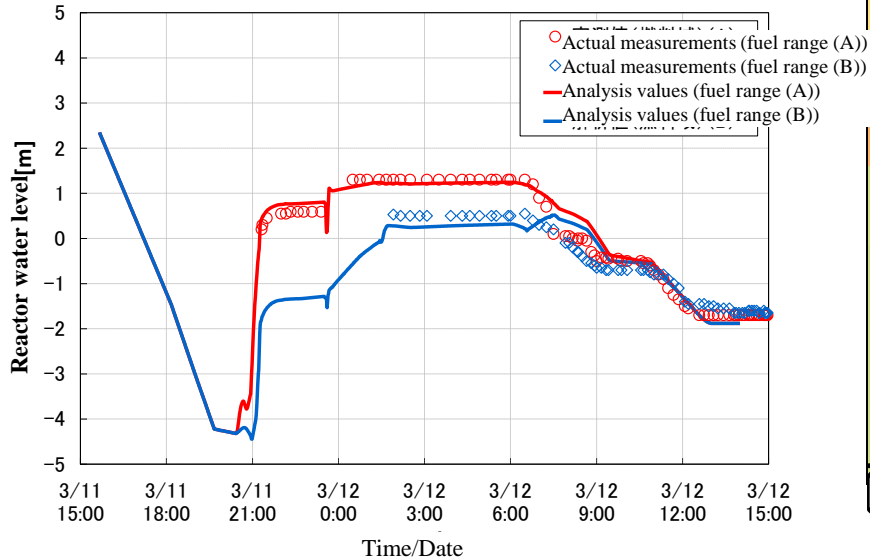
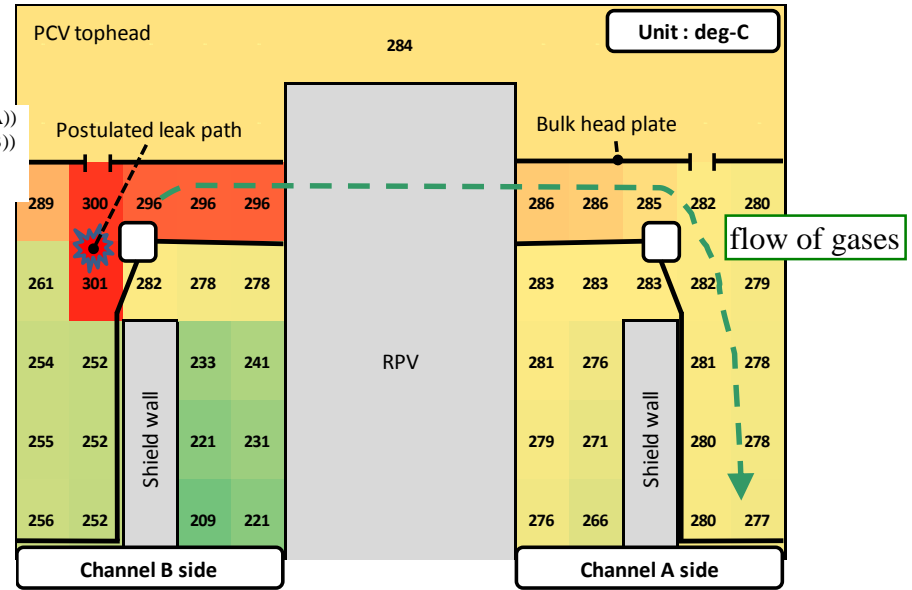
【Case 2】Leak location: Top of Containment vessel

The analysis showed that temperature increases are localized at the top of the containment vessel and that a decrease of water levels inside the water level meter reference leg side piping on one side can cause actual measurements to indicate a water level difference between System A and System B.

This suggests that the leak from the reactor pressure vessel to the containment vessel (D/W) occurred at the top of the contaminant vessel.
 This possibility will be further examined by revising analysis conditions as we continue to unravel the chain of events that happened during the accident.

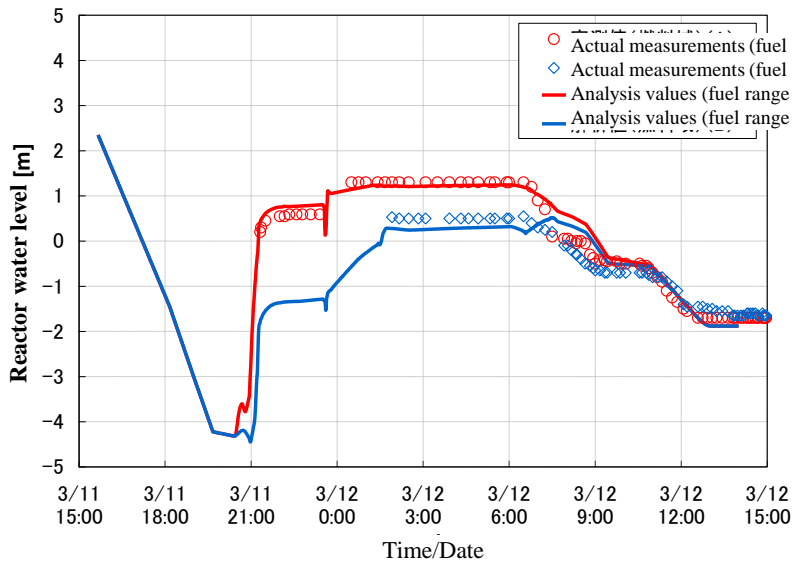
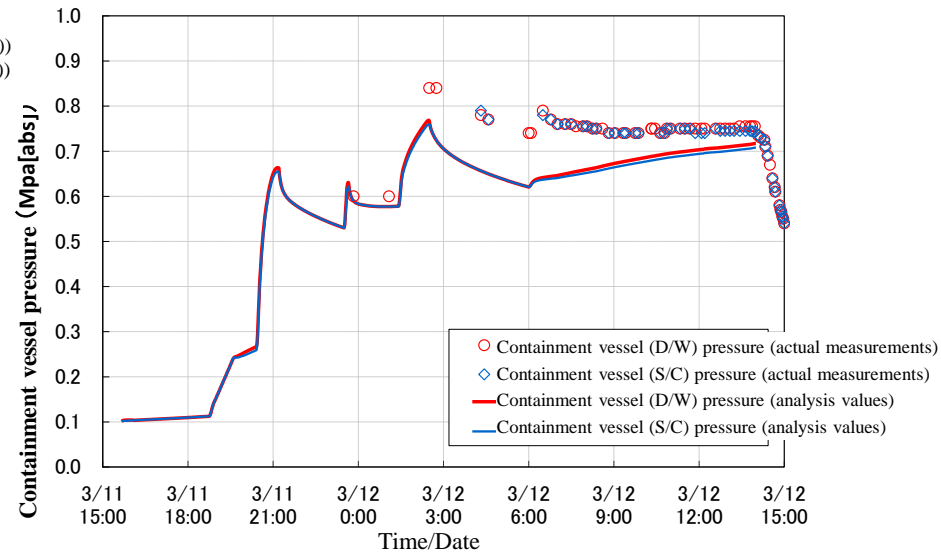
Reactor water levels
(Leak location: Top of Containment vessel)

Containment vessel pressure
(Leak location: Top of Containment vessel)

In this analysis results, we could reproduce certain degree of reactor water level and primary containment vessel pressure

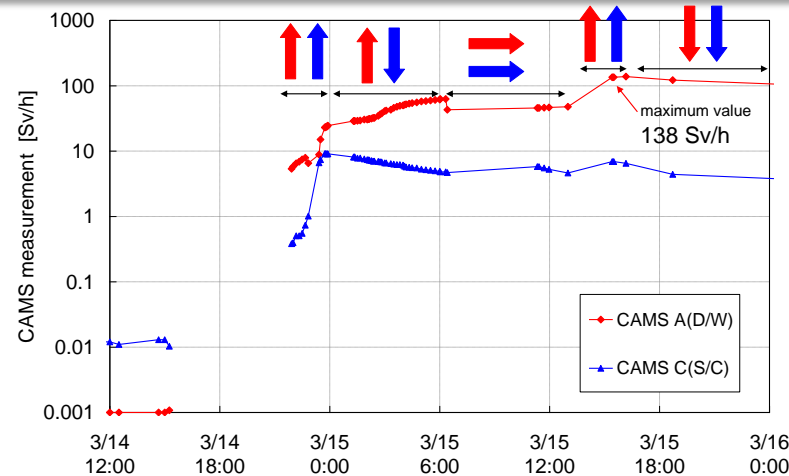
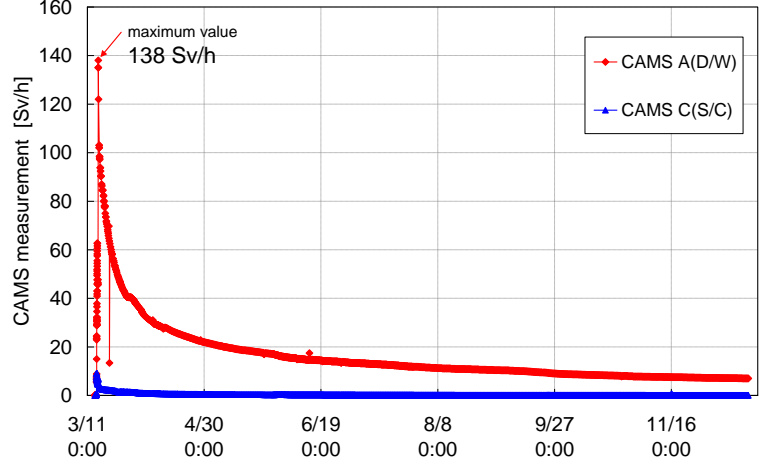
CAMS dose rate measurement data (Top: Short-term, Bottom: Long-term)

The data confirms that core damage and core meltdown occurred on the night of the 14th, and also supports the possibility of a large status change in the evening of the 15th.

Long-term CAMS dose rate measurement data shows a monotonical decrease from the maximum value of 138Sv/h recorded in the evening of March 15th. In other words, there was no reheating or remelting after March 15th.

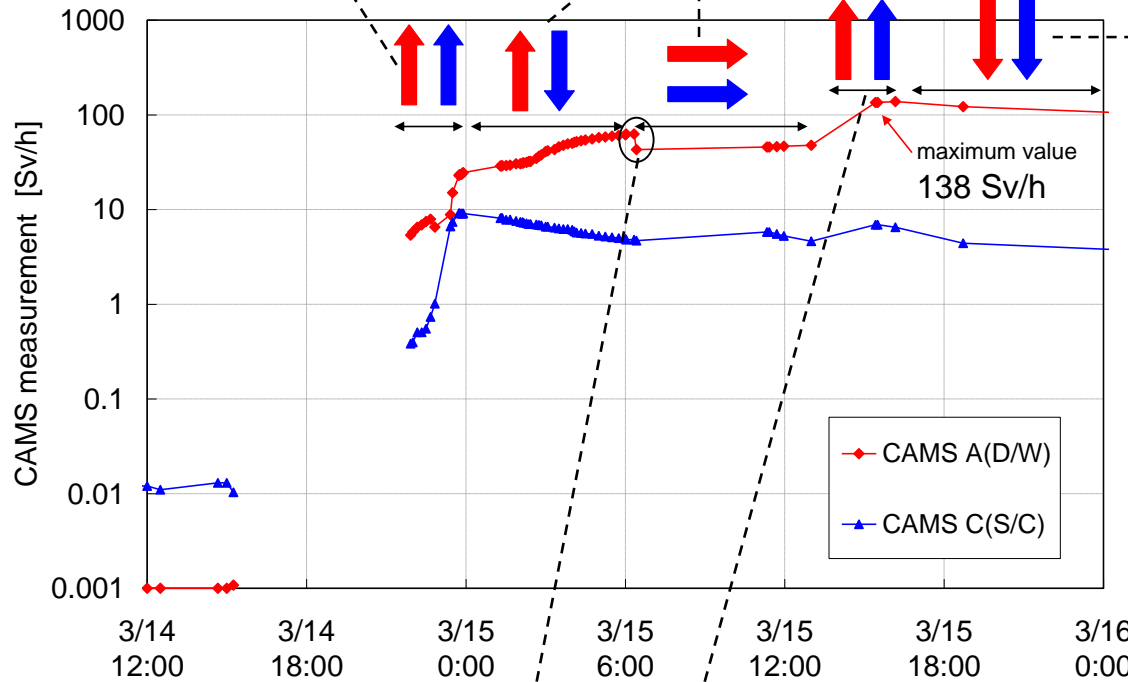
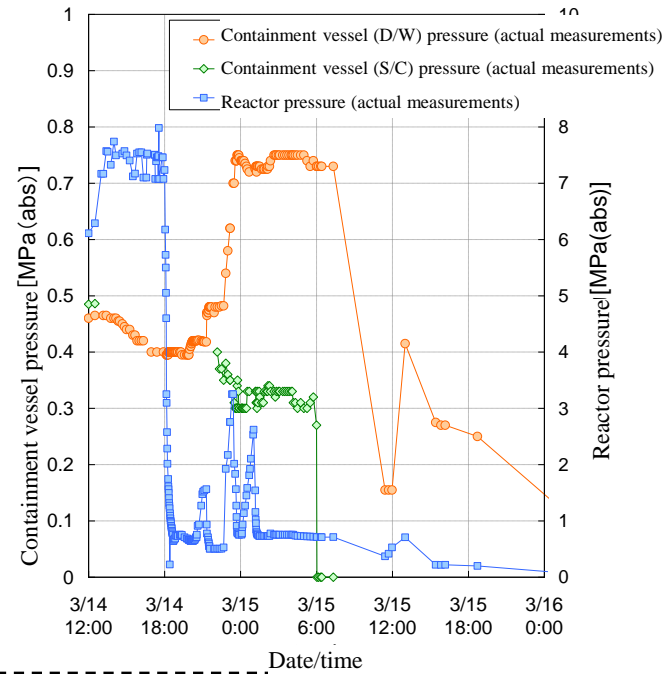
Period ①: Core damage begins, dose rates in D/W and S/C increase. Radioactive substances flow through the SRV from the reactor into the S/C and then into the D/W through the ruptured vacuum break valve.

Period ②: While D/W dose rates increase, S/C dose rates start to decrease. Indicates the possibility that radioactive substances are leaking directly from the reactor into the D/W

Period ③: No large dose rate changes are seen in either the D/W or the S/C. there is little measurement data for this period but it is possible that a state of equilibrium is reached

Early in the morning on March 15: Steam is seen emanating from the blowout panels, and records show that dose rates in the D/W decreased early in the morning on March 15 when dose rates increased. There is a possibility that this indicate a discharge of radioactive substances from the D/W.

Period ④: D/W dose rates quickly increase. Maximum value of 138Sv/h measured. S/C dose rates increase slightly thereby indicating a possible large status change at this point time. TEPCO estimates that the Unit 2 reactor pressure vessel was damaged and fuel had fallen into the containment vessel, but was the reactor damaged during this period of time?
