List of issues to be investigated

Reference [1] "Safety measures at the Kashiwazaki-Kariwa Nuclear Power Station of Tokyo Electric Power Company (First version, March 2013)"

List of issues

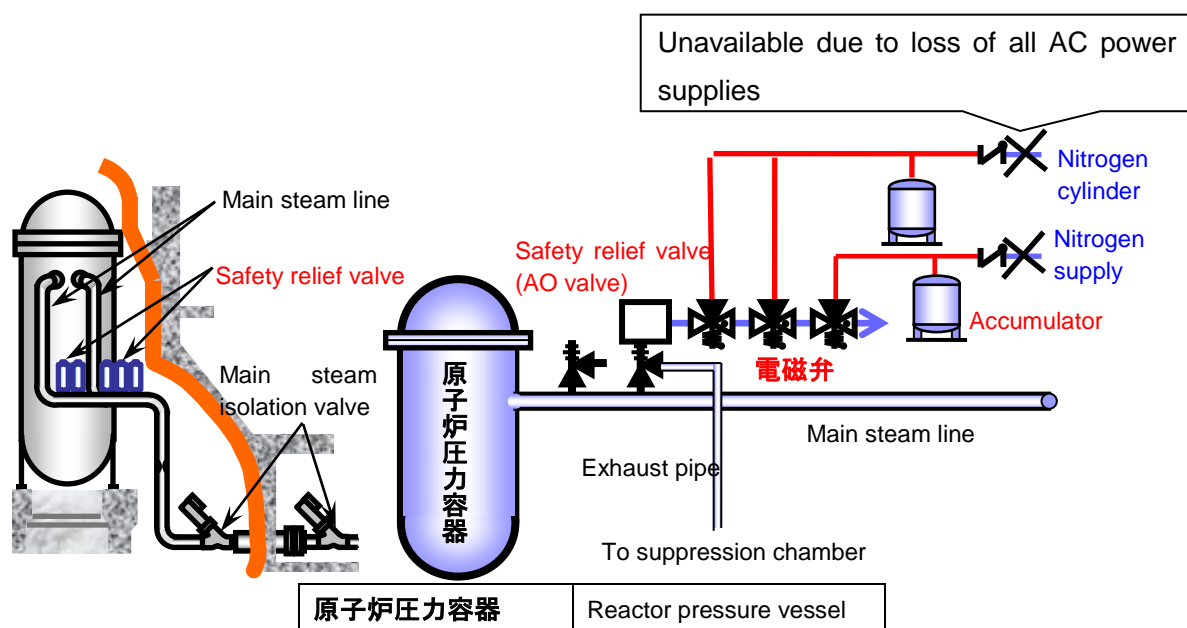
For example, at Unit-3, the SRV opening operation was attempted from the main control room (MCR) control panel after the HPCI had been manually shutdown at 02:42 on March 13, but no response was observed in the reactor pressure. Therefore, the operators recognized that the SRVs had not worked.

Possible causes of SRV failure to function may include insufficient pressure of driving nitrogen gas and the insufficient voltage to activate motor-operated valves. But other relevant matters, such as the SRV opening/closing operation after core damage or reactor pressure changes, are also to be examined in order to clarify the causes why the SRVs did not function, because there is not enough knowledge on the SRV functionality under severe accident conditions.

Figure Schematics of the main steam safety relief valves.

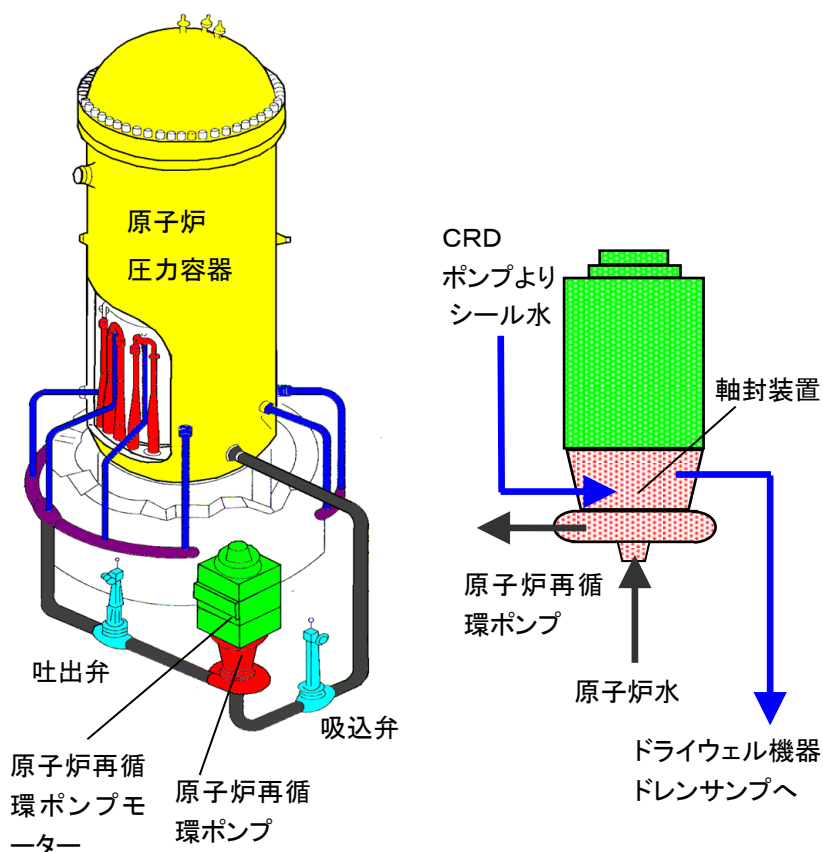
Mechanical seals are mounted on the primary loop recirculation (PLR) pumps as the shaft seal. During normal operations, sealing water for the shaft seals provided from the control rod drive (CRD) pumps prevents reactor water from leaking. When the external power supply is lost, CRD pumps are shut down and sealing water is lost from the CRD pumps; then the high pressure reactor water is discharged to the drywell (D/W) equipment drain sump via the PLR pump shafts and shaft seals.

As a matter of fact, at Unit-4 of the Fukushima Daini NPS, which did not need to run the D/W spray, it was found during a post-earthquake patrol in the PCV that water had filled the pedestal, which had housed the equipment drain sump, and reached even the diaphragm floor (the D/W bottom floor). Water discharge from the equipment drain sump stopped after the earthquake. Therefore, it is highly possible that this water was the leaked water from the reactor via the PLR pump shafts

As long as the mechanical seals are not damaged, the water leak from the reactor is expected to be below the design leak rate and has little impact on the reactor behavior. But, if the seal functions were lost in the process of accident progression, as O-ring damage for instance, the leak rate might have increased. It is necessary to clarify whether leaks actually occurred which might have influenced the reactor water levels, and the PCV temperatures, pressures and water levels.

Figure Illustration of PLR pumps

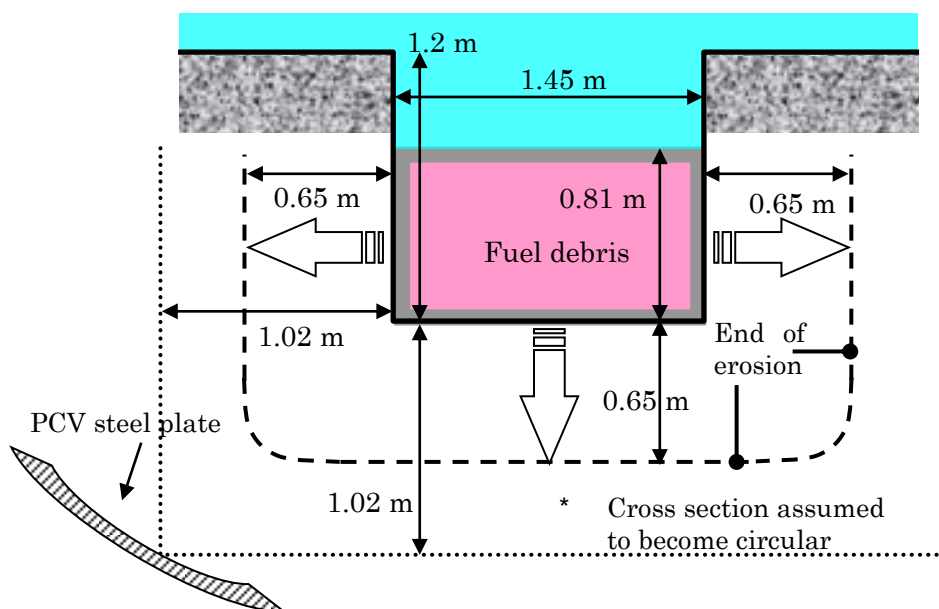
There is also a possibility of shell attacks which could open leak paths from the PCV by direct contact of molten fuel and PCV liners. However, no clear evidence has been observed to date which supports the occurrence of shell attacks: the pressures increased at Units-1 and 2 when nitrogen gas started to fill the PCV, while at Unit-3 the PCV water level was sufficiently high to have prevented them.

Figure Estimation of the scale of Unit-1 core-concrete reactions

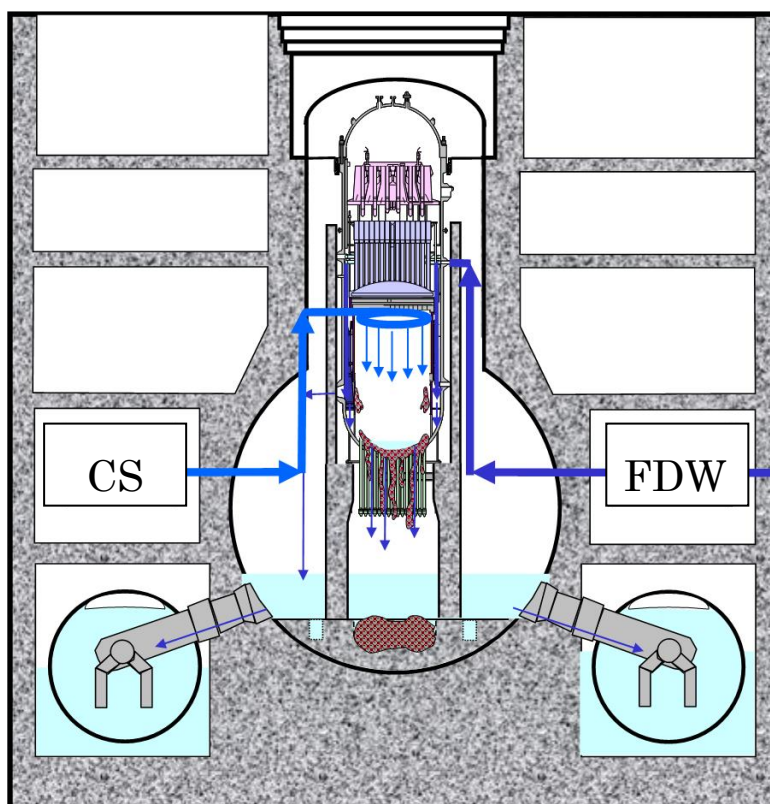
MAAP predicts that almost the whole Unit-1 core dropped to the RPV lower plenum and most of it fell further to the PCV pedestal, while the Unit-2 and Unit-3 cores remained in the core region, although there were partly molten fuel pools. Unit-1 lost all its existing water injection functions at an earlier stage and considerable time was taken to start water injection by fire engines. On the other hand, at Unit-2 and unit-3 the RCIC (Unit-2 and Unit-3) or HPCI (Unit-3) could continue injecting water to the reactor till a later stage. As a consequence, decay heat was lower when no more core cooling became possible by existing water injection means and less time was taken thereafter for the fire engines to start injecting water.

It should be noted, however, that MAAP analysis has uncertainties in setting its conditions, the analysis itself and the modeling. The results obtained have also uncertainties accordingly. MAAP predicts no RPV damage in Unit-2 and Unit-3, but the results depend greatly on the amounts of water injected to the reactor. As a matter of fact, the plant conditions thereafter indicate the reactor water levels were at very low levels and the RPVs are very likely to have been damaged. Further, core damage might have occurred even earlier at Unit-3 because the water injection by HPCI had been insufficient after the RPV pressure had decreased.

Currently, the location of debris, the ultimate result of the accident progression, is still unknown. It should be noted that the calculation results still have large uncertainties. Since this information is important input to decommission planning, further examinations are needed, based on the outcomes of the investigative research and development projects of the PCV and RPV, and other relevant projects.

Figure Estimated conditions of the core and PCV of Unit-1

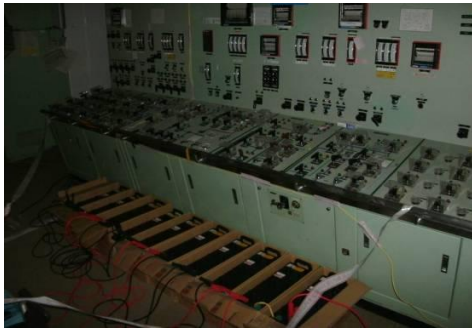
In the MCRs for Units-1 to 4, most instrumentation and control power supplies were lost after the tsunami had arrived and nothing was available for operators to monitor plant conditions or to take operational actions.

Connecting employees' private car batteries to power necessary instrumentations

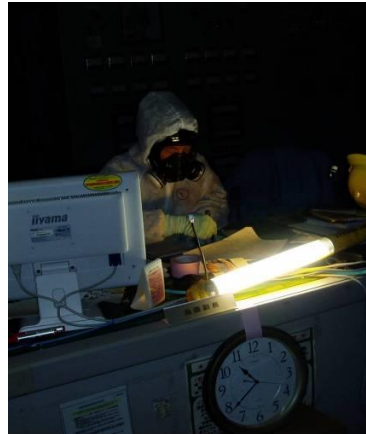
Photo of outer doors taken from indoors with no lights

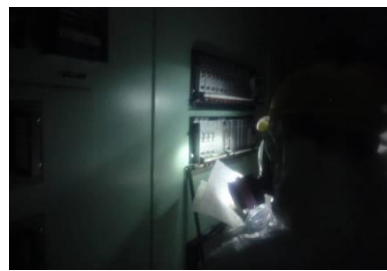
Indicator readings being checked with a flashlight in total darkness

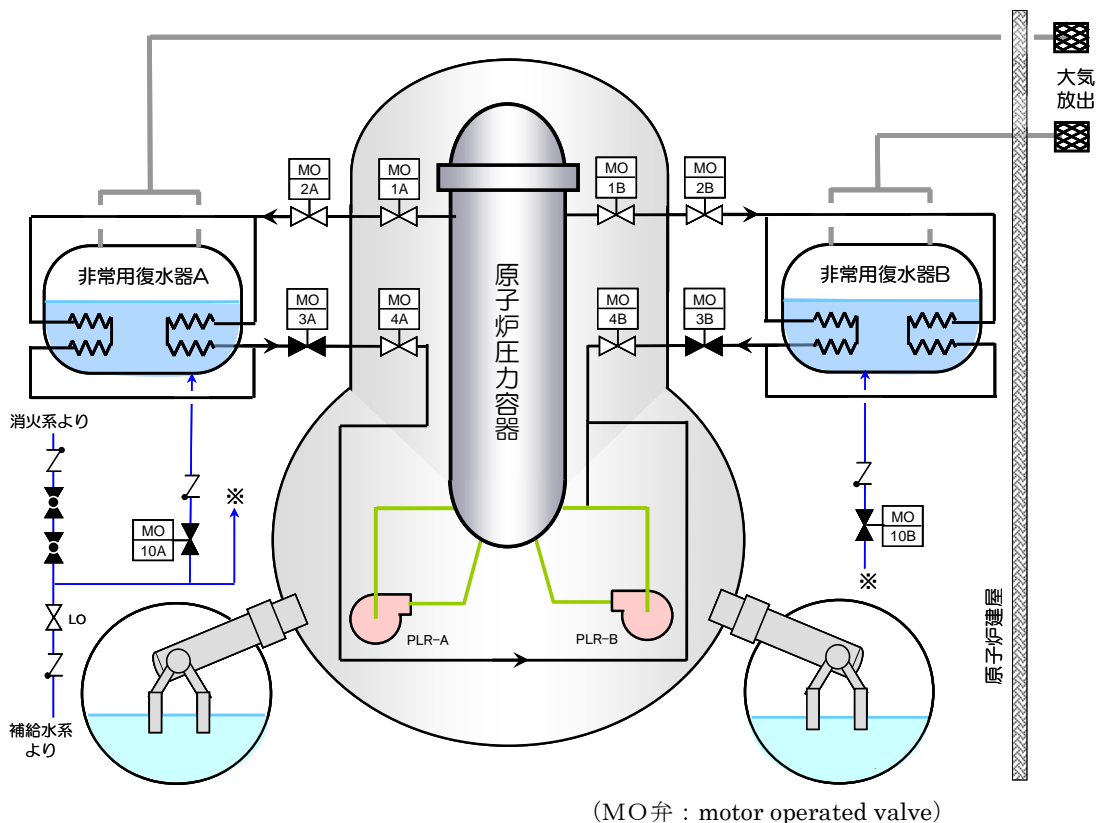
At Unit-1, the reactor pressure was being controlled after the earthquake by intermittent operation of the emergency isolation condensers (ICs). Immediately before all power supplies were lost due to the tsunami, the IC operation had been incidentally in a halted situation. In the station blackout condition, the shift operators in the MCR noticed the display lamps indicating the IC (Sub-system A) isolation valves (MO-2A, MO-3A) as “Closed” outside the PCV at around 18:00 on March 11<sup>th</sup>. They took opening action of the valves at 18:18 on March 11<sup>th</sup>, and confirmed the steam generating sounds and saw the steam when looking above the reactor building, but the amount of steam was limited and it stopped a while later. Concerned about the water inventory left in the IC shell side tank, at 18:25 the operators closed the isolation valve (MO-3A) on the return line.

It is considered that the non-condensable hydrogen gas generated by the water-zirconium reactions upon decrease of the reactor water level deteriorates the heat removal performance when it mixes in the IC cooling tubes. According to the analysis results, the reactor water level was slightly below TAF as of 18:18, and hydrogen gas might not have been being generated in large amounts. But hydrogen might have been generated by radiolysis as well. It is necessary to clarify how much the heat removal capability was actually deteriorated.

Figure Schematic illustration of IC systems

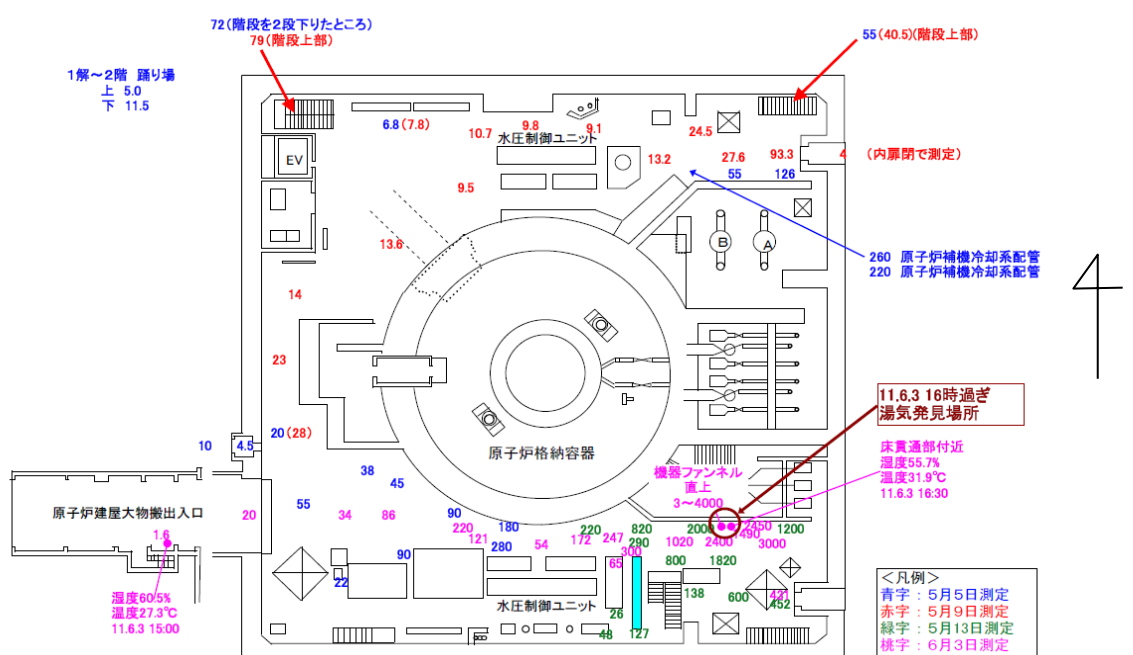
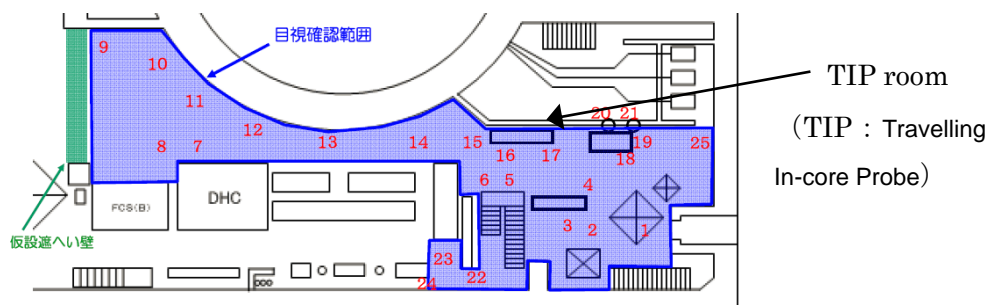
The investigations in May, June and October of 2011, and in July of 2012 located high dose rate areas of several thousand mSv/h in the southeast area of Unit-1 reactor building. In the June 2011 investigation, steam was also confirmed to be blowing out from a penetration of the floor in the area. In the July 2012 investigation, a robot attempted but failed to unlock the traveling in-core probe (TIP) room door in the area. The inside of the TIP room has not been investigated yet.

The high dose rate in the southeast area of the reactor building ground floor may be related to the steam blown from the floor penetration of the S/C venting line or possible damage of the TIP dry tubes due to the uncovered and overheated core. The causes of the high contamination are to be investigated.

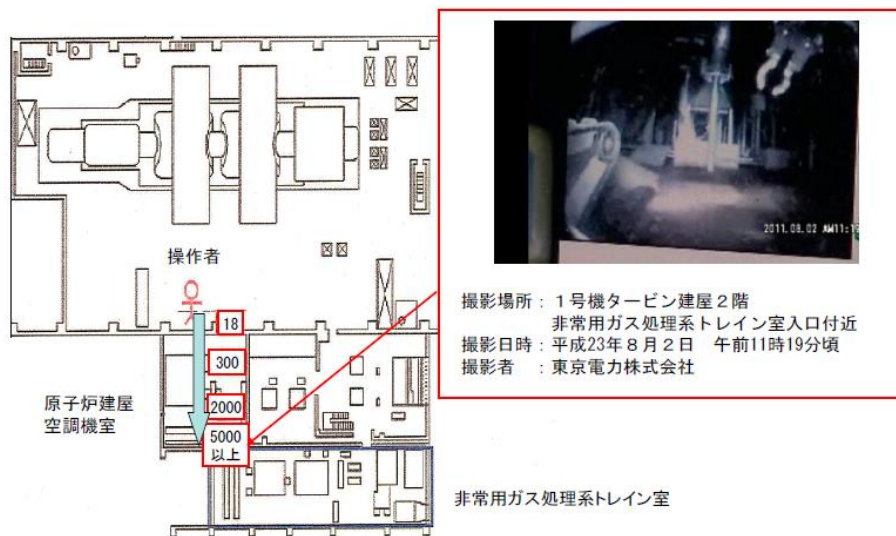
福島第一原子力発電所1号機タービン建屋2階 高線量検出箇所

The high dose rates near the SGTS piping can be considered to be caused by the deposited radioactive materials which were released from the damaged core. The detailed causes of the contamination are to be clarified.

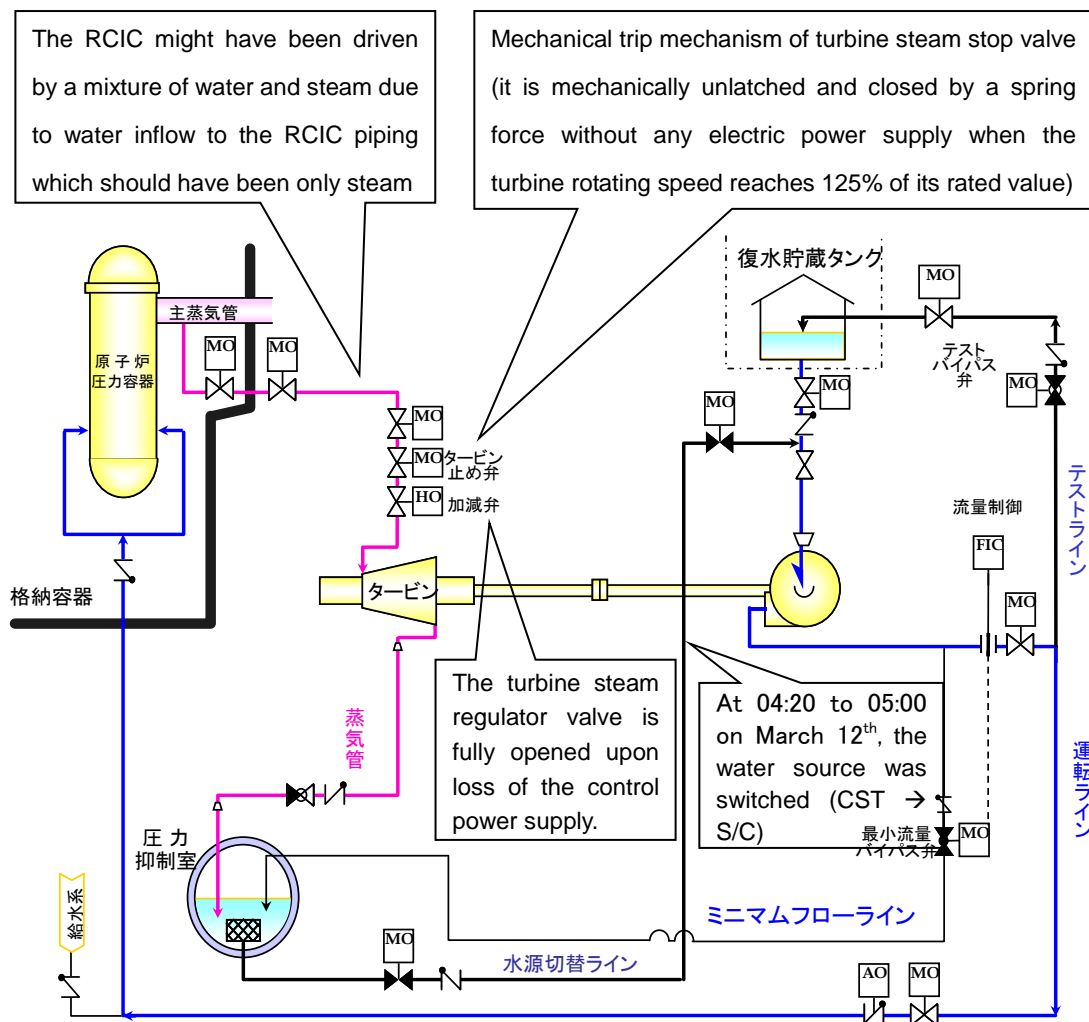
At about 09:00 on March 14<sup>th</sup>, the reactor pressure showed an increasing trend, and at about 12:00 noon the reactor water level showed a decreasing trend. The Emergency Response Center at the Fukushima Daiichi NPS concluded at 13:25 that the RCIC had lost its functions, but it is necessary to clarify why it lost them.

Figure RCIC schematic diagram

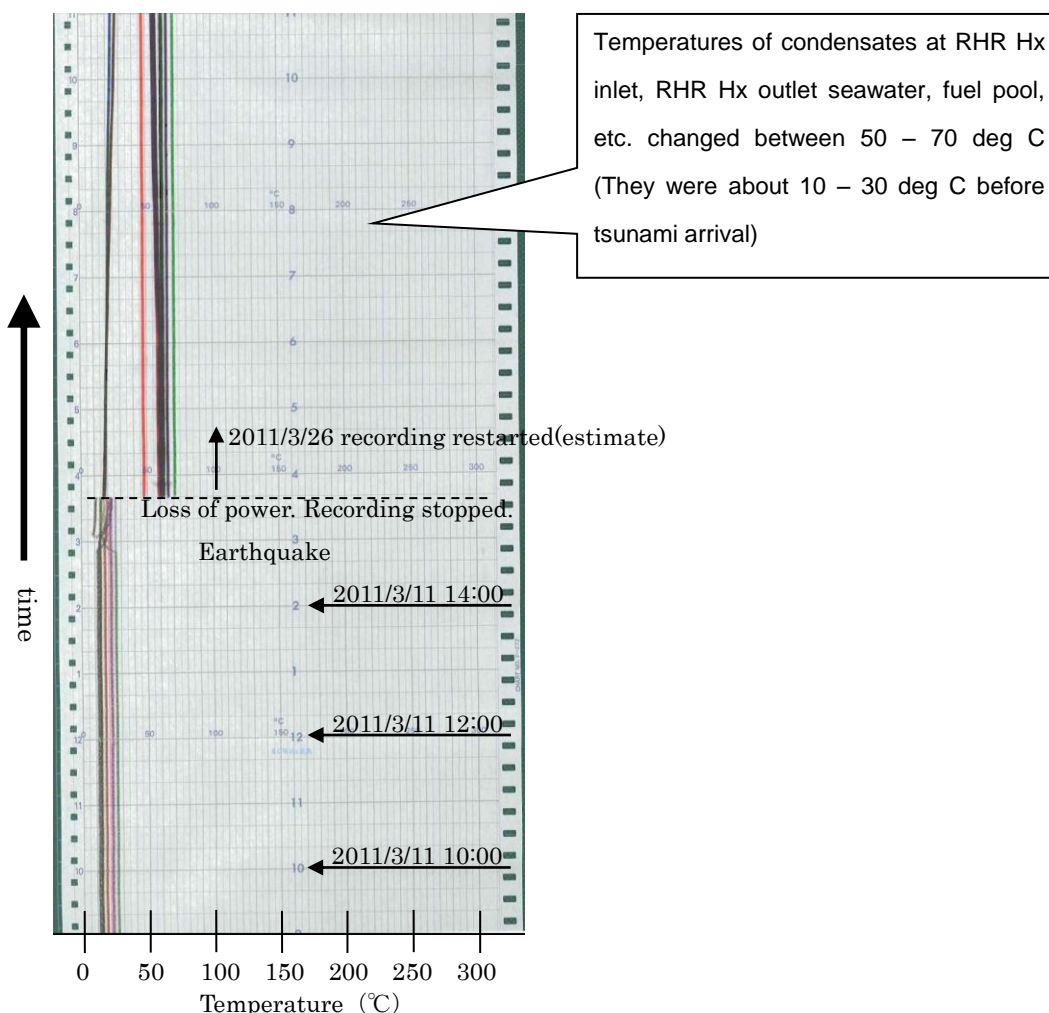
Examination will be done on the reason for the temperature increase and its possible connection to the post-earthquake RHR operation. , No temperature records are available for comparison at Unit-1 and Unit-3.

Figure Temperature recorder chart of Unit-2 (RHR and fuel pool temperatures)

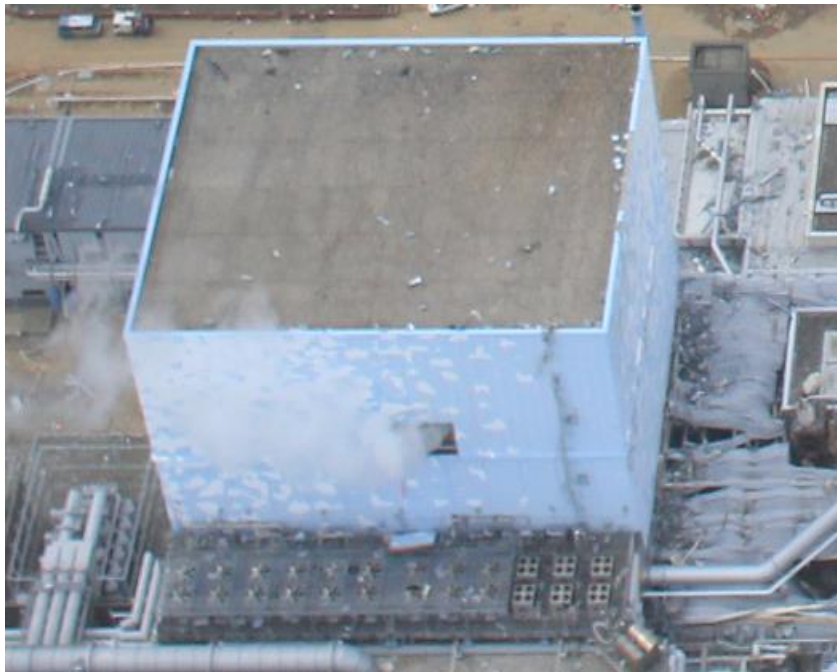
Figure Opened blow-out panel of Unit-2
