Dose increase around March 20th, 2011

1. Background

With this background, this report examines the cause of the dose increase observed on March 20th and 21st, based on the plant parameters at that time, conditions of the plant surroundings and responses to the accident.

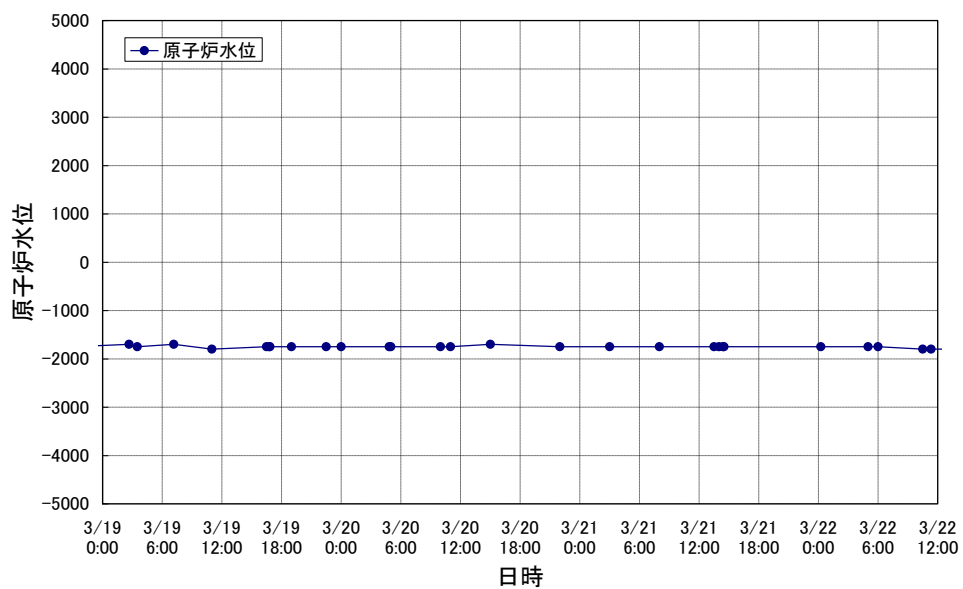
Figure 3 Reactor water level of Unit-1

Concerning Unit-1, Figure 3 and Figure 4 have no noticeable significant changes in the reactor water level, reactor pressure and PCV pressure during the time period when dose increase was observed, although the data points are limited. In Figure 5 CAMS (D/W) readings show a big drop after 12:00 on March 20th, which might indicate a possible release of radioactive materials from the containment vessel. But the PCV pressure shows no changes and the CAMS (S/C) data show no big changes during the period of interest. All in

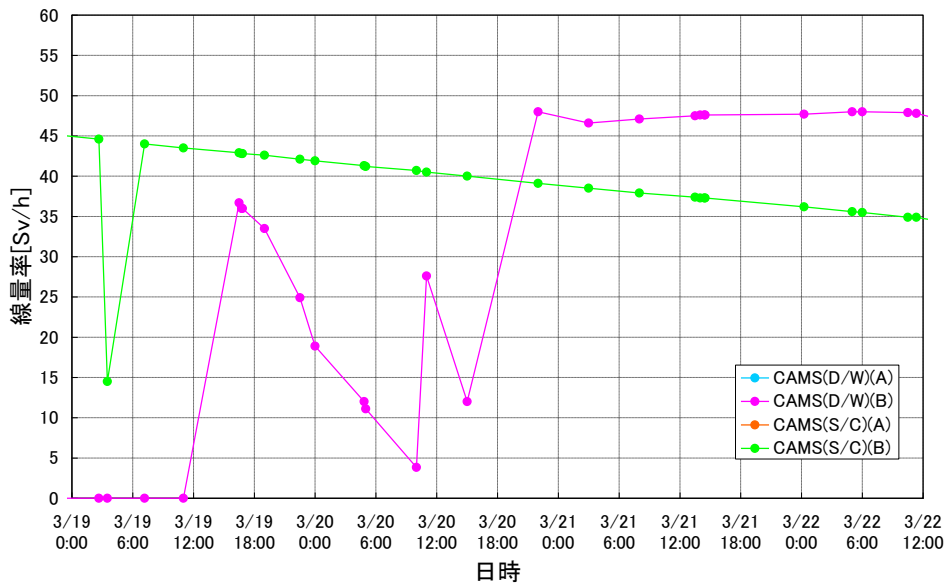
Figure 5 CAMS readings of Unit-1

all, the change in the CAMS (D/W) readings is reasonably attributed to defective individual readings.

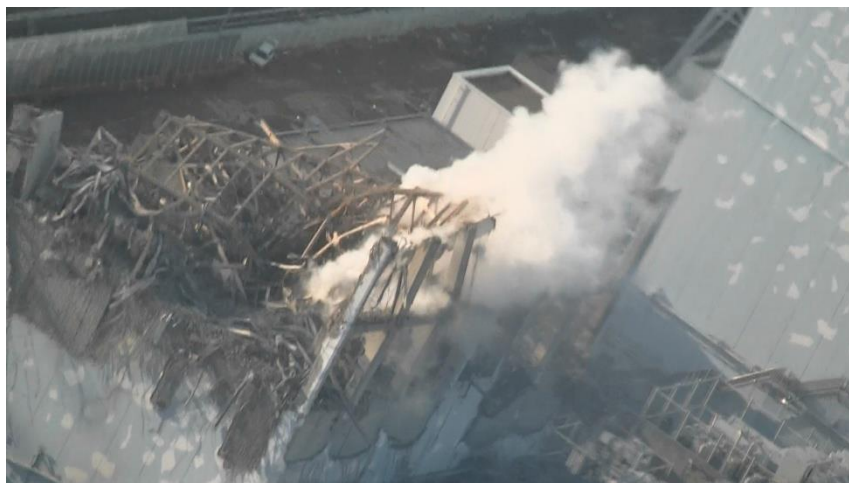
Figure 12 Aerial photo of Unit-3 (March 16th, 2011)

have been more or less continuously released from the containment vessel of Units-1 to 3. For example, steam and other gases rose from the Unit-3 containment vessel as white smoke that passed from the upper side of the building after it had been damaged by the hydrogen explosion. This situation can be seen in an aerial photo taken on March 16th (Figure 12).

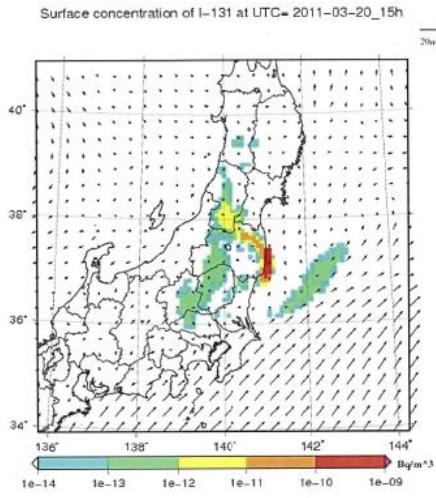
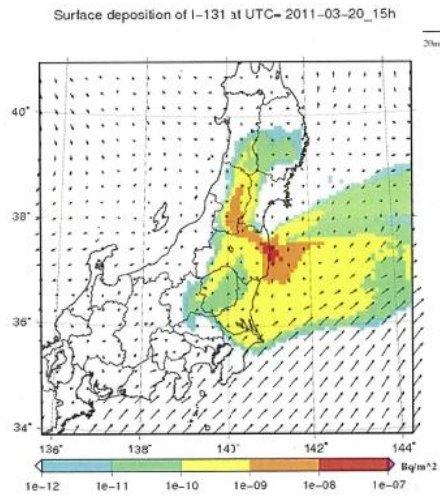
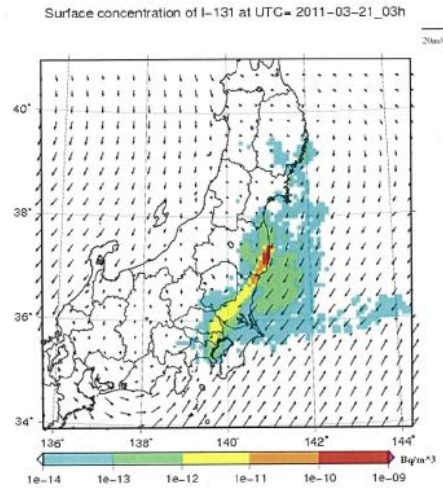
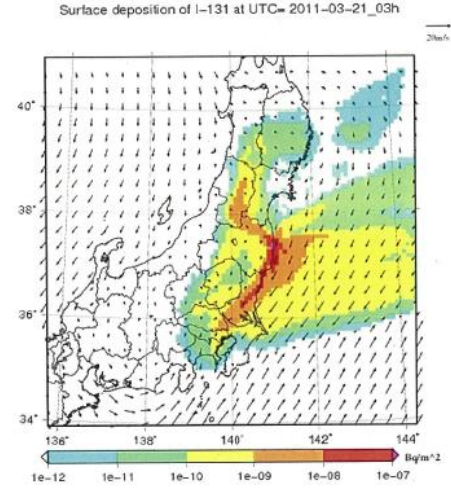
Figure 15 Dispersion state (calculated) as of 00:00 on March 21st and 12:00 on March 21st

Radioactive materials were dispersed over the Kanto region in the results, from which it can be reasoned that the impacts of the continuously released radioactive materials have also occurred in the Kanto region.

This indicates a possibility that the dose increase or increased radioiodine concentration in drinking water in the Kanto region, which led to the recommendation to refrain from tap water intake, might have been caused by not only an instantaneous release but also the continuous release of radioactive materials. Even if the dose increase observed around March 20th and 21st, 2011, at the Fukushima Daiichi NPS was due to changing wind directions, not an instantaneous release, the dose in the Kanto region could have increased.
