Evaluation of the situation of
cores and containment vessels of
Fukushima Daiichi Nuclear Power Station
Units-1 to 3 and examination into unsolved
issues in the accident progression

Progress Report No. 4

December 17, 2015

Tokyo Electric Power Company, Inc.

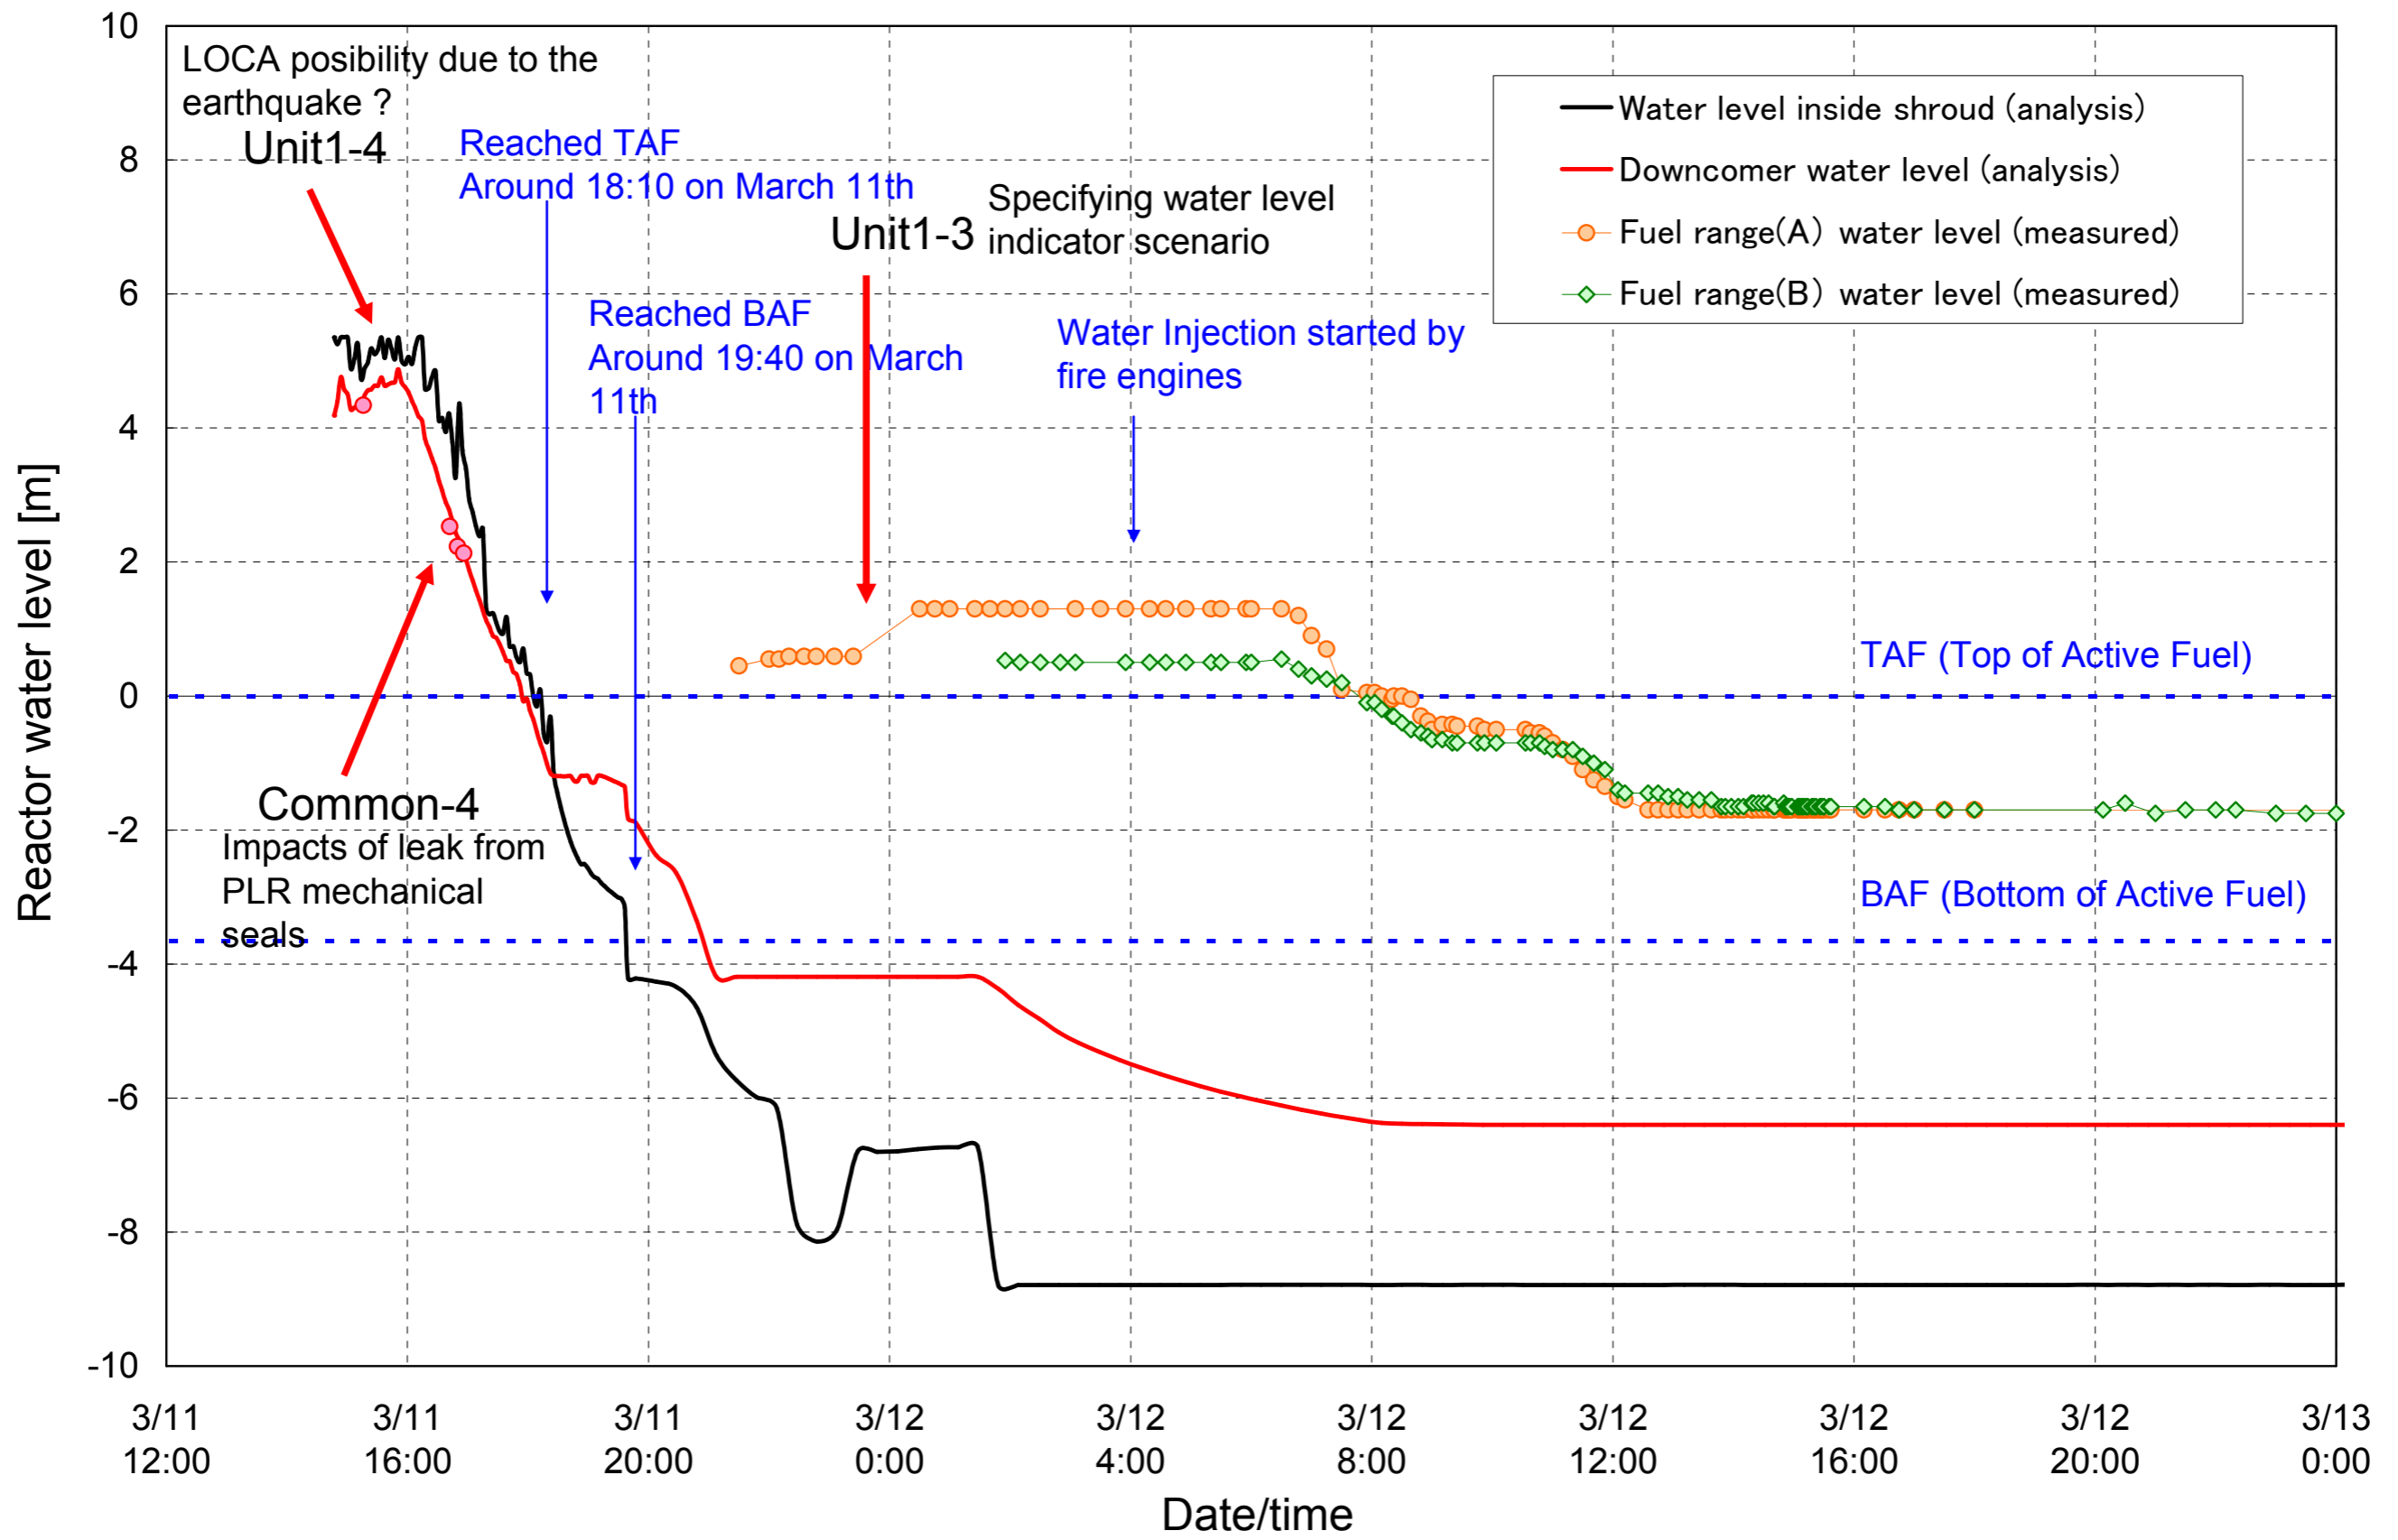
Figure 3.2.1 Issues derived from reactor water level change of Unit-1

The issues derived above are shown in Figures 3.2.1 to 3.2.3. They are also described in parallel in Attachment 2. The examination results obtained so far from among the issues extracted as unsolved are compiled in the Attachments and they are summarized briefly in the following section 3.3.

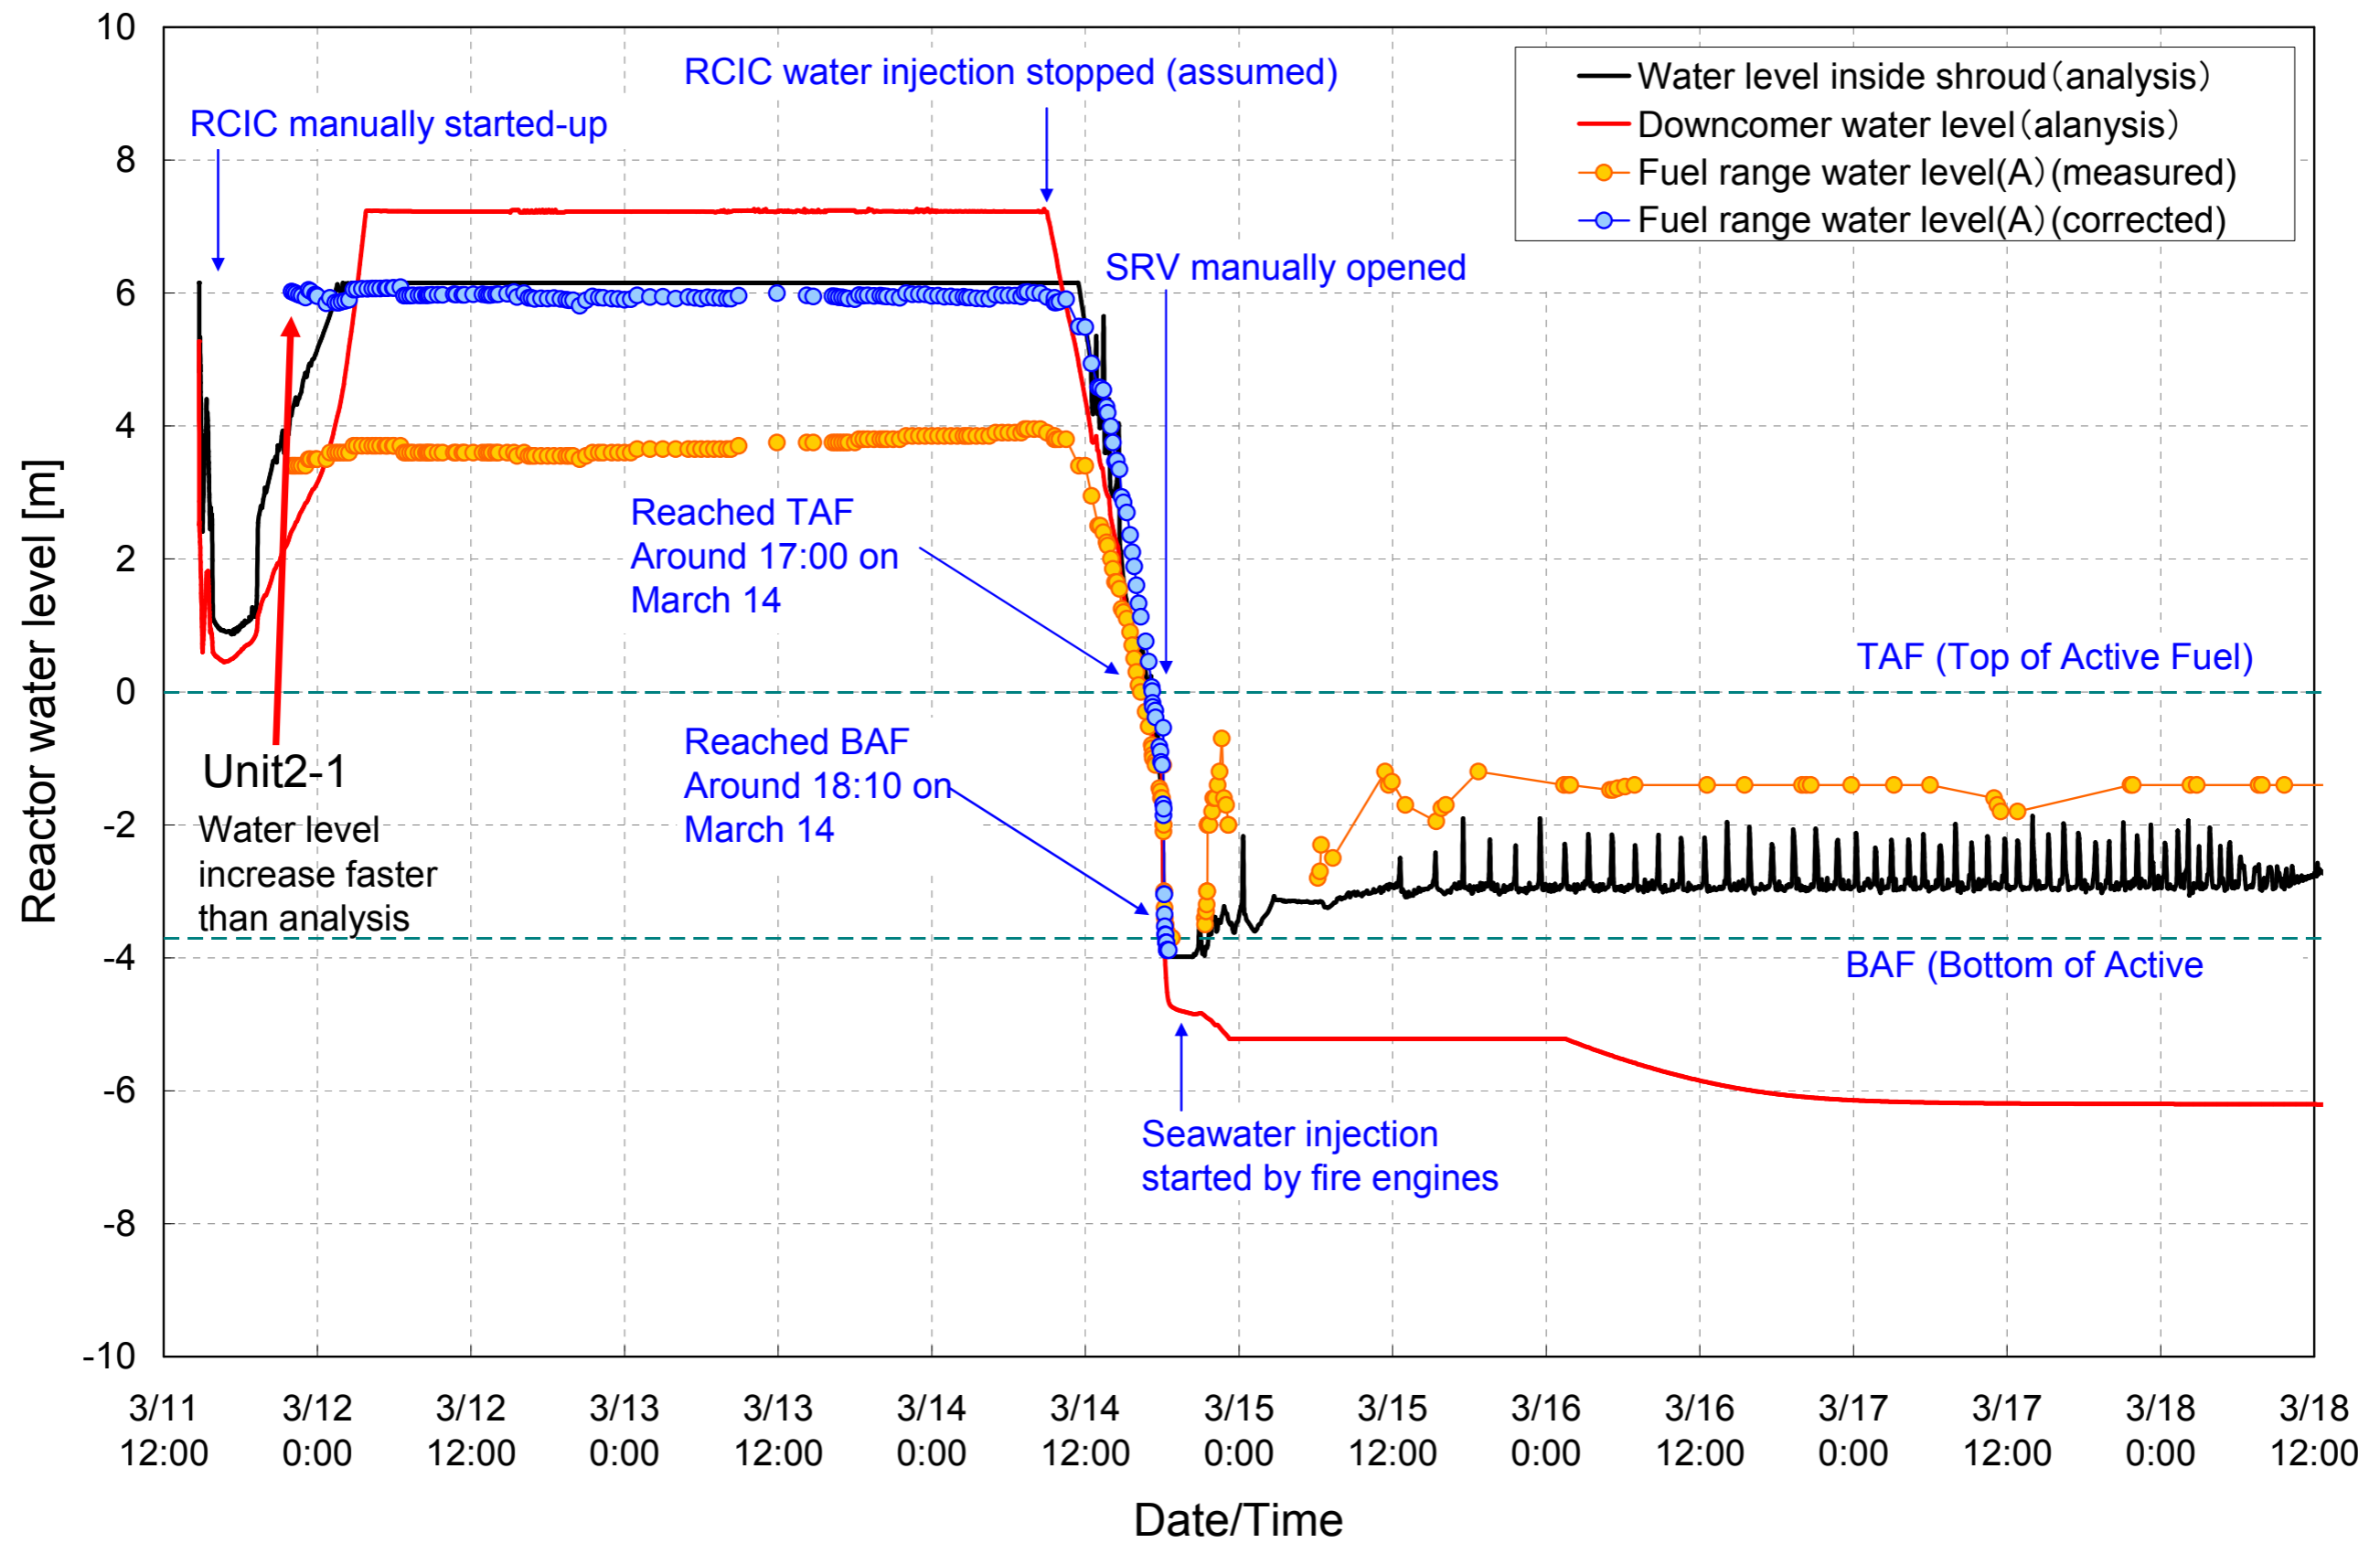
Figure 4.2.1 Issues derived from the reactor water level changes at Unit-2

The issues derived above are shown in Figures 4.2.1 to 4.2.3. They are also described in parallel in Attachment 2. The examination results obtained so far from among the issues extracted as unsolved are compiled in the Attachments and they are summarized briefly in the following section 4.3.

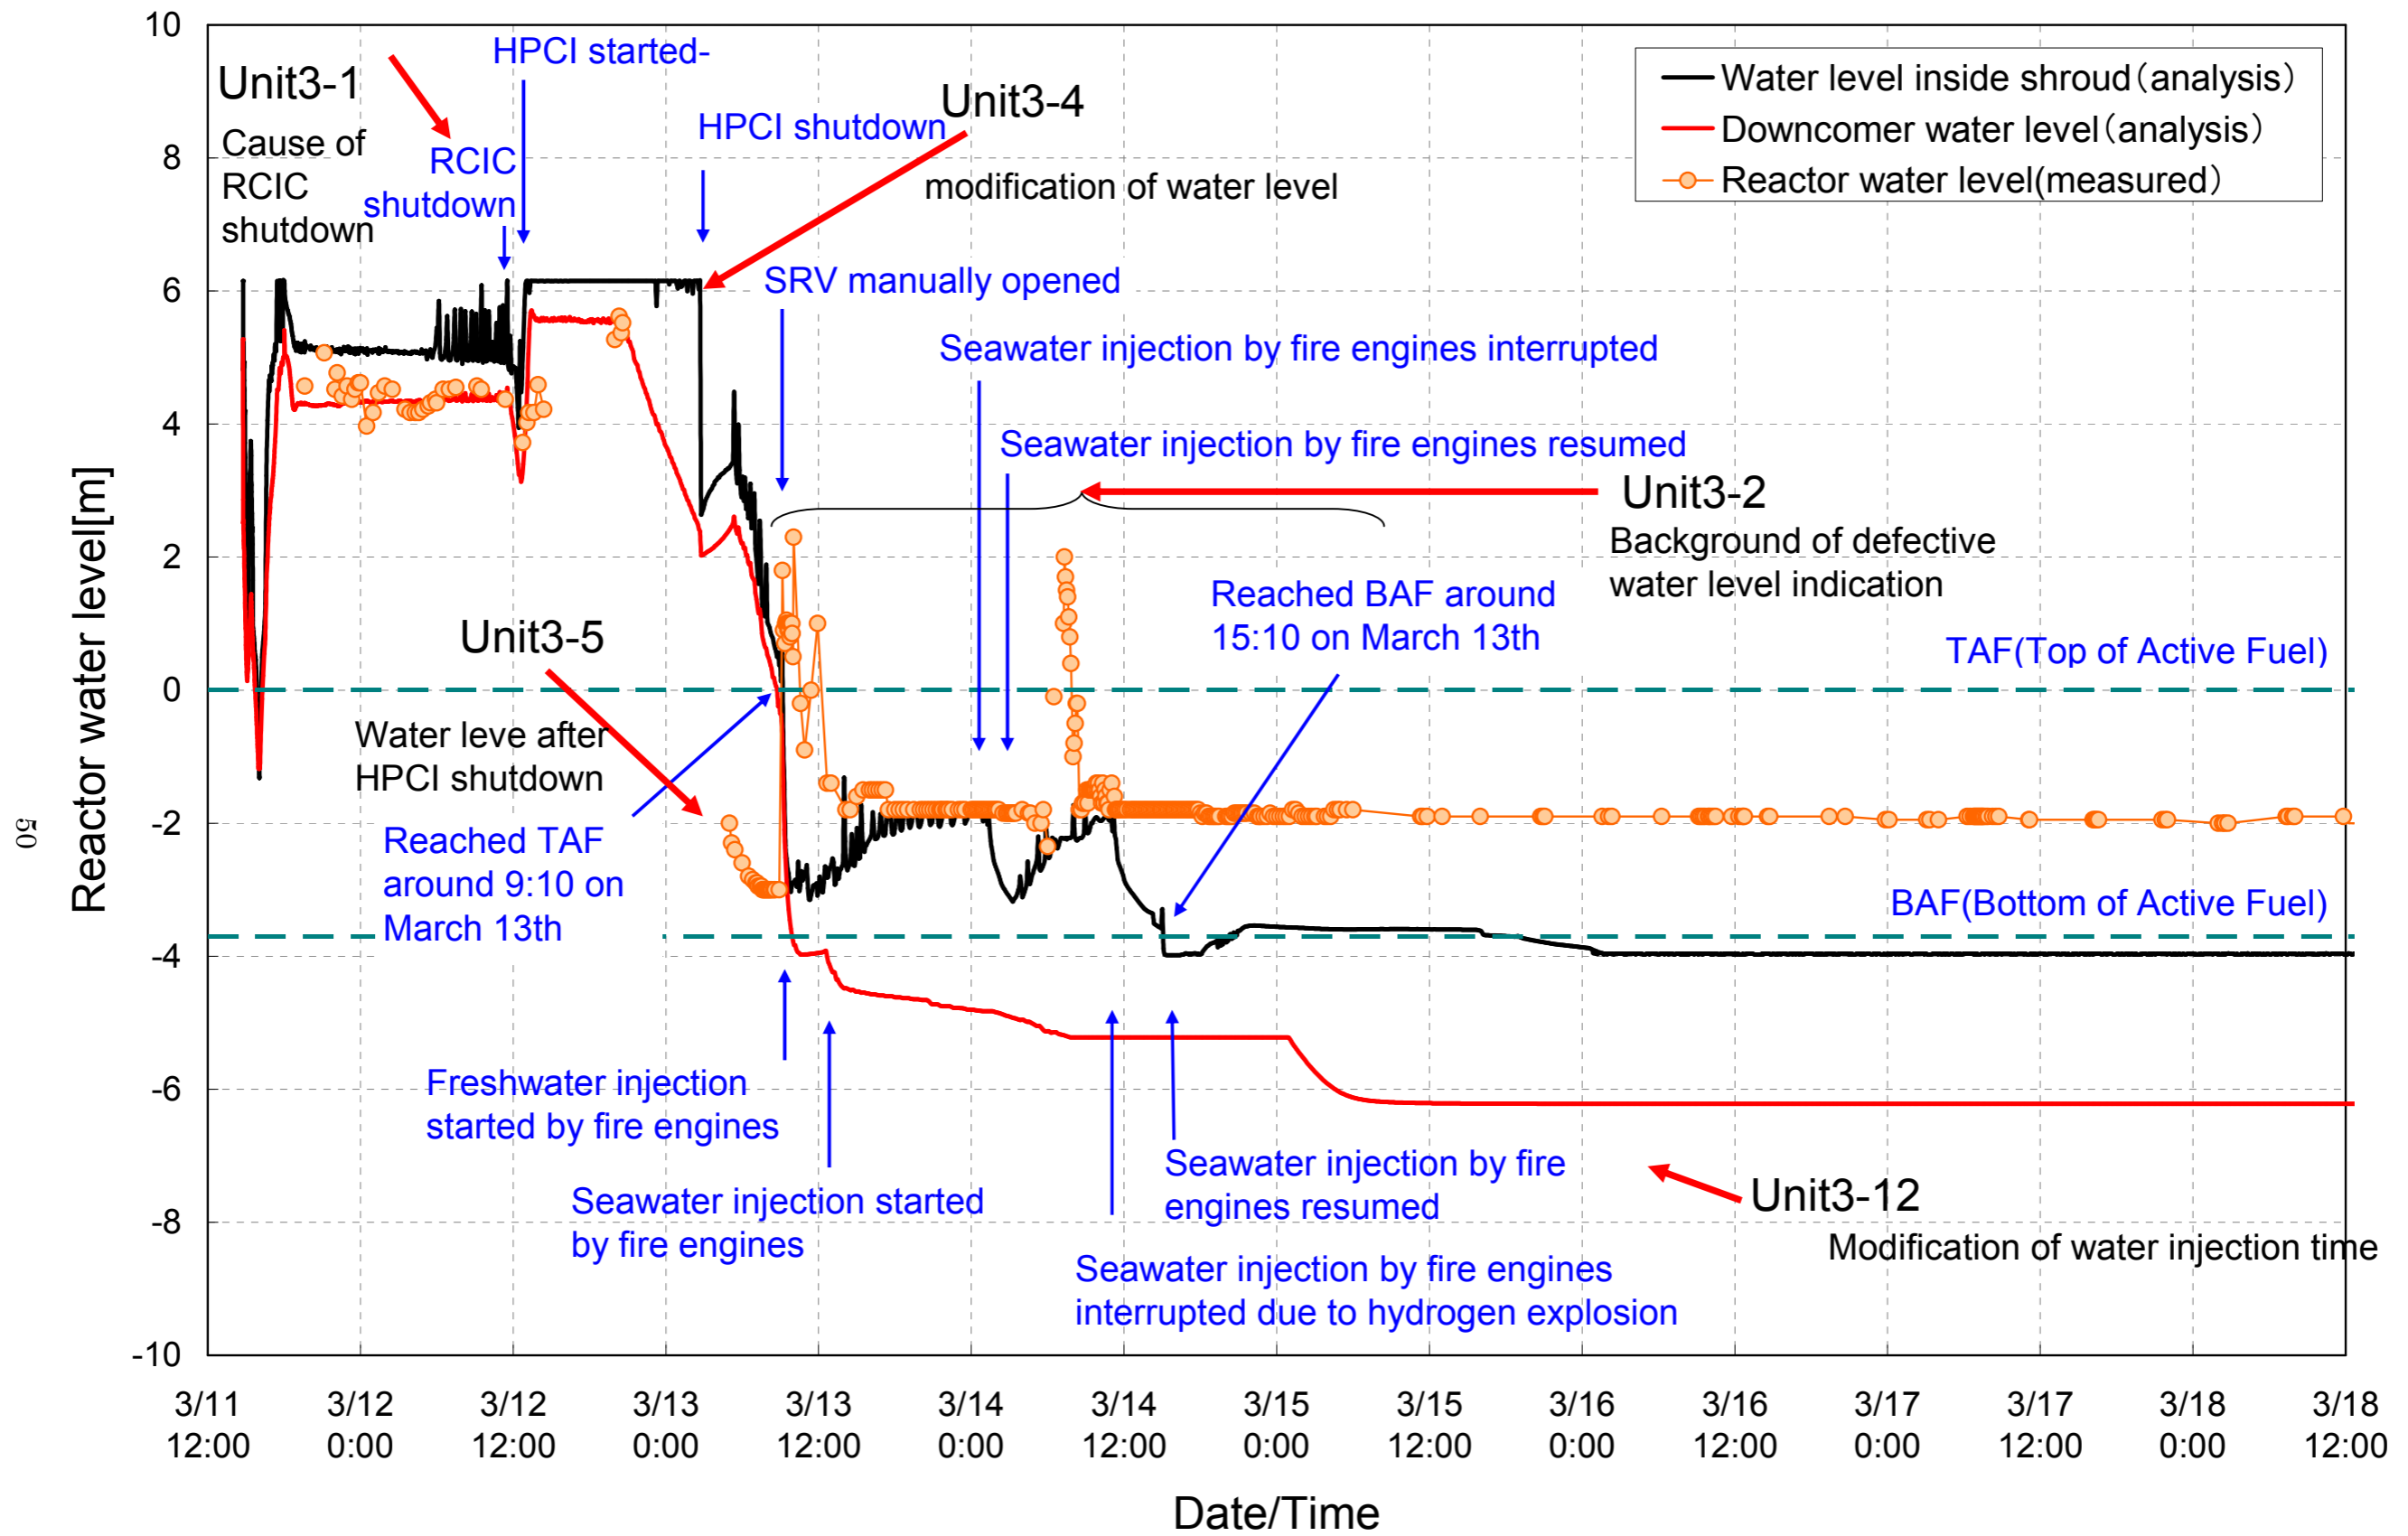
Figure 5.2.1 Issues derived from the reactor water level changes at Unit-3

The issues derived above are shown in Figures 5.2.1 to 5.2.3. They are also described in parallel in Attachment 2. The examination results obtained so far from among the issues extracted as unsolved are compiled in the Attachments and they are summarized briefly in the following section 5.3.

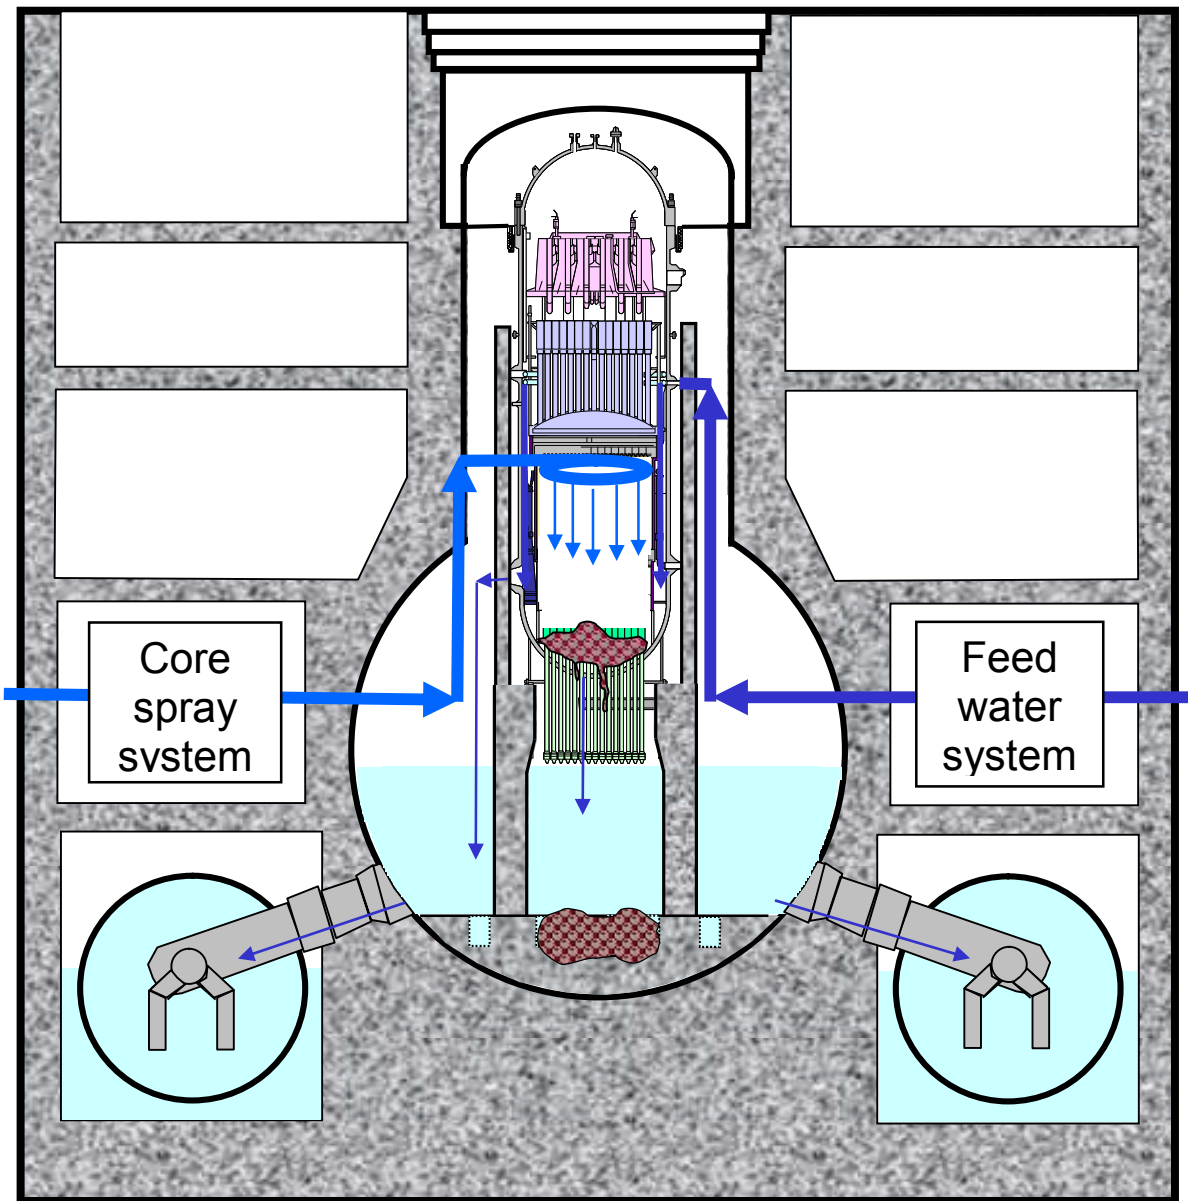
Figure 6.3.1 Estimated conditions of the core and PCV of Unit-3

injection possibly due to HPCI manual shutdown by the operators. This indicates the accident progression was faster than the earlier estimation. In the figure, more fuel than before is assumed to have dropped to the PCV. On this matter, further detailed examinations are needed, including the molten core concrete interaction (MCCI) development behavior.

No measured values are available so far concerning the D/W water level. But it could be estimated to be about 5.5 to 7.5m above the floor by converting the S/C pressure to water head. The S/C pressure was obtained from its existing pressure indicators, not calibrated since the accident, so they do not have high accuracies but they could be reliable as a trend to a certain extent because they have followed the pressure changes according to the water injection. In May 2014, water leaks were witnessed around the expansion joint at the PCV penetration of main steam piping D. This point is at the same elevation as the estimated water level in the containment vessel. This indicates most water leaks from the containment vessel occurred at this point.
