Status of investigation on estimating situation of cores and containment vessels

1. Introduction

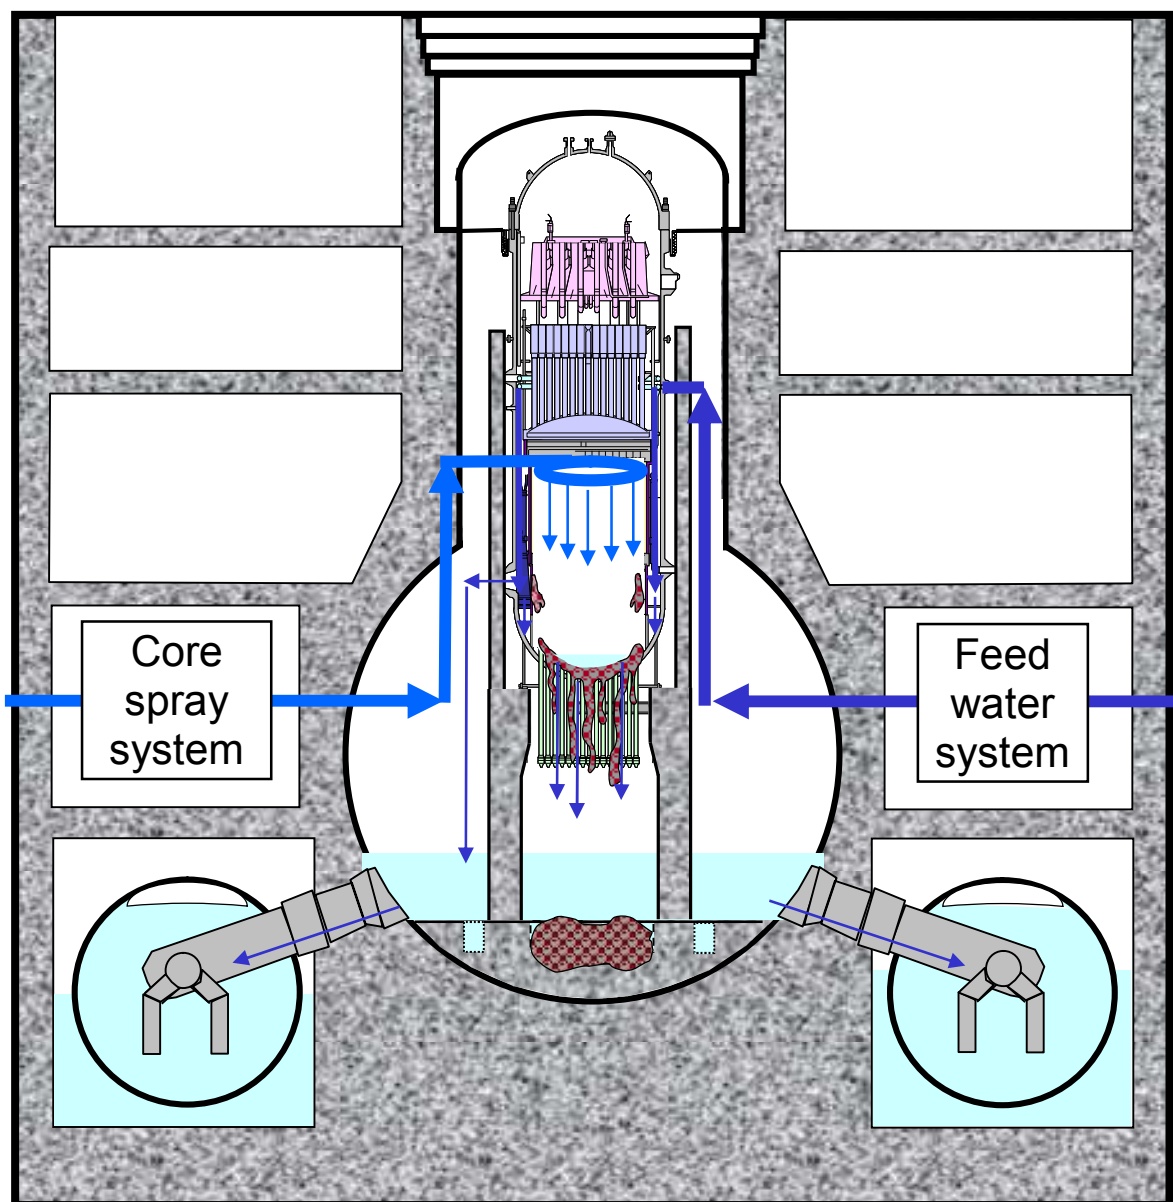
Figure 1-1 Estimated conditions of the core and PCV of Unit-1

(Note) Estimated conditions of the core and PCV are not updated from the previous report. The illustration does not accurately represent a quantitative image for the size, etc. of debris

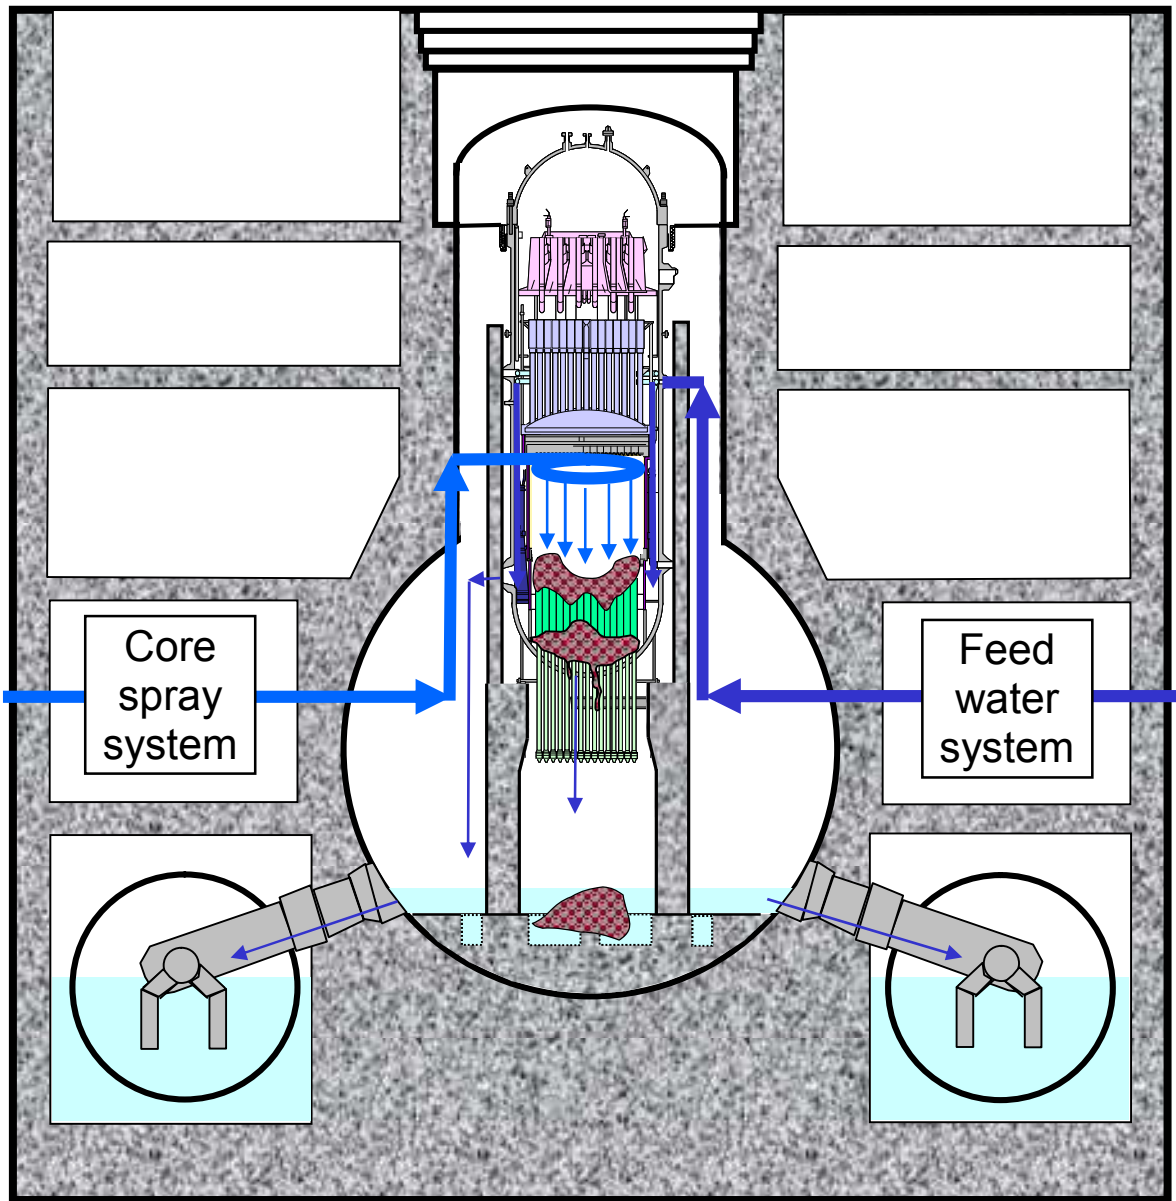
Figure 1-2 Estimated conditions of the core and PCV of Unit-2

(Note) Estimated conditions of the core and PCV are not updated from the previous report. The illustration does not accurately represent a quantitative image for the size, etc. of debris

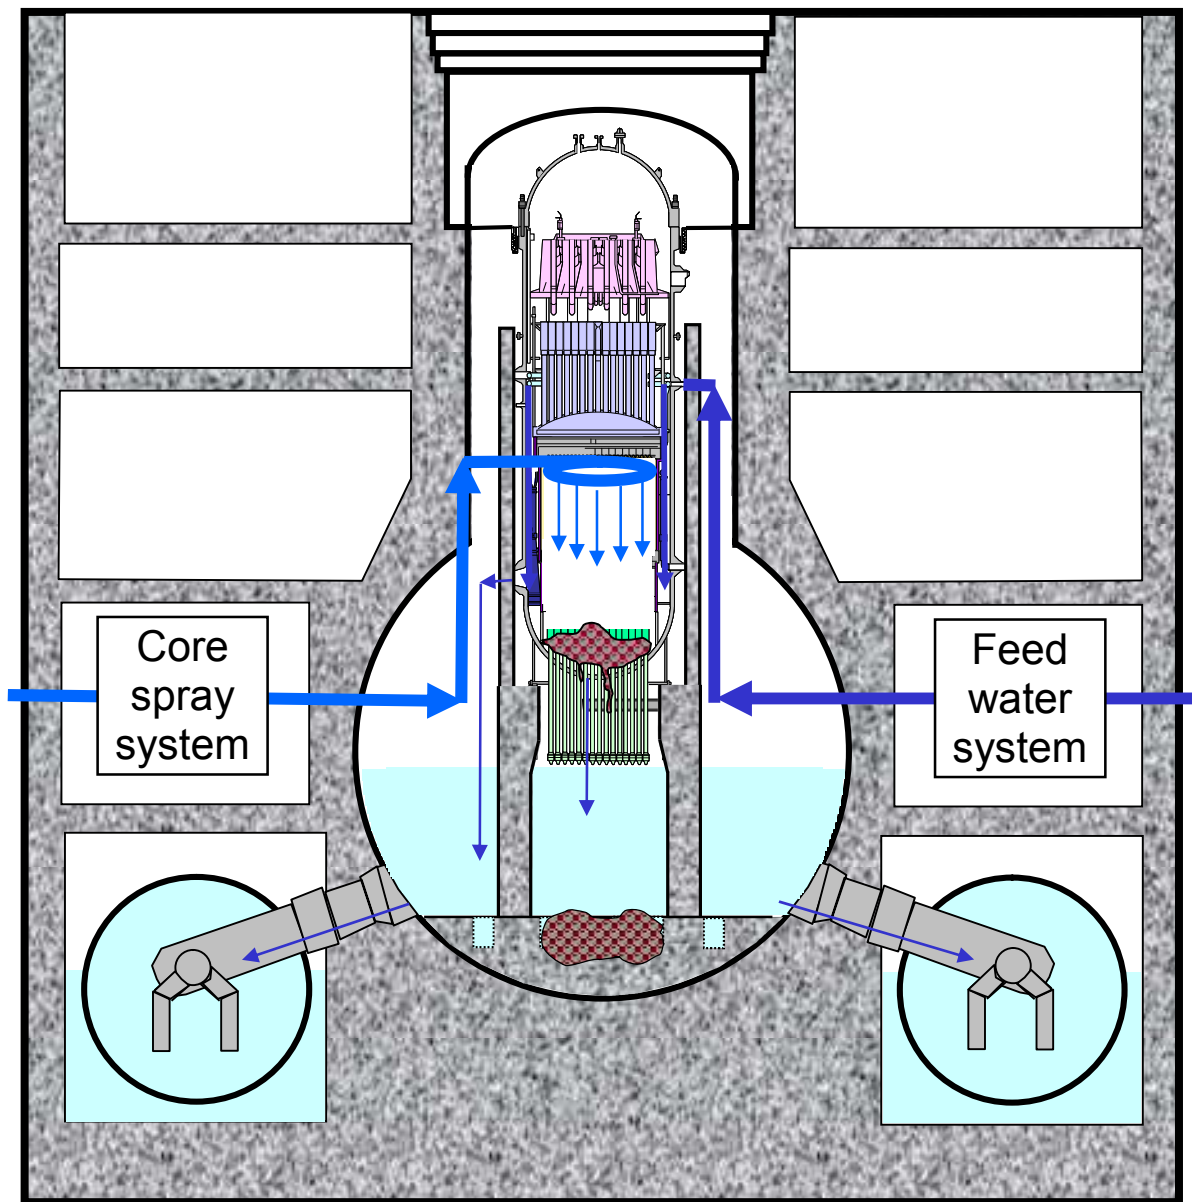
Figure 1-3 Estimated conditions of the core and PCV of Unit-3

(Note) The fallen debris on the PCV pedestal was shown larger this time, incorporating the analysis results of the case that sufficient water injection to the reactor had not been possible before the operator manually stopped the HPCI. The illustration does not accurately represent a quantitative image for the size, etc. of debris.

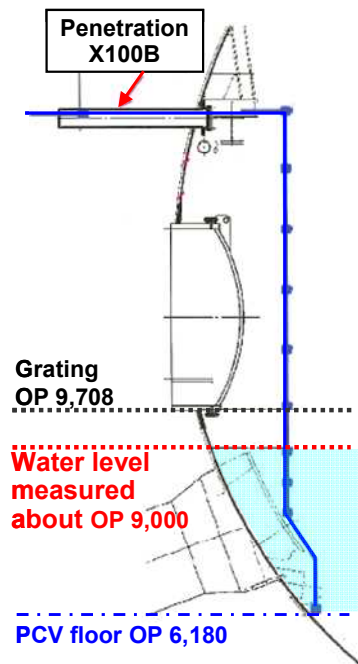
Figure 2-1 Measured level of water retained in Unit-1 PCV

The level of water retained was measured by lowering the CCD camera cable down to the water surface through the grating above in the PCV. The water level was found to be about 2.8m above the DW floor (as of October 10<sup>th</sup>, 2012) (Figure 2-1).

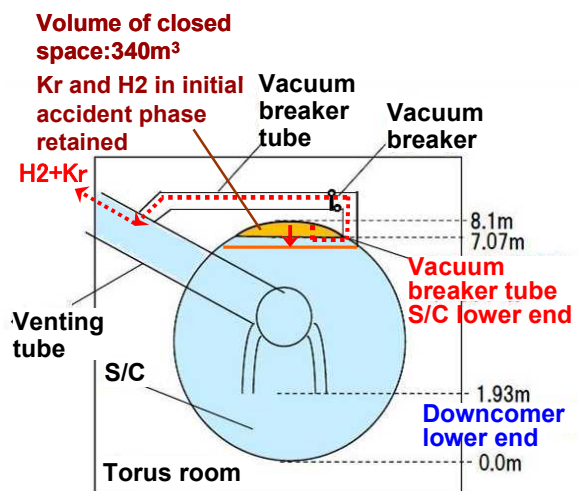
Figure 2-2 Closed space in gaseous phase inside S/C of Unit-1

In September 2012, a nitrogen gas injecting test was conducted into the suppression chamber (S/C), in which the theory was demonstrated that hydrogen gas and Kr-85 generated in the early stage of the accident and retained in the S/C upper space pushed down the S/C water level and were discharged to the DW through the vacuum breakers. This helped to confirm that the S/C was currently almost filled with water (the level at around the lowest end of the vacuum breaker tube [2] (Figure 2-2).

This test was conducted with an intention to explain the phenomenon of the intermittent increase of hydrogen gas concentration and Kr-85 radioactivity measured by the containment gas control system of Unit-1 that has been seen since April 2012. This intermittent increase was assumed to occur in the following sequence: When the S/C water

level drops, residual gas left in the closed space in the upper S/C is discharged to the D/W through vacuum breakers, and then the S/C water level rises and stops the gas discharge. In this hypothesis, Kr-85 is understood to originate in the early phase of the accident, because Kr-85 is a long half-life fission product and its amount cannot be explained as being newly produced by spontaneous fission, etc.

In the test to verify the mechanism hypothesis, the S/C pressure (being monitored by the existing instrumentation) rose after the injection of nitrogen gas started into the S/C, the hydrogen gas concentration and Kr-85 radioactivity monitored by the containment gas control system started to increase, which decreased when nitrogen gas injection was halted. This is interpreted to be that the nitrogen gas injection pressurized the closed space of the S/C upper part, which lowered the S/C water level and formed a gas discharge channel to the D/W through the vacuum breakers, thus the retained gas in the space was discharged together to the D/W by the injected nitrogen gas.

Most of the hydrogen gas retained in the S/C has been purged by continuously injecting nitrogen gas into the S/C since October 2012. Further tests are now underway to verify a mechanism of hydrogen production in the S/C by water radiolysis.

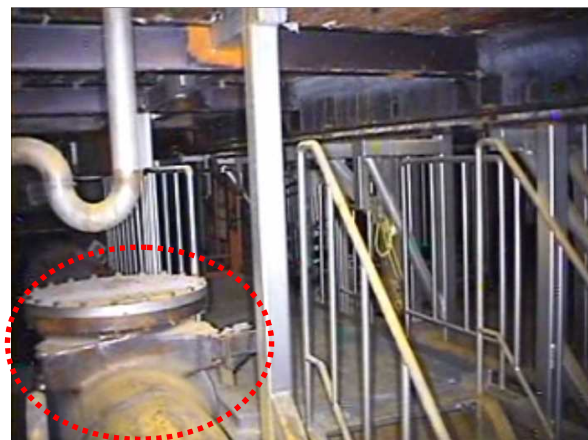
Figure 2-3 Camera photo of an S/C vacuum breaker in the torus room of Unit-1

No water leaking position in the S/C has been located yet. At least, no leak was confirmed on the flange of one of the eight vacuum breakers, as far as the camera photos showed (Figure 2-3).

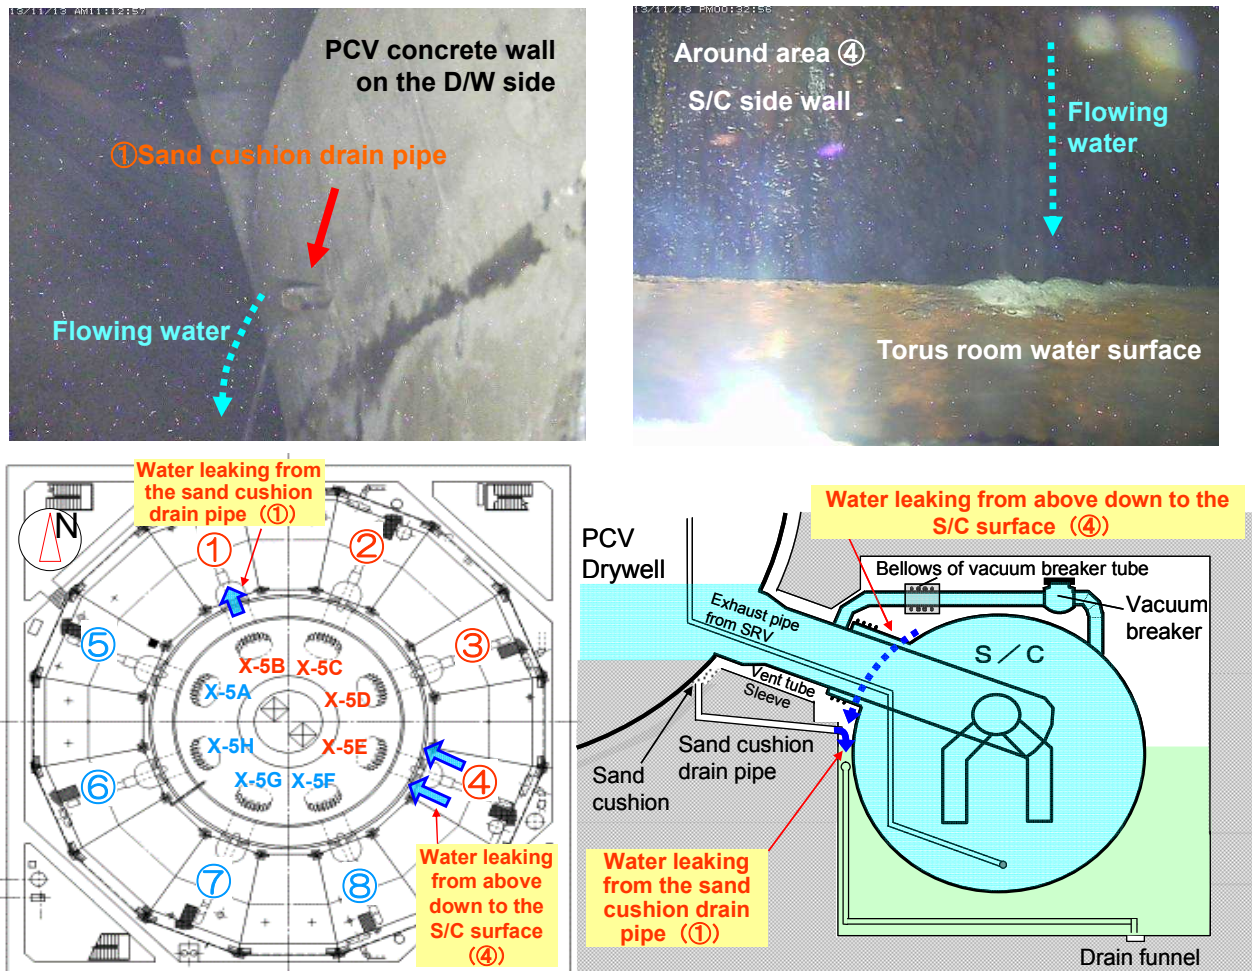
Figure 2-4 Camera images taken below the vent tubes in Unit 1 torus room (part)

Camera imaging confirmed water leaks at the following locations (Figure 2-4).

\*Water leaks at ① were confirmed since the vinyl chloride pipe (connecting the sand cushion drain tube and drain funnel with an insertion-type joint) had been displaced. Water leaks could not be confirmed at locations ② to ⑧, since the drain tubes had not been displaced. The concrete seams (joints) below the sand cushion drain piping were observed to be wet all around on the concrete wall.

Water leaks into the sand cushion occur only when water leaks directly from the drywell. The leakage is probably from a low position of the drywell below the water level (for example, the containment vessel shell, pipe penetrations, etc.). The low location of the water leaks in the drywell would indicate the possible influence of molten fuel that fell to the PCV bottom. This information is of critical significance in estimating the conditions of the core and PCV.

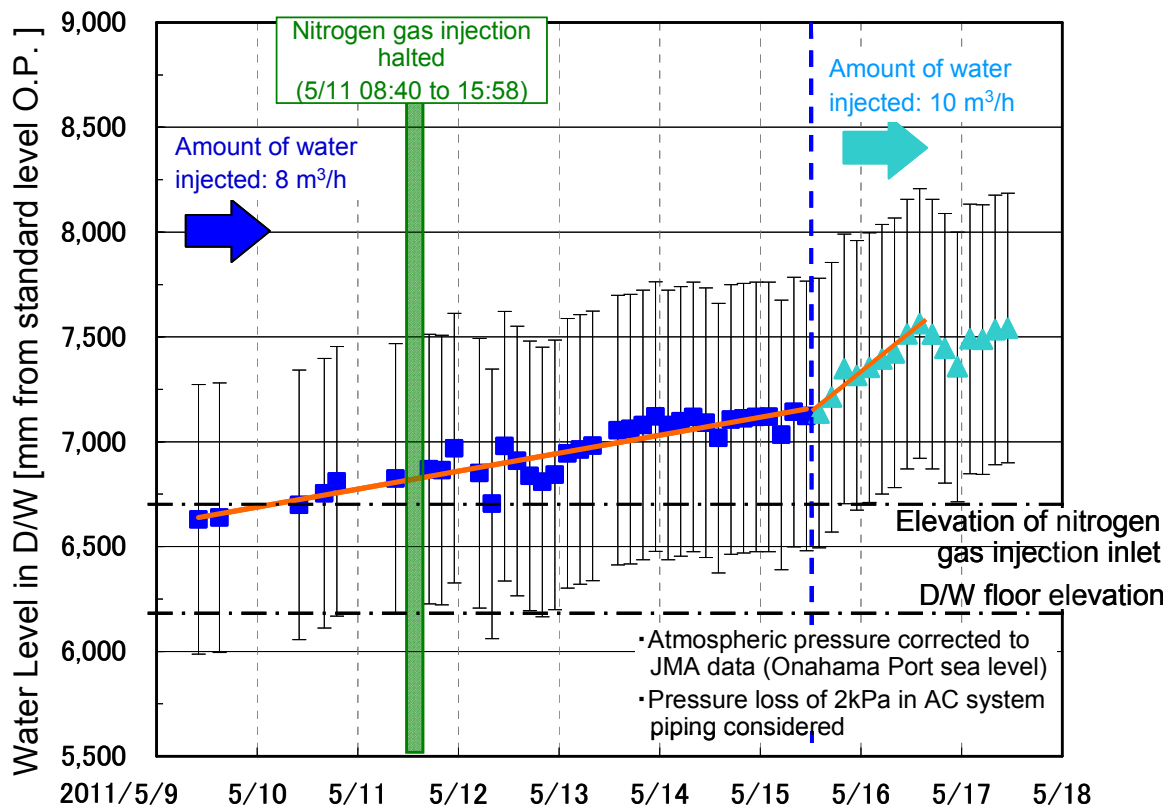
Figure 2-5 Estimated PCV water level changes during flooding operation of Unit 1 (May 2011)

Meanwhile, the water leakage down to the S/C surface around both sides of the vent tube X-5E indicates the possibility of water leaks from the vacuum breaker tube (its bellows, for example) immediately above the vent tube. This elevation of the vacuum breaker tube is about the same level as that of the upper limit of PCV water level which was reached in an attempt to flood the PCV by increasing the amount of water injected in May 2011; where the PCV water level was calculated from the injected nitrogen gas pressure. The nitrogen gas pressure was stopped from changing at a specified level, which means the PCV water level was leveled off, i.e., an indication of leak hole existence at the level (Figure 2-5) [5].

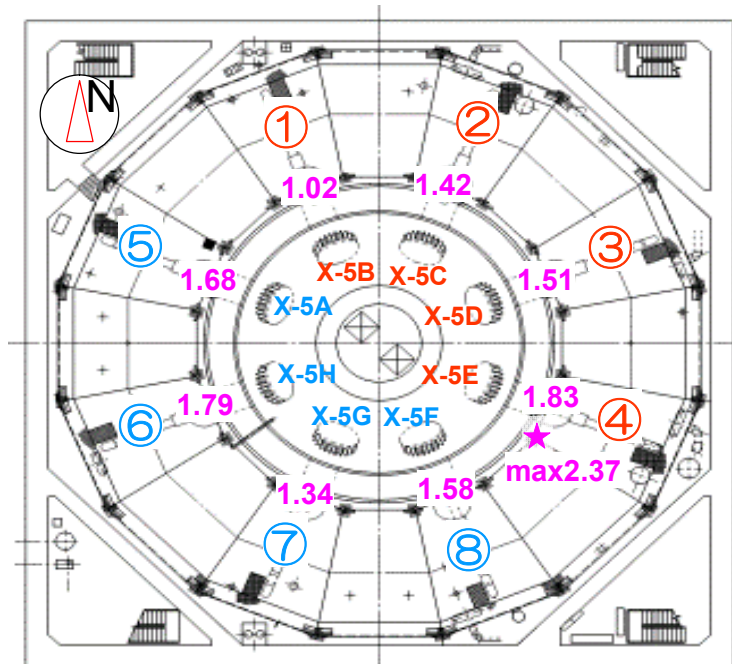
Figure 2-6 Dose distribution measured during the torus room investigation underneath vent tubes of Unit 1

The vertical distribution of radiation doses measured when lowering the instrumentation boat in November 2013 was similar to that measured in February 2013 (in the area surrounding the torus). Dose distribution along the boat traveling route was about 1 to 2 Sv/h, and the highest spots were in the southeast area (Figure 2-6).

In June 2011, steam blown from the pipe penetrations was witnessed at the southeast corner of the first floor of the reactor building. This would mean that radioactive materials carried by the steam were blown to the torus room after the accident and they deposited on the walls and structure surfaces there. The dose distribution in the torus room is considered to be the sum of doses due to these contamination sources. The estimated radiation dose levels on the water surface due to water-retained radionuclides ( $7.3 \times 10^4$  Bq/cm<sup>3</sup> of Cs-134 and  $1.5 \times 10^5$  Bq/cm<sup>3</sup> of Cs-137, sampled on February 22, 2013) are about 100 mSv/h and not a dominant contributor to the 1 to 2 Sv/h dose measured [6].

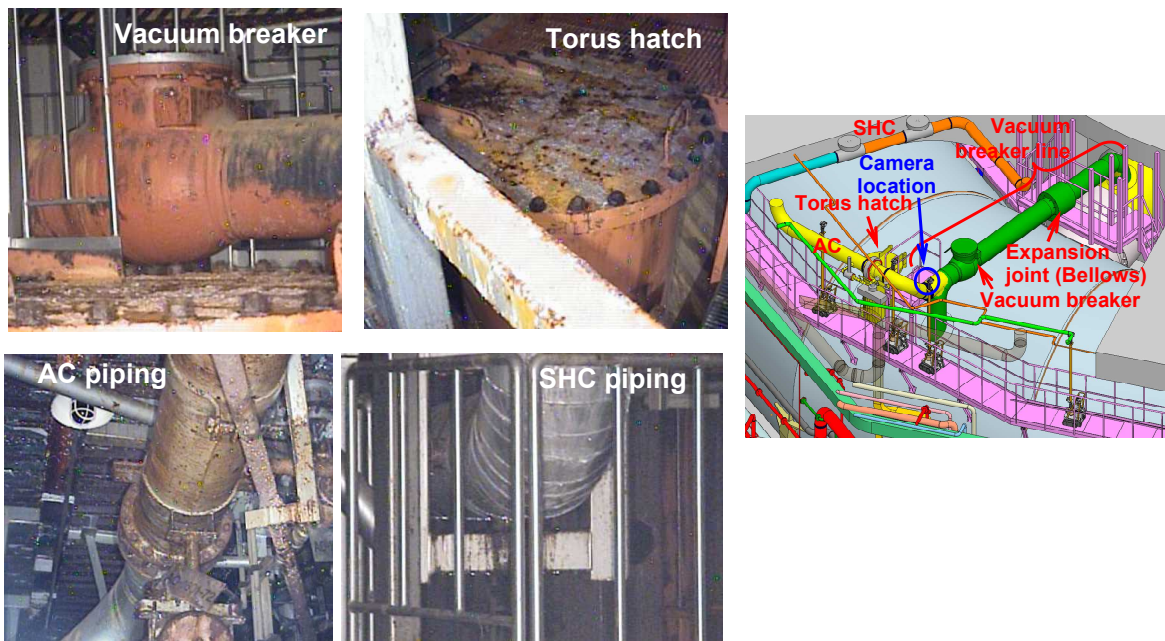
**Figure 2-7 Camera images of Unit-1 S/C top area exploration (around vent tube X-5E) (Part)**

In May 2014, survey instrumentation robot was introduced through a drilled hole in the northwest area of the first floor of the Unit1 reactor building to explore the S/C top area in order to locate the leak source near the vent tube X-5E, where leaking had been confirmed. By using the outer catwalk, the instrumentation robot made a camera survey around the vent tube X-5E, and the water leak was confirmed to be from the protective cover of the expansion joint on the vacuum breaker line. No leaks were noticed from the vacuum breaker valve, torus hatch, Shutdown cooling system (SHC) piping or Atmospheric control system (AC) piping (Figure 2-7) [7].

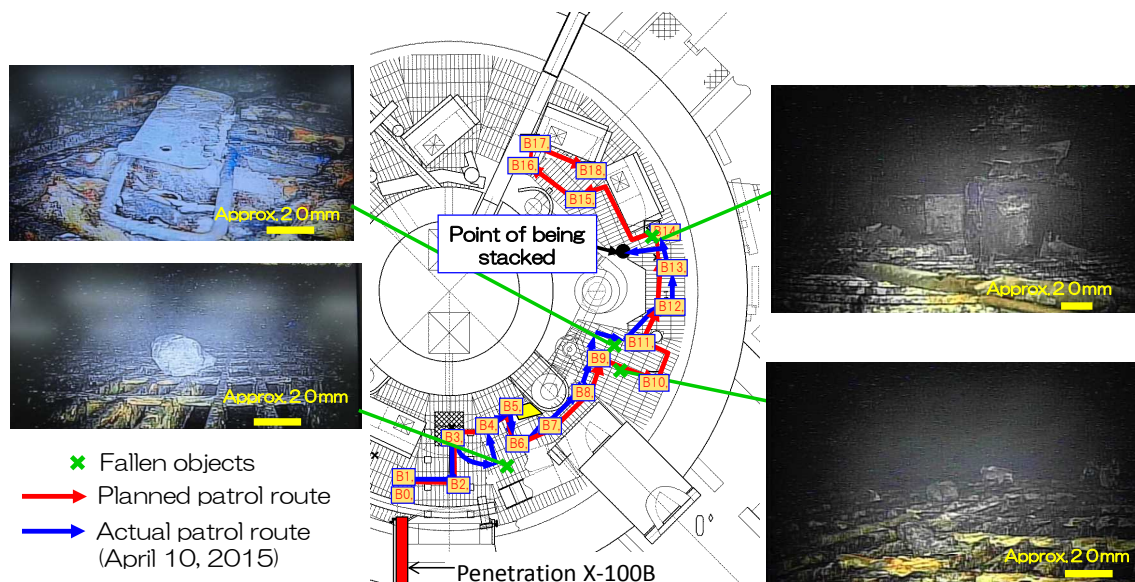
Figure 2-9 Photos taken during the anti-clock-wise patrol [9]

The grating floor on the ground level outside the pedestal of Unit-1 was investigated from April 10<sup>th</sup> to 18<sup>th</sup>, 2015. A running robot machine was sent through the PCV penetration X-100B. The robot patrolled clock-wise and anti-clock-wise by about 180 degrees for investigating damaged conditions of existing structures and presence of obstacles. Figure 2-9 and Figure 2-10 present a part of the photos taken during the anti-clock-wise and clock-wise patrols, respectively. As seen in Figure 2-9, no big damage was recognized on the HVH (Heating Ventilating Handling unit), PLR piping, pedestal walls, PCV inner walls, etc., although fallen objects were noticed on the patrol path.

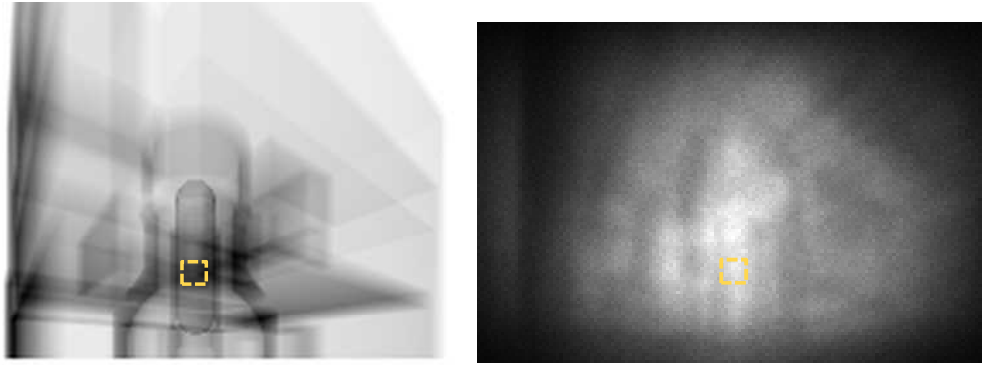
Figure 2-11 Muon image of the reactor predicted from the design (left) and that of the actual reactor based on measurements for 96 days (right)[10]  
(dotted region corresponds to the original core position)

Figure 2-11 shows the predicted image of the reactor from the design (left) and the image of the actual reactor obtained by muon measurements for 96 days (right); both are images by a single muon device. The basic principle of measurements by the muon transmission method is the same with that of X-ray (Roentgen) photography. High density objects absorb more muons and are photographed in black. In the image of the reactor as designed with intact fuel, a black portion is recognized corresponding to the position of the core. In the image of the actual reactor, on the other hand, some recognizable equipment such as the spent fuel pool and isolation condensers are found, but there is no high density object (fuel) at the core position.

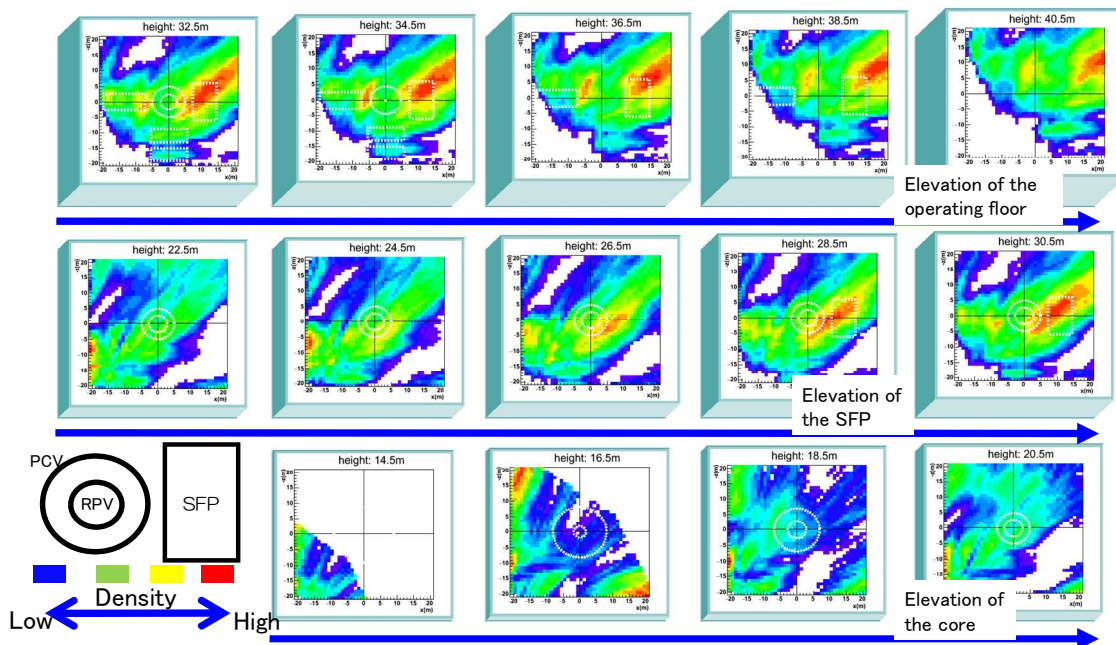
Figure 2-12 High density material distribution maps at three separate elevations

By combining data measured using two muon measurement devices, images can be restructured in three dimensions. Distribution maps of high density materials are shown in Figure 2-12 at different elevations of the reactor building (R/B). The red region on the distribution maps is where high density materials are detected by the two muon measurement devices at each elevation. High density materials are recognized at the spent fuel pool position, but not at the core position.

From these considerations, no fuel is thought to be left at the core position. This is consistent with the estimated conditions of the core and PCV previously announced by TEPCO.

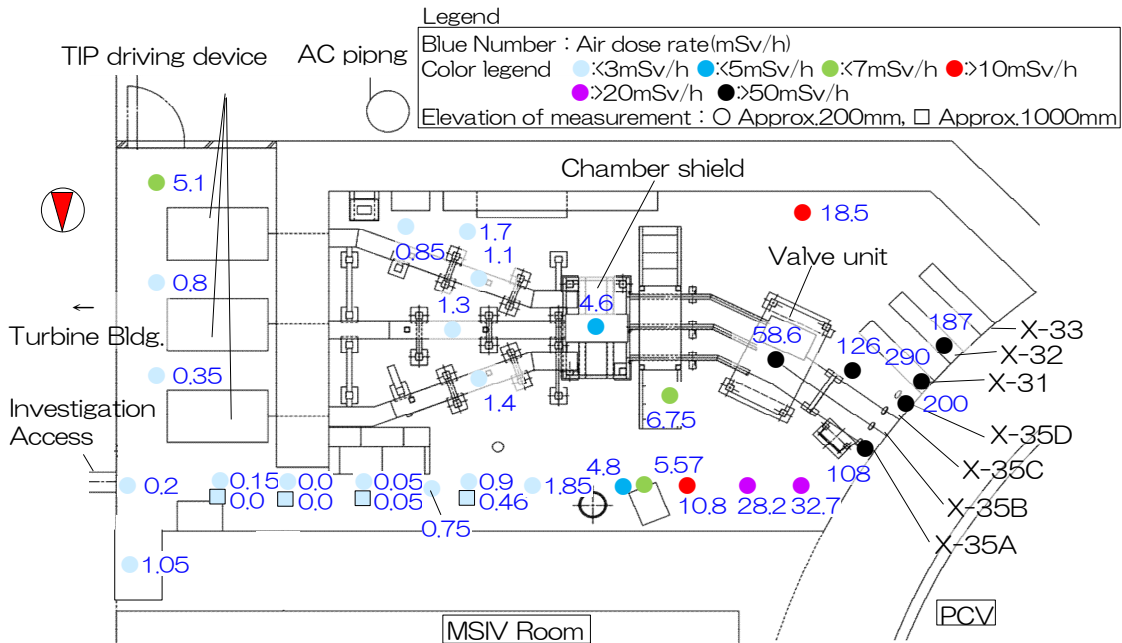
Figure 2-13 Air dose rates distribution measured in the TIP room [11]

Figure 2-13 presents the spatial air dose rates measured in the TIP room and Figure 2-14 shows a  $\gamma$ -camera photo taken there. A high radiation dose of above 100mSv/h was observed near the PCV penetrations, especially around X-31, -32 and -33, while on the turbine side behind the chamber shield the dose rate was as low as below 2mSv/h. The  $\gamma$ -camera photos located a radiation source near the penetrations X-31, -32 and -33 (Region 1 in Figure 2-14). No other outstanding radiation source was found in the room, including at the penetrations X-35A to -35D which were outside the view of the wide-angle lens camera (the area encircled by the broken line in Figure 2-14).

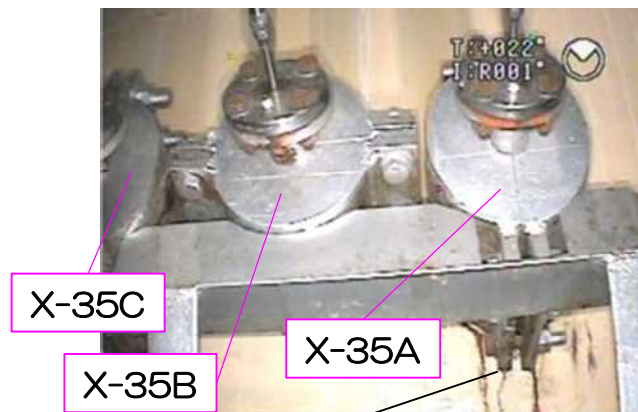
Figure 2-15 Optical camera photo taken at the penetration X-35 [11]

Exterior appearances of PCV penetrations, piping and other objects in the TIP room were surveyed by an optical camera. Some brown-colored specks hinting at flow lines were noticed around PCV penetration X-35A (Figure 2-15). But, as mentioned above, no radiation source was noticed around the area of penetrations X-35A to X-35D. No other marks hinting at leaks were recognized at any places around the penetrations, piping and other objects in the TIP room including the penetrations X-31, -32 and -33.

Brown color marks seen only below X-35

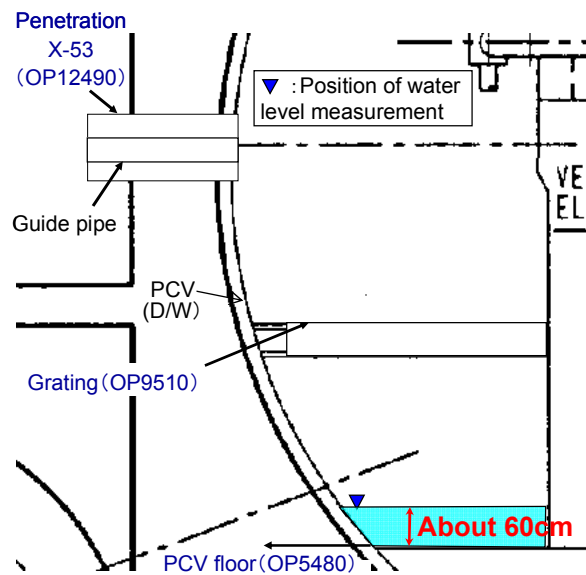
Figure 3-1 Measured level of retained water in Unit-2 PCV

The level of water retained was confirmed to be about 60 cm above the D/W floor by the video image scope (as of March 26<sup>th</sup>, 2012) (Figure 3-1).

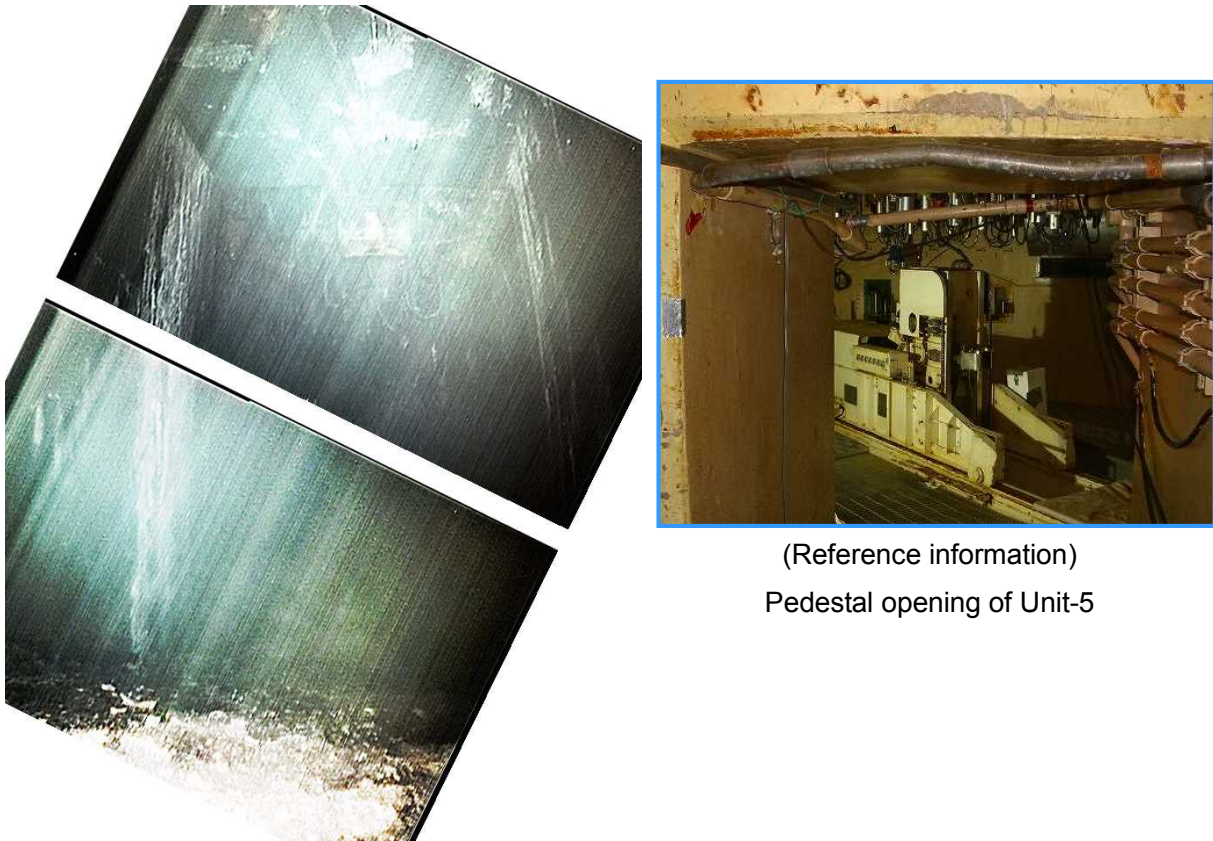
Figure 3-3 Photos inside the PCV pedestal taken at the pedestal opening (processed image)

Dosimeters measured the dose rates as far as the top of the CRD replacement rails. The values were about 45 – 80 Sv/h. As supplementary information, dose rates were estimated from the camera image noises; they were about 30 Sv/h near the landing point in replacement rail and

about 36 Sv/h near the pedestal opening. No clear indication was obtained about gaining access to fuel debris, even via the pedestal opening on the CRD replacement rail because access to fuel debris will result in rapid dose rate increase.

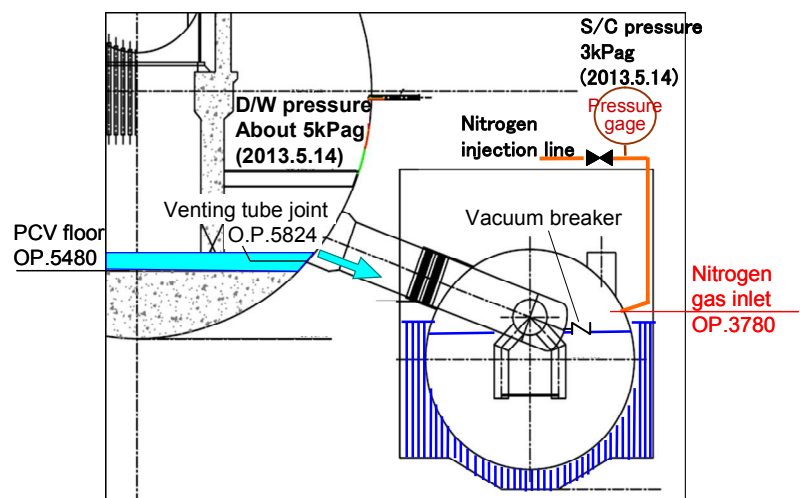
Figure 3-4 Closed space assumed in Unit-2 S/C

The S/C pressure was confirmed to be 3 kPag (as of May 14<sup>th</sup>, 2013) in a nitrogen gas injecting test into the S/C done in May 2013. The absolute water level in the S/C was not accurately known, but it was confirmed to be approximately on the level of the nitrogen gas inlet (O.P. 3780), because some reasonable pressure due to the water head should exist at the inlet if the S/C were almost filled with water. If the low water level in the

The gradual pressure increase of the S/C from 3kPag to 7kPag before and after the injection confirmed that nitrogen gas had been injected into the S/C. But no change was observed in the hydrogen gas concentration and Kr-85 radioactivity measured by the PCV gas control system. Further tests were conducted to check if this was because there was no flow path from the S/C to the D/W or the hydrogen gas concentration in the S/C was already too low to send response signals.

From these findings, it was confirmed that nitrogen gas injected into the S/C was flowing to the D/W. And also from findings of nitrogen gas injection into the S/C flowing to the D/W with no change in hydrogen gas concentrations observed in the PCV gas control system, it was concluded that no more hydrogen gas remained in the S/C. It is considered, in this situation, that the vacuum breaker valve (OP. 3305) was not flooded and the nitrogen gas was flowing through this valve, because the water level in the reactor building was below about OP. 3400 during the tests and the S/C water level would follow the torus room water level (torus room water level minus level decrease due to internal pressure)

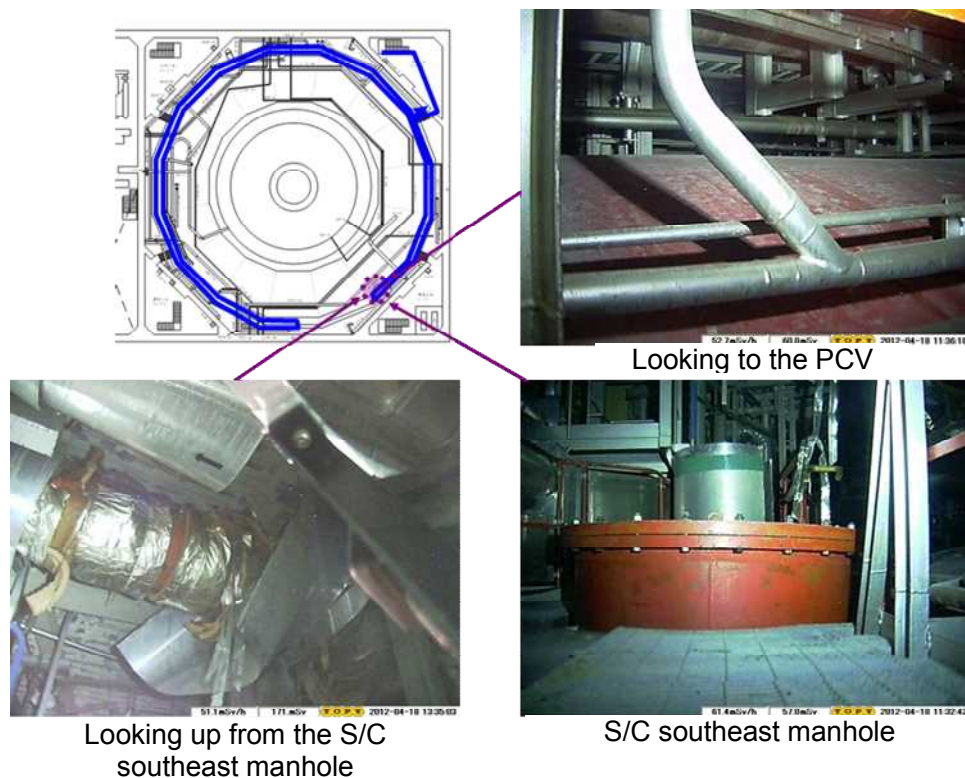
Figure 3-5 Camera photos in the torus room of Unit-2 (part)

No water leaking position in the S/C has been located yet. At least, no leak was confirmed on the flange, etc. of the S/C manholes, as far as the camera photos show (Figure 3-5).

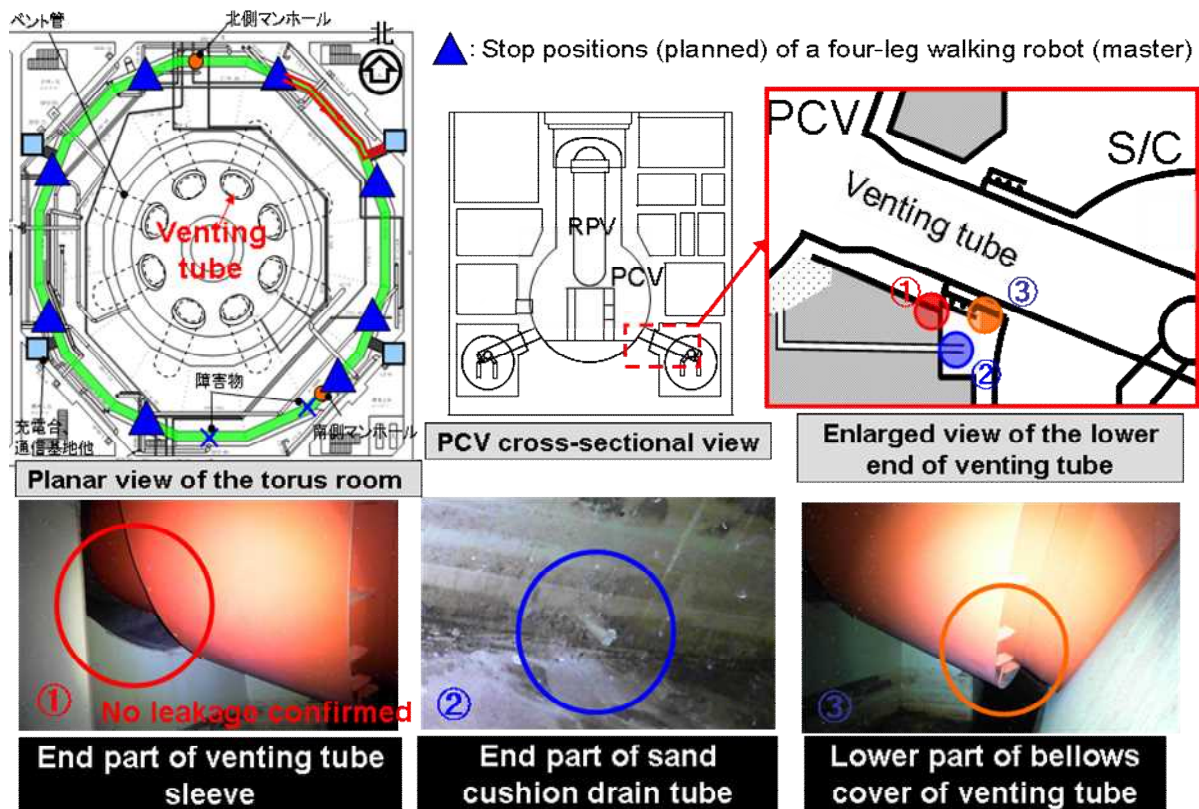
Figure 3-6 Camera photos around the lower end of the venting tubes in the torus room of Unit-2 (part)

No water leaking position in the S/C has been located yet. At least, no leak was confirmed from the lower end of venting tubes within the visible range (Figure 3-6).

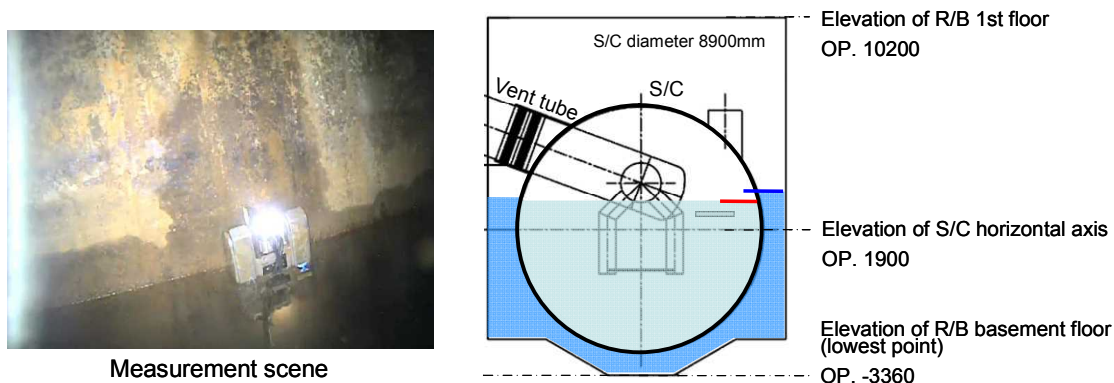
Figure 3-7 S/C water level measurements of Unit-2

The S/C water level is in correspondence with the level of water retained in the torus room. This is consistent with the water level estimated earlier by the nitrogen gas injection tests. This information confirms that water leaks occurred at the S/C lower position (including piping).

(Note) S/C water level seems to be affected by water level retained in the torus room

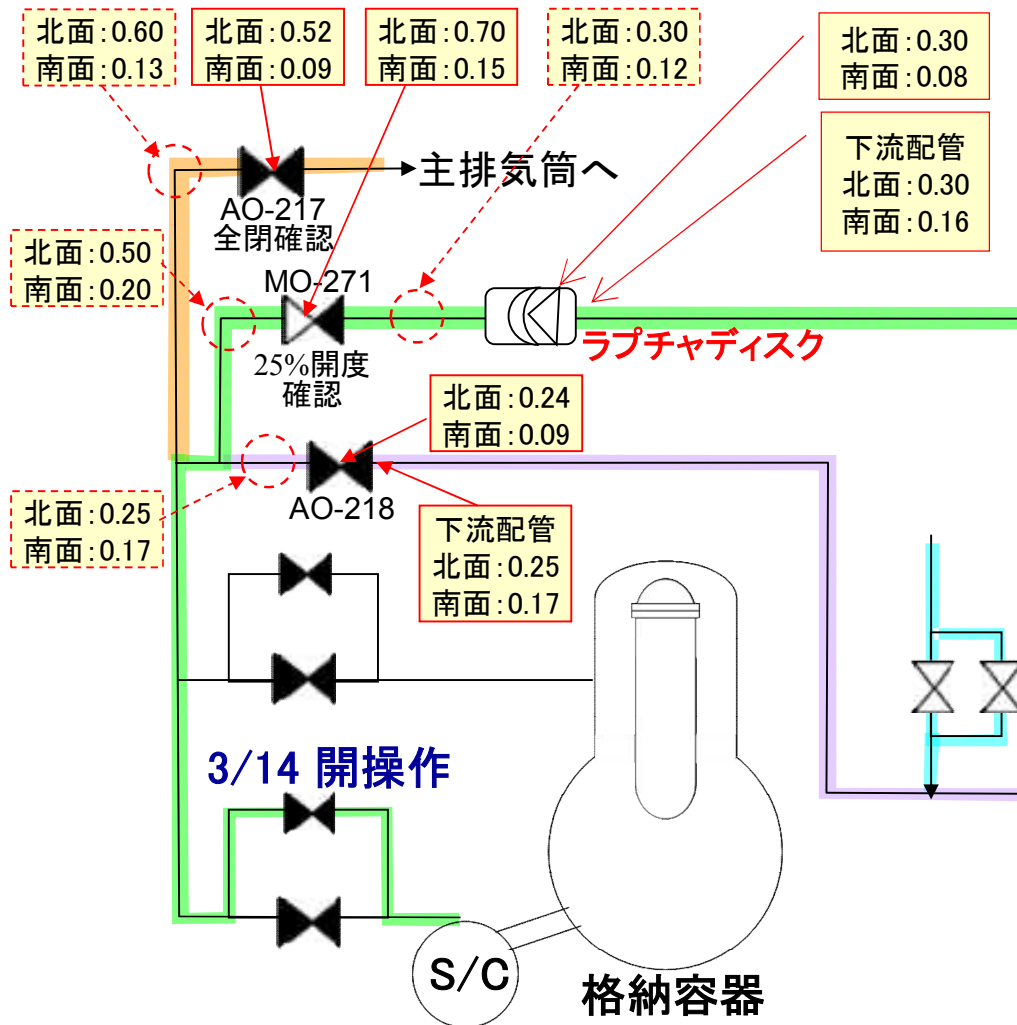
Figure 3-9 Radiation levels observed around the rupture disk (mSv/h)

Figure 3-9 shows the results of radiation measurement around the rupture disk. The measurement was done on October 8<sup>th</sup>, 2014. The radiation level measured was 0.30mSv/h from the north face, while it was 0.08mSv/h from the south face. Both were at about the same level of 0.30mSv/h (north face) and 0.12mSv/h (south face) before the rupture disk on the venting line, or 0.30mSv/h (north face) and 0.16mSv/h (south face) after the disk. These values indicate that the area is not contaminated to the extent predictable for such lines as the Unit-1 venting line, through which gas containing a large amount of radioactive materials went.

Furthermore, there exists a consistent tendency in the surrounding area that the levels on the north face are higher than those on the south face. This may indicate that the observed radiation levels were influenced by some unknown high level radioactive source existing on the north side of

the rupture disk area, i.e., the radiation levels observed on the north face of the venting line and the rupture disk were actually measurements of radiation coming from that unknown high level radioactive source on the north side without the shielding effect of the piping, while the radiation levels obtained on the south face were actually measured after being shielded by the piping. Therefore, it is highly likely that the rupture disk and the piping around the disk are the least contaminated.

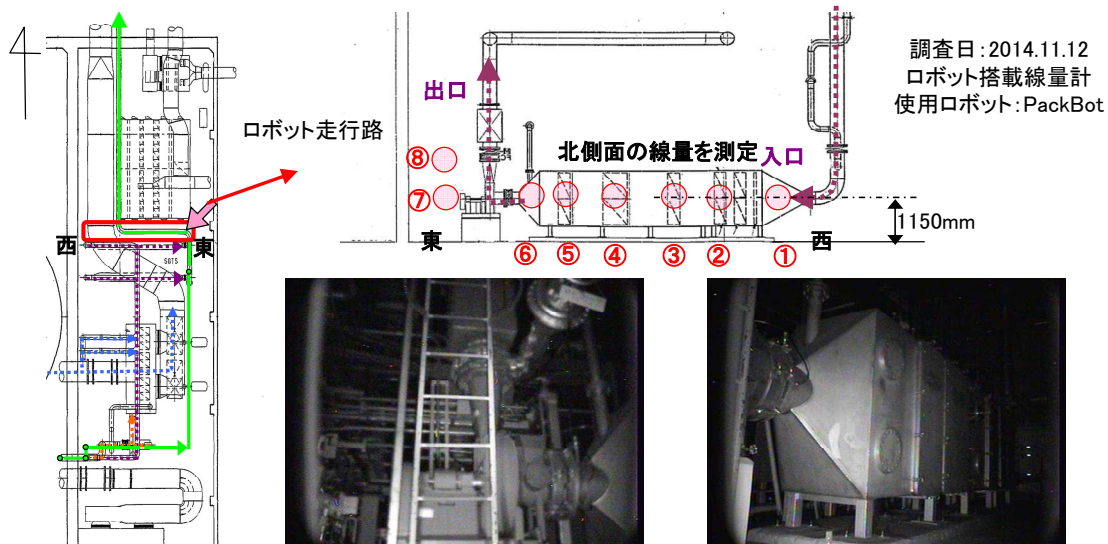
Figure 3-10 Radiation level observed (SGTS filter (A))

Figures 3-10 and 3-11 show the radiation measurement results around the SGTS filters (A) and (B), respectively. For both filters (A) and (B), radiation levels as high as about 1Sv/h were obtained. The maximum contamination has been observed on the HEPA filter at the SGTS filter outlet. Generally, the SGTS filter captures radioactive materials from its inlet side, which means that the results observed may indicate the gas containing the radioactive materials flowed into the SGTS filter from the opposite direction (backward flow). As clearly recognizable from Figure 3-8, there are two possible paths for this backward flow: from the Unit-2 venting line and the Unit-1 venting line (this is the same situation as having occurred when hydrogen gas flowed backward from Unit-3 to Unit-4).

Contamination around the rupture disk was not confirmed by the radiation measurements in the relevant area in October 2014. But still the information is insufficient in order to judge whether the Unit-2 rupture disk worked at the accident. Therefore, the investigation continues on this issue, including the identification of the source which contaminated the SGTS filters.

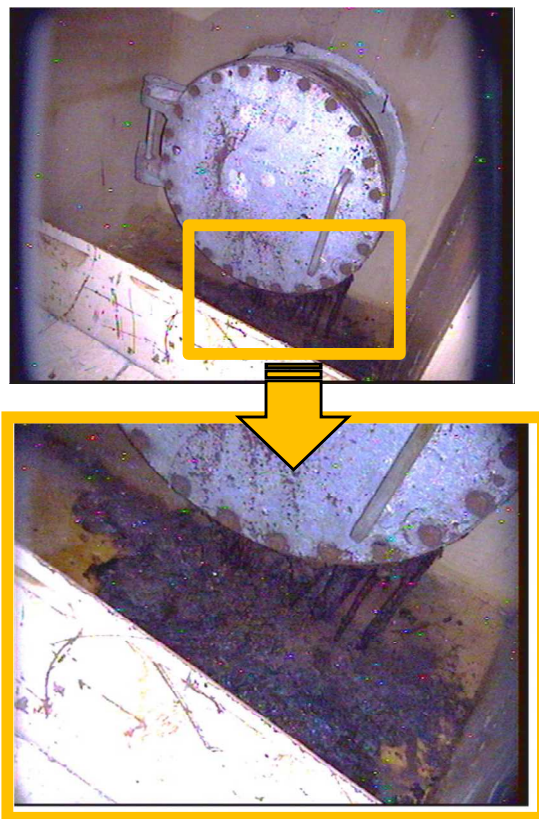
Figure 3-13 Melted material at the penetration flange [20]

Figure 3-13 shows a photo of the melted material. The melt hung from the penetration flange and lay spread on the floor. It is thought to be materials that had covered cables of the CRD replacement machine or O-ring materials of the penetration flange seals. The melt on the floor was solidified and confirmed to be easily removable by spatulas or similar tools.
