Status of investigation on estimating situation of cores and containment vessels

1. Introduction

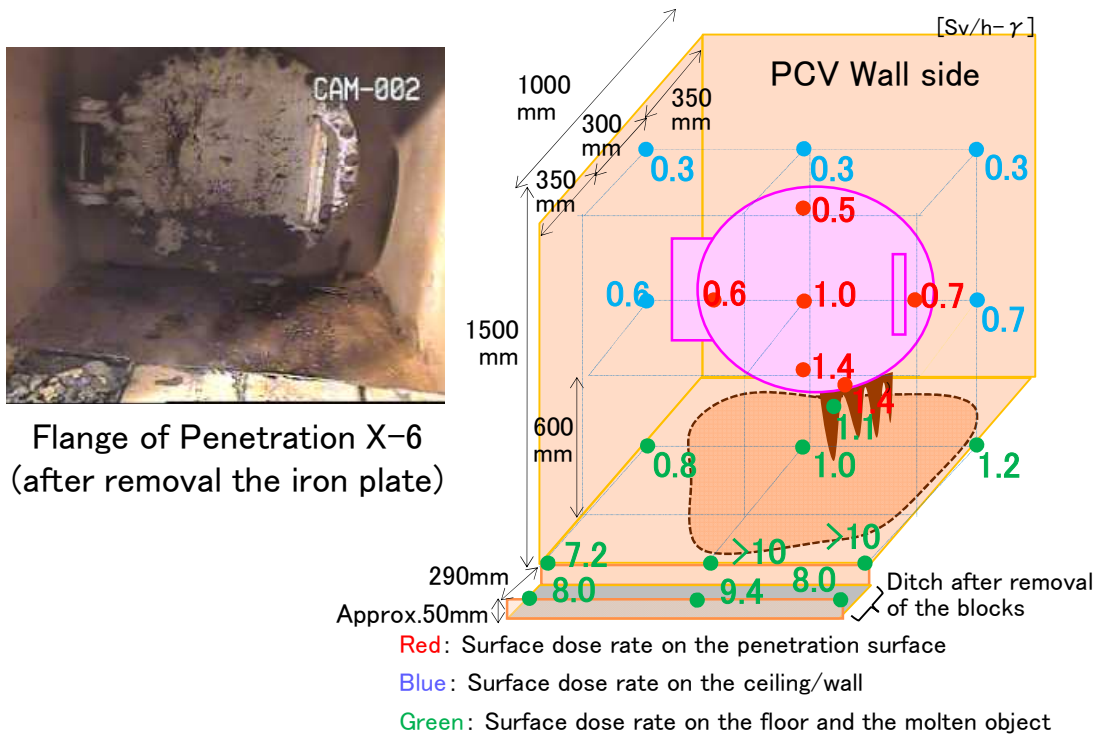
Figure 3-14 Measurement results of surface radiation dose rate [21]

Figure 3-14 gives the radiation dose rate measured on the surface. An increasing tendency for the surface dose is noticed in the order: “on the ceiling < in the middle < on the floor”; and especially a high dose rate is observed in the ditch after the shield blocks had been removed. The contamination might have spread from the area where the melt lay to the ditch. If the radiation dose difference between the locations of “at the penetration” and “on the wall” comes from the contribution of a radiation source inside the penetration X-6, it is estimated to be approximately 1Sv/h at the maximum.

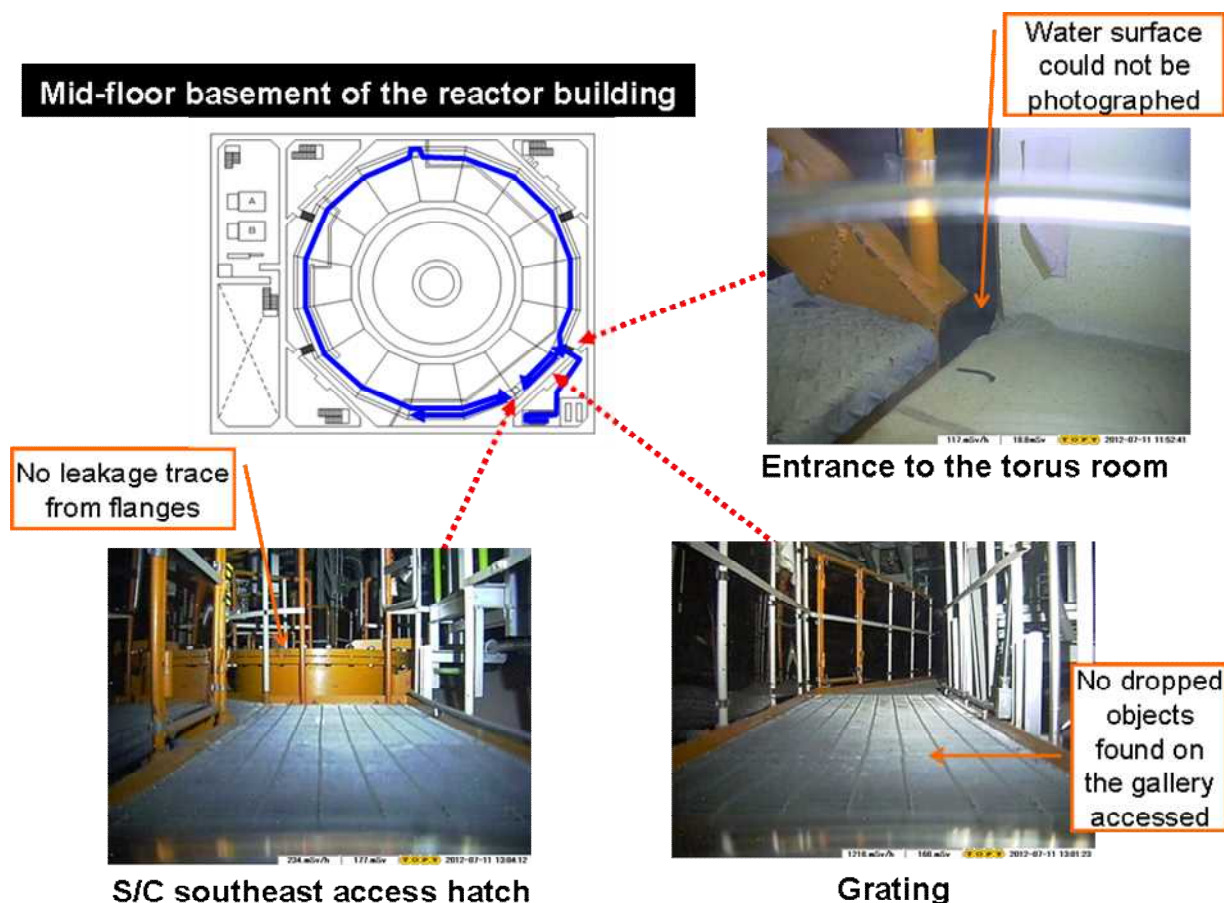
Figure 4-1 Camera photos in the torus room of Unit-3 (part)

No water leaking position in the S/C was located yet. At least, no leak was confirmed on the flange, etc. of the S/C manholes, as far as the camera photos show (Figure 4-1).

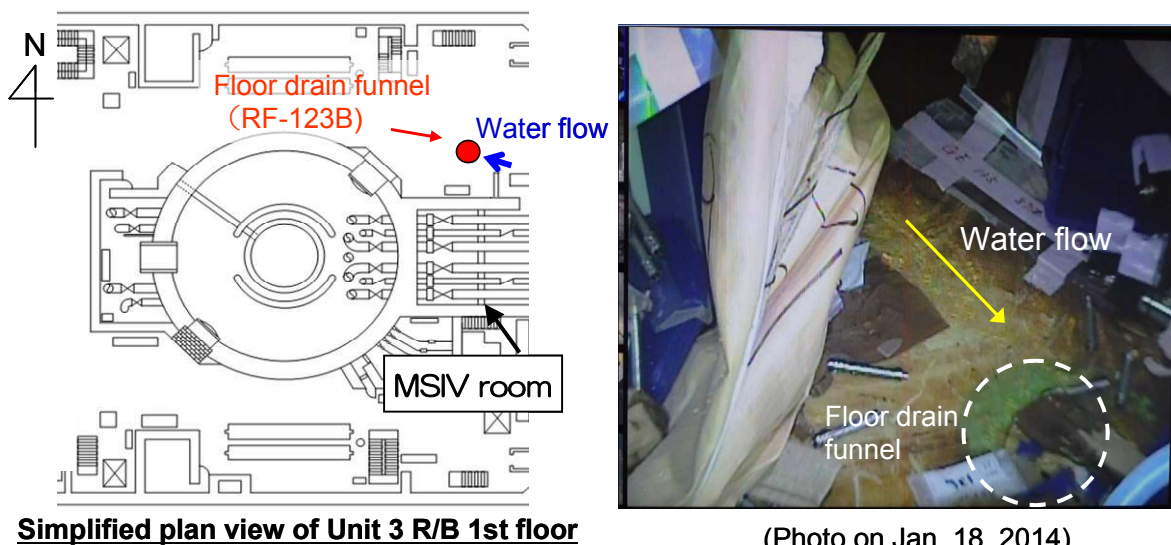
Figure 4-2 Water leak near the MSIV room door of Unit-3

In January 2014, while camera photos taken by the rubble and wreckage removal robot in the Unit 3 reactor building were being checked, water was seen to be flowing from near the main steam isolation valve (MSIV) room door in the northeast area of the reactor building first floor. The water was flowing towards a nearby floor drain funnel (Figure 4-2) [24].

The water level in the PCV is estimated as about OP.12m (about 2 m above the reactor building first floor) by converting the S/C pressure obtained by the existing pressure indicators to water head. This elevation is on the level of PCV penetrations for main steam lines, thus indicating the possibility of water leaks from the PCV penetration in the MSIV room as the source of the water flow. In consideration of this possibility, instrumentation was inserted into the MSIV room from the HVAC system room on the floor above, in April and May 2014, and photos were taken and dose rates were measured in the room, in order to locate the water flows in the room. Water leaks were from near the expansion joint of main steam line D. It was concluded [25] that the leakage had occurred only from the main steam line D, based on: (1) confirmation of no leaks from the main steam lines A, B and C, and their main steam drain pipes; and (2) the flow directions of leaked water on the floor.

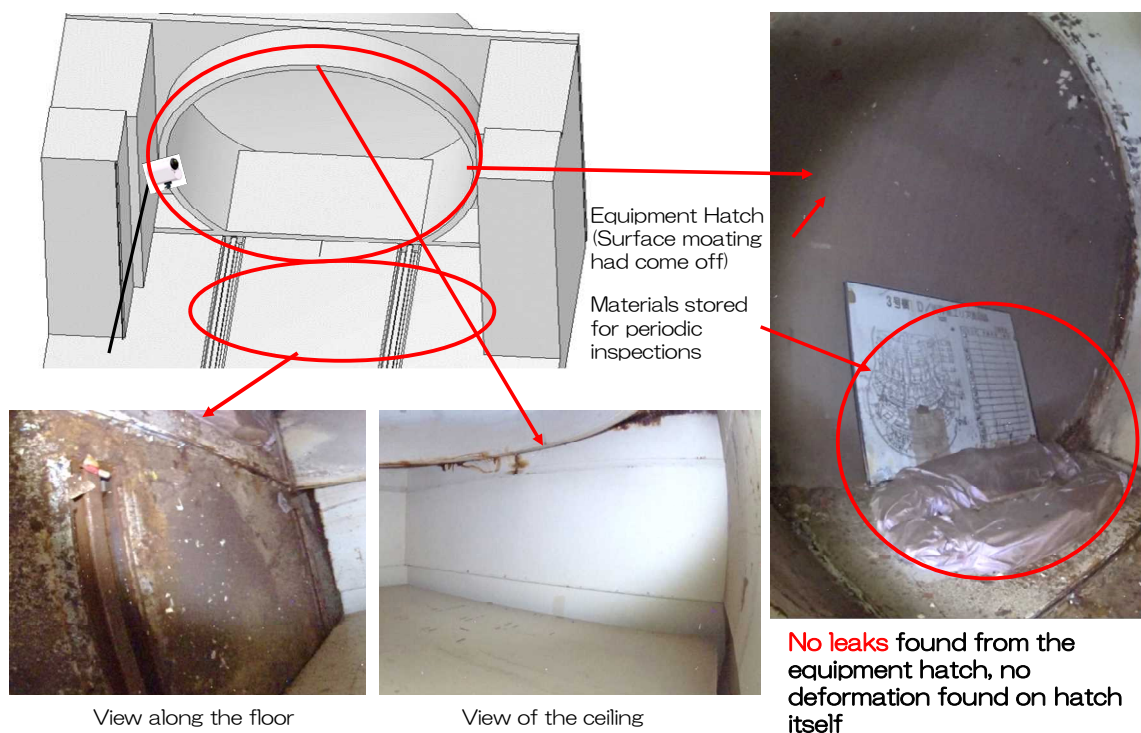
Figure 4-4 Photos of the equipment hatch [26]

in the ditches for the shield plug rails and in their vicinities. A possibility was pointed out therefore that the water retained in the PCV had leaked out through the equipment hatch seals.

In the current investigation, a small camera was inserted through the space between the shield plug and the wall originally surrounding the shield plug and the equipment hatch conditions were surveyed. Figure 4-4 presents photos taken of the hatch and around it. No water leaks from the hatch were recognized and no deformation of the hatch itself was recognized, either. Furthermore, no damage was found on the materials for periodic inspections that had been stored in front of the equipment hatch. Rather, it was noticed that the surface coating on the equipment hatch had come off and fragments of coating and other things had been accumulated on the floor in front of the equipment hatch.

At the original location for the shield plug, water (raindrops or condensed dew) was dripping from above and the floor seemed wet. Water puddles were recognized in the ditches for the shield plug travelling rails.

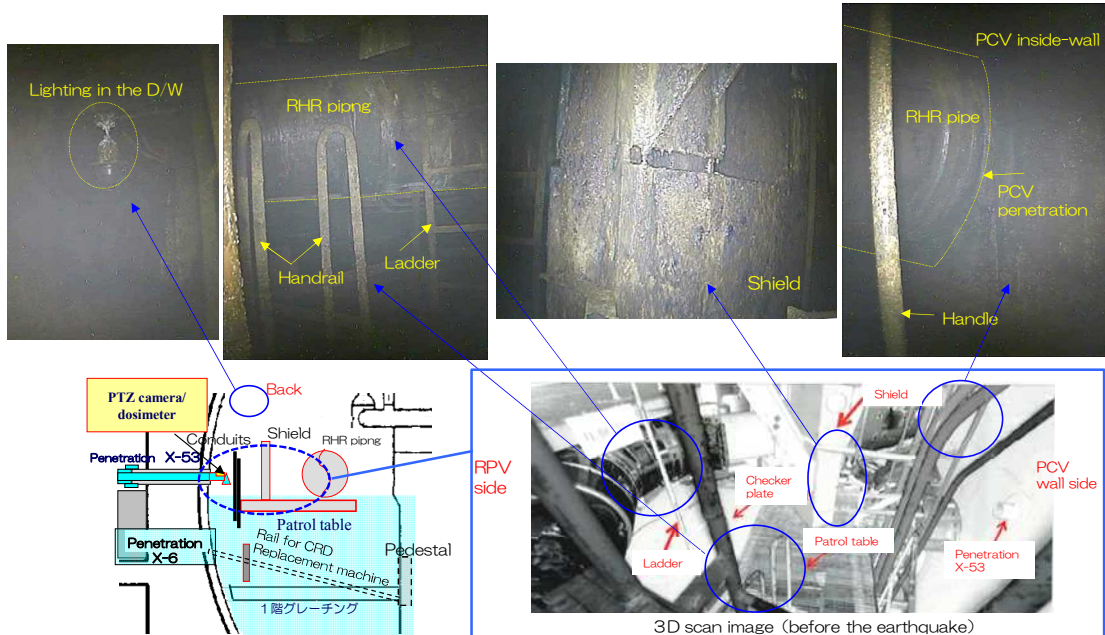
Figure 4-5 Photos of penetration X-53 taken from the front<sup>27</sup>

ladder and other things were visible, but no damage was recognized. Including the underwater photos, no damage was recognized in the PCV in the current investigation.

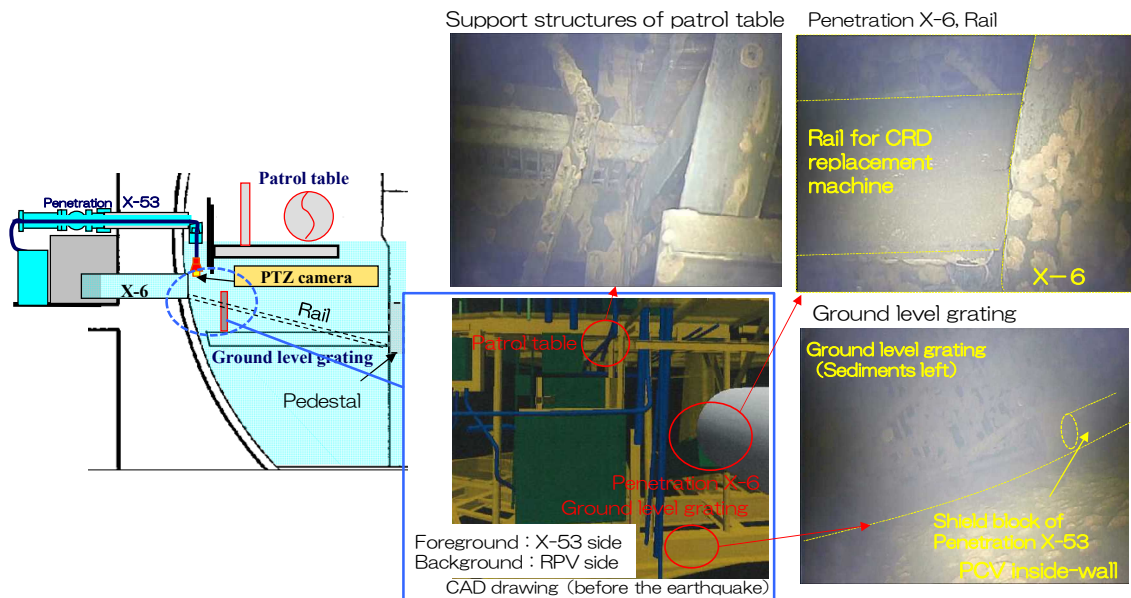
Figure 4-6 Photos in the water retained in the PCV<sup>28</sup>

Figure 4-6 shows photos taken underwater by a PTZ camera. The camera was inserted through penetration X-53. Sediments were recognized on the grating and the rails for the CRD replacement machine.
