Impacts of the earthquake on Unit-1

1. Overview of the incident and subjects for examination

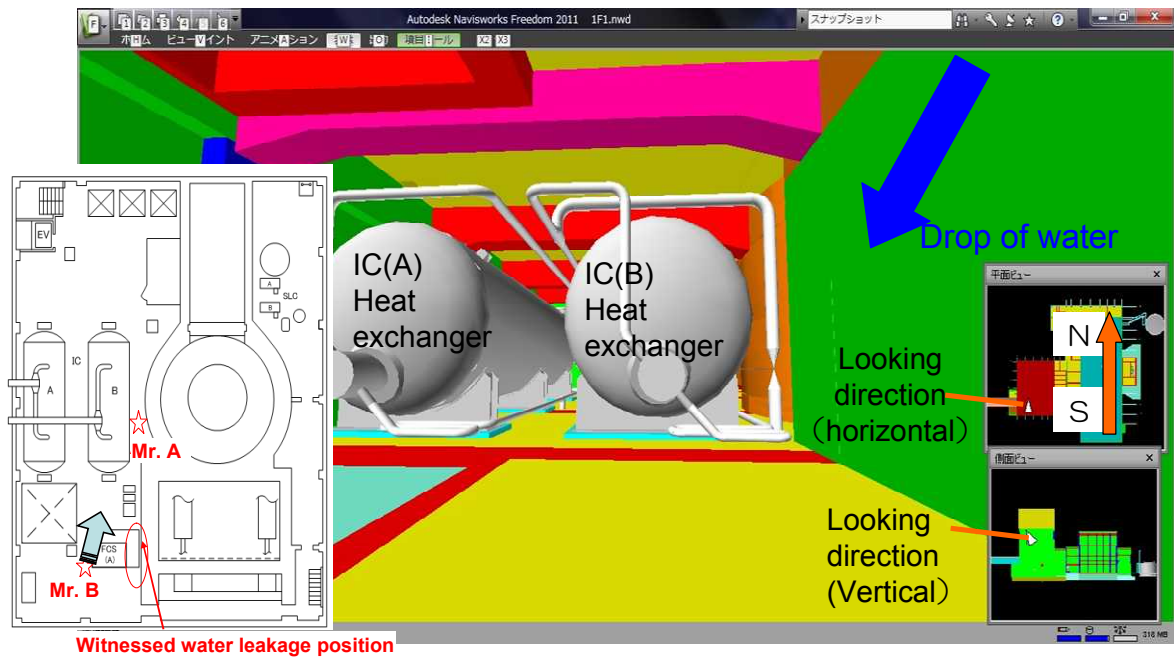
Figure 1 Situation of Person B at the time

The actual positional relations on the site can be estimated as illustrated in Figures 1 to 3 from the statements of Person B, who confirmed water leaking from the nearest position, and Person A, who confirmed water leaking in the direction of Person B. As can be seen in Figure 1, Person B stood immediately next to the hatch of the opening of the carrying-in entrance, was able to see the IC in front of him, and confirmed water leaking from the upper right. Person A, on the other hand, as can be seen in Figure 2, was hiding between the IC and containment vessel, from where he confirmed water leaking from his upper left in the direction toward Person B. Statements of these two people concerning the leak position (arrows) illustrated in Figures 1 and 2 are consistent. Therefore, it seems certain that the water was leaking from an elevated position of the east wall, as shown in Figure 3. According to a document ^{*1)} of the Nuclear Regulatory Authority (NRA) of Japan, Person A stood between the IC (A) tank and IC (B) tank. In whichever position he was confirming the water leakage at the time, there is no difference in the direction of the water leakage.

As clearly understood, the water leakage was confirmed not from the IC itself but from some other direction. It is difficult to assume the water leaked was the steam, which flowed into the IC, or the condensate for return.

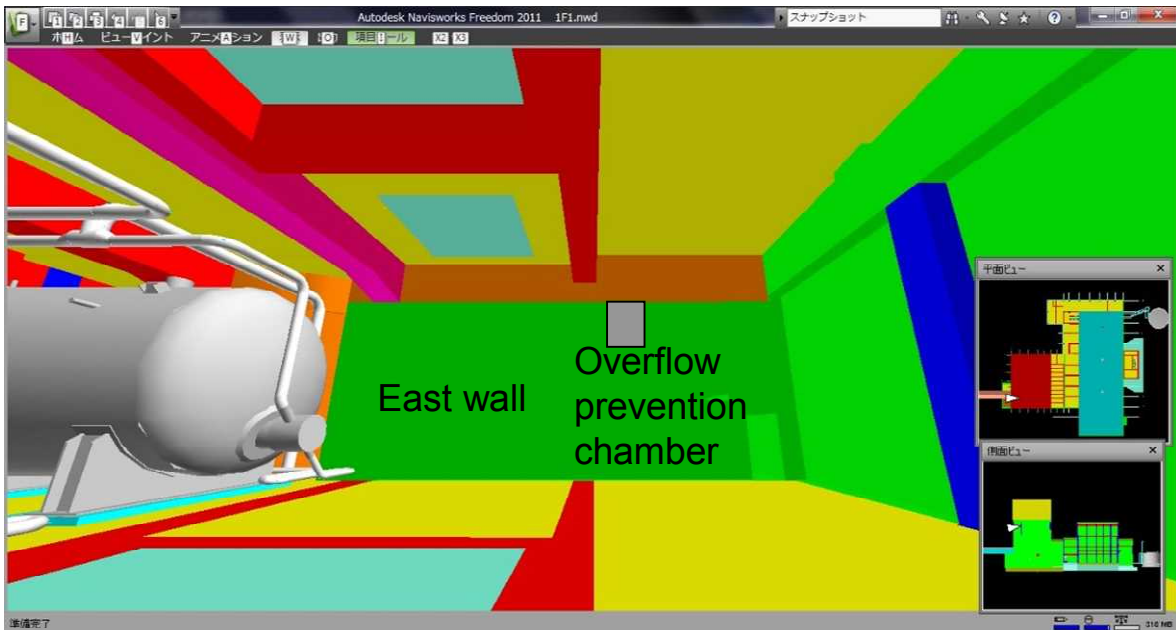
Figure 3 Position of water leak

The first subject is the water leakage in the IC room on the 4th floor of the Unit-1 reactor building. According to the Diet Investigation Commission report, it was near the hatch of the opening of the large object carrying-in entrance in the southwest area on the 4th floor of Unit-1 reactor building where the water leakage had been confirmed and the water had been leaking from an elevated position on the east wall (the spent fuel storage pool was on the other side of this wall).

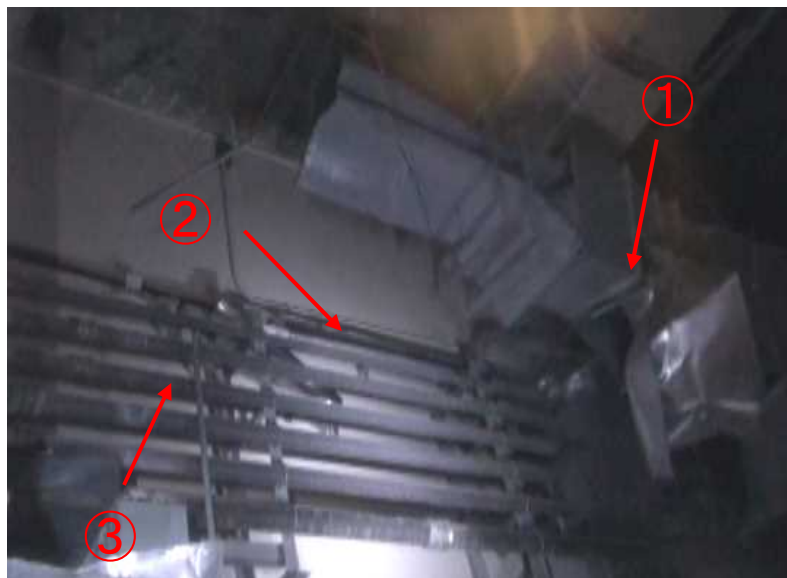
Figure 4 Pipes on the east wall

On the east wall, from where water was leaking, there were pipes and ducts, as shown in Figure 4. Among them, those pipes which could have contained water or steam were the overflow prevention chamber (①) and the IC steam venting line (②). Other multiple pipes (③) are for electric cables and contain no fluid in them.

The overflow prevention chamber was connected to a duct which took in air from the surface of the spent fuel pool and discharged it to the outside. In the case that water of the spent fuel pool flowed into the duct, this overflow prevention chamber was installed to receive the water first and then drain it via a drain line. But at the time of an earlier earthquake, an incident had been experienced in which water of the spent fuel pool flowed into a duct due to sloshing, the water was too much to be drained by the drain line, part of that water flowed further into another duct downstream, and leaked outside the radiation control area. Based on this lesson, modification work had been done to isolate the overflow prevention chamber and the duct downstream by a diaphragm.

The IC steam venting line had a role to prevent water hammers in the IC steam line. To this end, steam was constantly circulated during normal plant operations in order to warm the steam line. Once the IC started up, this venting line was isolated by a valve and no more steam was circulated. Although it is not known whether the IC was operating when the water leaked, because it is not known when the water leakage was observed, but at any rate the leakage from this path does not last long, i.e., a LOCA scenario does not exist on this path.

The fluid of the IC steam venting line was steam, and no liquid water leaked but high temperature steam of high pressure would have blown out even if a pipe break occurred. The statements are quite different from this situation. The on-site investigation conducted in later days found no pipe damage on this line, either. The overflow prevention chamber was completely destroyed so had not kept its original shape, perhaps due to the hydrogen explosion. However, from the following reasons, the water confirmed leaking on the 4th floor could be assumed to have come to the overflow prevention chamber from the spent fuel storage pool and leaked out for some reason.

It can be concluded, therefore, that the possibility of a LOCA having caused the water leakage in the reactor building, which the Diet Investigation Commission pointed out in its report based on the workers' statements, actually has no connection with a LOCA.

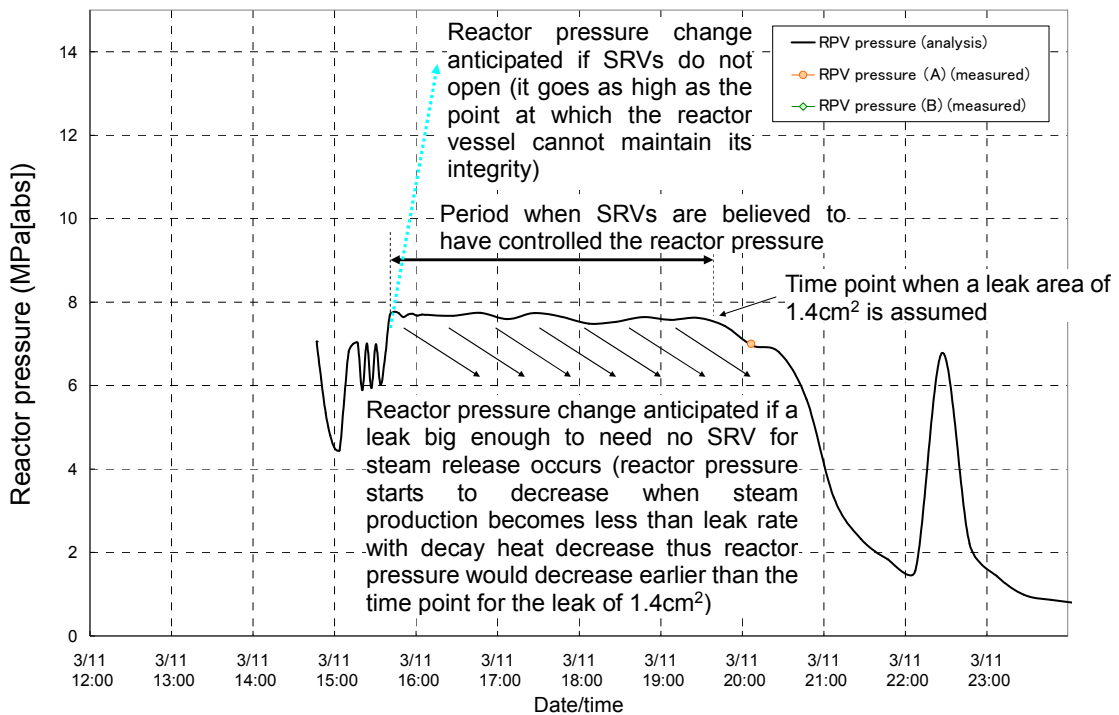
Figure 5 Reactor pressure change of Unit-1

Based on the considerations above, a new scenario was assumed, which could meet the condition of no SRV working. The new scenario assumed that the leak area had enlarged after it became impossible to measure the plant parameters in the wake of the tsunami. In this case, the leak area had to have enlarged to a area big enough to release steam by about 16:00 on March 11th, when the reactor pressure was to approach the SRV working pressures. The steam production rate decreases monotonously in accordance with the decrease of decay heat. Therefore, once the leak area is enlarged enough to stop the pressure increase, steam discharge becomes more dominant than steam production. As a consequence, the reactor pressure starts to decrease as shown in Figure 5.

In TEPCO's MAAP results (made available on March 12th, 2012), a leak hole of 1.4cm² was assumed to have been generated at about 18:50 on March 11th. This area of leak turned out not to be big enough to release sufficient steam even with the amount of steam produced at about 18:50 on March 11th. Only by combining intermittent SRV working, could the reactor maintain a stable pressure at about 7.5MPa. This means that, as long as the MAAP results are considered, the leak area could not be less than 1.4cm² even at about 17:00 on March 11th, and the scenario cannot be concluded valid without a fairly larger leak area.

In the MAAP results, the reactor pressure started to decrease at about 19:40 on March 11th, by a leak 1.4cm² in area, and MAPP reproduced the pressure of 6.9MPa at 20:07 on March 11th. So, if the pressure decrease started much earlier and the leak area was much bigger, the pressure at 20:07 on March 11th could not be 6.9MPa, but it must have been much lower. In other words, the pressure decrease after about 19:40 on March 11th must have been faster than the MAAP results. This is inconsistent with the measured values of reactor pressure.

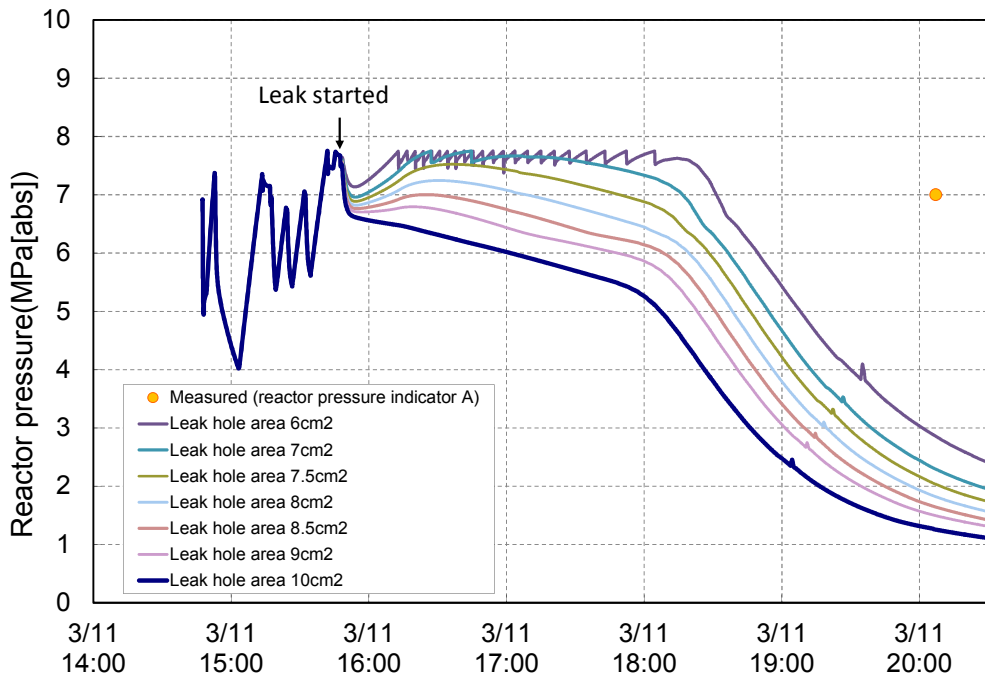
Figure 6 Reactor pressure change as a function of leak hole area

A series of MAAP analyses was conducted with leak area as the parameter by assuming

a small leak after the tsunami arrival in order to examine the above scenario (Figure 6). In the analyses, the leak was set as having started one hour after the scram. The analysis results showed that the reactor pressure had increased and reached the level high enough to activate the SRVs if the leak area had been less than 7cm². The leak area, therefore, must be bigger than 7cm² in order to satisfy the assumption “the SRVs did not work.” On the other hand, the analysis results showed that, if the leak area had been bigger than 7.5cm², the SRVs certainly had not worked, but the reactor pressure had decreased quickly and the pressure 6.9MPa[gage] at 20:07 on March 11th could not have been reproduced. The MAAP analysis has shown that a small LOCA did not occur which was consistent with the reactor pressure of 6.9MPa[gage] measured at 20:07 on March 11th under the condition of no SRV activation.

It can be concluded from the deliberations above that the three points noted by the Diet Investigation Commission as hinting at a LOCA had no connection with a LOCA and that, should they have been caused by a LOCA, they could not have occurred physically at the same time.

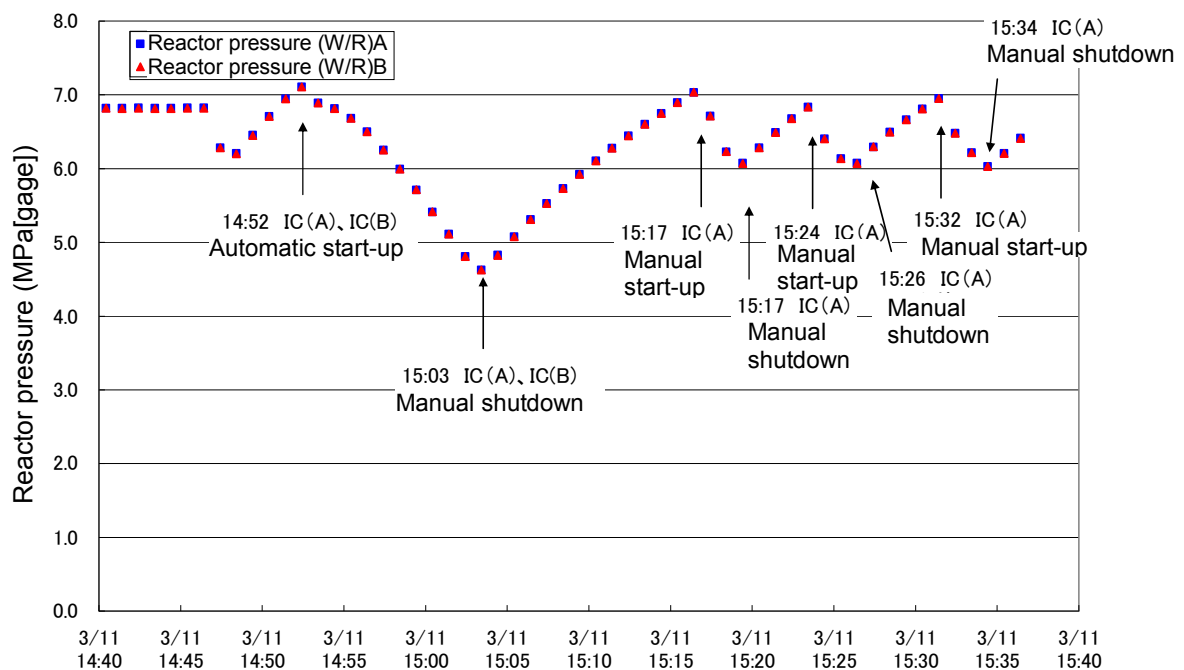
Figure 7 Reactor pressure change prior to tsunami arrival, and operators' IC maneuvering actions.

Figure 7 presents the reactor pressure changes and the IC maneuvering actions by the operators. At 14:47 on March 11th, the earthquake occurred and Unit-1 was scrammed by the “large seismic acceleration” signal. The reactor pressure decreased a little at the time of the scram, but started to increase thereafter due to steam production by decay heat. IC (A) and IC (B) were automatically started up at 14:52 when the reactor pressure reached the preset level for automatic IC start-up. It should be noted that the preset pressure for automatic IC start-up was lower than the SRV working pressures and therefore SRVs did not work when the ICs were started up.

After IC (A) and IC (B) started up, the reactor pressure started to decrease by their cooling effects and pressure was cut to 5MPa in about 10 minutes. This means that the coolant temperature in the reactor dropped about 20 deg C in about 10 minutes, because the saturation temperature of reactor coolant is about 285 deg C in normal operations with about 7MPa, while about 265 deg C when the pressure drops to about 5MPa. This temperature change rate exceeded the upper limit of the rate allowed for normal cooling at reactor shutdown, which is 55 deg C per one hour. For negating the possibility of a leak causing at the rapid pressure decrease, and for reducing the cooling speed (temperature

decrease rate) and controlling the reactor pressure, the operators manually shut down IC (A) and IC (B).

The pressure started to increase again and reached about 7MPa. Thereafter, three times the operators repeated manual start-up and manual shutdown. In all actions, the pressure increase and decrease were under the operators' control.

From the above deliberations, it is considered that the operators thought of the possibility of a LOCA at the beginning but negated it based on the plant behavior upon IC start-up and shutdown. It is not extraordinary for the operators of Unit-1 to be concerned about leaks from the reactor pressure change because they are trained, by operation simulators, etc. to always take operating actions considering the possibility of leaks.

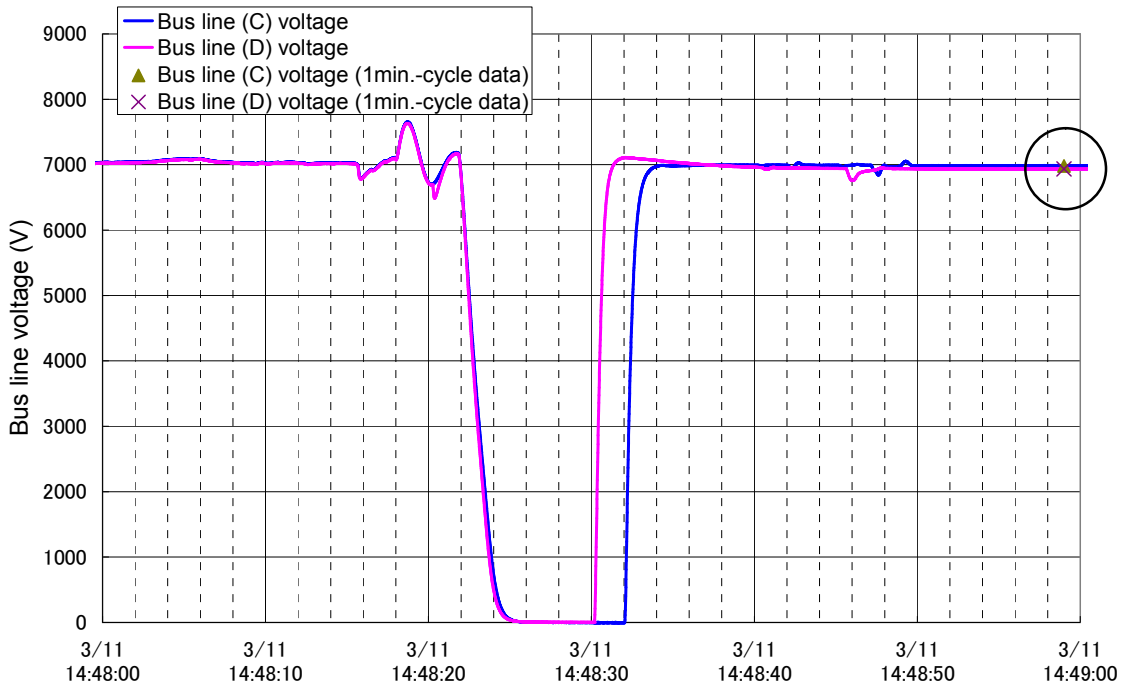
Figure 8 Comparison of 10-ms-cycle data and one-minute-cycle data by transient recorder

There is a big gap between the amount of information in the 10-ms-cycle and the one-minute-cycle. Figure 8 compares the voltage changes of bus lines C and D using these two data sets at around 14:48 on March 11th, when DGs started up upon loss of the external power supply. The 10-ms-cycle data show the voltage fluctuations and drops of bus lines as well as the subtle difference in start-up timings of DG (A) and DG (B). However, the information in the one-minute-cycle during this time period is available only for one time point at 14:48:59 (marked in the circle in Figure 8). Neither the bus line voltage loss nor the successful start-up of DGs can be explained from this single piece of information. From this background, the one-minute-cycle data were considered meaningless in analyzing transient behavior.

It has been found, however, that relevant information could be extracted regarding the time sequence of bus line voltage losses and DG operations. This is because the transient recorder keeps one-minute-cycle data, which are outside between 5min before a transient (the earthquake) to the time beyond 30min after the transient as the original system function, specifically to the time immediately before the transient recorder itself lost its functions due to the tsunami arrival. The data beyond 30min after the transient are not recorded in the 10-ms-cycle data.

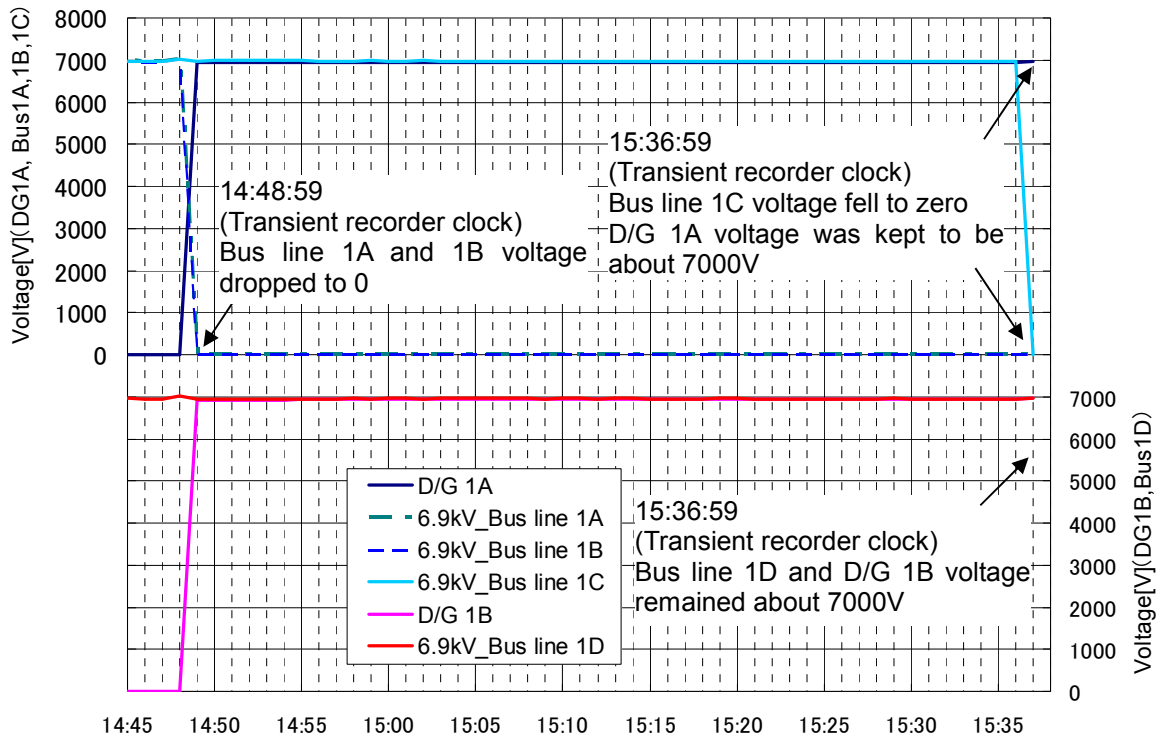
Figure 9 Voltage changes of bus lines and DGs

Figure 9 presents voltage changes of bus lines and DGs. Voltage changes of bus lines A, B, C and DG (A) are plotted at the top, while voltage changes of bus line D and DG (B) are plotted at the bottom. First to note is that the voltage of bus lines A and B, which were not connected to DGs, dropped to zero upon loss of the external power supply. It can also be confirmed that DG (A) and DG (B) started up following the loss of the external power supply,

because their voltages rose from zero to about 7,000V. Bus lines C and D were connected to DG (A) and DG (B), respectively, and therefore they maintained their voltages by receiving electricity from each DG even after loss of the external power supply. As mentioned earlier, no information is visible in one-minute-cycle data concerning the voltage drops upon loss of external power supply and voltage gains upon DG start-up. When the data around 15:37 when the tsunami arrived at the site are looked into, the voltage drop of bus line C down to zero can be seen (in the one-minute-cycle data chart the voltage dropped between 15:35:59 and 15:36:59). On the other hand, voltages of bus line D, DG (A) and DG (B) were maintained at about 7,000V as of 15:36:59 and it is after 15:37 when they lost their functions. It should be noted that the DGs can maintain their voltage by themselves even if the recipient lost its voltage.

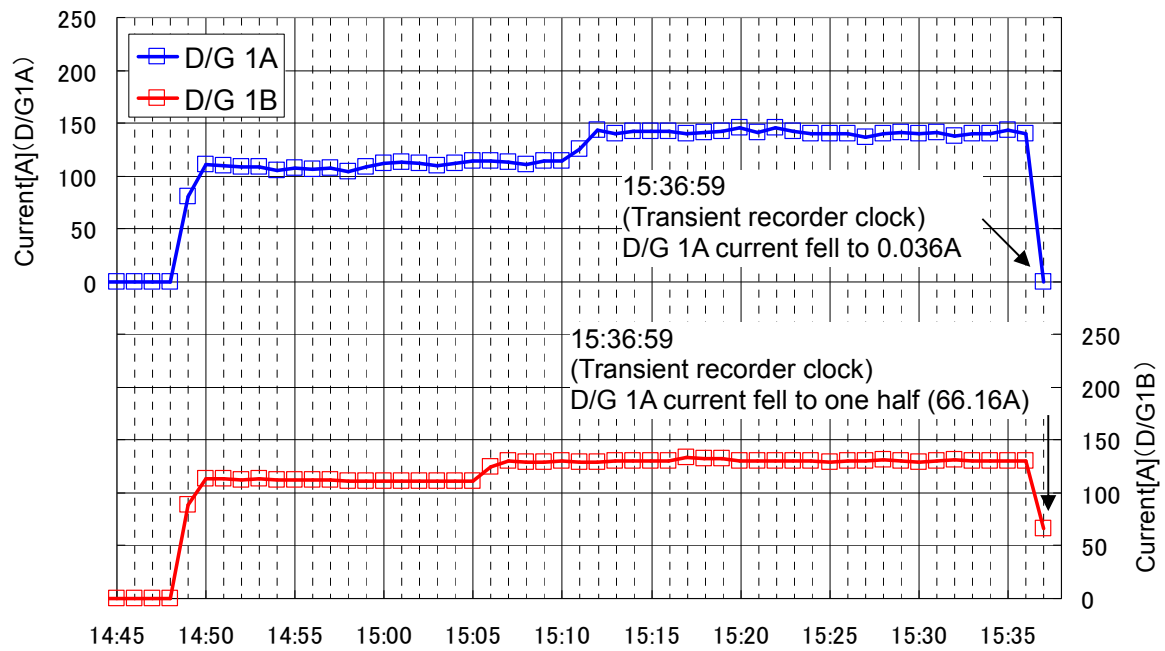
Figure 10 Changes of DG (A) current and DG (B) current

Finally, Figure 10 shows the current changes of DG (A) and DG (B). The increase of currents at the DG start-up and at the time of containment cooling system (CCS) start-up for suppression pool water cooling can be confirmed from the figure. Looking at the changes at the time of tsunami arrival, it can be seen that the voltage of DG (A) connected to bus line C dropped to zero, and so did the current as well. At the same time, some decrease in current on bus line D can also be recognized, which maintained the voltage of about 7,000V. This can be presumed as due to the loss of its load such as the loss of functions of seawater pumps, which were installed in low elevation areas of the site.

Based upon the deliberations above, the tsunami impacts on power sources can be presumed to have proceeded from the seaside as in the following sequence and the loss of power supplies was reconfirmed to have been caused by tsunami.
