Estimation of causes of high contamination of RCW piping at Unit-1

1. Background

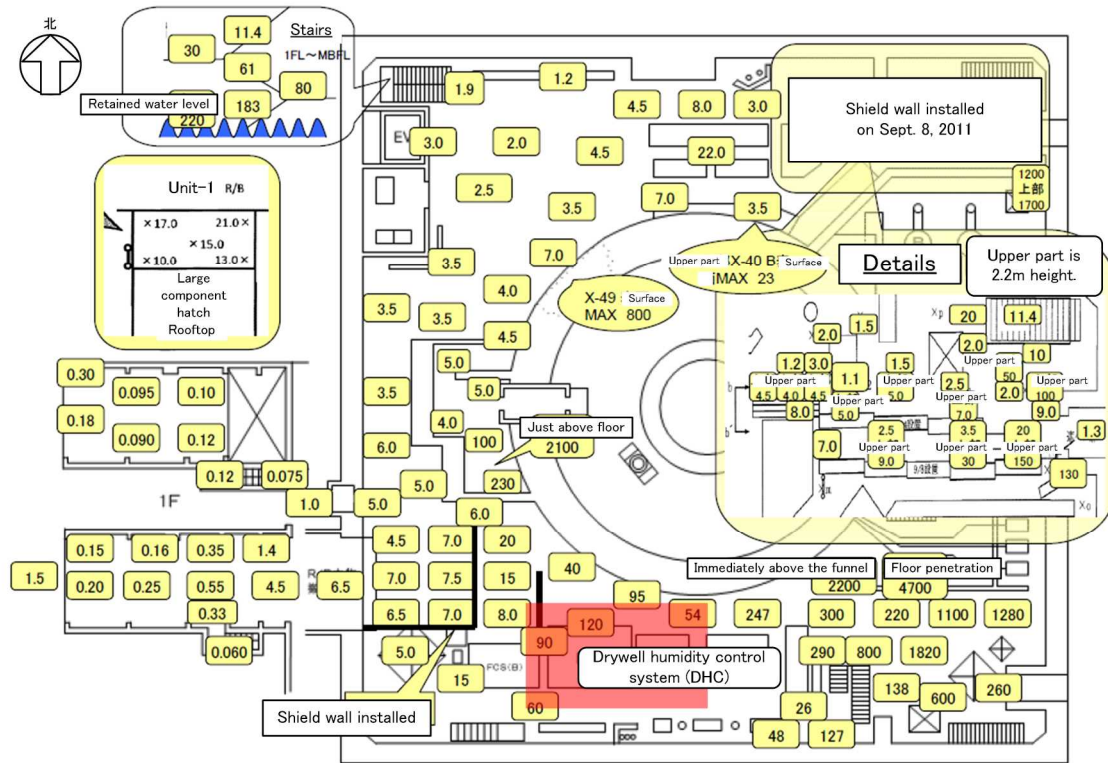
Figure 2 Air dose rates measured on Floor 1 of Unit-1 R/B (mSv/h) [1]

On the R/B Floor 1, high dose rates were measured in the southeast area (Figure 2). For this spot, a correlation with the vent line of the PCV vent (wet well (W/W) vent) is suggested [2]. Therefore, the possibility of high dose rate contamination due to RCW piping damage can be considered as low. Besides the southeast area, high dose rates (120mSv/h) were measured in the vicinity of the dry-well humidity control (DHC) system in the southwest area. The DHC is one piece of auxiliary equipment to be cooled by the RCW system.

radioactive materials could be deposited therein. This estimation is consistent with the high dose rates observed around the RCW heat exchanger on R/B Floor 2 (Figure 3). It is also consistent with the high dose rates near DHC on R/B Floor 1 (Figure 2).

- High dose rates near the dry-well humidity control system (DHC) in the southwest area on R/B Floor 1 (the high dose rate in the southeast area was excluded from evaluation, because it came probably from other reasons)
- High dose rates near the RCW heat exchanger in the south area on R/B Floor 2
- High dose rates near the surge tank in the southwest area on R/B Floor 4

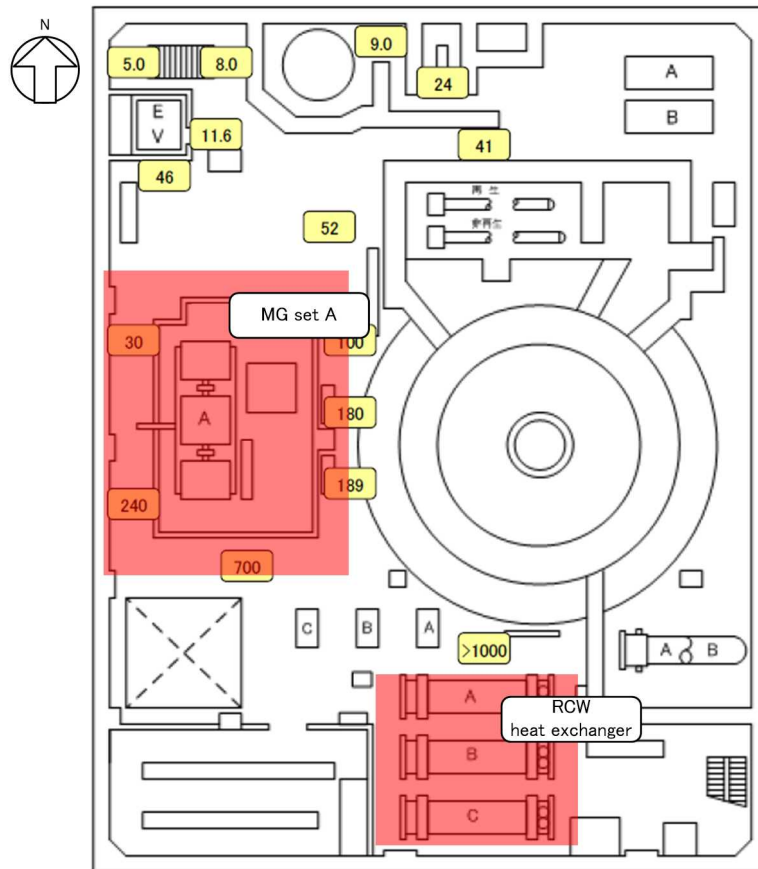
Figure 3 Air dose rates measured on Floor 2 of Unit-1 R/B (mSv/h) [1]

On Floor 2, high dose rates were measured in the south area (higher than 1,000mSv/h) and in the west area (30 to 700mSv/h) (Figure 3). An extremely high dose rate was measured in

the south area, where the RCW heat exchanger was installed. In the west area, the MG set oil cooler (A) was installed, which was cooled by the RCW system. In the west area, the highest dose rates were measured in the lower area on the figure (700mSv/h) and the lowest dose rates in the left area on the figure (30mSv/h). This hints at possible impacts from the high dose rates in the vicinity of the RCW heat exchanger in the south area.

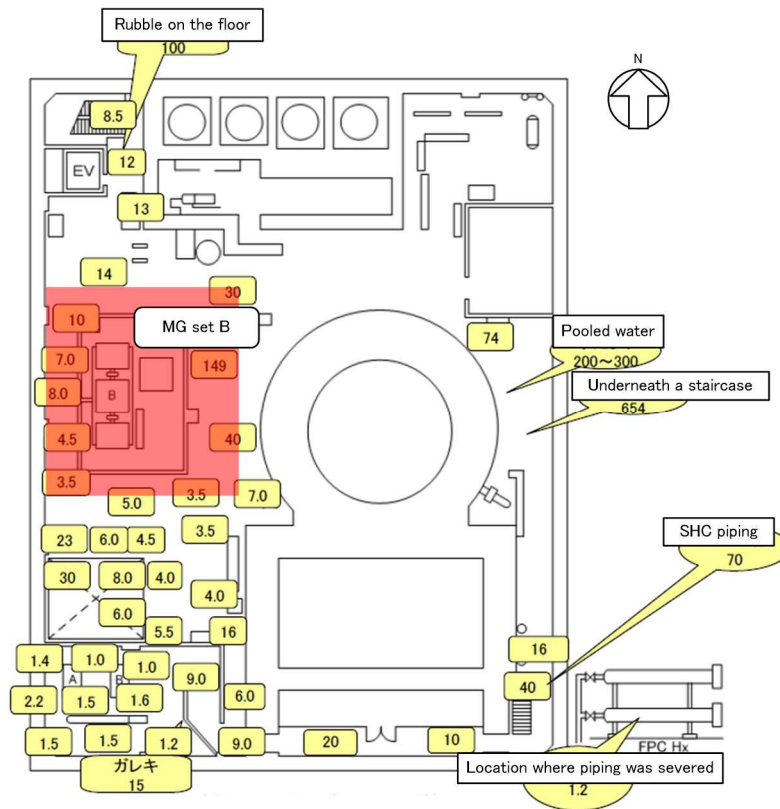
Figure 4 Air dose rates measured on Floor 3 of Unit-1 R/B (mSv/h) [1]

On Floor 3, high dose rates were measured in the west area (149mSv/h) (Figure 4). A possible cause is the MG set oil cooler (B) in the area, but other causes may be possible because the air dose rates in the surrounding area were low (3.5 to 40mSv/h). On Floor 4, dose rates in several tens of mSv/h were measured in the west and southwest areas, the highest value being 90mSv/h measured in the southwest area (Figure 5). The RCW surge tank which adjusts the RCW water inventory was installed in this area.

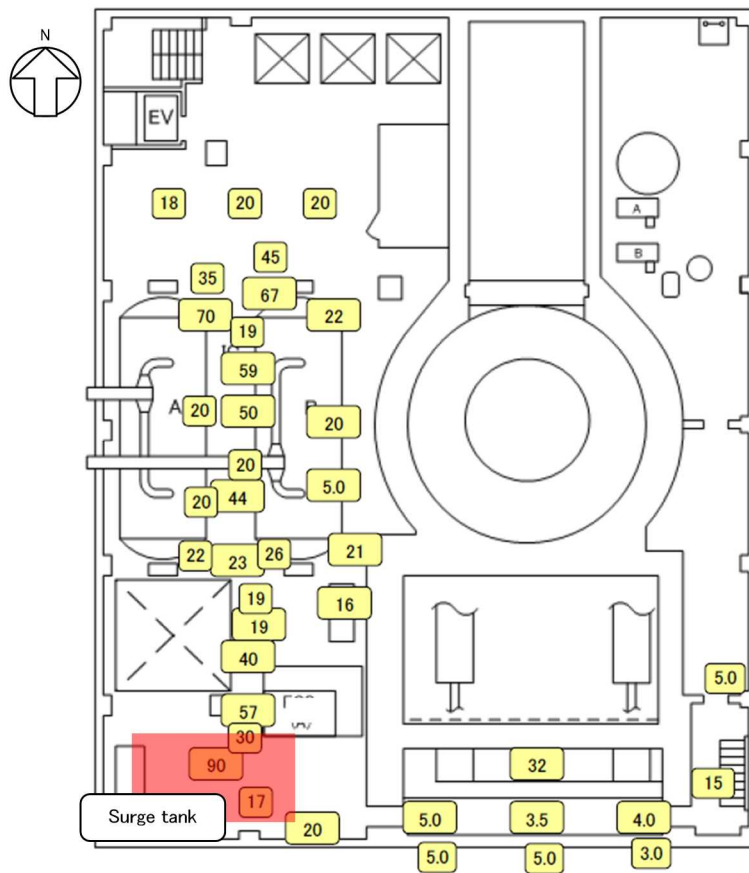
Figure 5 Air dose rates measured on Floor 4 of Unit-1 R/B (mSv/h) [1]

The RCW piping ② has four branch lines. The line to the surge tank is likely to be at about atmospheric pressure at its end and therefore the radioactive materials could have tended to migrate in the direction of the surge tank. This is consistent with the high dose rates observed

around the surge tank on the R/B Floor 4 (Figure 5). Migration to other lines depends on the distance and paths to the destination equipment or on the elevational relations with the surge tank, which is an easier destination for migration. But all downstream lines return to the heat exchanger outlet line in a closed circuit. Therefore, the line pressures are considered close to the RCW pressures and it can be considered to have been hard for radioactive materials to migrate to these lines. It should be noted that the relatively high dose rates observed in the vicinity of the MG set (A) could have been affected by the RCW heat exchanger, as mentioned in Section 2, and they could have been caused not only by the contamination in the piping.

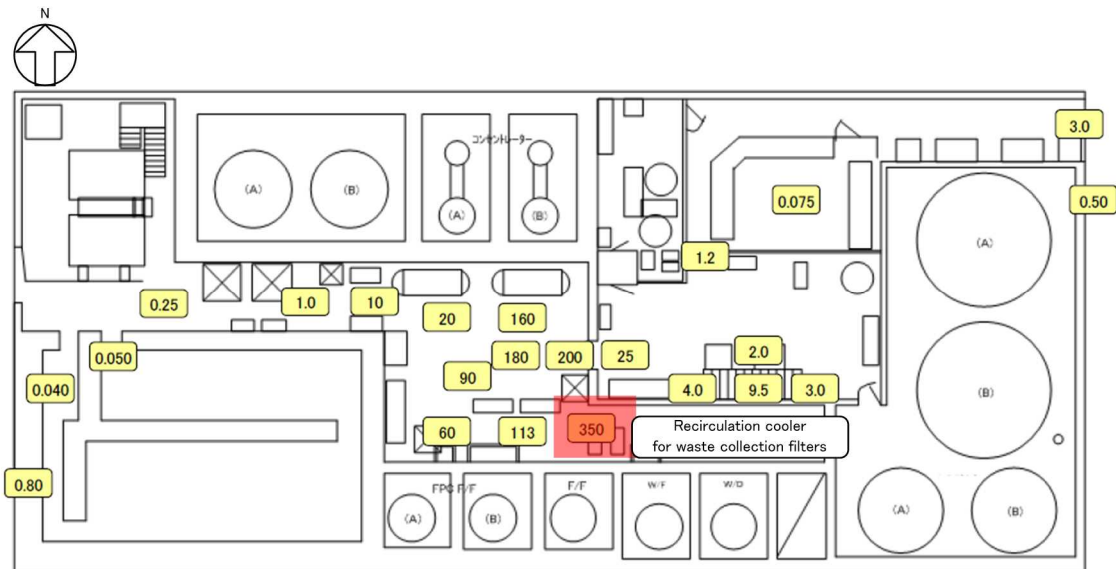
Figure 6 Air dose rates measured on Floor 1 of Unit-1 Rw/B (mSv/h) [1]

On the R/B Floor 1, a high dose rate (350mSv/h) was measured in the south area (Figure 6). In this area, a recirculating cooler for waste collection filters was installed, which was one piece of equipment to be cooled by the RCW system.

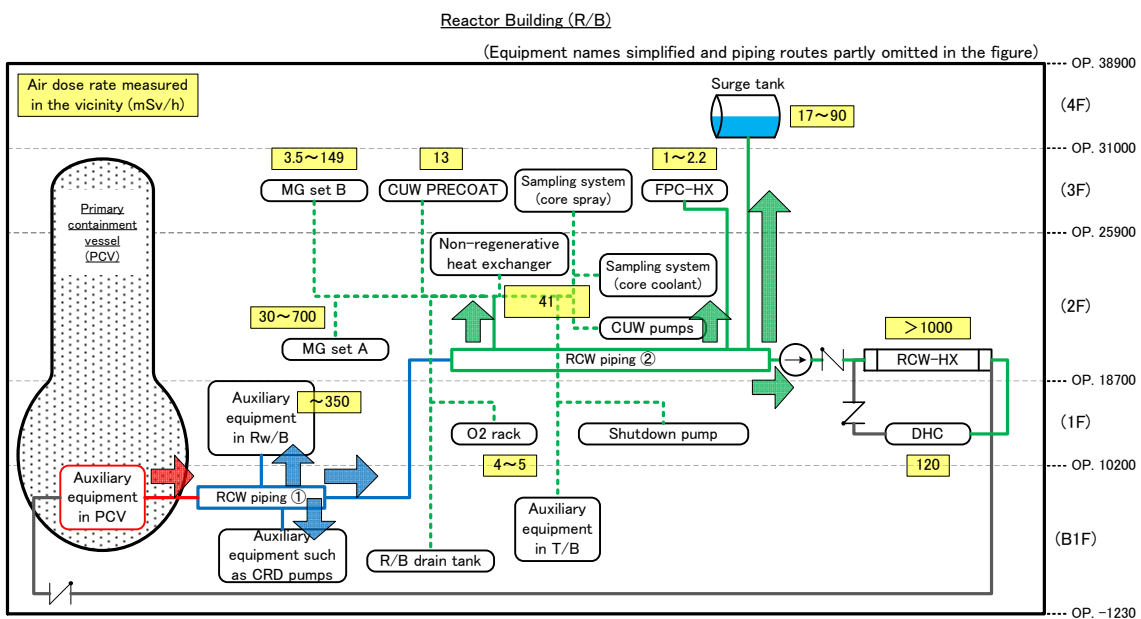
Figure 8 Migration of radioactive materials in the case of high PCV pressures

Radioactive materials migrate from the PCV to the RCW piping, since the PCV pressure at the location of damage (of the RCW piping) is higher than the pressure at the surge tank with the elevation difference and other factors being taken into account. Figure 8 shows the evaluation results of radioactive material migration in the RCW piping for the high PCV pressure situation, based on the RCW piping routes shown in Section 2 (Figure 1). When the RCW piping in the PCV pedestal is damaged, radioactive materials migrate into the RCW piping ① in Figure 8. The other side of the piping (upstream) was excluded in the evaluation, because it has a check valve near the inlet to the PCV and therefore the radioactive migration was considered to be insignificant. The RCW piping ① has three branch lines: the junction to the R/B is located closer to the PCV; the line goes to the CRD pumps and other auxiliary equipment in the Basement Floor 1; and the last line, the RCW main piping ② has a surge tank downstream. None of these three lines would have presented particular difficulties for radioactive materials to migrate through, although it is difficult to show this quantitatively. It should be noted that the high dose rates observed on the R/B Floor 1 could be due to the radioactive materials migrating to the R/B. The situation in the R/B Basement Floor 1 has not yet been investigated; it is the installed location of CRD pumps and other auxiliary equipment.

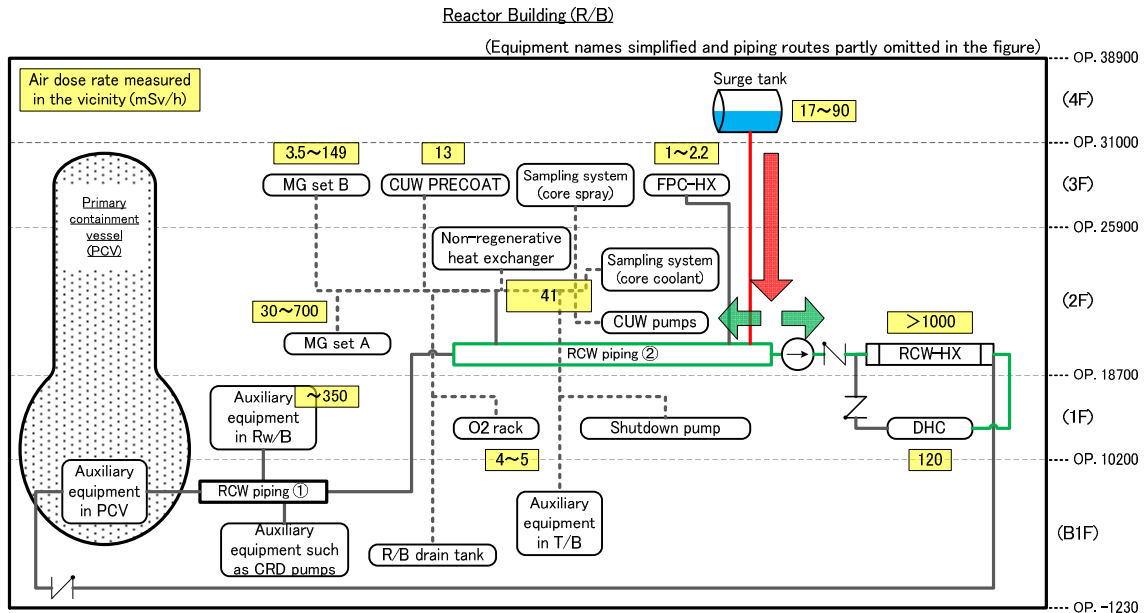
Figure 9 Migration of radioactive materials in the case of low PCV pressures

At Unit-1, the PCV pressures decreased from 14:30 to 14:50 on March 12th on the occasion of W/W venting. The radioactive materials which migrated to the surge tank when the PCV pressures were high would come down to the level where the pressures balanced with the PCV pressures. Figure 9 shows feasible migration paths for the radioactive materials accumulated in the surge tank.

When the radioactive materials being accumulated in the surge tank migrated to the RCW piping ②, they would proceed to the RCW piping ① (to the left in Figure 9) or the RCW heat exchanger (to the right). The heat exchanger had a large surface area and a large amount of
