Leaks from Unit-3 PCV and steam release in a large amount

1. Background

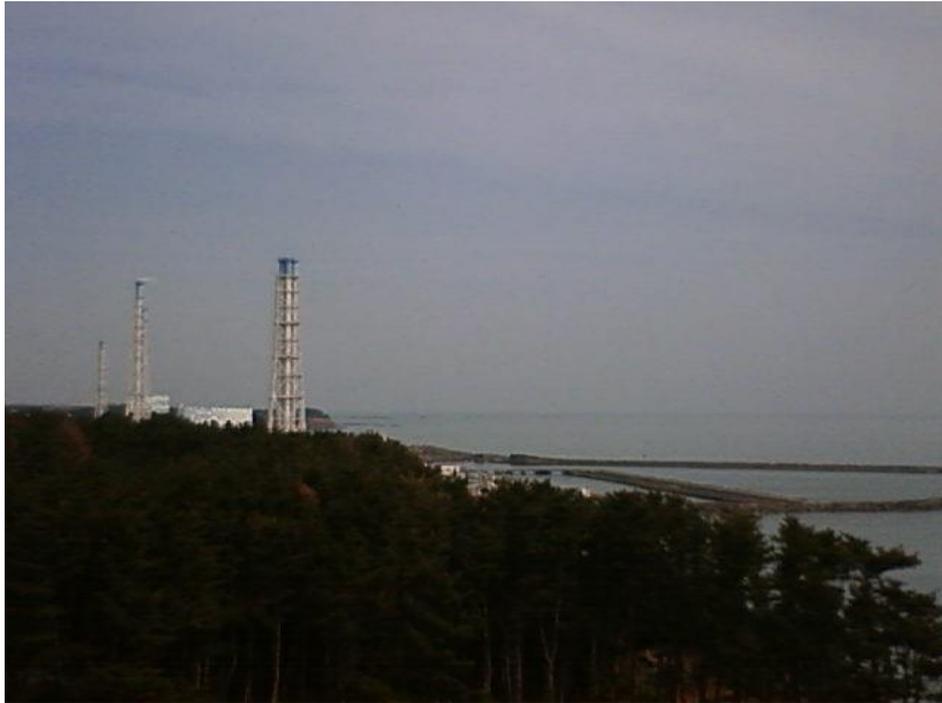
Unit-3 is considered to have been successfully vented at about 09:20 on March 13th and Figure 2 shows a photo live camera taken at 10:00, about 40 minutes after the venting. As can be seen in the enlarged photo of the Unit-3/4 stack, steam was being discharging by venting. Meanwhile, no extraordinary conditions are recognized for the R/B.

Figure 2 Photos by the live camera at the Fukushima Daiichi NPS (taken at 10:00 on March 13th) (Top: Full screen view of the live camera, Center: Enlarged Unit-3/4 stack, Bottom: Enlarged R/B surroundings)

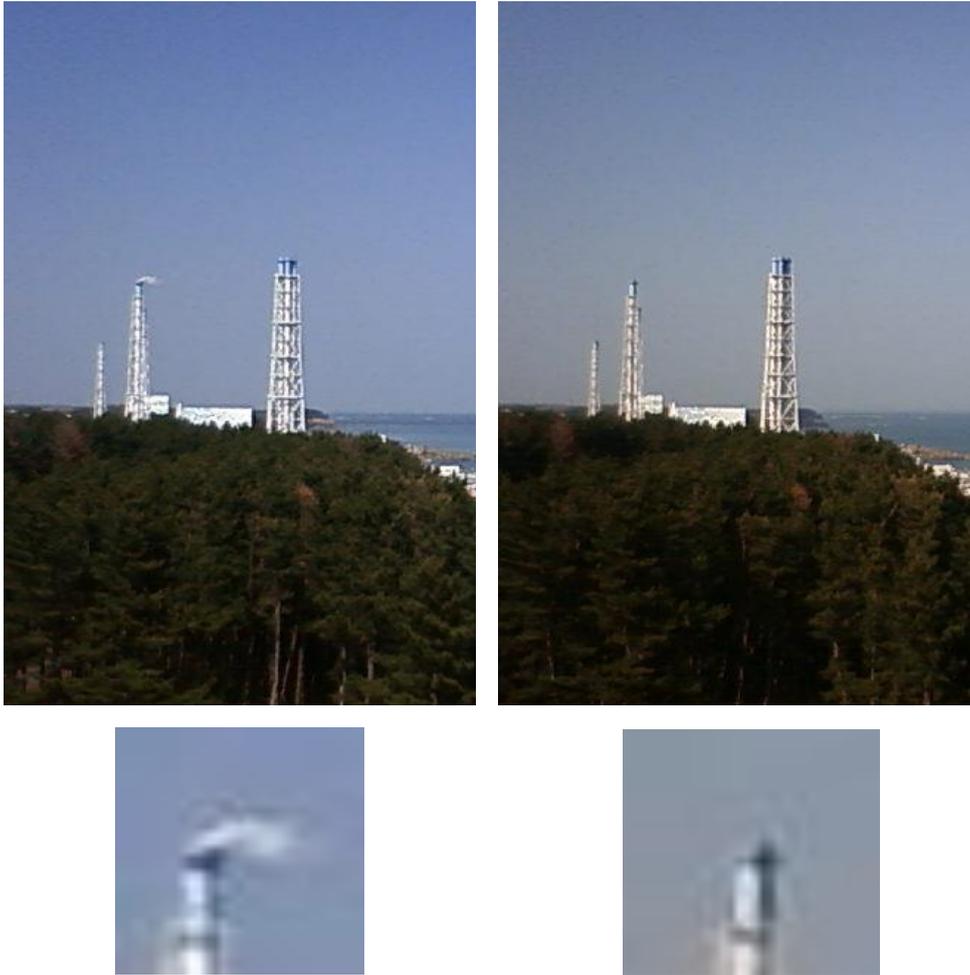
Figure 3 shows photos by the live camera at 13:00 and 15:00 on March 13th. It is recorded elsewhere that the vent valve closure was confirmed at 11:17 and the vent valve opening (second opening operation) was confirmed at 12:30. Therefore, the steam release as confirmed in the live camera photo of 13:00 is considered as the result of the successful venting. No clear steam release can be recognized in the photo of 15:00.

Figure 3 Photos by the live camera at the Fukushima Daiichi NPS (Part) (Left: taken at 13:00 on March 13th, Right: taken at 15:00 on March 13th) (Top: Live camera photos (excerpt), Bottom: Enlarged Unit-3/4 stack)

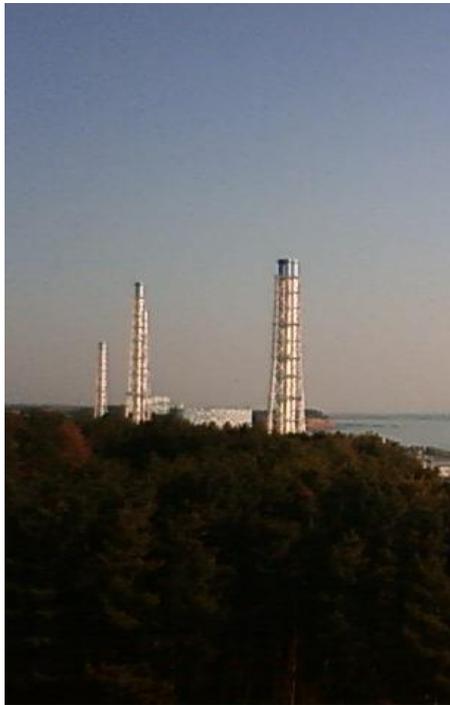
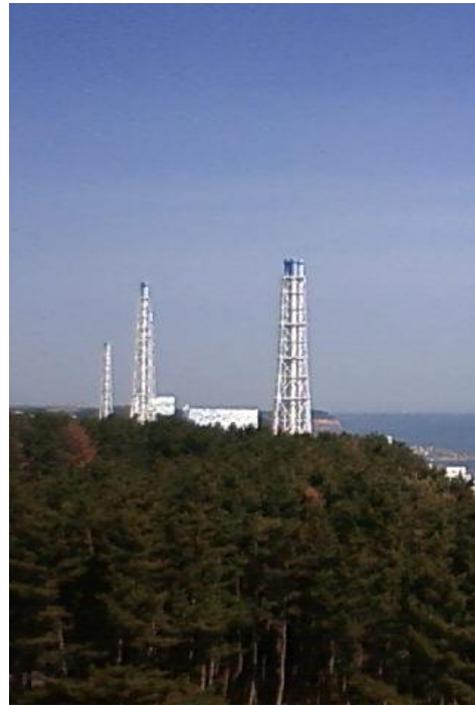
Figure 4 shows photos by the live camera at 07:00 and 10:00 on March 14th. In the records operation of the vent valve (small valve) was completed at 06:10 (fourth operation time). Steam release cannot be recognized clearly in either of these live camera photos. There is a possibility, though, that the steam released by the small vent valve operation was limited and not recognizable in live camera photos.

Figure 4 Photos by the live camera at the Fukushima Daiichi NPS (Part) (Left: taken at 07:00 on March 14th, Right: taken at 10:00 on March 14th) (Top: Live camera photos (excerpt), Bottom: Enlarged Unit-3/4 stack)

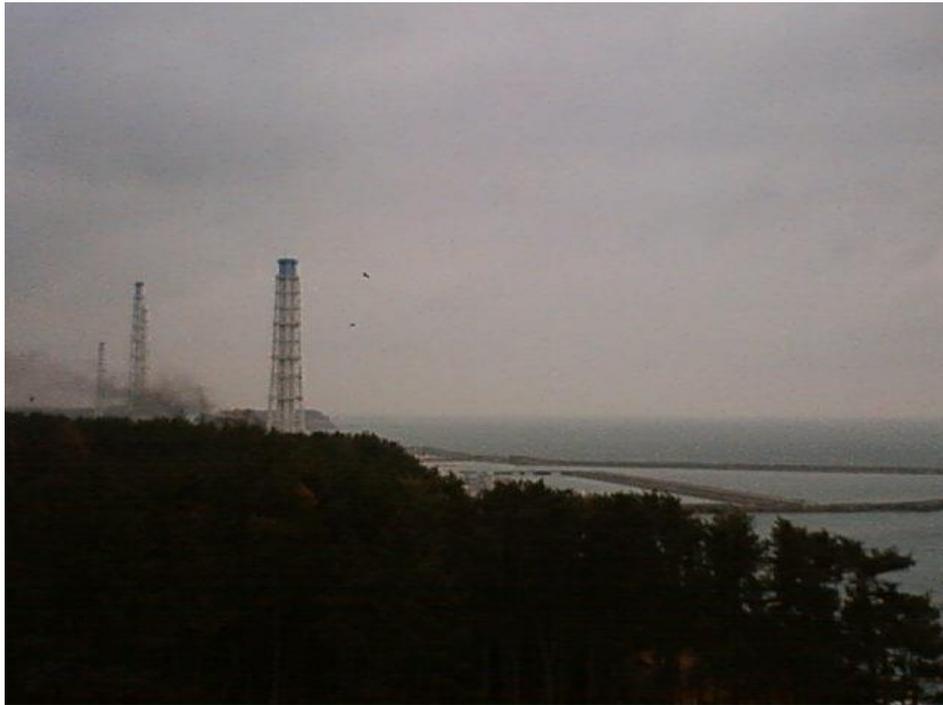
Figure 5 shows photos by the live camera at 07:00 on March 15th. At this timing, steam release from the Unit-3/4 stack cannot be recognized, but from the enlarged photos around the R/Bs, steam release, probably from the top of the R/B of an unknown unit, can be recognized.

Figure 5 Photos by the live camera at the Fukushima Daiichi NPS (taken at 07:00 on March 15th) (Top: Full screen view of the live camera, Center: Enlarged Unit-3/4 stack, Bottom: Enlarged R/B surroundings)

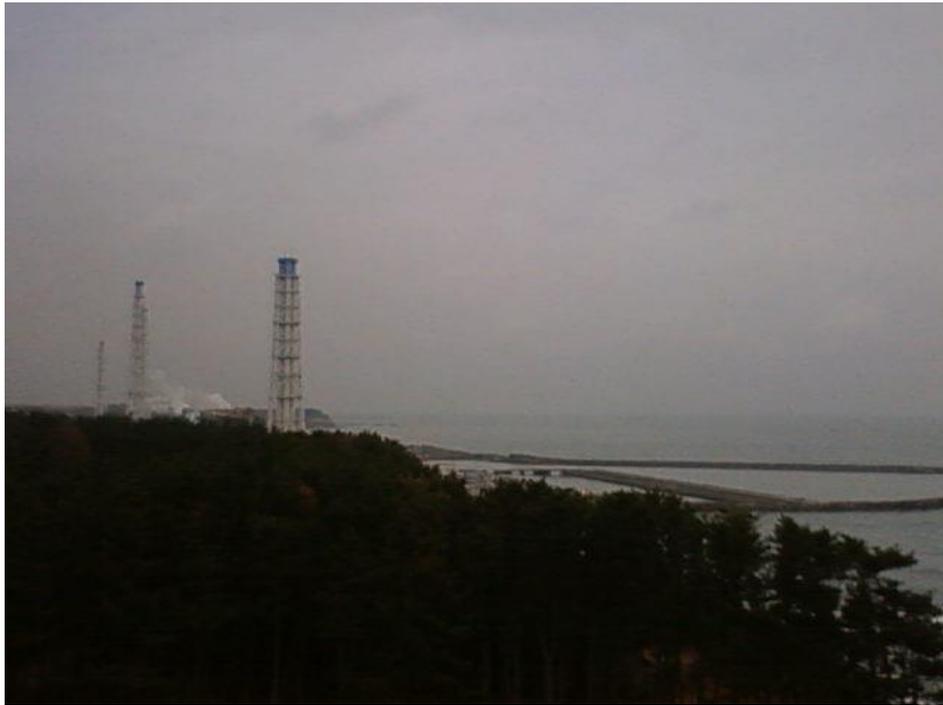
Figure 6 shows photos by the live camera at 16:00 on March 15th. At this timing, steam release from the Unit-3/4 stack cannot be recognized, but from the enlarged photos around the R/Bs, steam release, probably from the top of R/B of an unknown unit, can be recognized.

Figure 6 Photos by the live camera at the Fukushima Daiichi NPS (taken at 16:00 on March 15th) (Top: Full screen view of the live camera, Center: Enlarged Unit-3/4 stack, Bottom: Enlarged R/B surroundings)

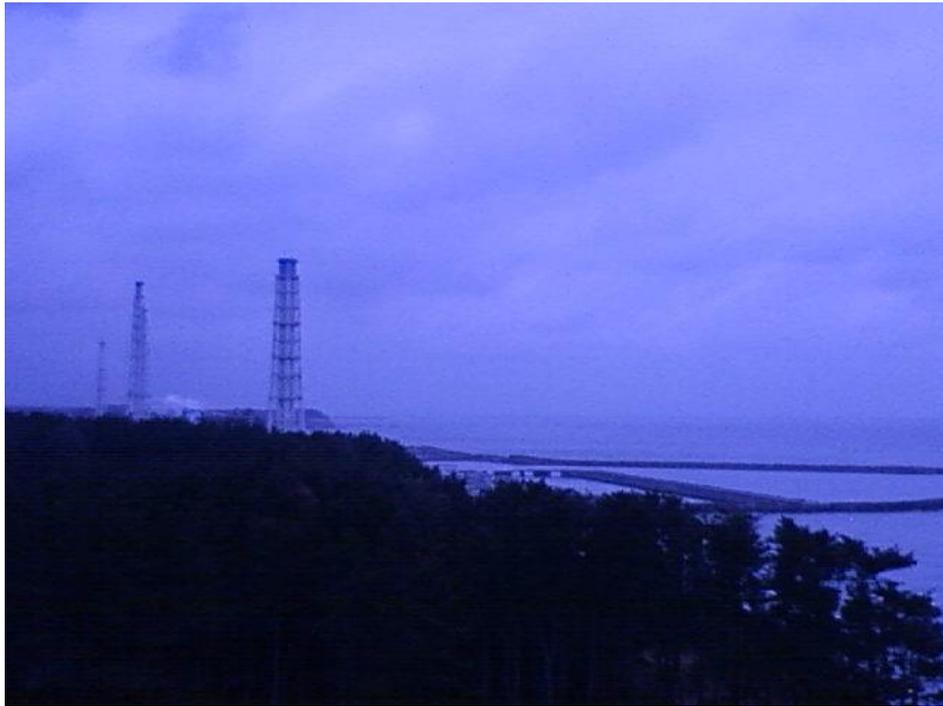
Figure 7 shows photos by the live camera at 17:00 on March 15th. In the records, the small generator for opening operations of vent valves was replaced and opening operation was done for the fifth time, but no clear steam release can be recognized in the live camera photos. Like in the photos at 16:00 (Figure 6), steam release, probably from the top of an R/B, can be recognized.

Figure 7 Photos by the live camera at the Fukushima Daiichi NPS (taken at 17:00 on March 15th) (Top: Full screen view of the live camera, Center: Enlarged Unit-3/4 stack, Bottom: Enlarged R/B surroundings)

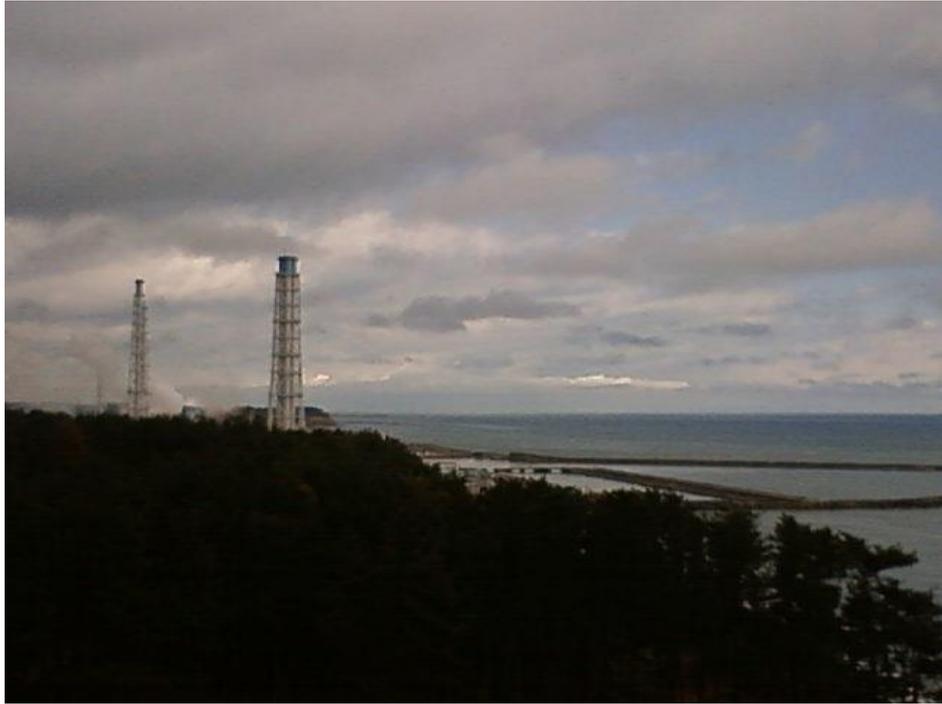
Figure 8 shows photos by the live camera at 10:00 on March 16th. At this timing, steam release from the Unit-3/4 stack cannot be recognized yet. But steam release probably from the top of an R/B can be recognized. In the earlier photos, the shape of the RW/B was clearly visible, but at this timing the RW/B was partially invisible due to the released steam. Therefore, the steam released at this timing from the R/B, i.e., leaks from PCV, can be considered as significantly large scale.

Figure 8 Photos by the live camera at the Fukushima Daiichi NPS (taken at 10:00 on March 16th) (Top: Full screen view of live camera, Center: Enlarged Unit-3/4 stack, Bottom: Enlarged R/B surroundings)

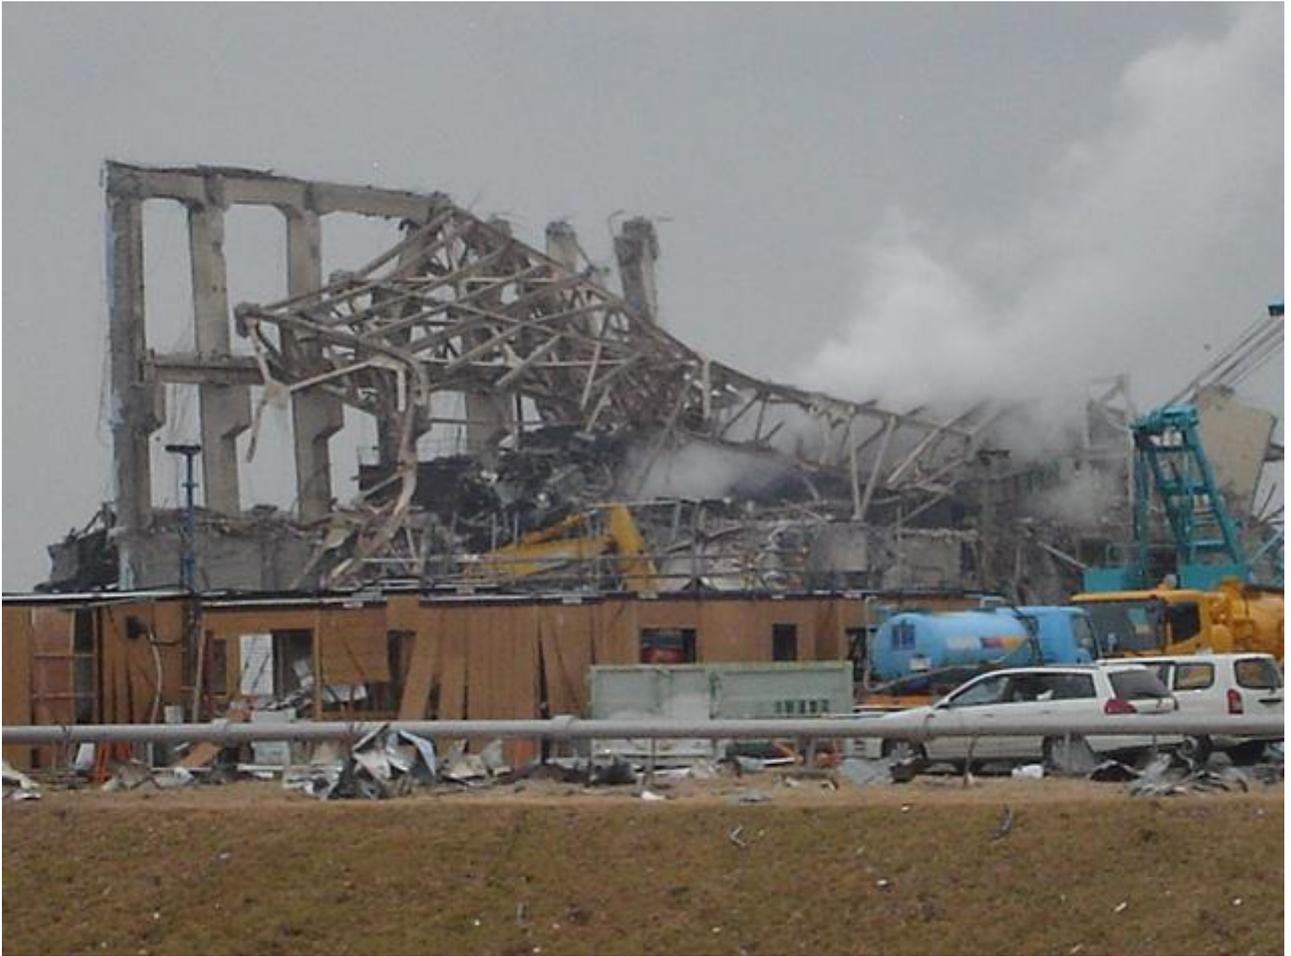
Figure 9 shows a photo taken by a digital camera in the morning of March 15th. It confirms that steam release from the top of Unit-3 R/B had started by this timing. The photo by the live camera at 07:00 on March 15th (Figure 5) also shows steam release. Therefore, the date information in the digital camera photo is roughly correct.

Figure 9 Steam release from Unit-3 (photographed at 07:31 on March 15th)

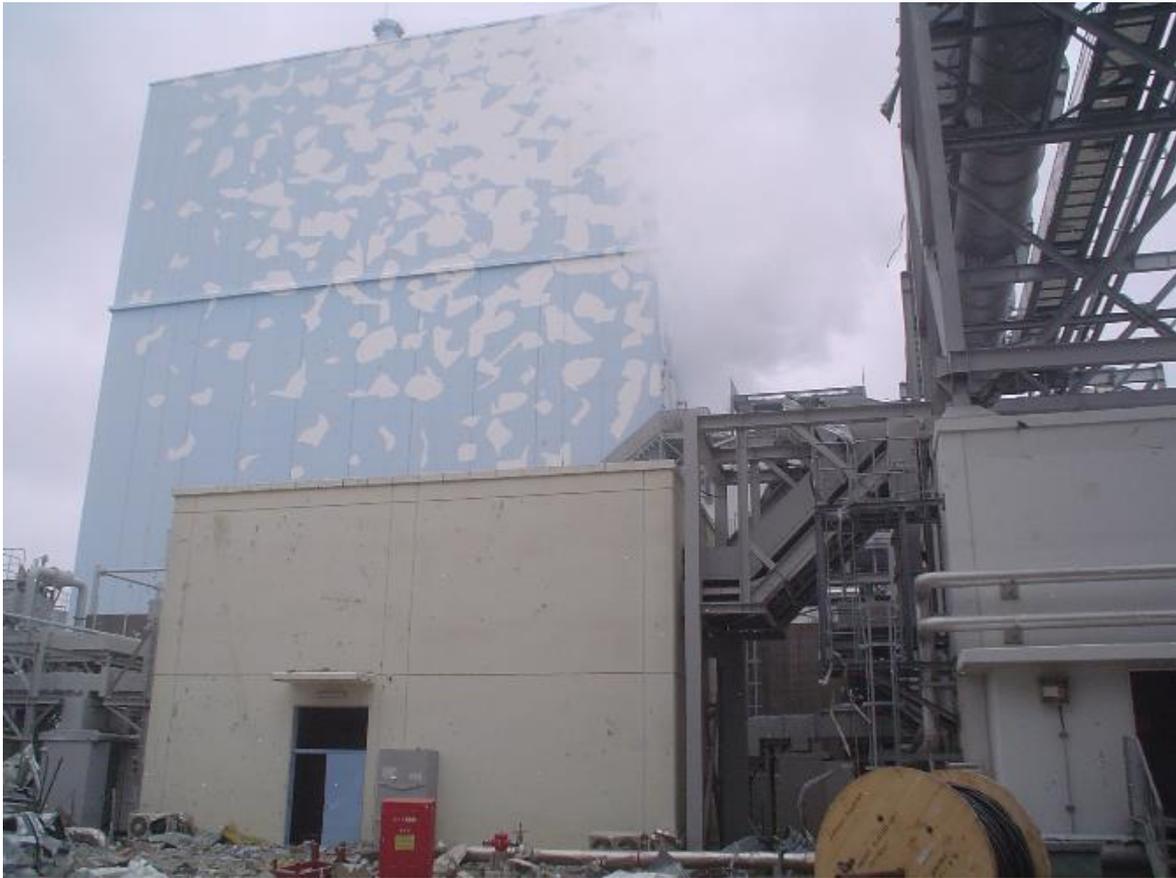
Figure 10 shows a photo of the Unit-2 R/B taken in the morning of March 15th. It is known that the blowout panel of the Unit-2 R/B opened at the time of the Unit-1 R/B hydrogen explosion and steam was being released through this blow-out panel. It is reported in Reference [1], too, that white smoke (like steam) was confirmed to be rising at 08:25 on March 15th from around the 5th floor of the Unit-2 R/B. Therefore, this date information can be regarded as roughly correct.

Figure 10 Steam release from Unit-2 (photographed at 08:58 on March 15th)

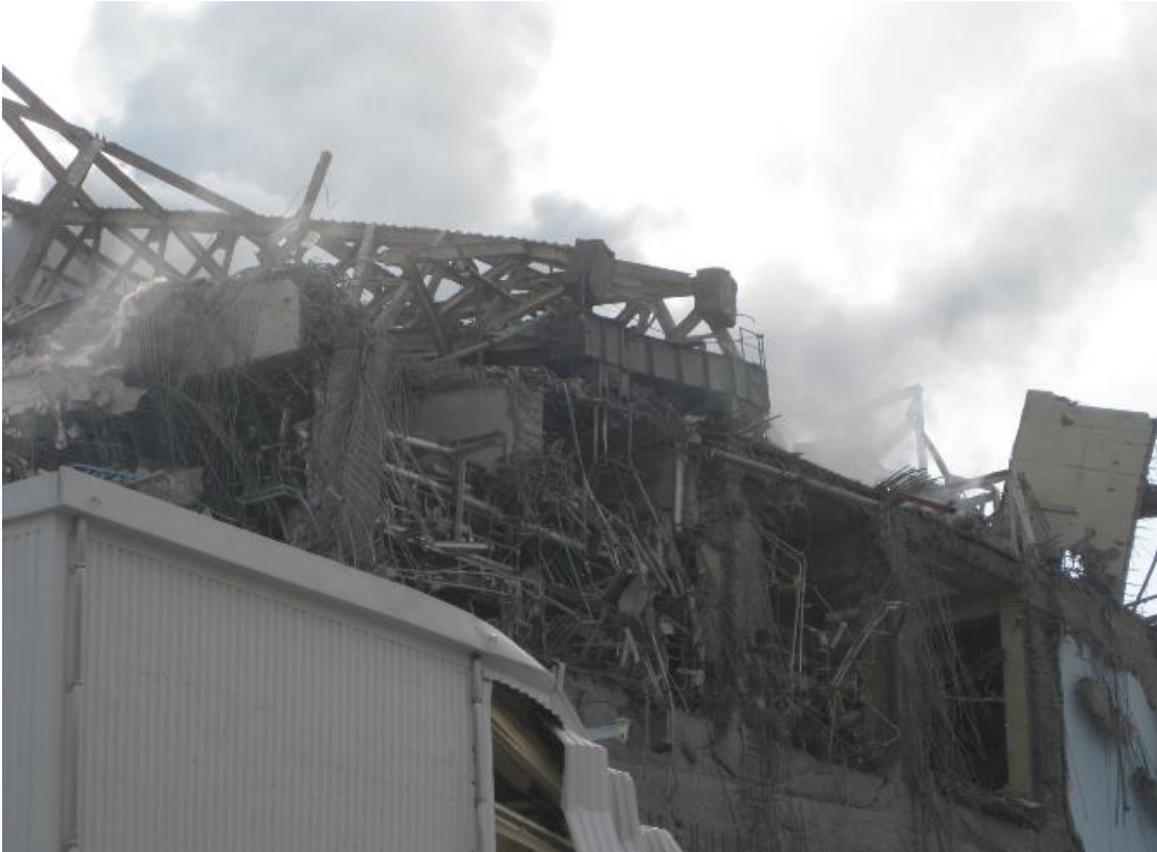
Figure 11 shows a photo taken in the morning of March 16th. It confirms that the steam release from the top of the Unit-3 R/B was still continuing. The amount of steam being released seems larger than that on the previous day. This is consistent with the live

Figure 11 Steam release from Unit-3 (photographed at 09:51 on March 16th)

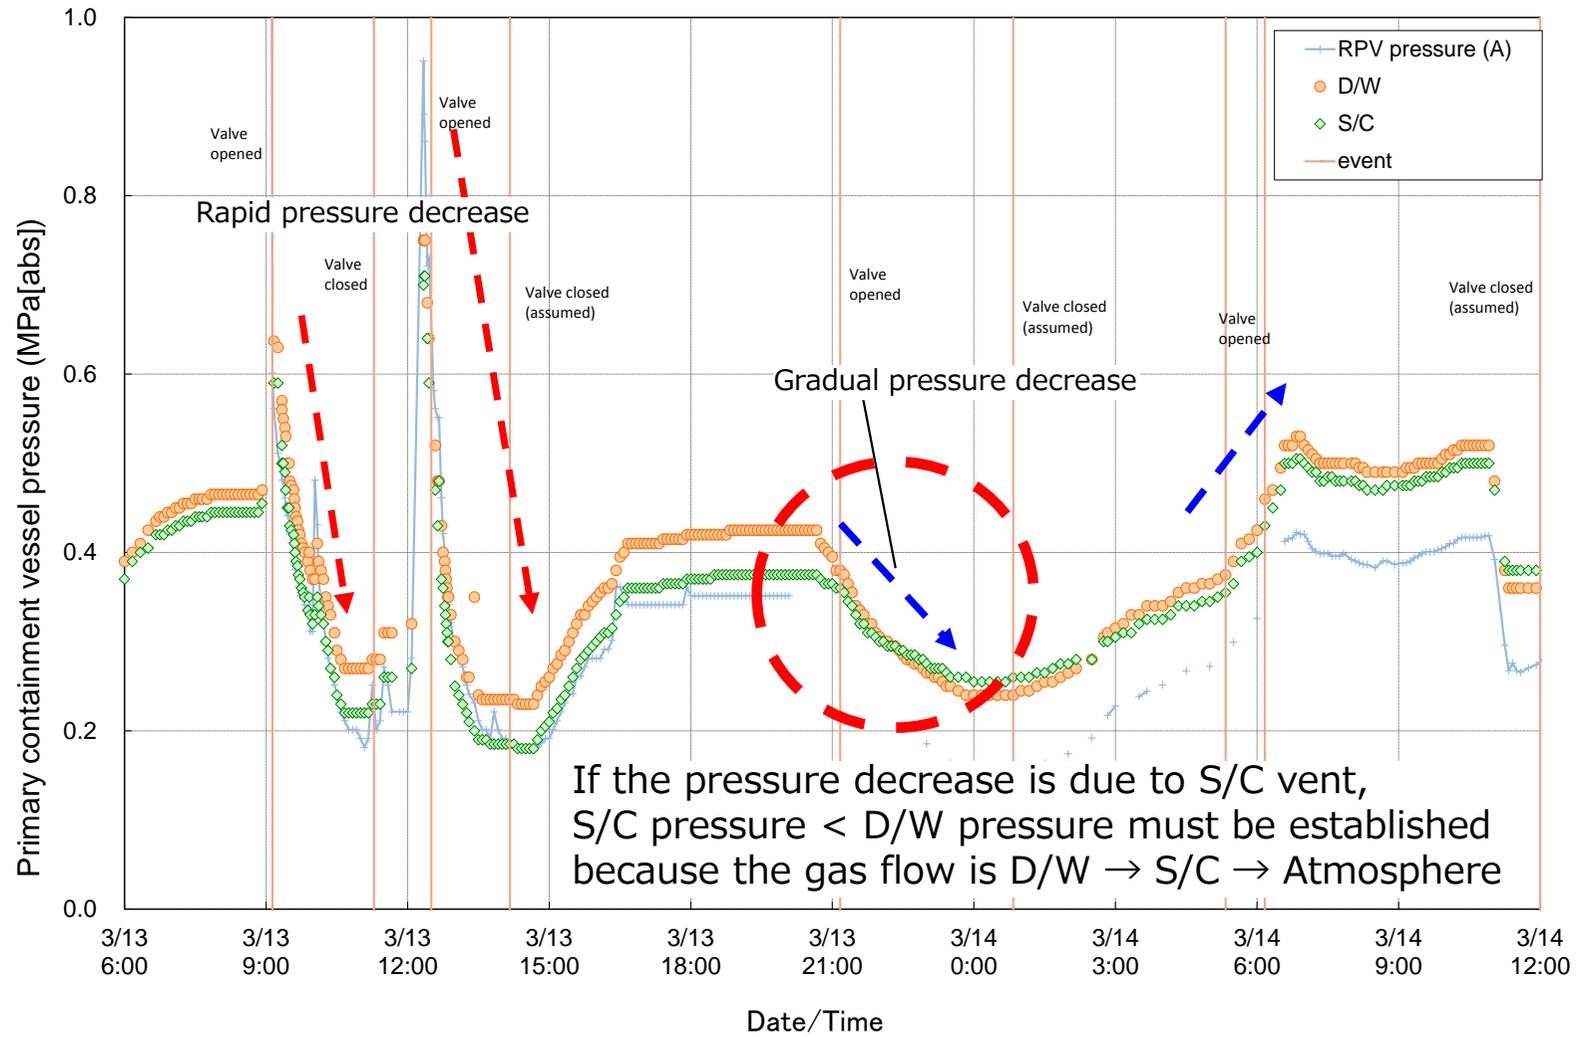
Figure 12 PCV pressure changes at Unit-3 (from 06:00 on March 13th to 12:00 on March 14th)

Figure 12 presents the PCV pressure changes over this time span. At Unit-3, the high pressure coolant injection system (HPCI) lost its water injection function before its manual shutdown (Attachment 3-3). Therefore, it is interpreted that the core was damaged by about 05:00 on March 13th and a large amount of hydrogen gas was being generated. This means the continuous PCV pressure increase till just before 09:00 is considered to be due to the inflow of non-condensable hydrogen gas into the PCV. At about 09:00 when the reactor was depressurized, the hydrogen gas in the reactor vessel was instantly released to the PCV and the PCV pressure increased high enough to activate rupture discs for venting.

At this first (1st) venting, the PCV pressure dropped fairly rapidly, about 0.4MPa in 90 minutes, that is, from 0.637MPa(D/W) and 0.590MPa(S/C) at 09:10 to 0.270MPa(D/W) and 0.220MPa(S/C) at 10:40.

At the second (2nd) venting, too, the PCV pressure dropped fairly rapidly, about 0.5MPa in 75 minutes, that is, from 0.750MPa(D/W) and 0.700MPa(S/C) at 12:20 to 0.235MPa(D/W) and 0.190MPa(S/C) at 13:35. The vent valves were judged based on the

From 19:00, at the mid-point of this time span, temporary compressors were connected for driving vent valves upon observing the PCV pressure increase. When the D/W pressure decreased at about 21:10, the vent valves were concluded to have opened (3rd venting). The PCV pressure decrease this time was very slow when compared with those of the 1st and 2nd vents: about 0.2 to 0.15MPa in 200 minutes from 0.425MPa(D/W) and 0.375MPa(S/C) at 20:40 to 0.240MPa(D/W) and 0.255MPa(S/C) at 24:00.

The relation between the D/W pressure and S/C pressure should draw more attention. At this timing the heat source is considered to exist in the D/W. It is reasonable, therefore, that the D/W pressure is higher than the S/C pressure. If gases are vented via the S/C, the gases move from the D/W to the S/C and then are released from the stack. In order to move gases from the D/W to the S/C, some pressure difference is required for the water to spill over in the S/C downcomer pipe. It is physically reasonable that there is a difference of about 0.05MPa between the D/W and S/C pressures until about 21:00. But, the pressures were reversed at 22:30 as 0.285MPa(D/W) and 0.290MPa(S/C) and at 24:00 the S/C pressure exceeded that of the D/W by 0.015MPa. If the PCV pressure had decreased by venting, gases must have moved from lower pressure points to higher pressure points, which is physically impossible.

It would be more natural, therefore, to interpret as follows: the cause of the PCV pressure decrease at the occasion assumed as the 3rd venting should be shifted to the D/W side, not by venting. Leaks from the D/W would be most probable from the PCV upper head due to deterioration of seal materials by the high temperature environment.

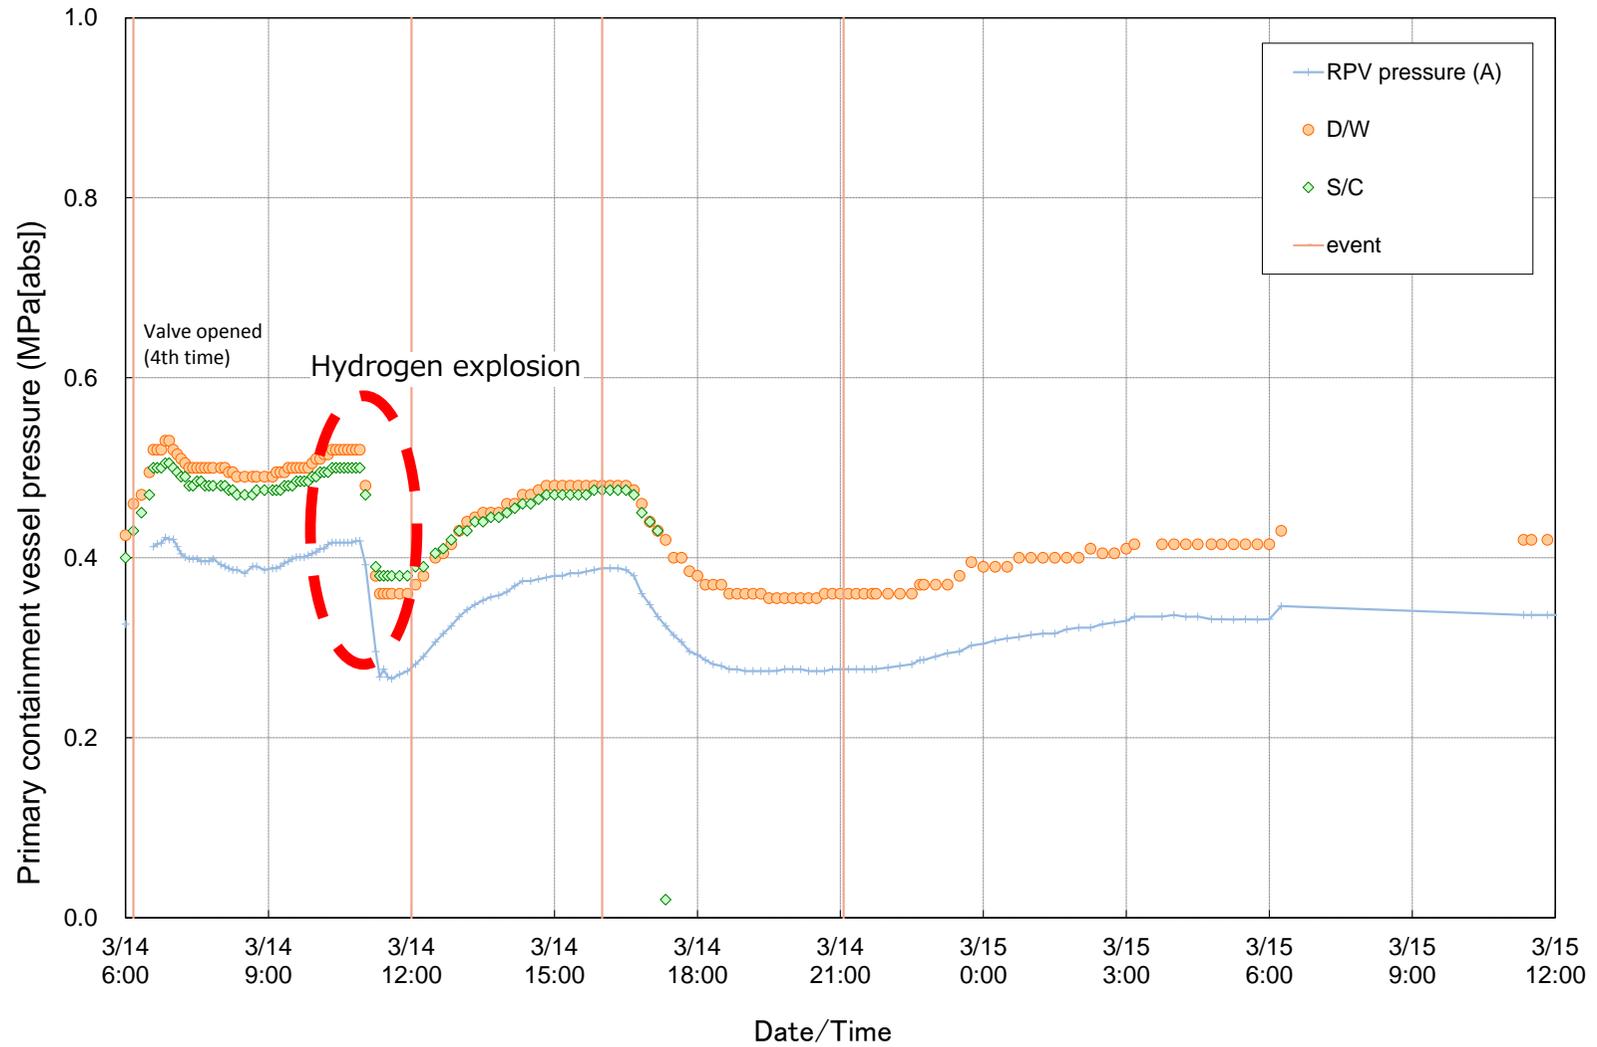
Figure 13 PCV pressure changes at Unit-3 (from 09:00 on March 14th to 12:00 on March 15th)

The pressure changes over this time span are shown in Figure 13. During this period, Unit-3 experienced the hydrogen explosion at 11:00 on March 14th. This explosion occurred due to the hydrogen gas leaked to the R/B. It is consistent with the actual accident progression to assume that the leak from the PCV to the R/B started by the time of the 3rd vent operation.

It should be noted that the PCV pressure dropped largely at the hydrogen explosion occurrence. The reason of this pressure decrease is not clarified. The D/W and S/C pressures are reversed again. If leaks occurred from the PCV, it would be from the D/W.

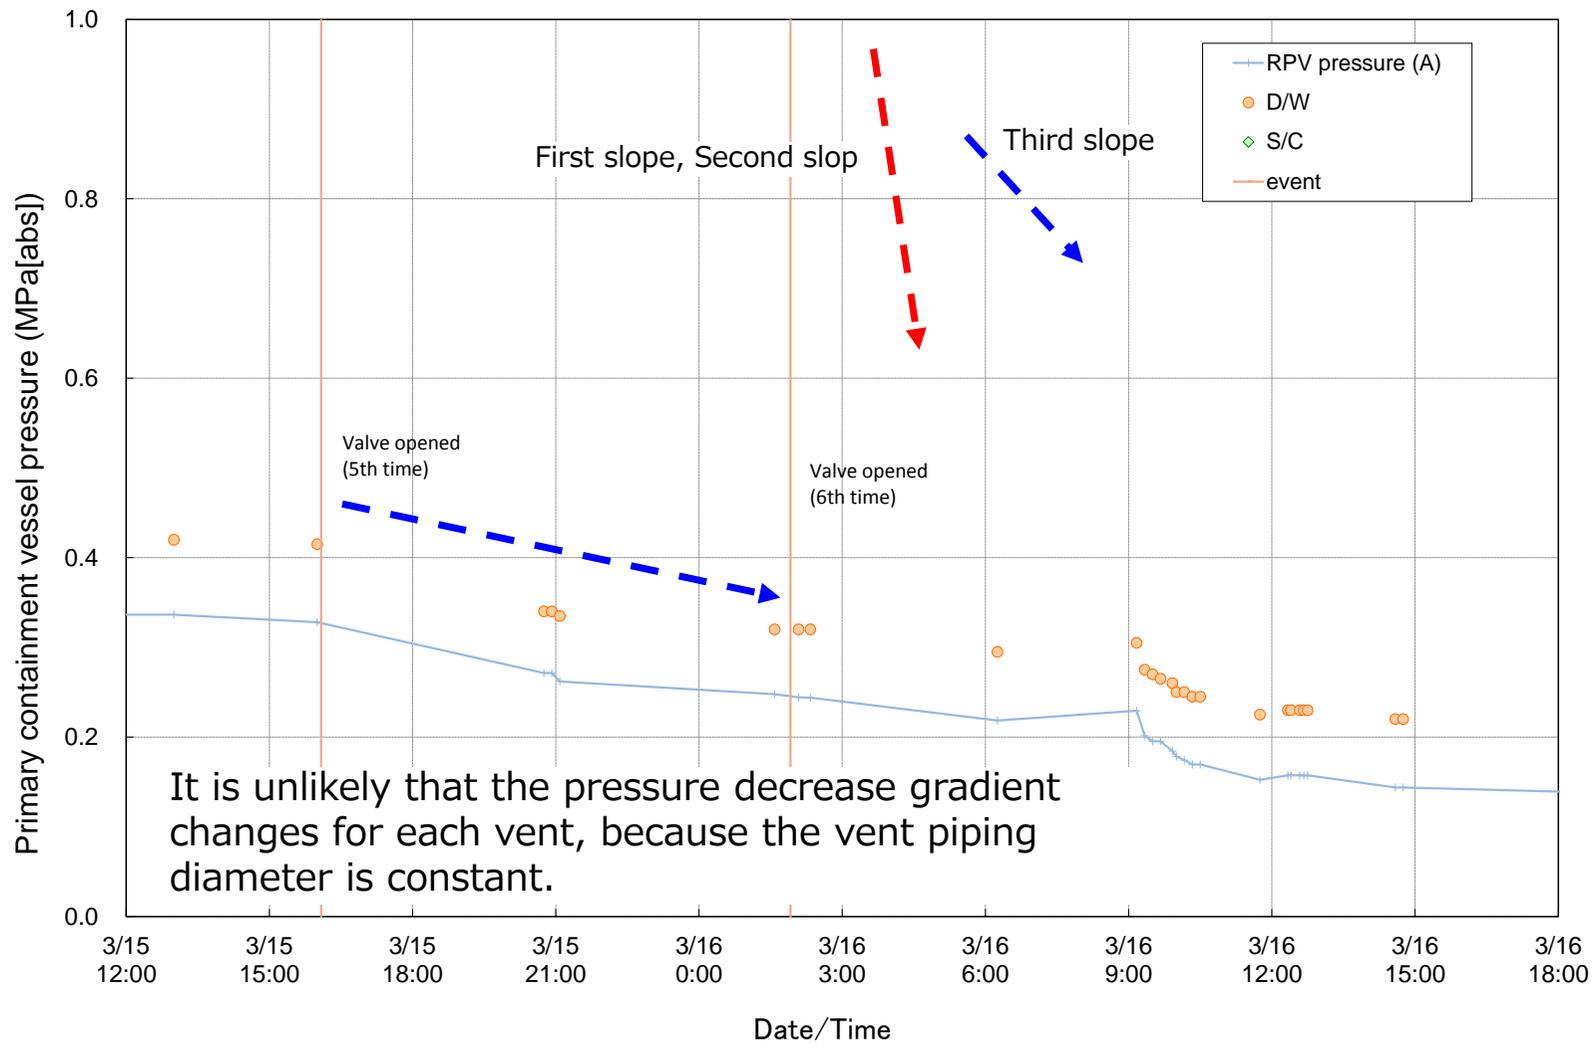
Figure 14 PCV pressure changes at Unit-3 (from 12:00 on March 15th to 18:00 on March 16th)

The pressure changes over this time span are shown in Figure 14. During this period, the 5th vent operation was implemented according to the records. The relevant part of Annex 2 to Reference [1] is cited below.

Although the opening operation of vent valves was taken, the result is not clarified. As a matter of fact the PCV pressure decrease of about 0.1MPa during 5 hours was lower than the anticipated rate by venting: from 0.415MPa(D/W) at 16:00 to 0.335MPa(D/W) at 21:05, although no data are available for the S/C pressures. From the morning of March 15th, steam release was continuously recognized from the top of Unit-3 R/B as shown in Item 2 above. Therefore, the PCV pressure decrease of this low rate probably comes from the direct release from the PCV.
