# “Development of a technology to investigate inside the Reactor Primary Containment Vessel (PCV)”

- Site test “Investigation B1” on grating around the pedestal inside Unit 1 PCV -

April 15, 2015

Tokyo Electric Power Company

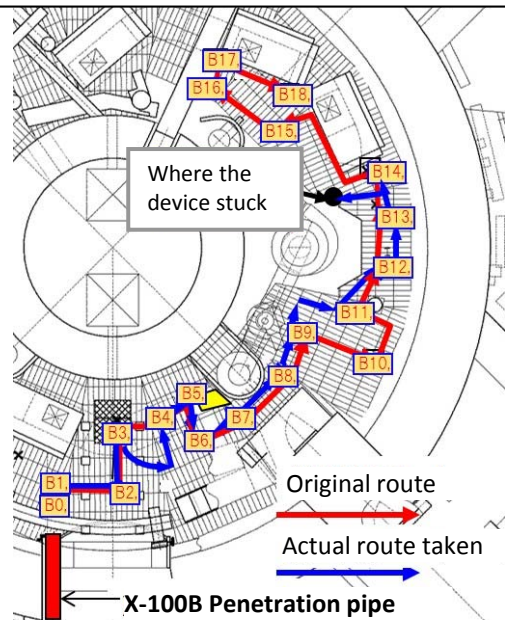
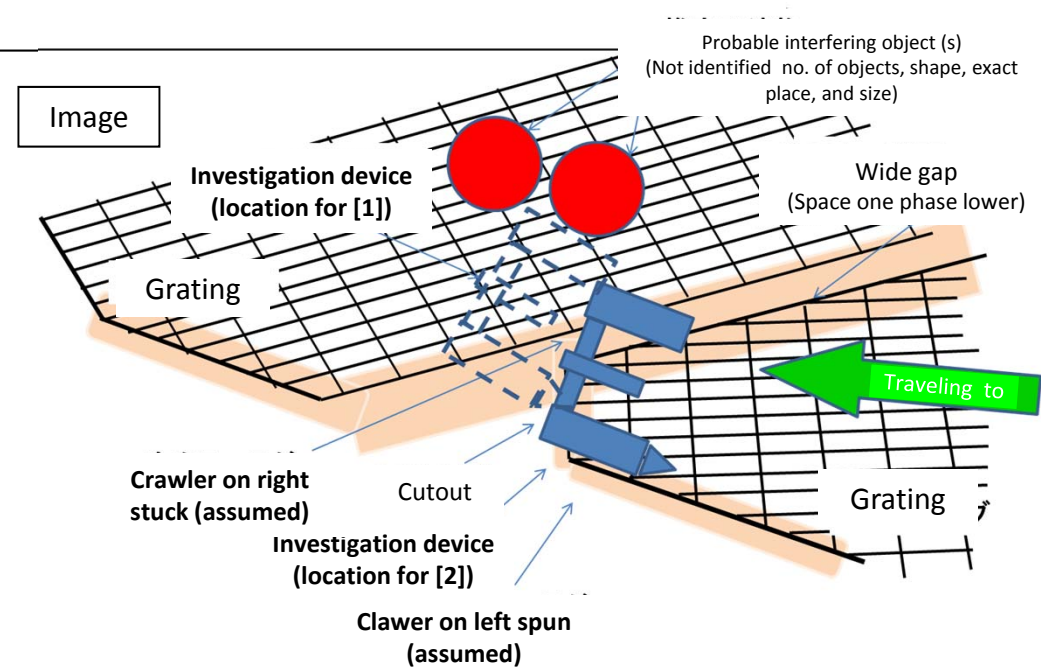
Through the investigation using mock-up, the following was found to be considered as a cause of the incident.

- [1] When the device was running through a narrow part of the route, one of its crawlers on the left side came off on the cutout portion of the grating.
- [2] After that, while struggling to get out of the spot, another crawler on the right side has also stuck in the gap between the joint parts of the grating.

The following countermeasures will be taken in a careful manner:

- At the investigation along the clockwise route, check constantly if there is a presence of fallen or interfering object, and the grating conditions in detail before proceeding further. When in doubt, stop the operation and study how to handle the situation.
- Also, given a knowledge through the investigation on the counterclockwise route that the robot can tolerate another few days in the radiation exposure inside the vessel, when there is any problem occurred with the device in running along the access route because of an interfering object, etc., stop the operation, discuss how to handle the problem and investigate the matter.
