## Construction to Return J Village and the Naraha Municipal Parking Lot to their Original Condition, and Dose Reduction Measures

## Restoration and decontamination work at Naraha town-managed parking lot

# Restoration work at J-Village and its surrounding areas

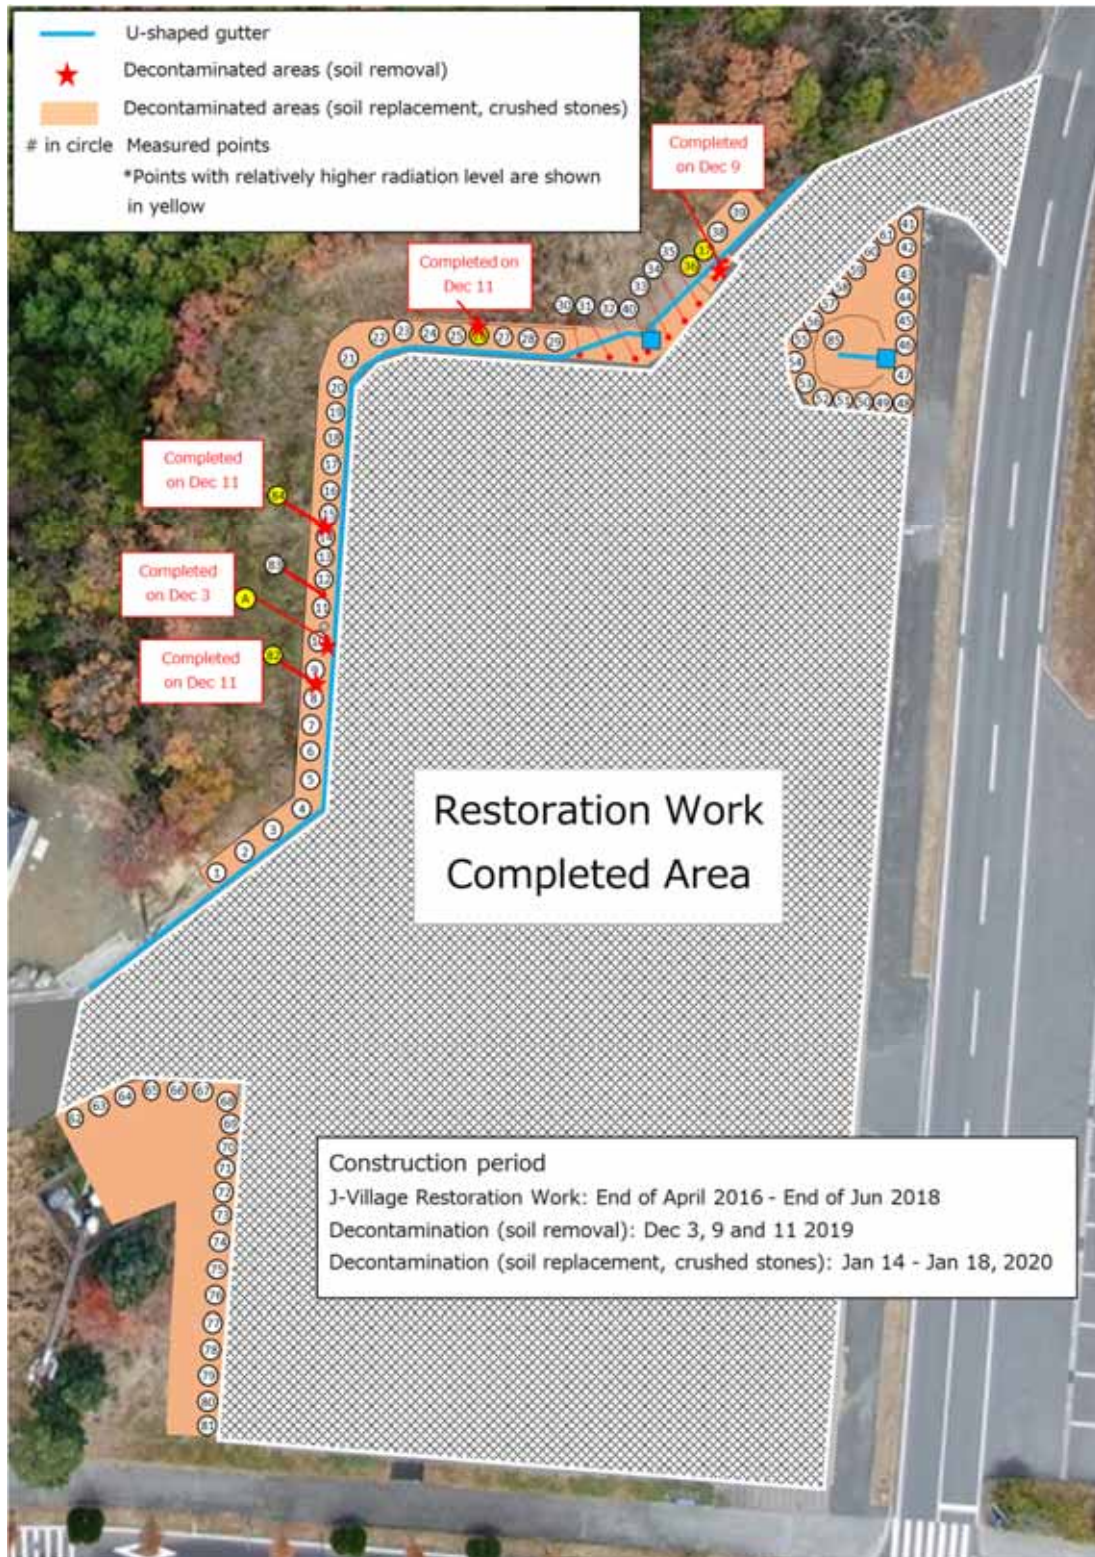
## Air dose rate before/after decontamination (soil removal)

Area	Before decontamination		After decontamination		Date of decontamination (MM/DD)
	( 1m above ground )	(1cm above ground)	( 1m above ground )	(1cm above ground)	
A	1.79μSv/h	70.2μSv/h	0.39μSv/h	0.44μSv/h	12/3
NO36	1.42μSv/h	11.20μSv/h	0.24μSv/h	0.19μSv/h	12/9
NO37	1.10μSv/h	7.57μSv/h	0.28μSv/h	0.28μSv/h	
NO26	0.46μSv/h	27.50μSv/h	0.23μSv/h	0.17μSv/h	12/11
NO82	0.57μSv/h	1.10μSv/h	0.22μSv/h	0.16μSv/h	12/11
NO84	0.45μSv/h	0.46μSv/h	0.30μSv/h	0.20μSv/h	12/11

64	0.18	0.26	20191210	0.10	0.10	20200114
65	0.16	0.24	20191210	0.11	0.11	20200114
66	0.15	0.23	20191210	0.12	0.12	20200114
67	0.14	0.24	20191210	0.12	0.11	20200114
68	0.18	0.44	20191210	0.13	0.16	20200114
69	0.20	0.41	20191210	0.14	0.14	20200114
70	0.19	0.86	20191210	0.14	0.17	20200114
71	0.21	0.40	20191210	0.13	0.14	20200114
72	0.19	0.38	20191210	0.13	0.15	20200114
73	0.18	0.32	20191210	0.14	0.13	20200114
74	0.17	0.33	20191210	0.13	0.14	20200114
75	0.17	0.26	20191210	0.14	0.12	20200114
76	0.22	0.69	20191210	0.15	0.24	20200114
77	0.24	0.88	20191210	0.15	0.18	20200114
78	0.25	0.69	20191210	0.12	0.17	20200114
79	0.24	0.53	20191210	0.12	0.12	20200114
80	0.21	0.44	20191210	0.11	0.13	20200114
81	0.17	0.31	20191210	0.10	0.11	20200114
82	0.57	11.00	20191210	0.15	0.14	20200118
83	0.40	1.70	20191210	0.15	0.13	20200118
84	0.45	12.00	20191210	0.16	0.14	20200118
85	0.90	3.25	20191210	0.20	0.19	20200118
	Relatively higher radiation level detected

- As noted in the announcement released on March 26, the construction consisted of relaying asphalt, and also laying new asphalt over old asphalt after it was cleaned with high-pressure water cleaners.
