< Reference document> September 19, 2024 Tokyo Electric Power Company Holdings, Inc. Fukushima Daiichi Decontamination & Decommissioning Engineering Company

Investigation status so far

Video converters and fiber-optic cables integrity check

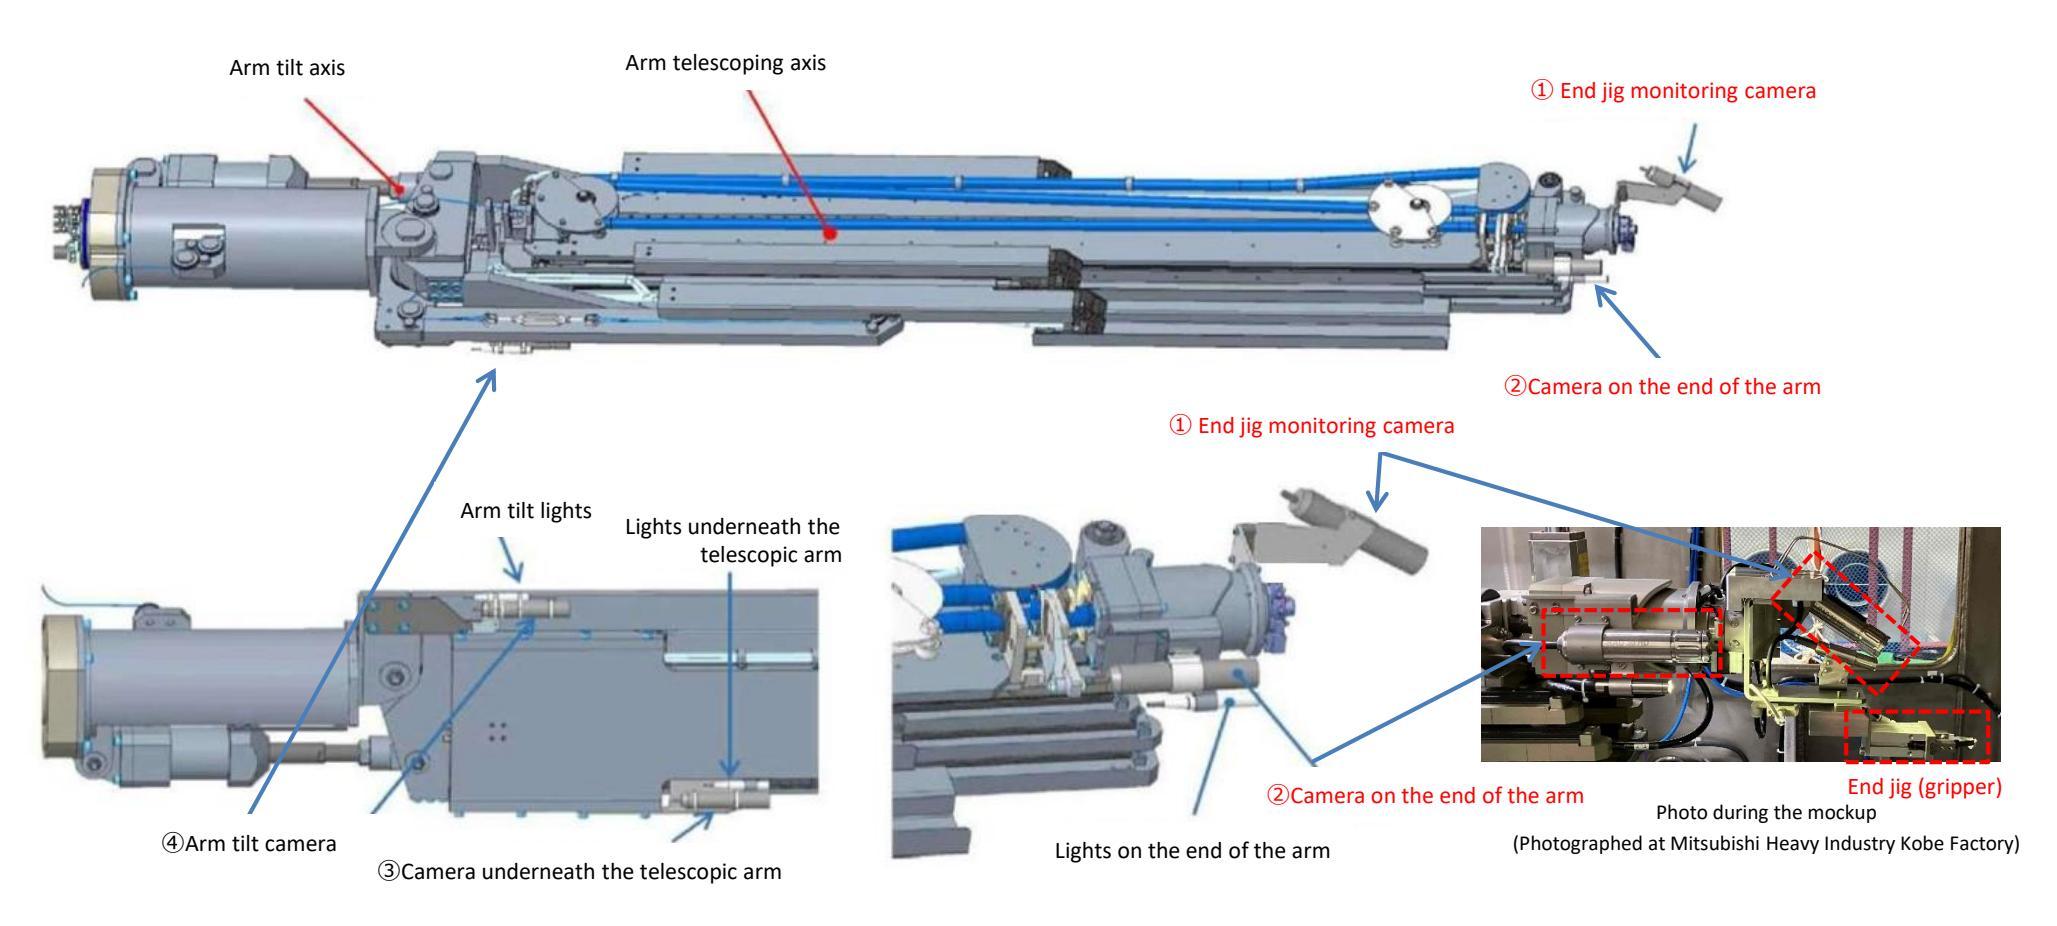
On September 17, as a preparation to grasp fuel debris, conditions inside the primary containment vessel was being checked and a functions check of the telescopic device was being performed. As a result, it was detected that footage from the cameras on the end of the telescopic device (1) End jig monitoring camera, 2) Camera on the end of the arm) was not being sent properly to the monitors in the remote operations room for some reason.

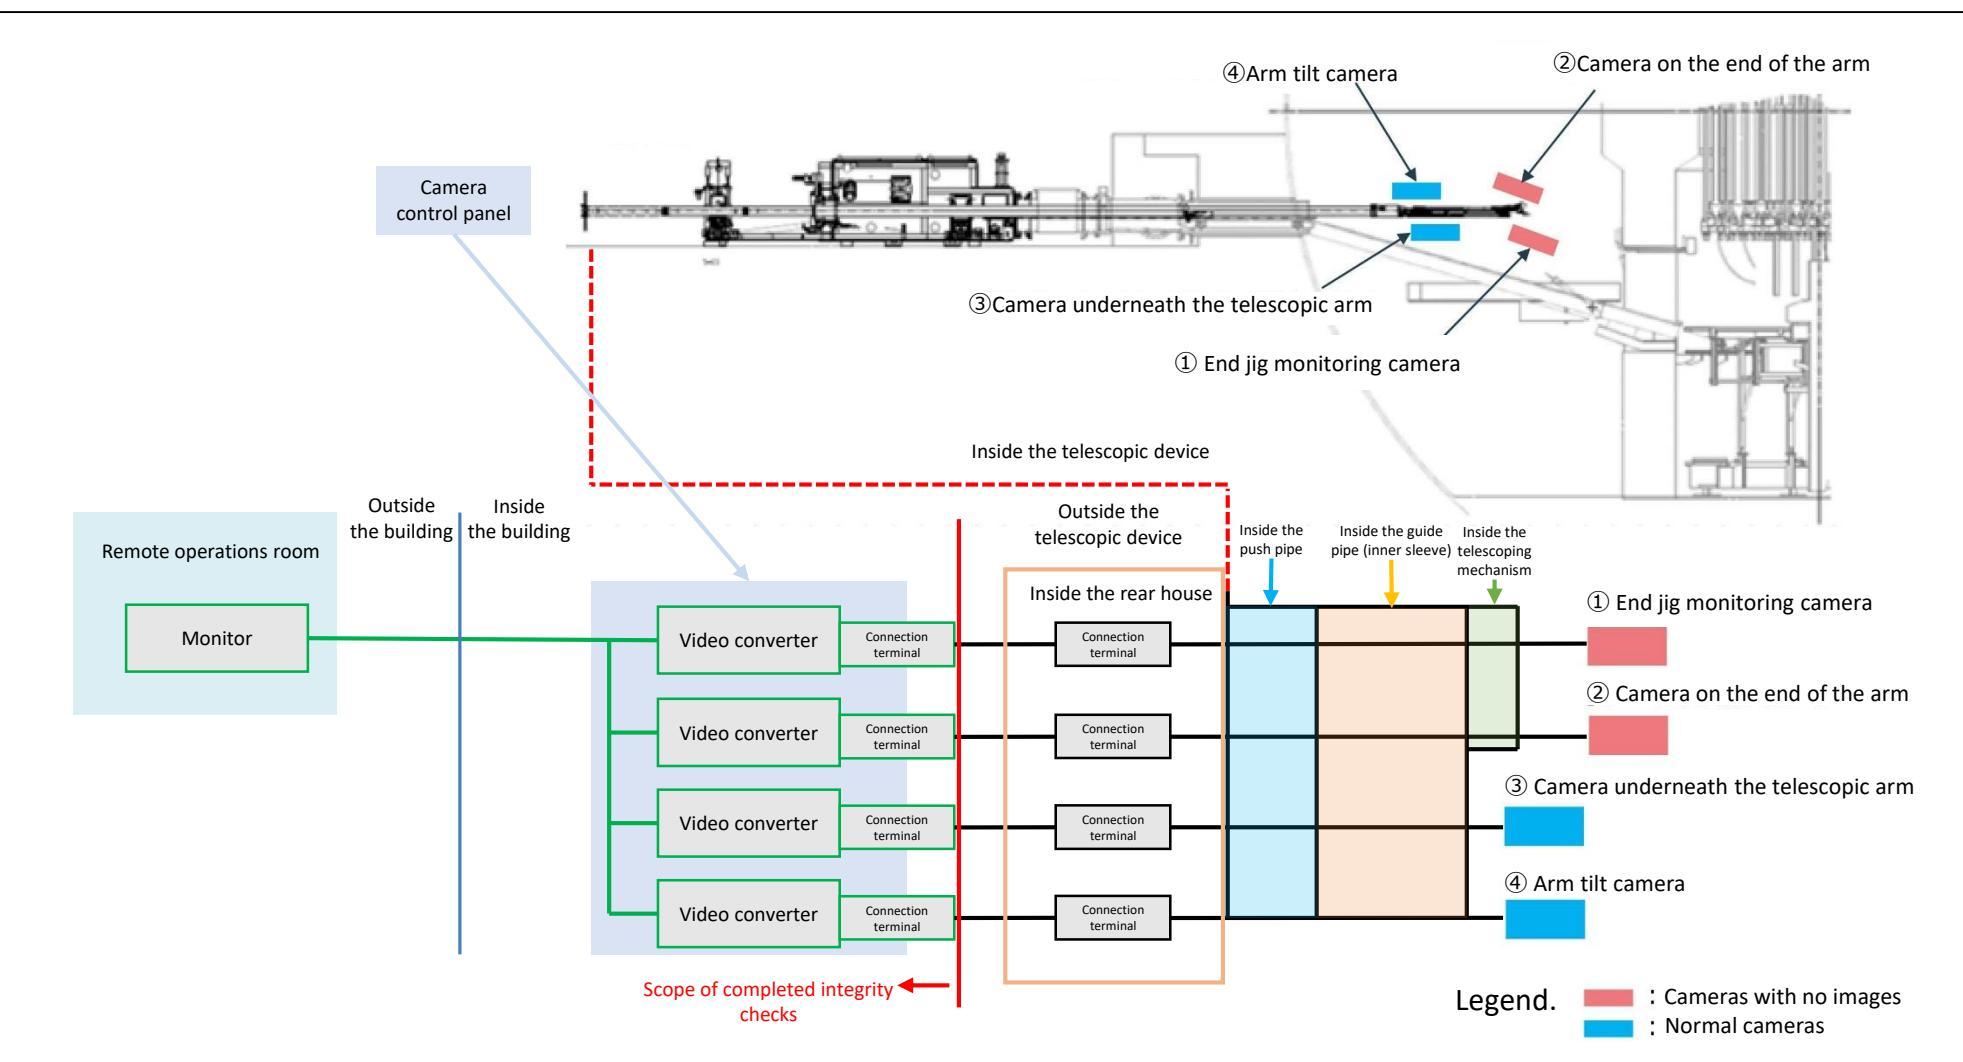
- In order to investigate the cause of this incident, we have been inspecting all camera cables, connection terminals, and the outside of the video converters by checking their exterior, signals and measuring insulation resistance.
- Going forward, we will check the video signals coming from the 2 camera on the end of the arm and 1 end jig monitoring camera, by using measuring instruments.

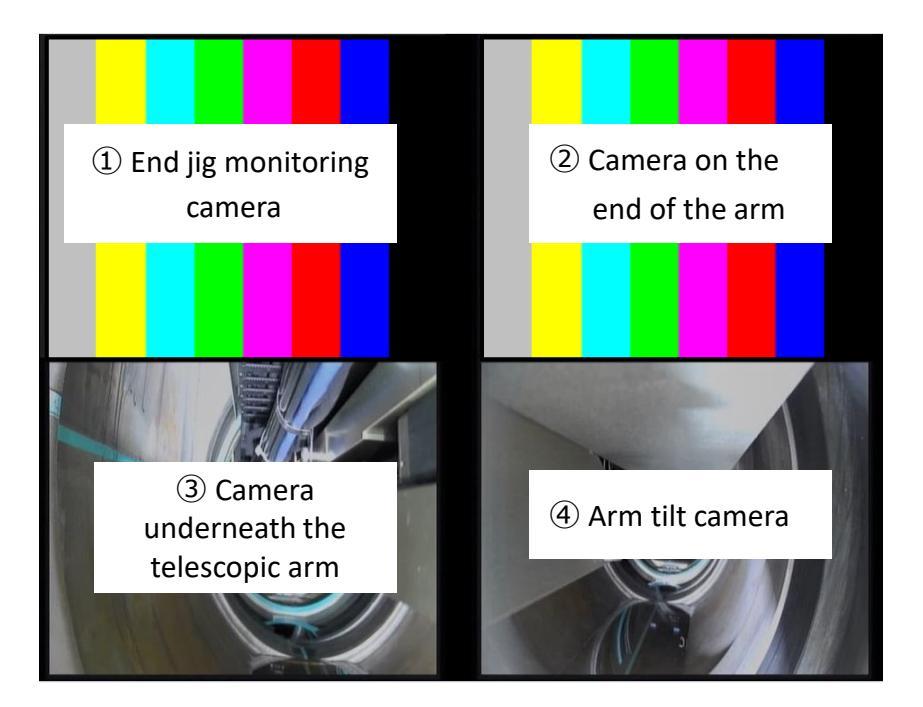
- On September 17, cameras ① and ② out of the four cameras attached to the telescopic device were not sending video to the monitors in the remote operations room, and only the color bar test pattern was displayed.

Prior to swapping video converter connections (reference photos)

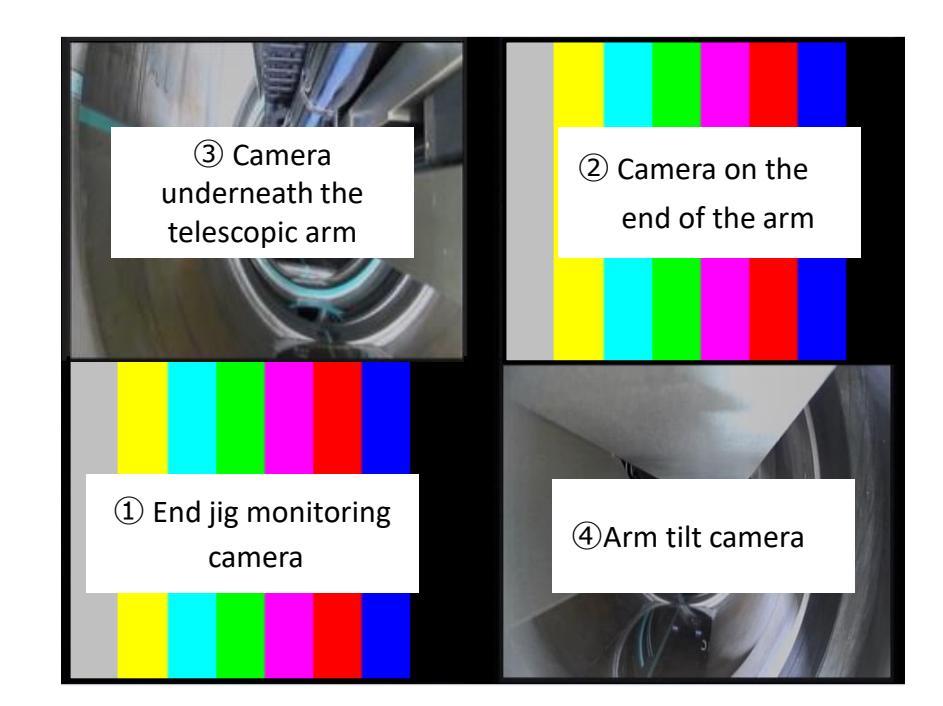
- When the connections to the four video converters for each of the cameras were switched (changed connections of ①and③), the monitors to which the problematic cameras were connected to displayed the color bar test pattern (refer to the images below) thereby confirming that there are no problems with signal wiring from the control panel in the reactor building to the remote operations room.

After swapping video converter connections (reference photos)
