# **Response to the Comments Received at the Eighth Meeting of the Committee for Monitoring and Evaluating the Specified Nuclear Facilities**

- Water Treatment Operation Plan Excluding the Use of the Underground Reservoirs**
- Usage of the Filtrate Water Tank in Response to the Disuse of the Underground Reservoirs**

April 19, 2013

Tokyo Electric Power Company

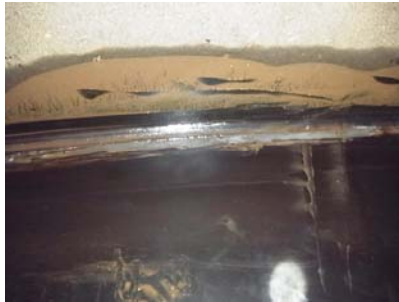
Paint coming off of the bottom plate

- For the areas with paint damages, the paint will be removed and repaired.
- For the corroded flanges, the flange surface will be cleaned and leakage prevention measure using repairing materials will be implemented.
- Detailed visual inspection and soundness evaluation will be performed on the areas with deformation.

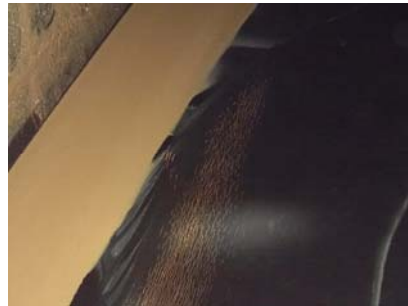
Paint cracks along almost all circumference

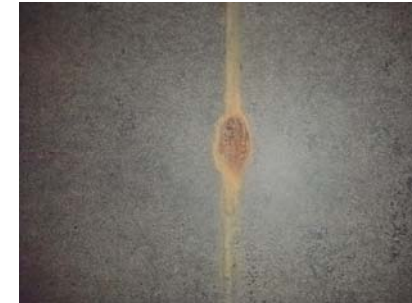
Paint bubbles in some locations of the side surface

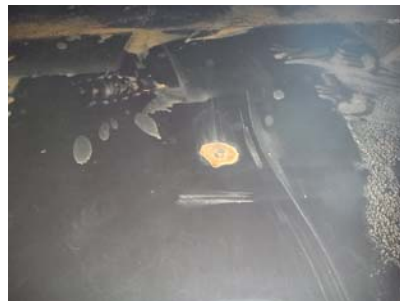
Paint bubbles in some locations of the bottom plate

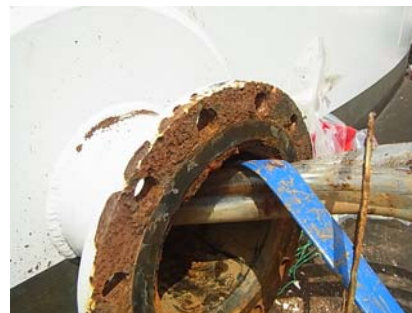
Corrosion of the spare nozzle flange

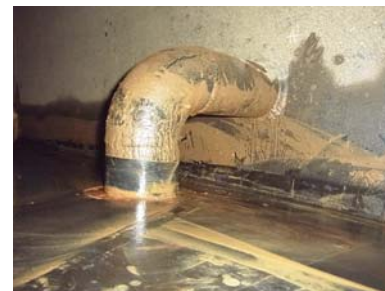
Trace of the drain pipe touching the bottom plate

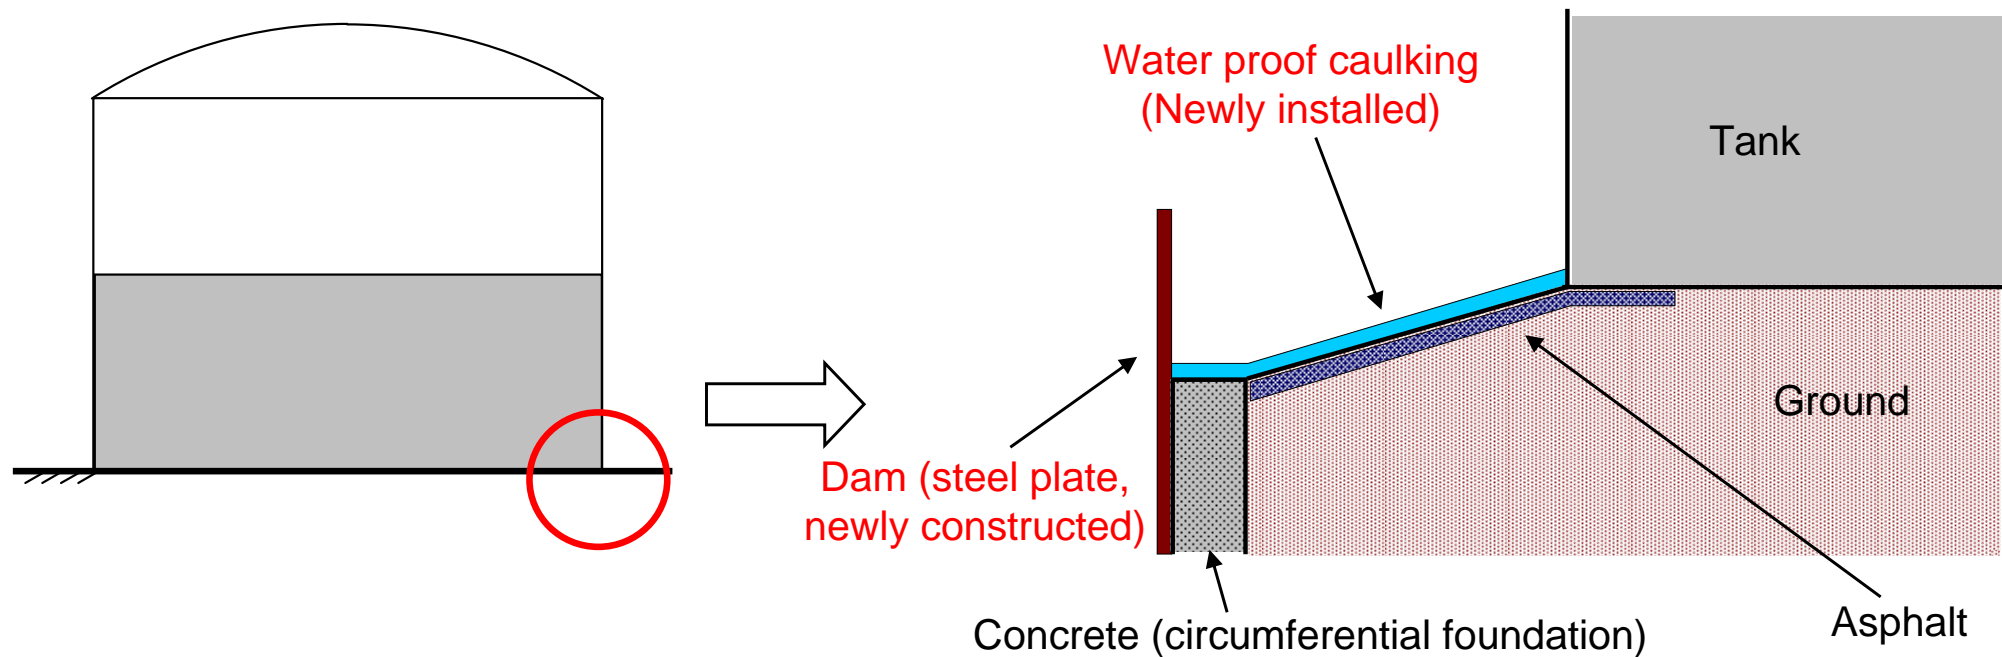
Dam to prevent leakage expansion (Draft)

- Considering that the filtrate tanks are welded structures, there is little possibility of leakage. However, a dam will be constructed around the tanks to ensure safety in the case of leakage.
