Duct Replacement at Unit 2 PCV Gas Control System at Fukushima Daiichi Nuclear Power Station

October 15, 2012 Tokyo Electric Power Company

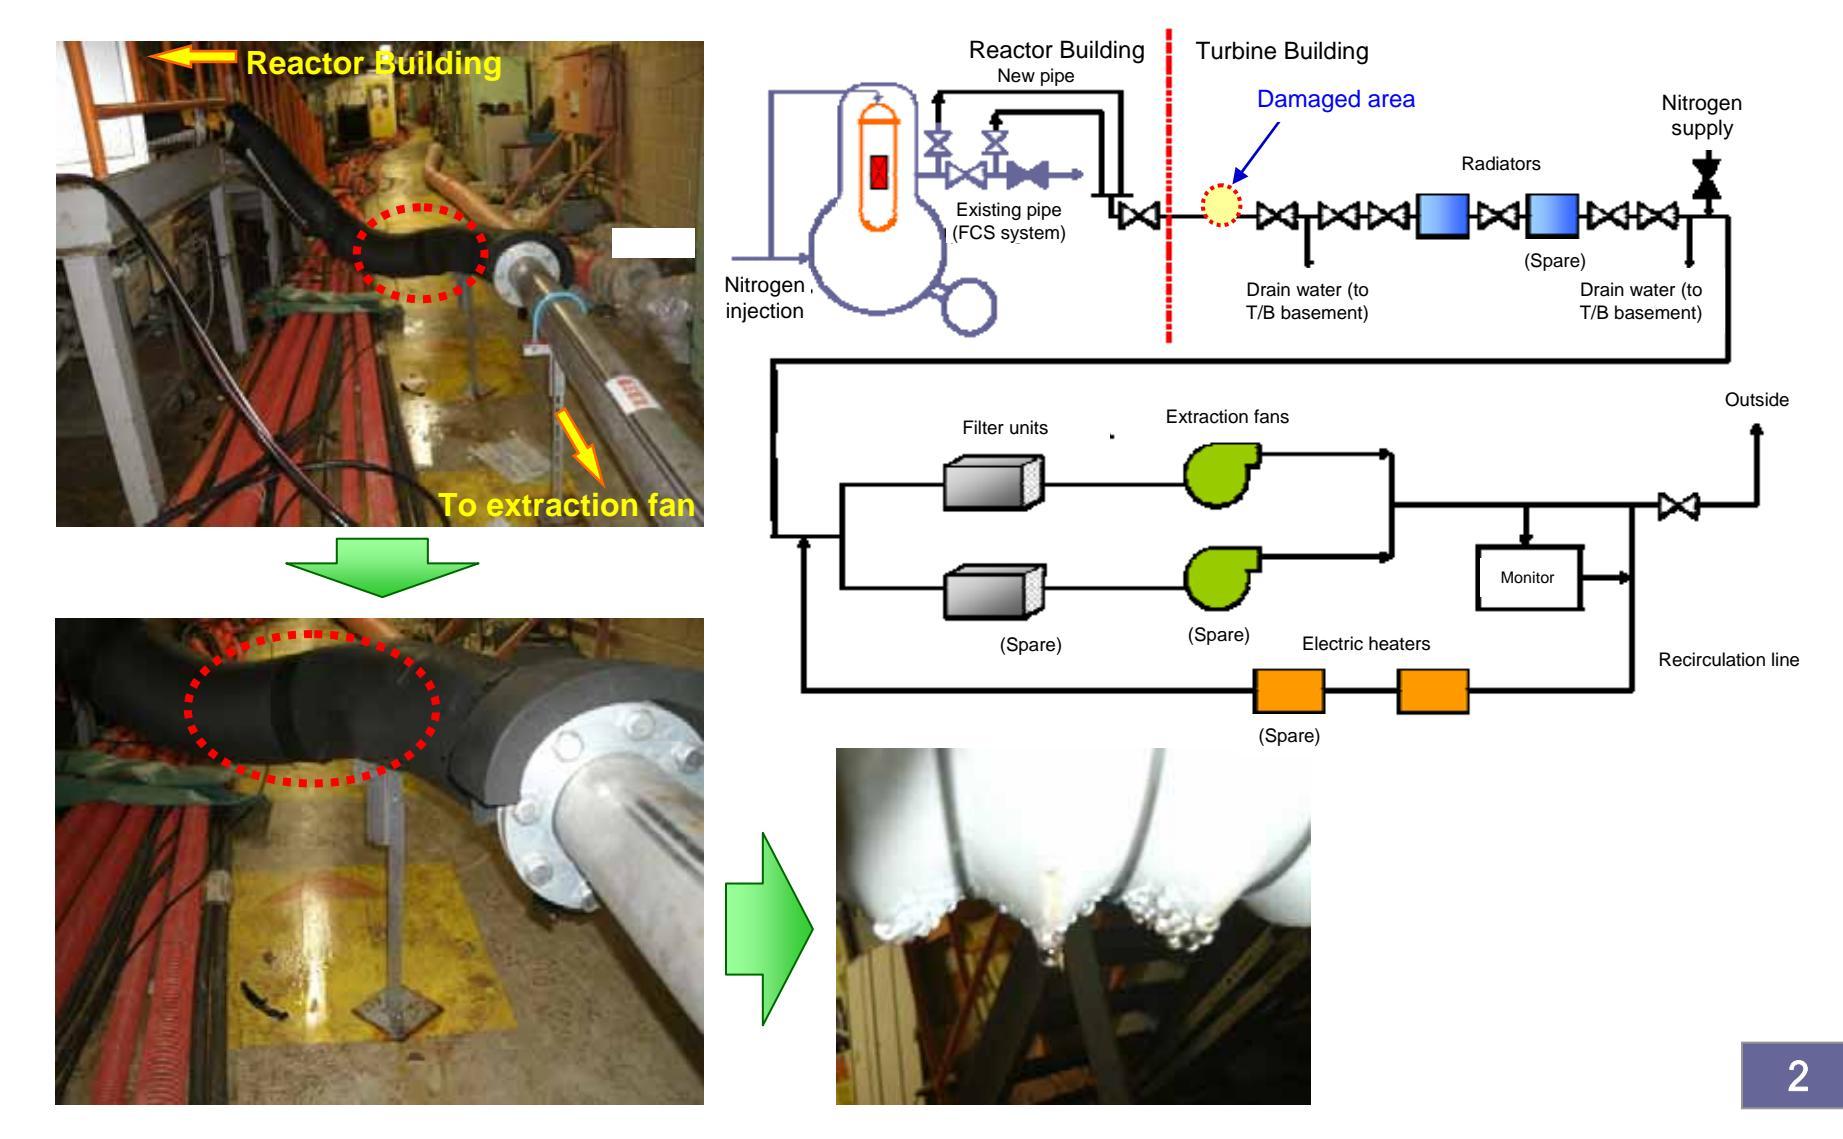
1. Duct damage

On September 9, 2012, a duct damage was found at Unit 2 PCV gas control system.

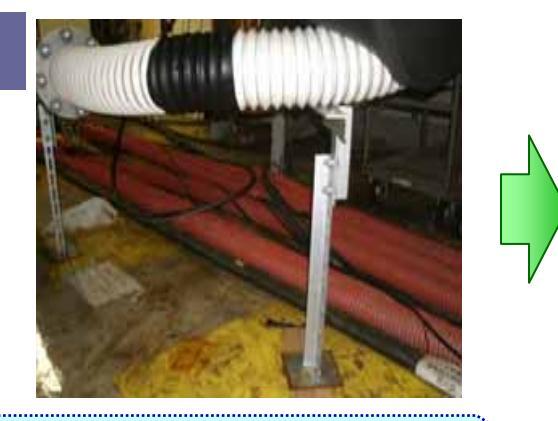
The damaged area was covered with duct tape to stop leakage

After covering up the damaged area with duct tape to stop leakage, protective material was put on top of it to repair the entire duct.

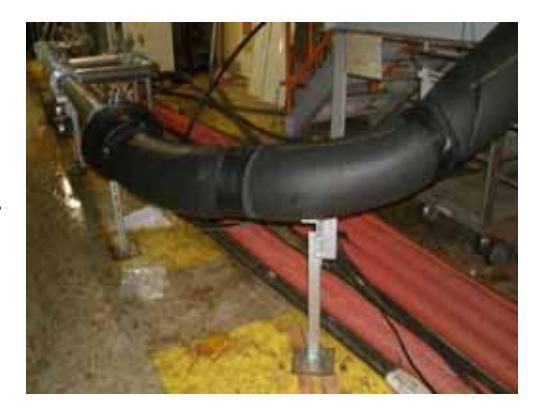
Protective material was put on top of it to repair the entire duct

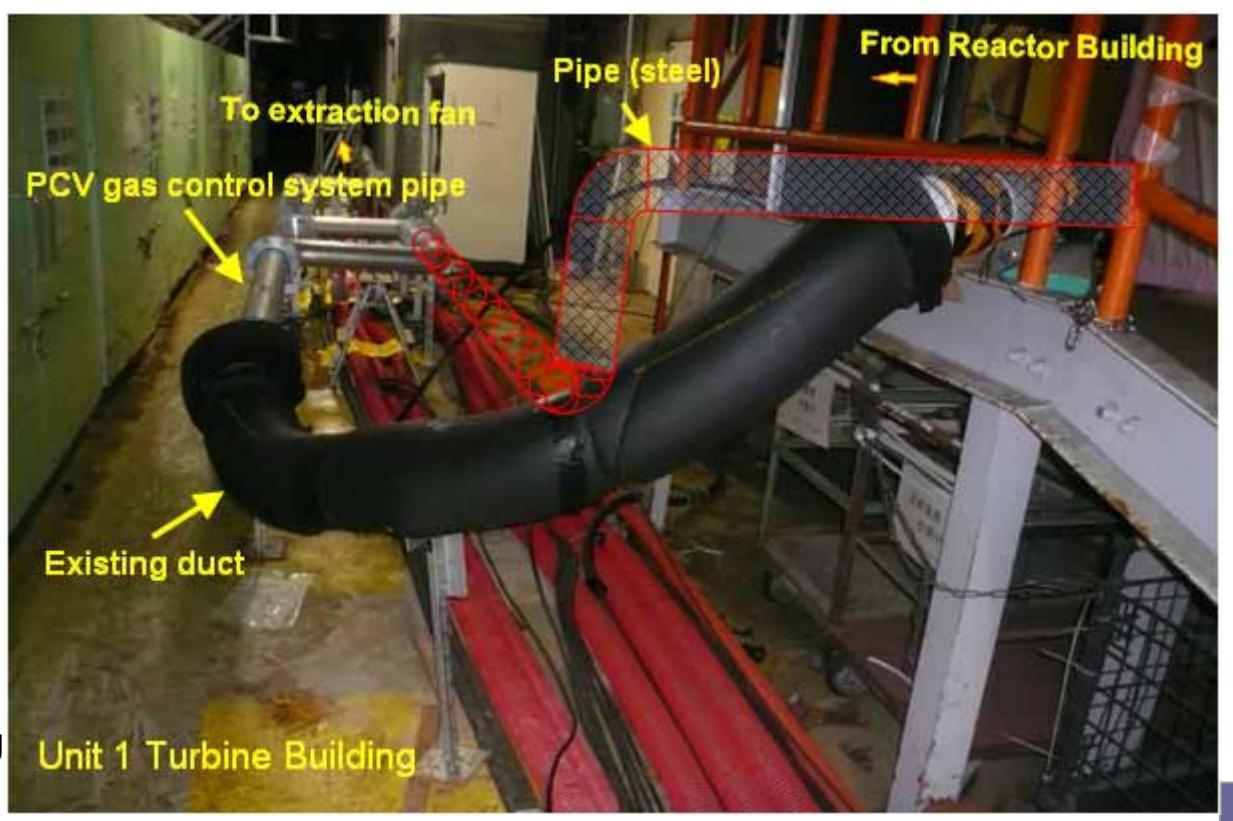
The additional radiation exposure dose at the site boundaries due to the system suspension (considering changes in hydrogen concentration and radioactive material emission) is estimated to be less than 0.0002mSv (assuming a system suspension of 24 hours).

The pipe will be replaced with stainless steel pipe. The PCV gas control system will be temporarily stopped for the replacement on October 16.
