Findings from the latest analyses using MAAP5

1. Latest analysis of Unit-1 by MAAP5.01

2. Latest analysis of Unit-1 by MAAP5.01

3. Latest analysis of Unit-3 by MAAP5.01

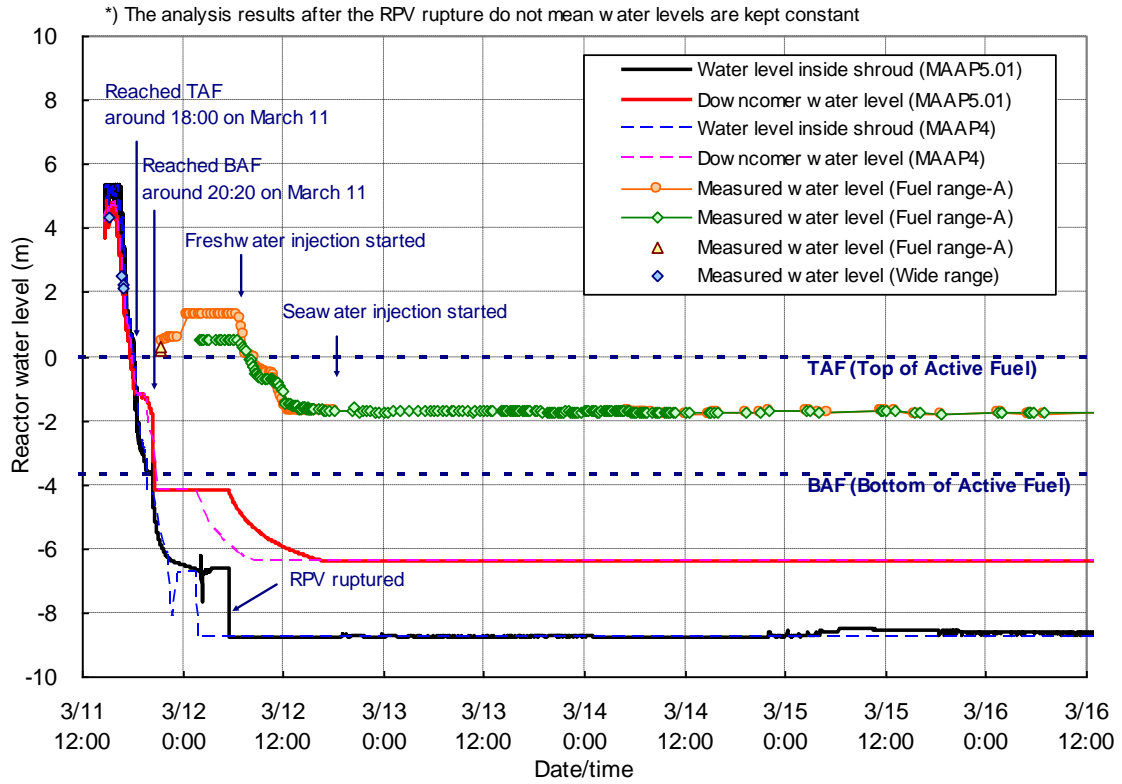
Figure 1-1 Reactor water level changes of Unit-1

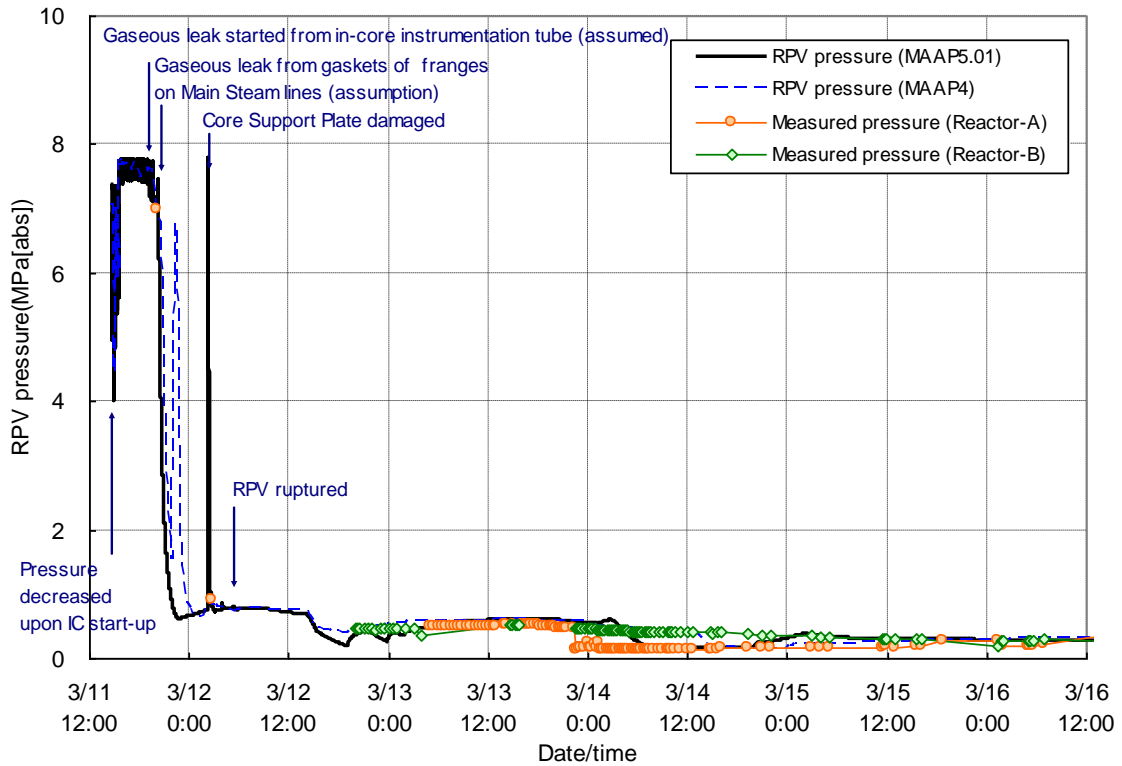
Figure 1-2 RPV pressure changes of Unit-1

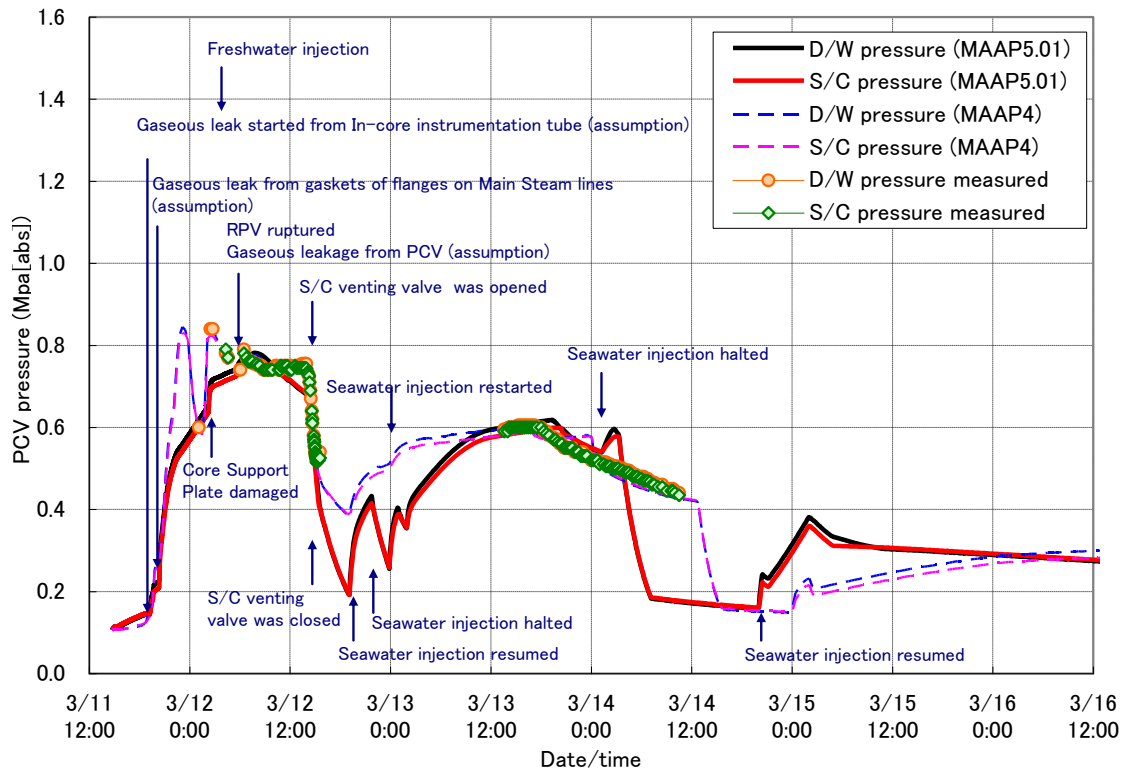
Figure 1-3 PCV pressure changes of Unit-1

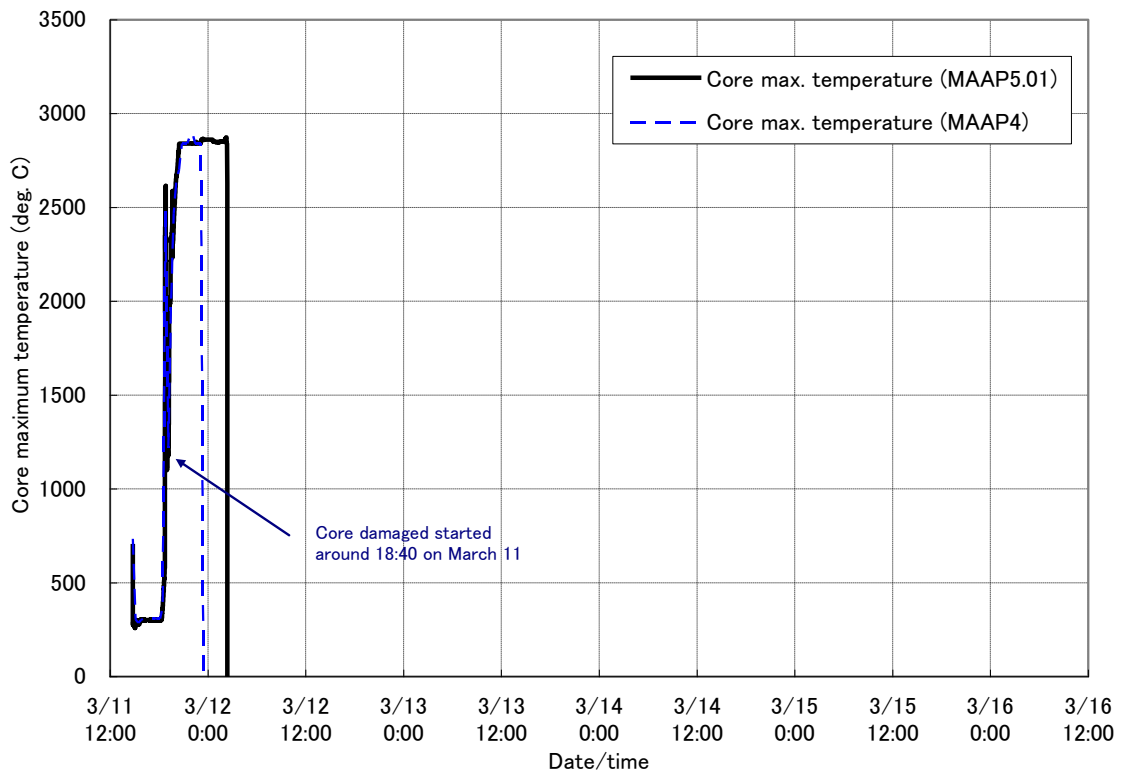
Figure 1-4 Core temperature changes of Unit-1

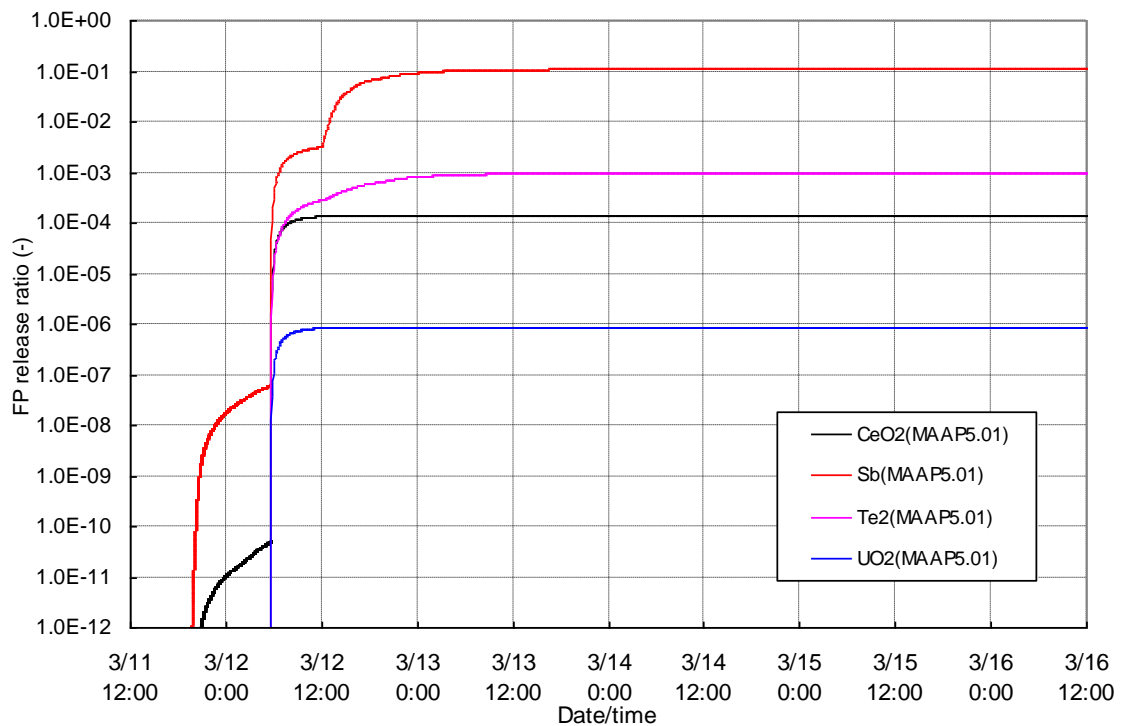
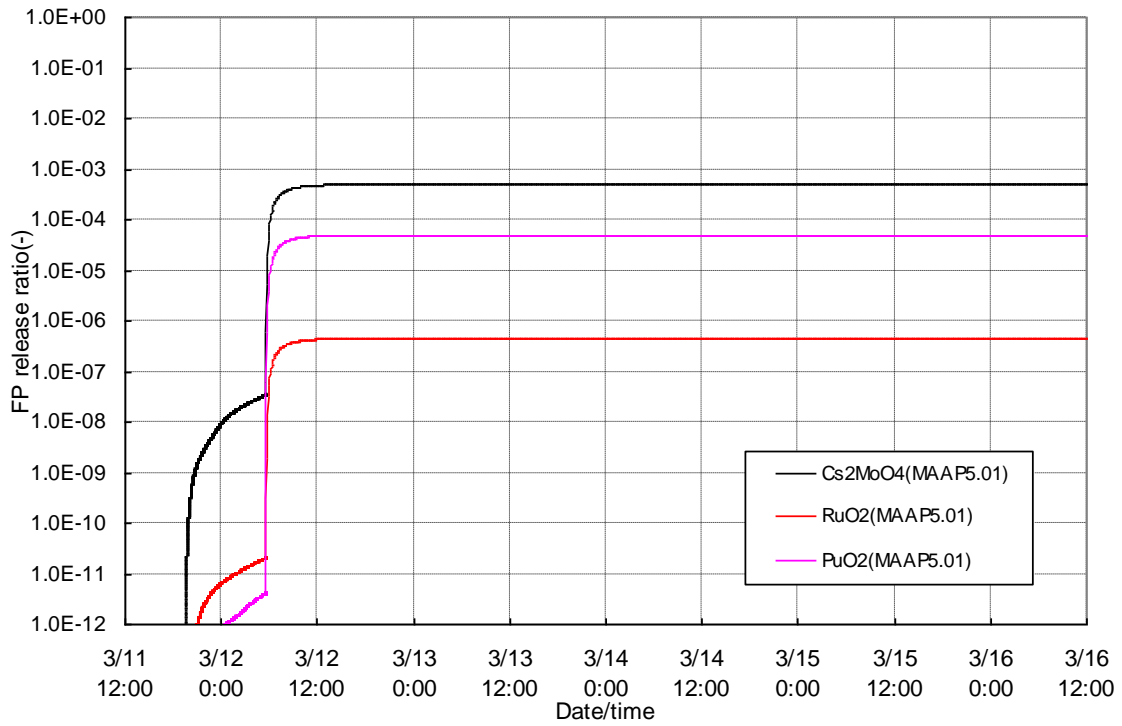
Figure 1-8 FP release ratio at Unit-1 (1/4)

Figure 1-9 FP release ratio at Unit-1 (2/4)

Figure 1-10 FP release ratio at Unit-1 (3/4)

Figure 1-11 FP release ratio at Unit-1 (4/4)

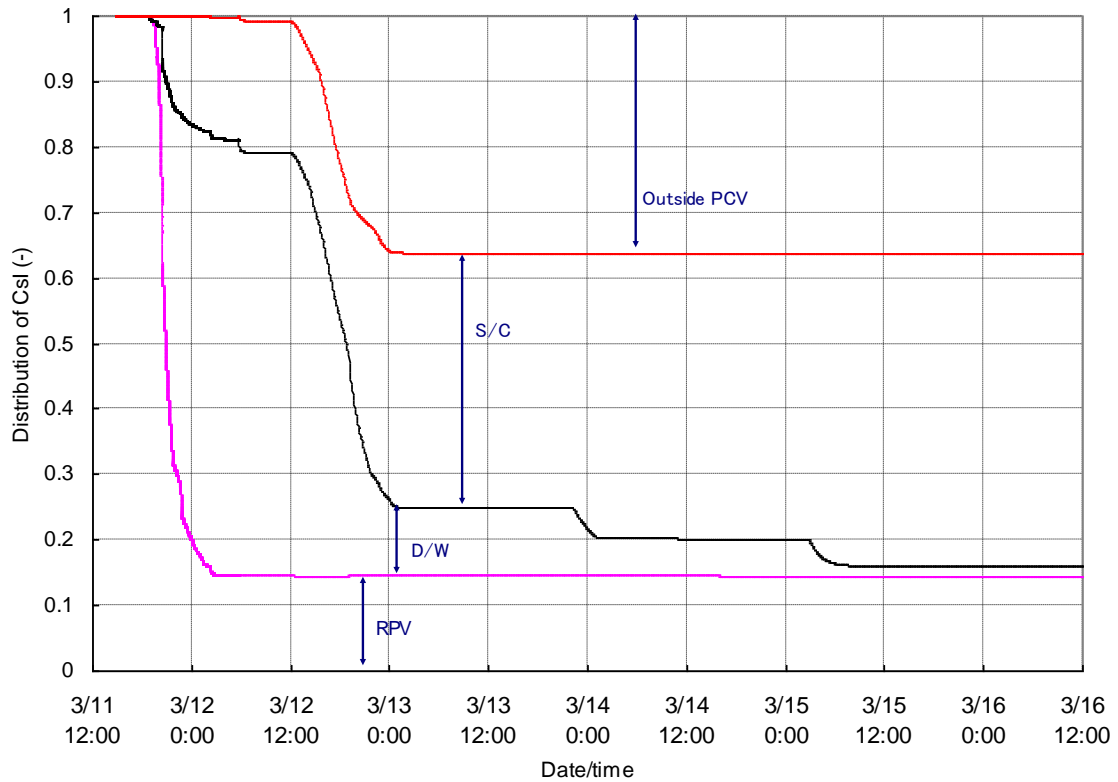
Figure 1-12 Distribution of FPs at Unit-1 (1/2)

Figure 1-13 Distribution of FPs at Unit-1 (2/2)

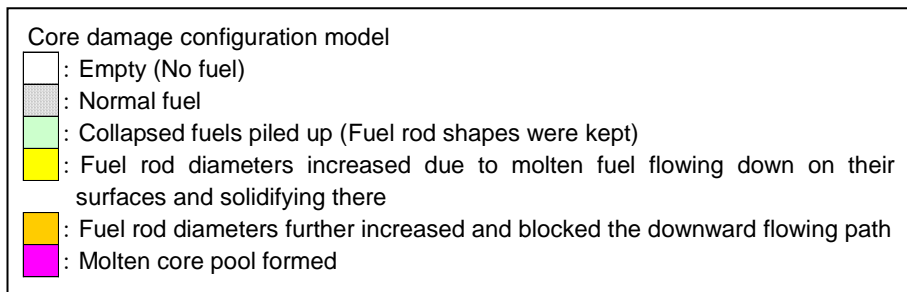
About 3.9 hours after SCRAM

About 5.0 hours after SCRAM

About 11.5 hours after SCRAM

About 12.0 hours after SCRAM

Figure 1-14 Core status of Unit-1

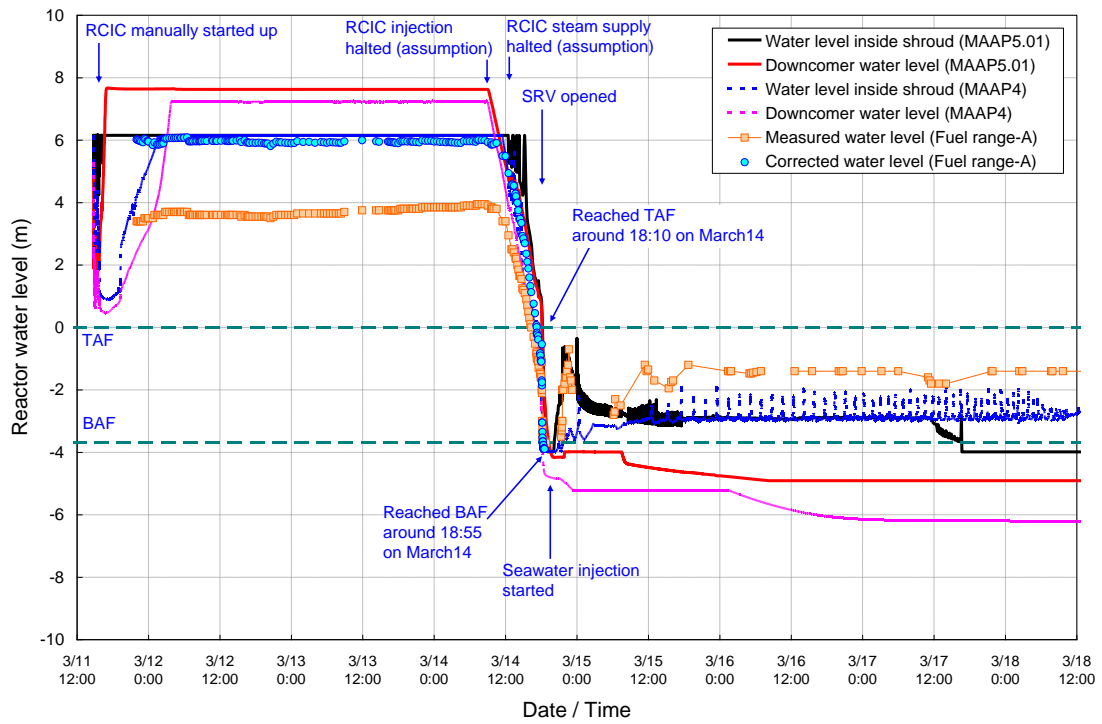
Figure 2-1 Reactor water level changes of Unit-2

- The reactor water level increased earlier because of the increasing RCIC water injection rate after the station blackout.
- After the reactor depressurization, water injection from fire engines into the uncovered core induced the water-zirconium reaction, which resulted in the increase in reactor and containment vessel pressure with one SRV kept opened. However, the simulated increase was still smaller than the observed increase. There are many unclear issues regarding actual SRV workings and water injection rate from fire engines. Further investigation is needed.
- Moreover, RPV was not ruptured in the analysis result, which is strongly affected by water injection rate from fire engines and the uncertainties in its analysis conditions.

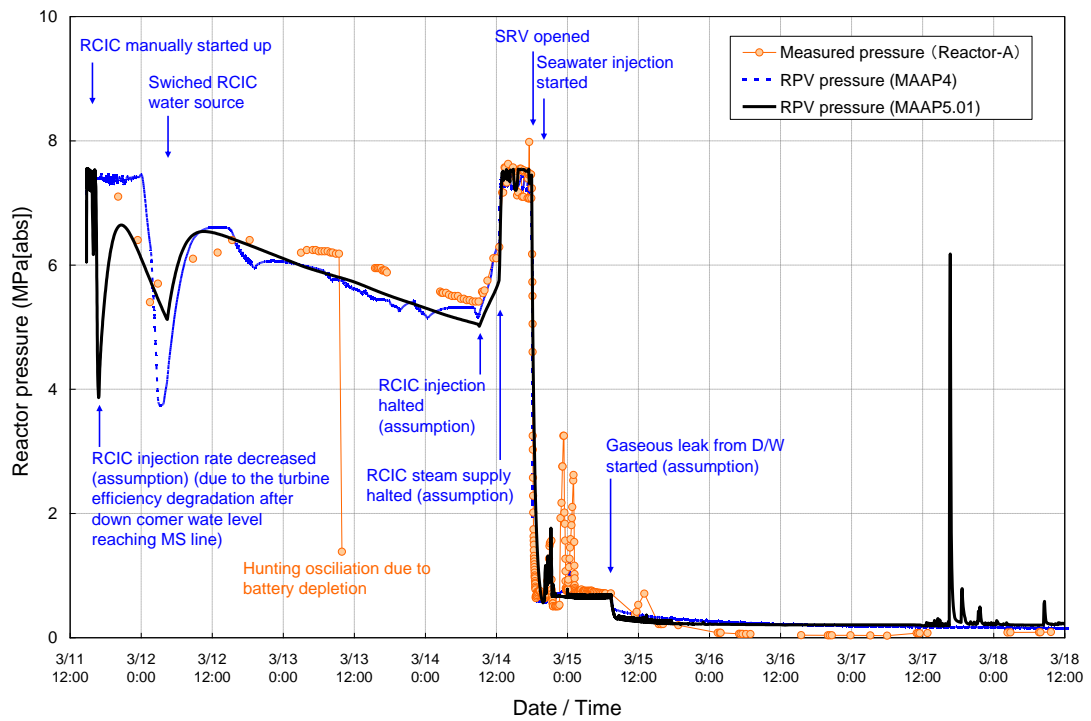
Figure 2-2 RPV pressure changes of Unit-2

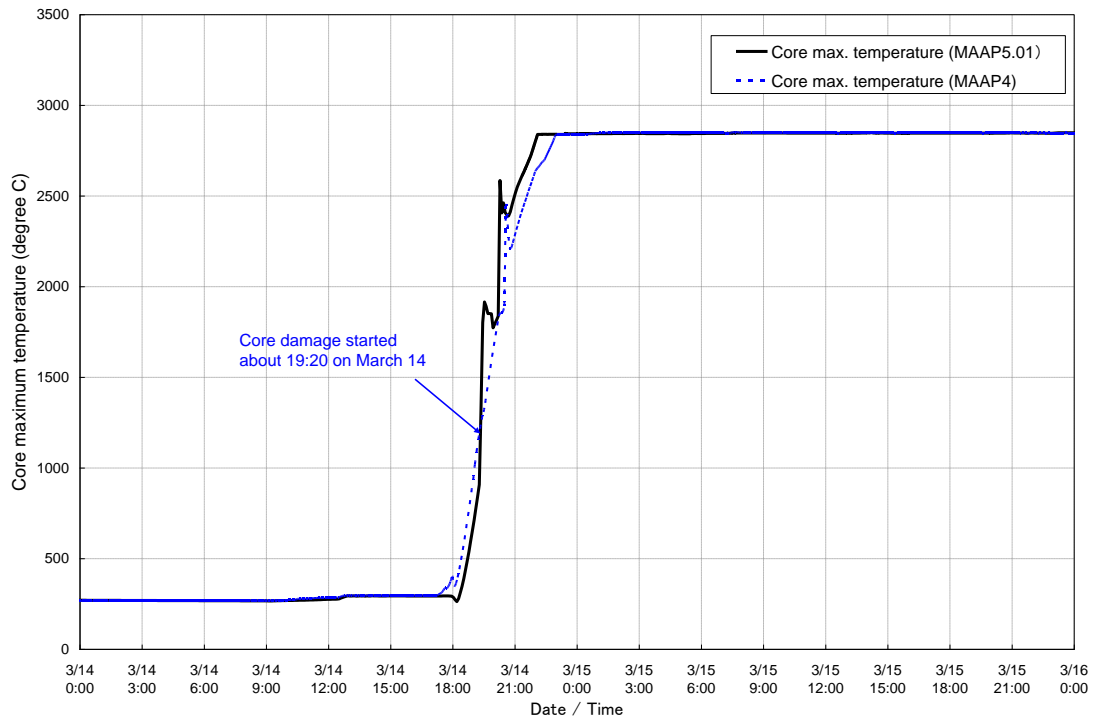
Figure 2-4 Core temperature changes of Unit-2

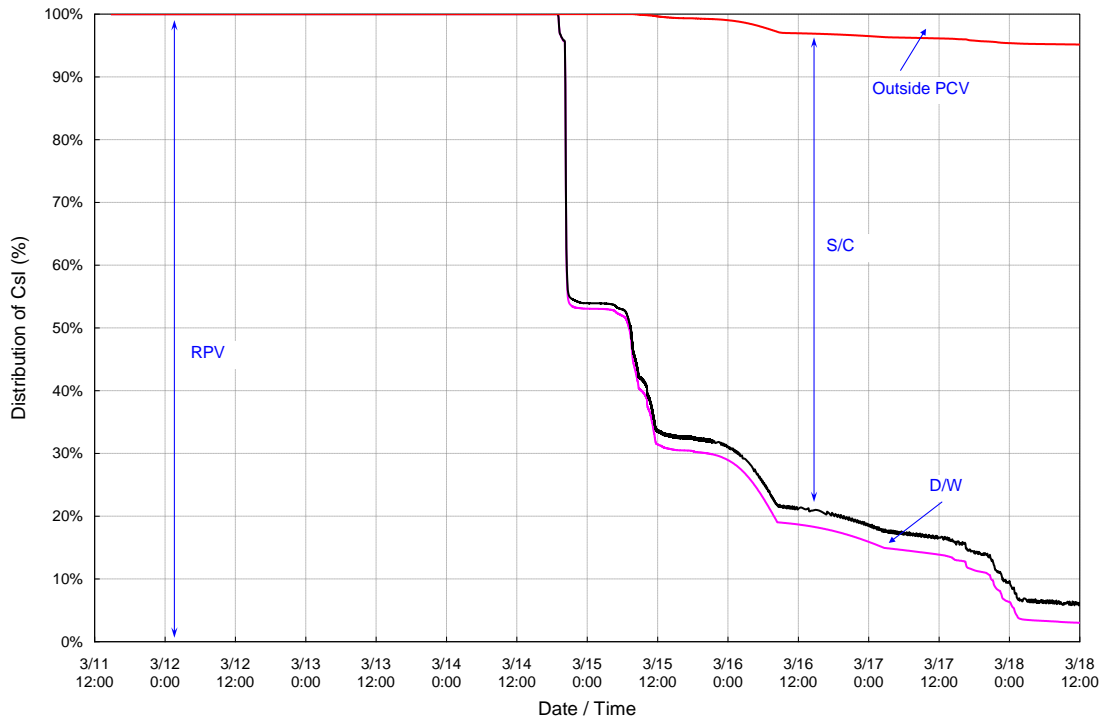
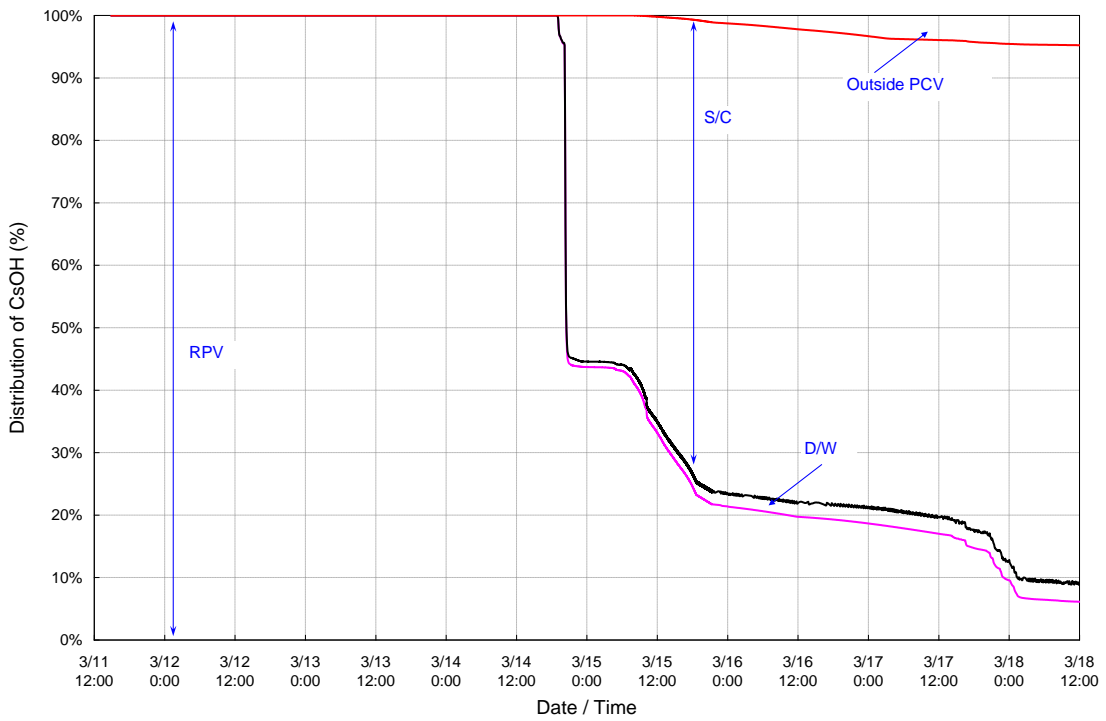
Figure 2-11 Distribution of FPs at Unit-2 (1/2)

Figure 2-12 Distribution of FPs at Unit-2 (2/2)

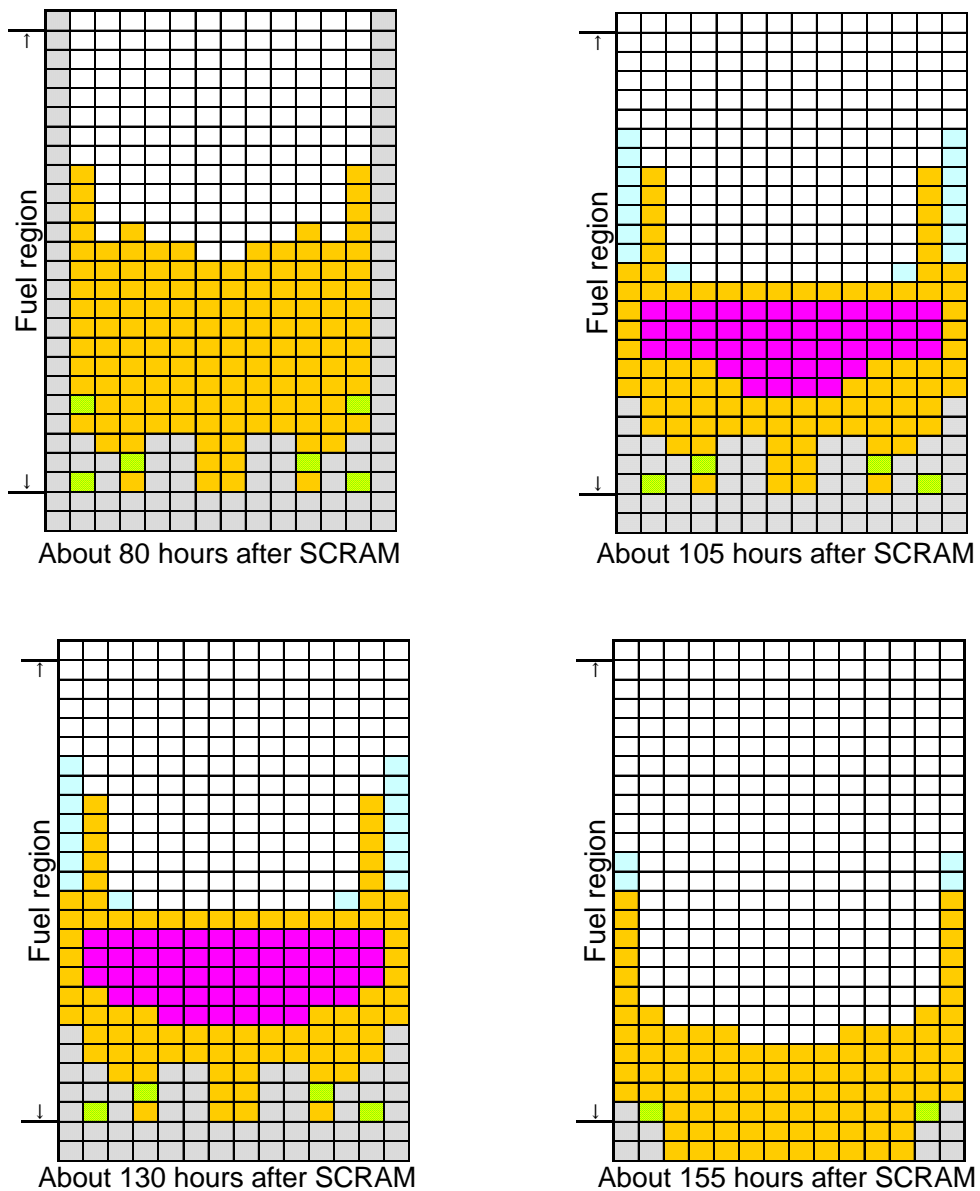
Figure 2-13 Core status of Unit-2

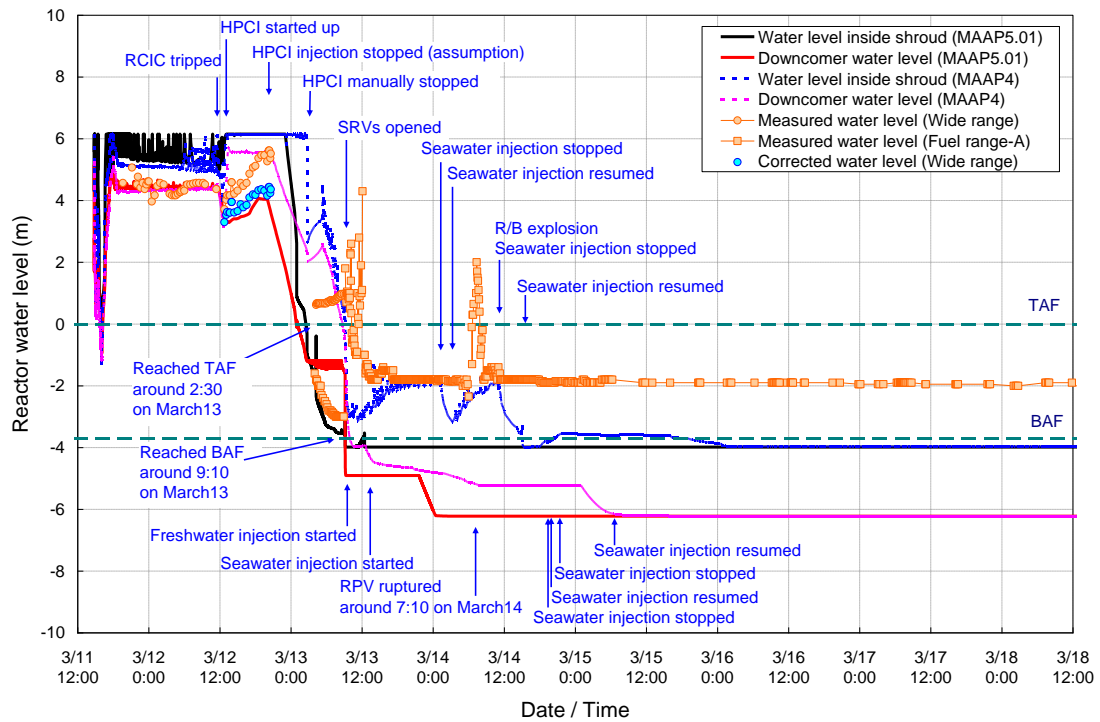
Figure 3-1 Reactor water level changes of Unit-3

- The reactor water level decrease significantly advanced, and it reached near the TAF by the time when the operators manually stopped the HPCI at about 02:42 on March 13th. The core was not covered already by around this time.
- As a result, the timing of core damage also advanced. By the time when the water

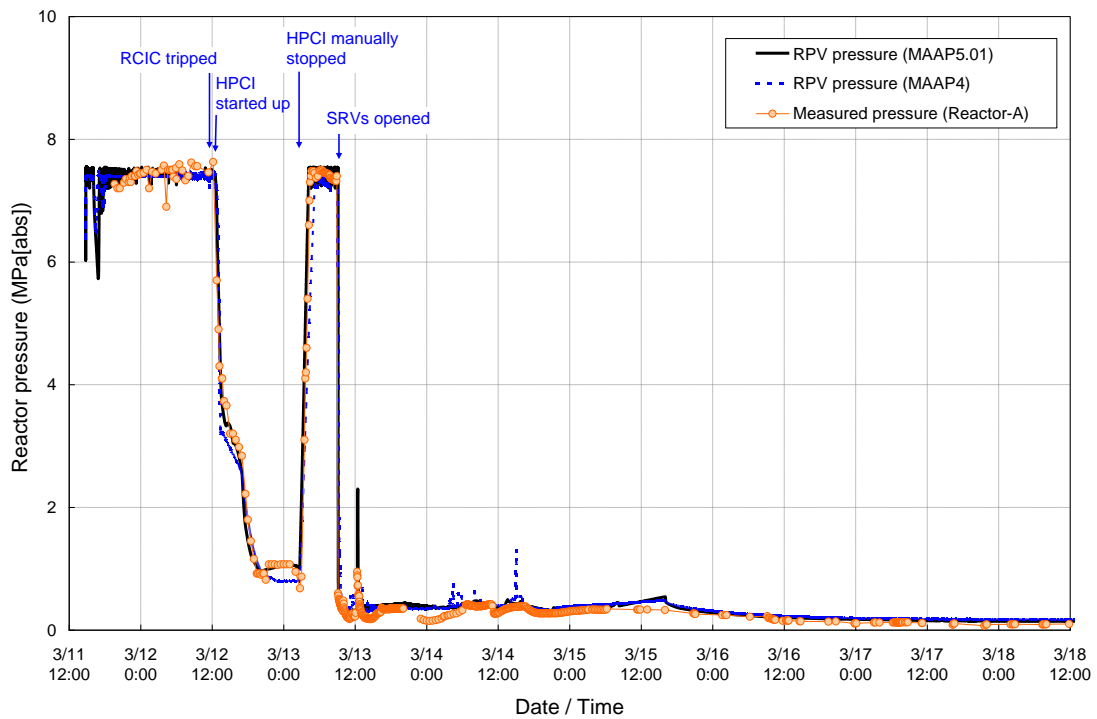
Figure 3-2 RPV pressure changes of Unit-3

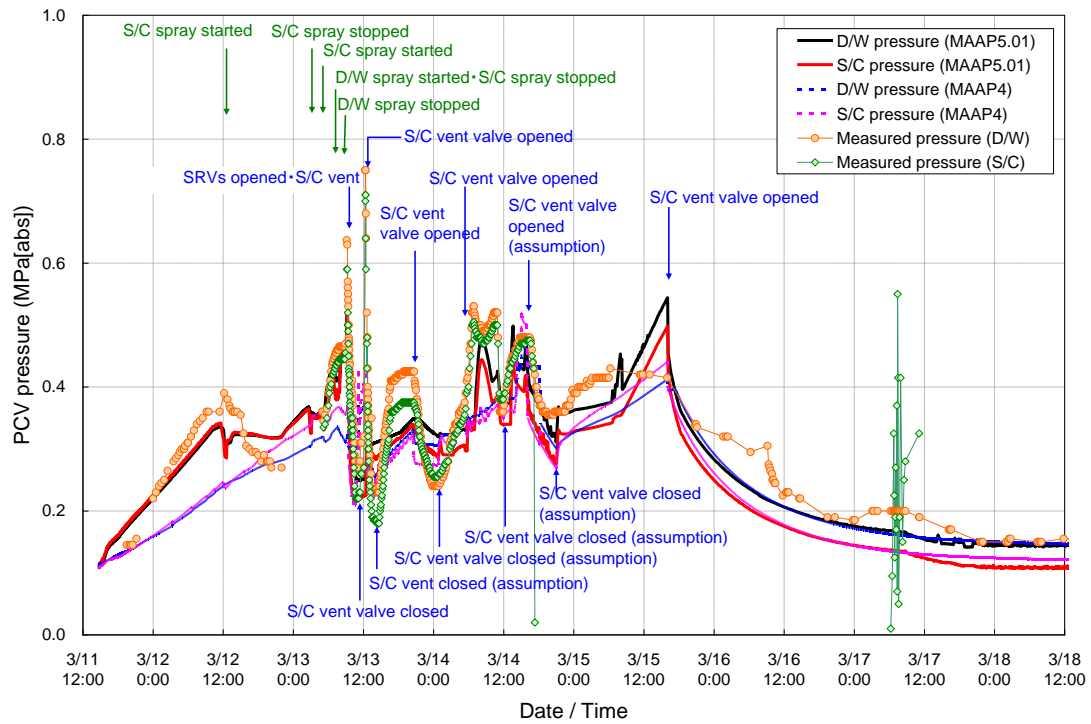
Figure 3-3 PCV pressure changes of Unit-3

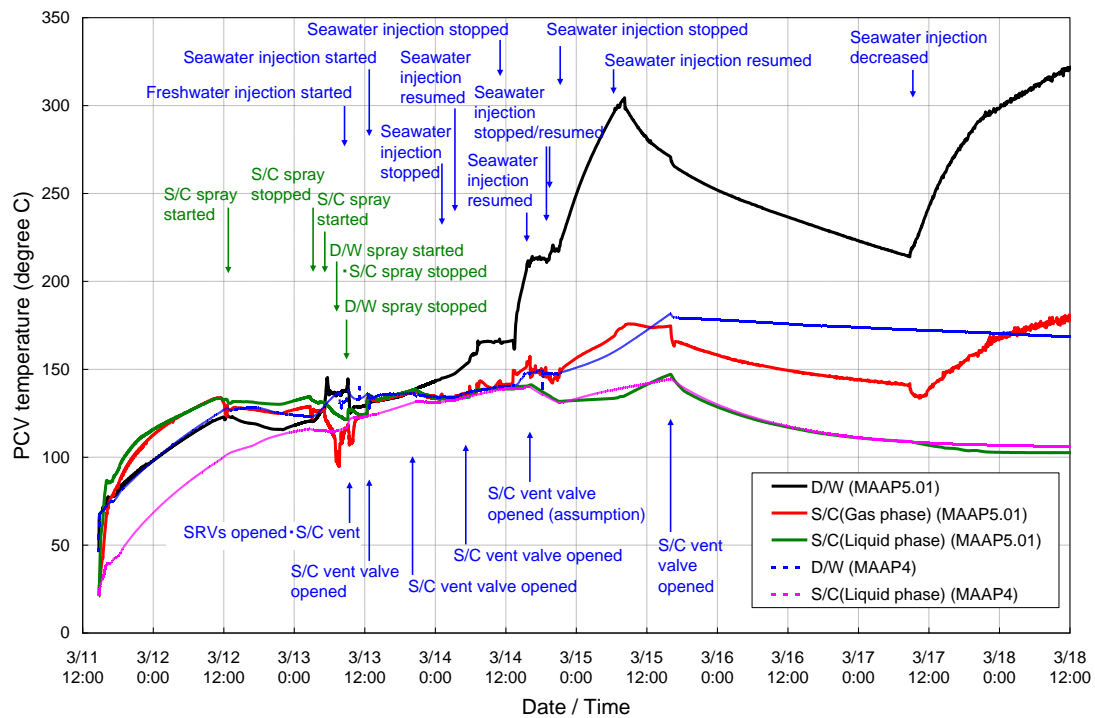
Figure 3-5 PCV temperature changes of Unit-3

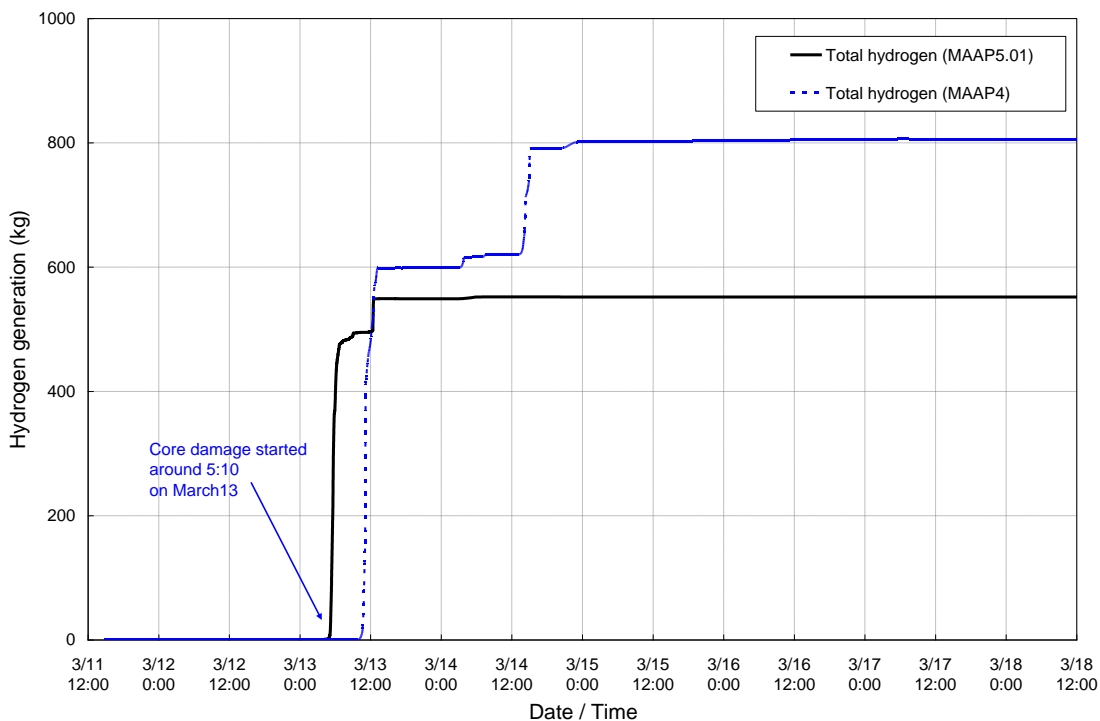
Figure 3-6 Hydrogen gas generation at Unit-3

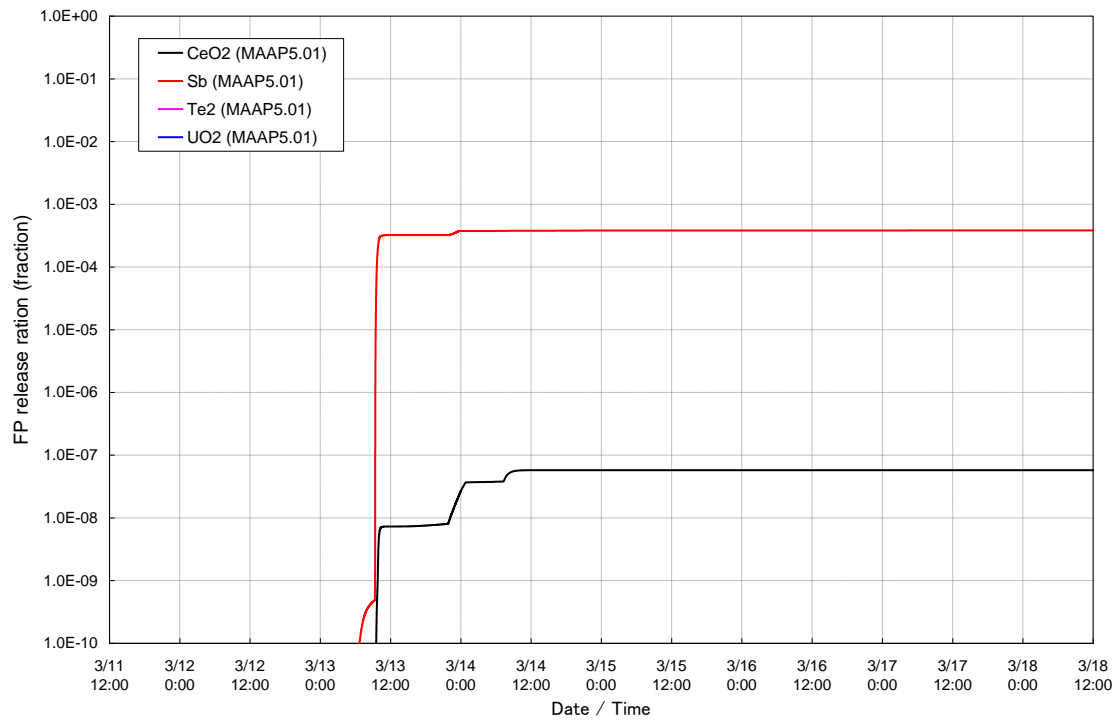
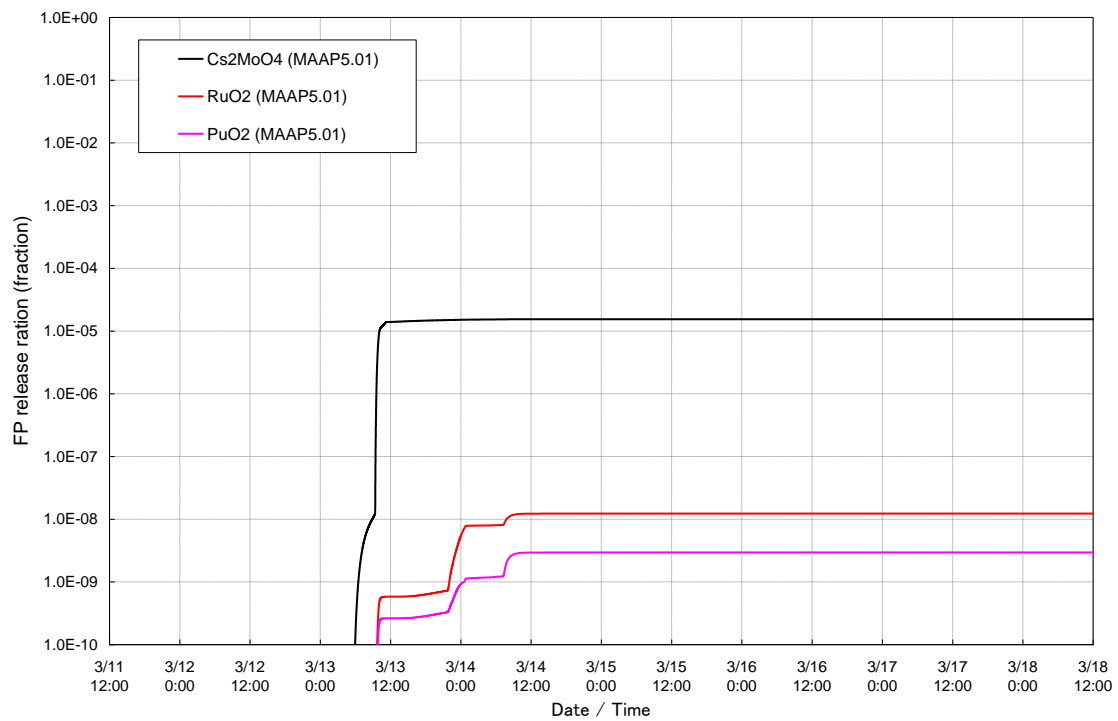
Figure 3-7 FP release ratio at Unit-3 (1/4)

Figure 3-8 FP release ratio at Unit-3 (2/4)

Figure 3-9 FP release ratio at Unit-3 (3/4)

Figure 3-10 FP release ratio at Unit-3 (4/4)

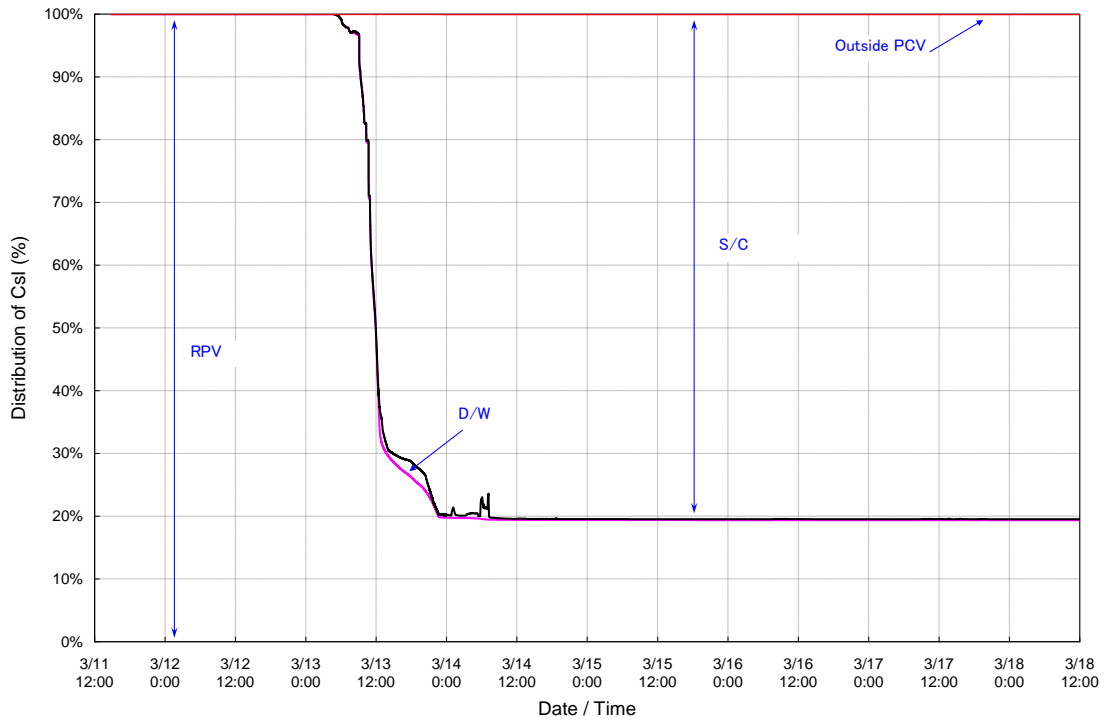
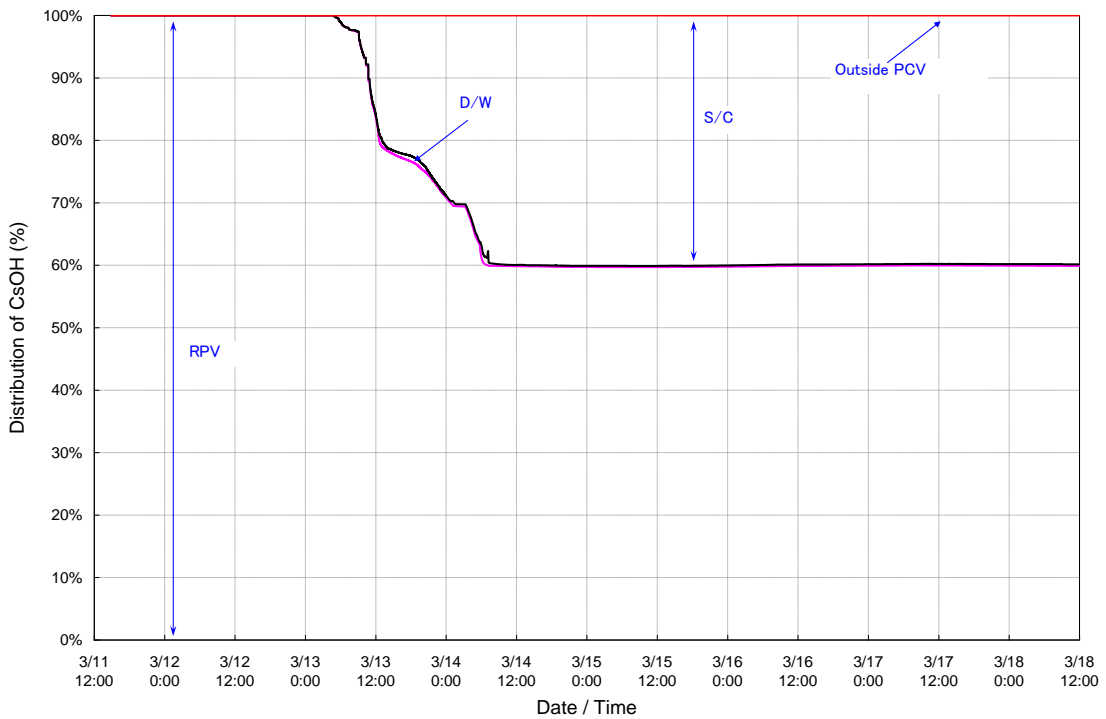
Figure 3-11 Distribution of FPs at Unit-3 (1/2)

Figure 3-12 Distribution of FPs at Unit-3 (2/2)

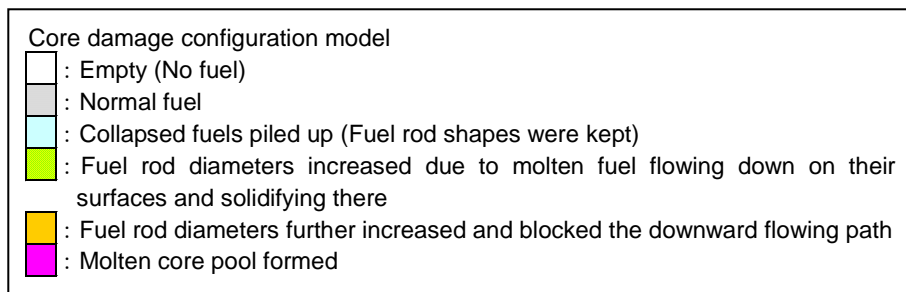
About 42 hours after SCRAM

About 44 hours after SCRAM

About 46 hours after SCRAM

About 64 hours after SCRAM

Figure 3-13 Core status of Unit-3
