Main decommissioning work and steps

Progress status

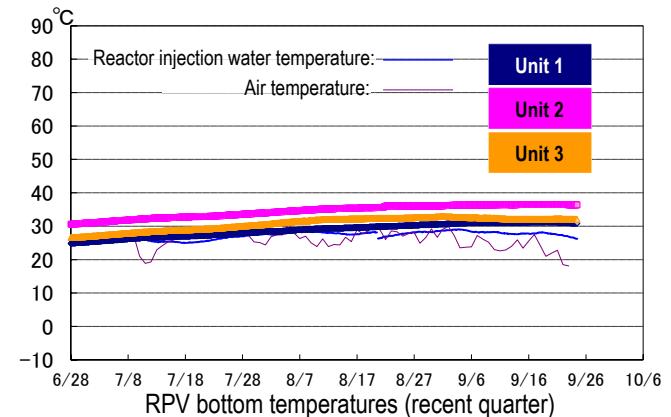
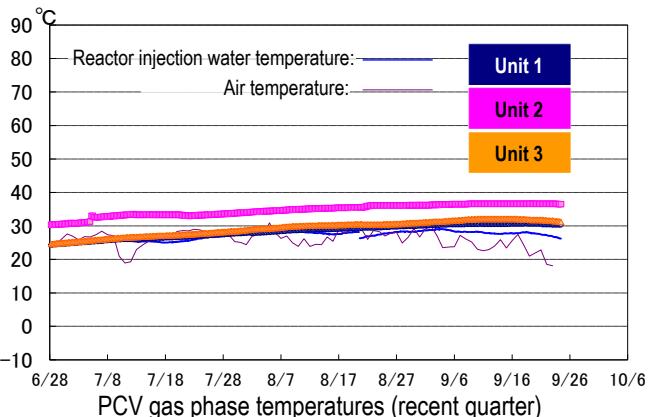
Through continuous reactor cooling by water injection, the temperatures of the Reactor Pressure Vessel (RPV) bottom and the Primary Containment Vessel (PCV) gas phase were maintained as shown below for recent, though they varied depending on the unit and location of the thermometer.

*1 The trend graphs show part of the temperature data measured at multiple points.

*2 A part of data could not be measured due to maintenance and inspection of the facility and other work.

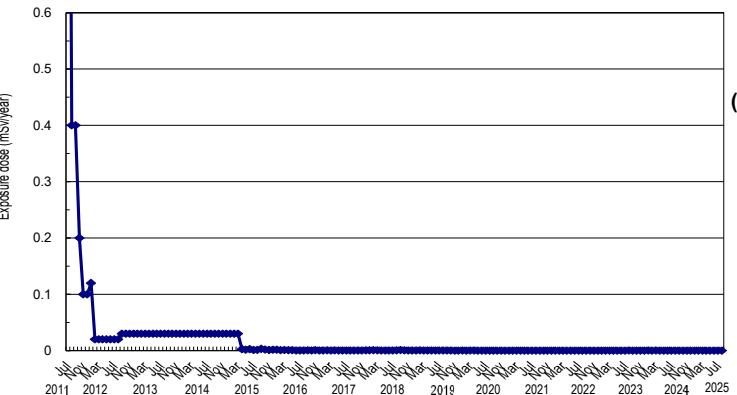
Annual radiation dose at site boundaries by radioactive materials (cesium) released from Reactor Building Units 1-4

As of August 2025, the concentration of radioactive materials newly released from Reactor Building Units 1-4 into the air and measured at the site boundary was evaluated at approx. 6.2×10^{-12} Bq/cm³ and 4.8×10^{-12} Bq/cm³ for Cs-134 and -137 respectively, while the radiation exposure dose due to the release of radioactive materials there was less than 0.00002 mSv/year.

Note 1: Different formulas and coefficients were used to evaluate the radiation dose in the facility operation plan and monthly report. The evaluation methods were integrated in September 2012. As the fuel removal from the spent fuel pool (SFP) commenced for Unit 4, the radiation exposure dose from Unit 4 was added to the items subject to evaluation since November 2013. The evaluation has been changed to a method considering the values of continuous dust monitors since FY2015, with data to be evaluated monthly and announced the following month.

Note 2: Radiation dose was calculated using the evaluation values of release amount from Units 1-4 and Units 5 and 6. The radiation dose of Unit 5 and 6 was evaluated based on expected release amount during operation until September 2019 but the evaluation method was reviewed and changed to calculate based on the actual measurement results of Units 5 and 6 from October.

Note 3: Dose assessment has been changed since July 2024 due to the change of standard meteorology, etc. in the implementation plan (effective July 8, 2024).

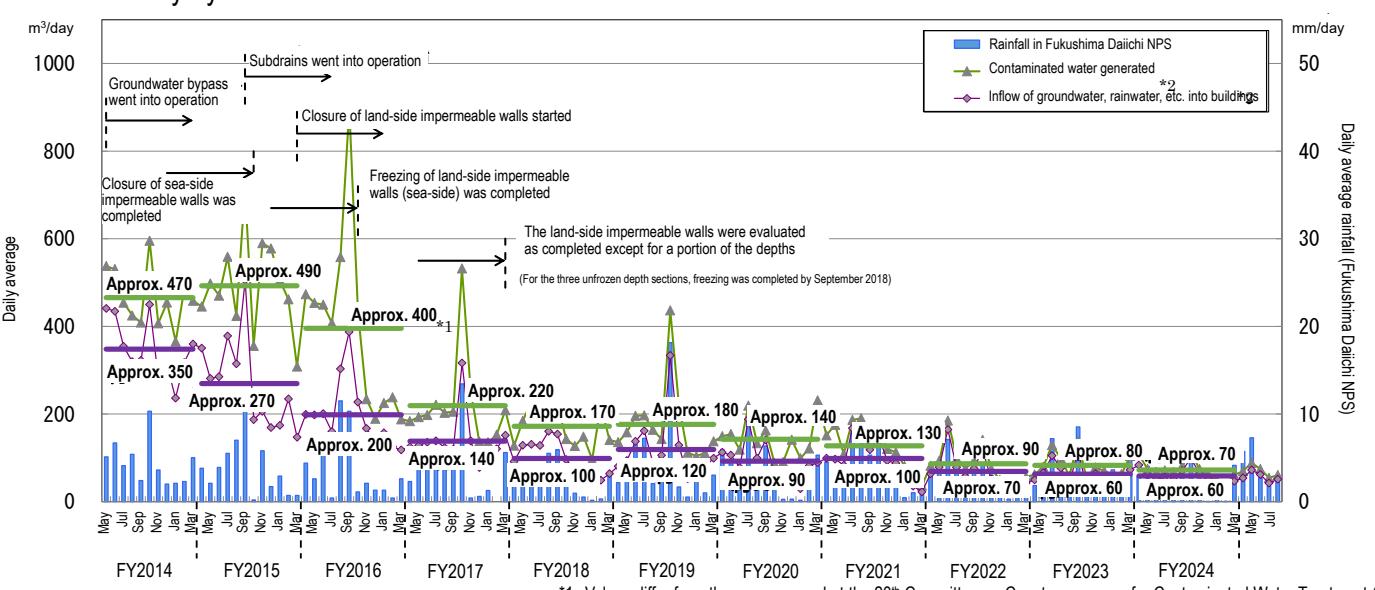
Figure 1: Changes in contaminated water generated and inflow of groundwater and rainwater into buildings

- Multi-layered contaminated water management measures, including land-side impermeable walls and subdrains, have stabilized the groundwater at a low level and the increased contaminated water generated during rainfall is being suppressed by repairing damaged portions of building roofs facing onsite. Through these measures, the generation of contaminated water has been suppressed and reduced from approx. 540 m³/day (in May 2014) before implementing measures to approx. 70 m³/day (in FY2024). It was confirmed that the milestone of “suppressing the amount of contaminated water generated to 100 m³/day or less during average rainfall within FY2025,” which was achieved in FY2023, has been maintained in FY2024.
- Measures will proceed to further reduce the amount of contaminated water generated and suppress to approx. 50–70 m³/day by FY2028.

*1 Values differ from those announced at the 20th Committee on Countermeasures for Contaminated Water Treatment (held on August 25, 2017) because the method of calculating the contaminated water volume generated was reviewed on March 1, 2018. Details of the review are described in the materials for the 50th and 51st meetings of the Secretariat of the Team for Countermeasures for Decommissioning and Contaminated Water Treatment.

*2: The monthly daily average is derived from the daily average from the previous Thursday to the last Wednesday, which is calculated based on the data measured at 7:00 on every Thursday

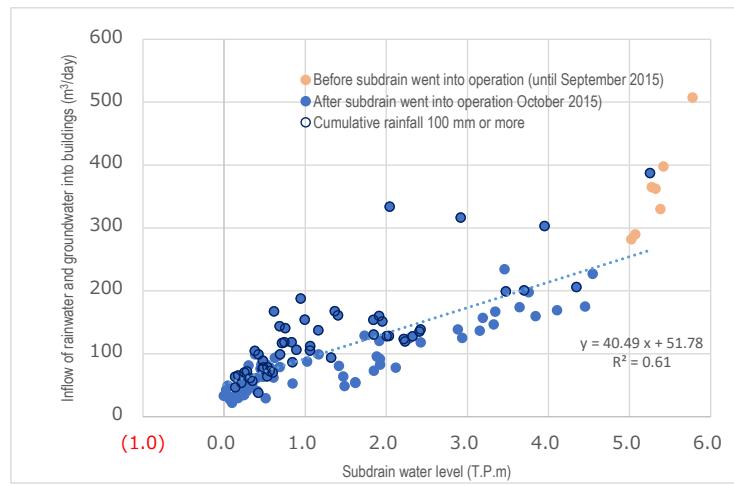
Figure 2: Correlation between inflow such as groundwater and rainwater into buildings and the water level of Units 1-4 subdrains

- Operation of the Water-Treatment Facility Special for Subdrains & Groundwater drains
 - At the Water-Treatment Facility Special for Subdrains & Groundwater drains, release started from September 14, 2015, and up until September 10, 2025, 2768 release operations had been conducted. The water quality of all temporary storage tanks satisfied the operational target.

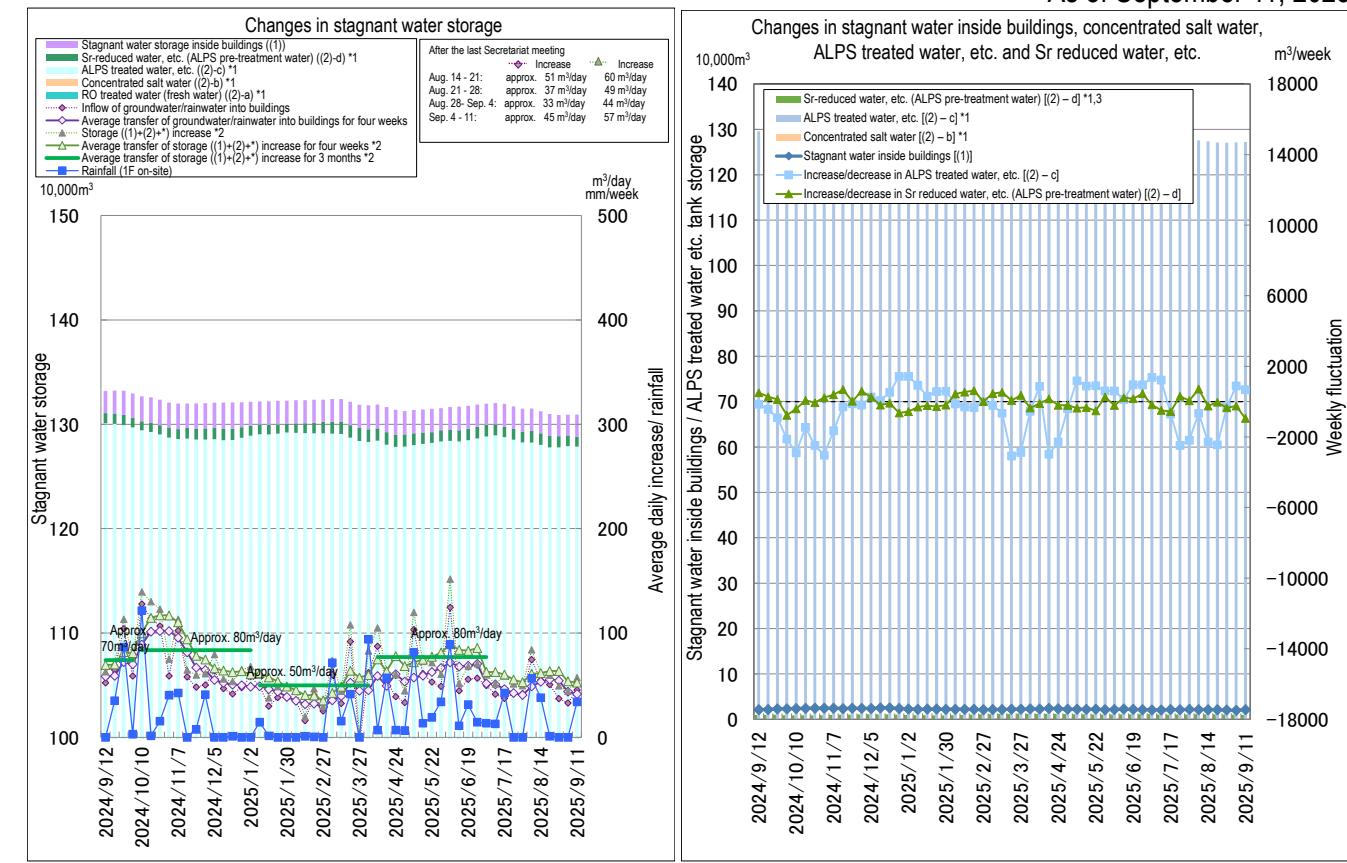
Figure 3: Status of stagnant water storage

- The volume of ALPS treated water, etc. was approx. 1,274,511 m³ as of September 11, 2025.

(1): Stagnant water storage inside buildings (Units 1-4, Process Main Building, High Temperature Incinerator Building, Waste Liquid Supply Tank, SPT (A), SPT (B), Units 1-3 CST, buffer tank)

(2): Units 1-4 tank storage [(2)-a RO-treated water (fresh water)] + [(2)-b Concentrated salt water] + [(2)-c ALPS treated water, etc.] + [(2)-d Sr-reduced water, etc. (ALPS pre-treatment water)]
 *: Water amount from tank bottom to water-level gauge 0% (DS)
 *1: Water amount for which the water-level gauge indicates 0% or more
 *2: Calculated in the method of contaminated water generated [(Inflow of groundwater/rainwater into buildings) + (other transfer) + (chemical injection into ALPS)], amount of ALPS treated water discharged was not taken into account.
 *3: Amount of Sr-reduced water and others increased and decreased depending on the operation status of facilities due to clog of the cross-flow filter for the multi-nuclide removal system.

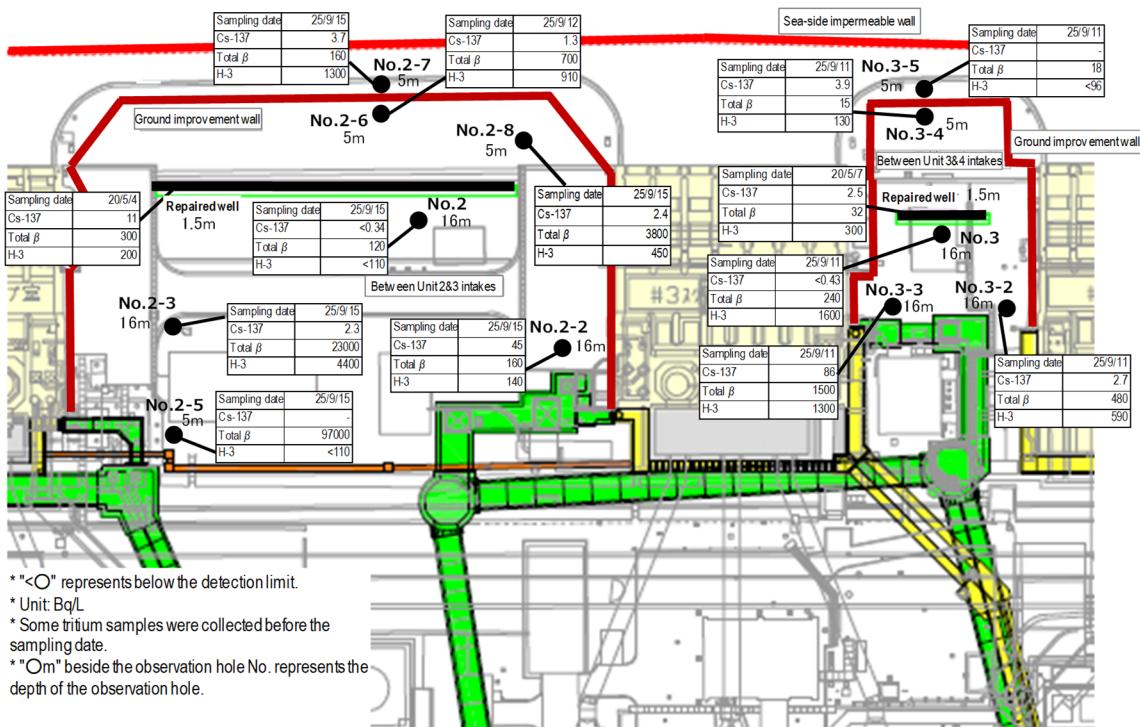
Figure 4: Groundwater concentration on the Turbine Building east side

- In the open channel area of the seawater intake for Units 1 to 4, the concentration of radioactive materials in seawater has remained below the legal discharge limit and been declining long term, despite the temporary increases in Cs-137 and Sr-90 observed during rainfall. They have also been declining following the completed installation and the connection of steel pipe sheet piles for the sea-side impermeable walls. The concentration of Cs-137 remained slightly higher in front of the south-side impermeable walls and slightly lower on the north side of the east breakwater since March 20, 2019, when the silt fence was transferred to the center of the open channel due to mega float-related construction.

<Unit 1 intake north side, between Unit 1 and 2 intakes>

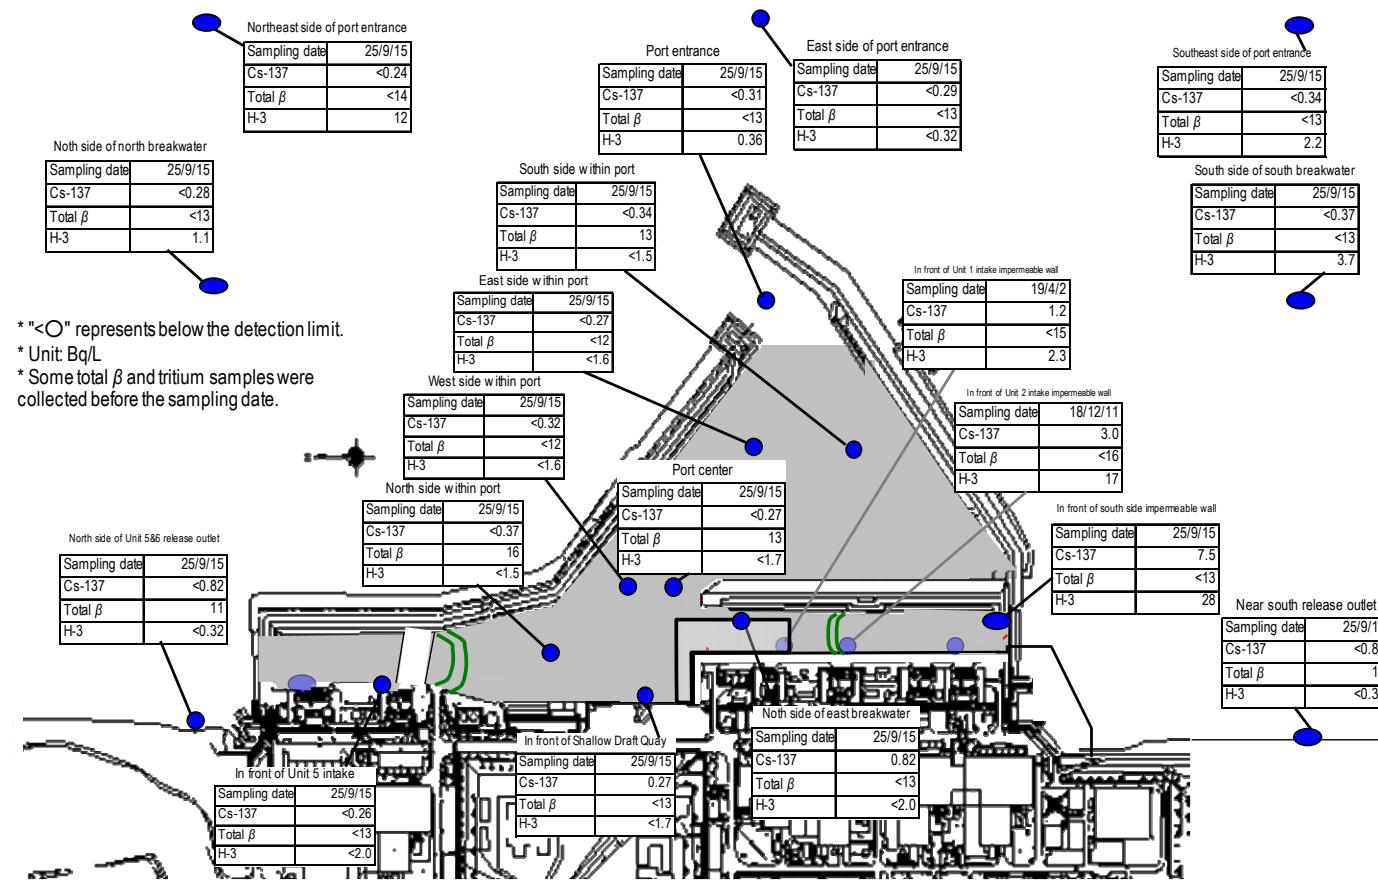
Figure 5: Seawater concentration around the port

- In the port area, the concentration of radioactive materials in seawater has remained below the legal discharge limit and been declining long term, despite temporary increases in Cs-137 and Sr-90 observed during rainfall. They have remained below the level of those in the Units 1-4 intake open channel area and been declining following the completed installation and connection of steel pipe sheet piles for the sea-side impermeable walls.

- In the area outside the port, regarding the concentration of radioactive materials in seawater, those of Cs-137 and Sr-90 declined and remained low after steel pipe sheet piles for the sea-side impermeable walls were installed and connected. Regarding the concentration of Cs-137, a temporary increase was sometimes observed on the north side of the Units 5 and 6 outlets and near the south outlet due to the influence of weather, marine meteorology and other factors. Regarding the concentration of Sr-90, variation was observed in FY2021 in the area outside the port (north and south outlets). Monitoring of the tendency continues, including the potential influence of weather, marine

meteorology and others. During the period for which ALPS treated water was discharged, the tritium concentration increased at the sampling point near the discharge outlet, but this was considered within the assumed range based on the oceanic dispersion simulation results.

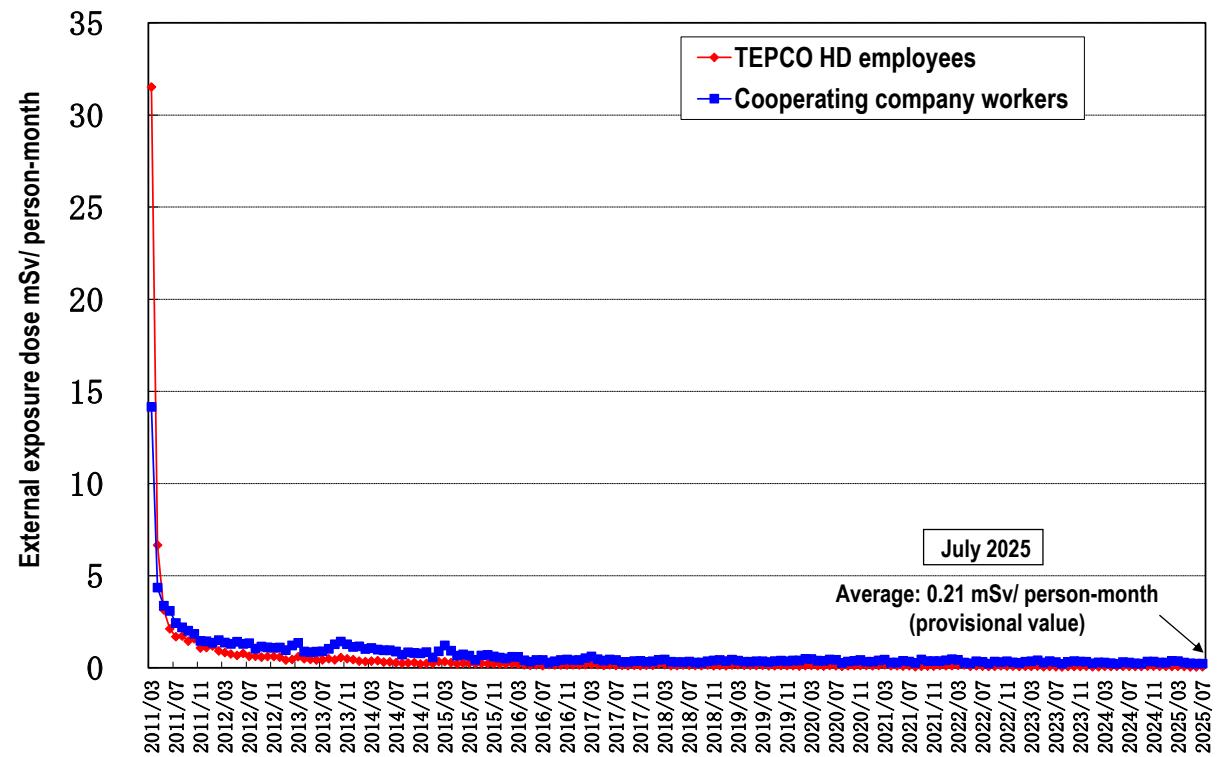
Figure 7: Changes in monthly average exposure dose of individual worker (monthly exposure dose since March 2011)

- The average exposure doses of workers were approx. 2.16, 2.18 and 2.08 mSv/person-year during FY2022, 2023 and 2024, respectively (The legal exposure dose limits are 100 and 50 mSv/person-year respectively over five years, the TEPCO HD management target is 20 mSv/person-year).

- For most workers, the exposure dose remained sufficiently within the limit and allowed them to continue engaging in radiation work.

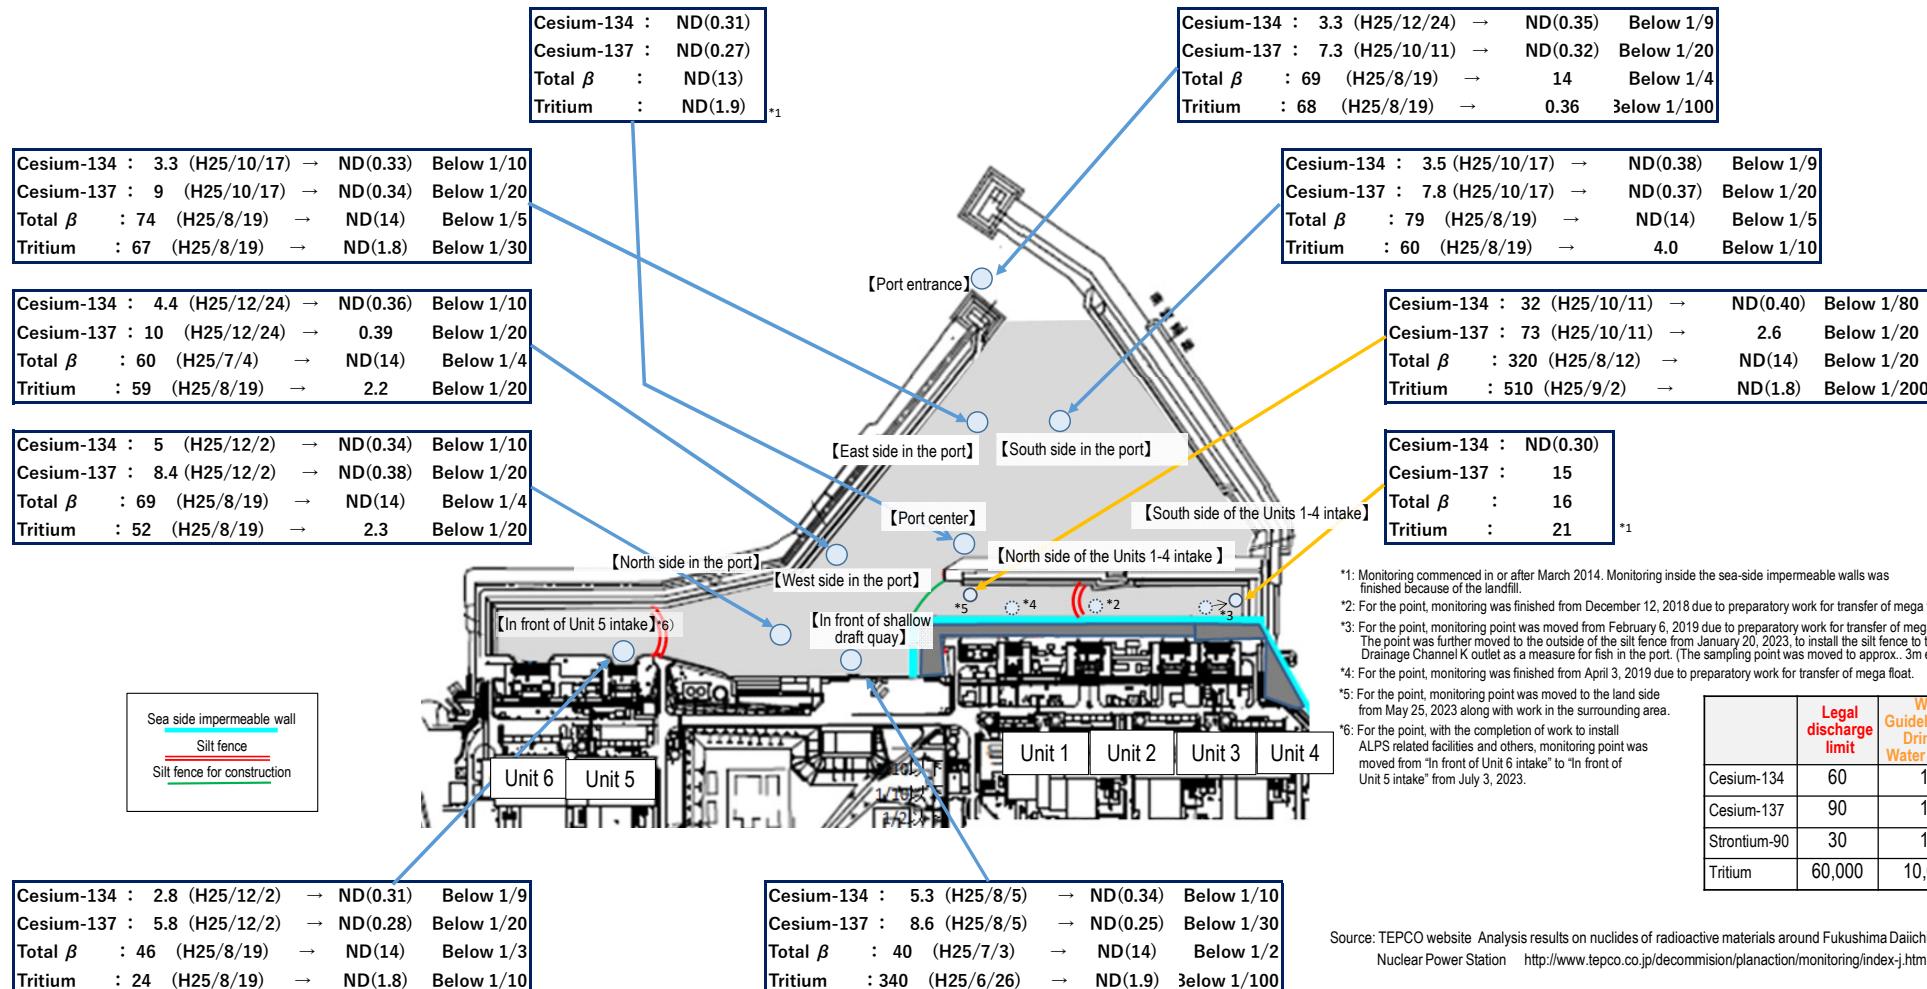
Note: The Total β measurement value is the total radioactivity concentration of radioactive materials that emit β -ray (Potassium-40, Cesium-137, Strontium-90, progeny nuclide Yttrium-90, etc.). In general, approx. 12 Bq/L of natural nuclide Potassium-40 is included in seawater.

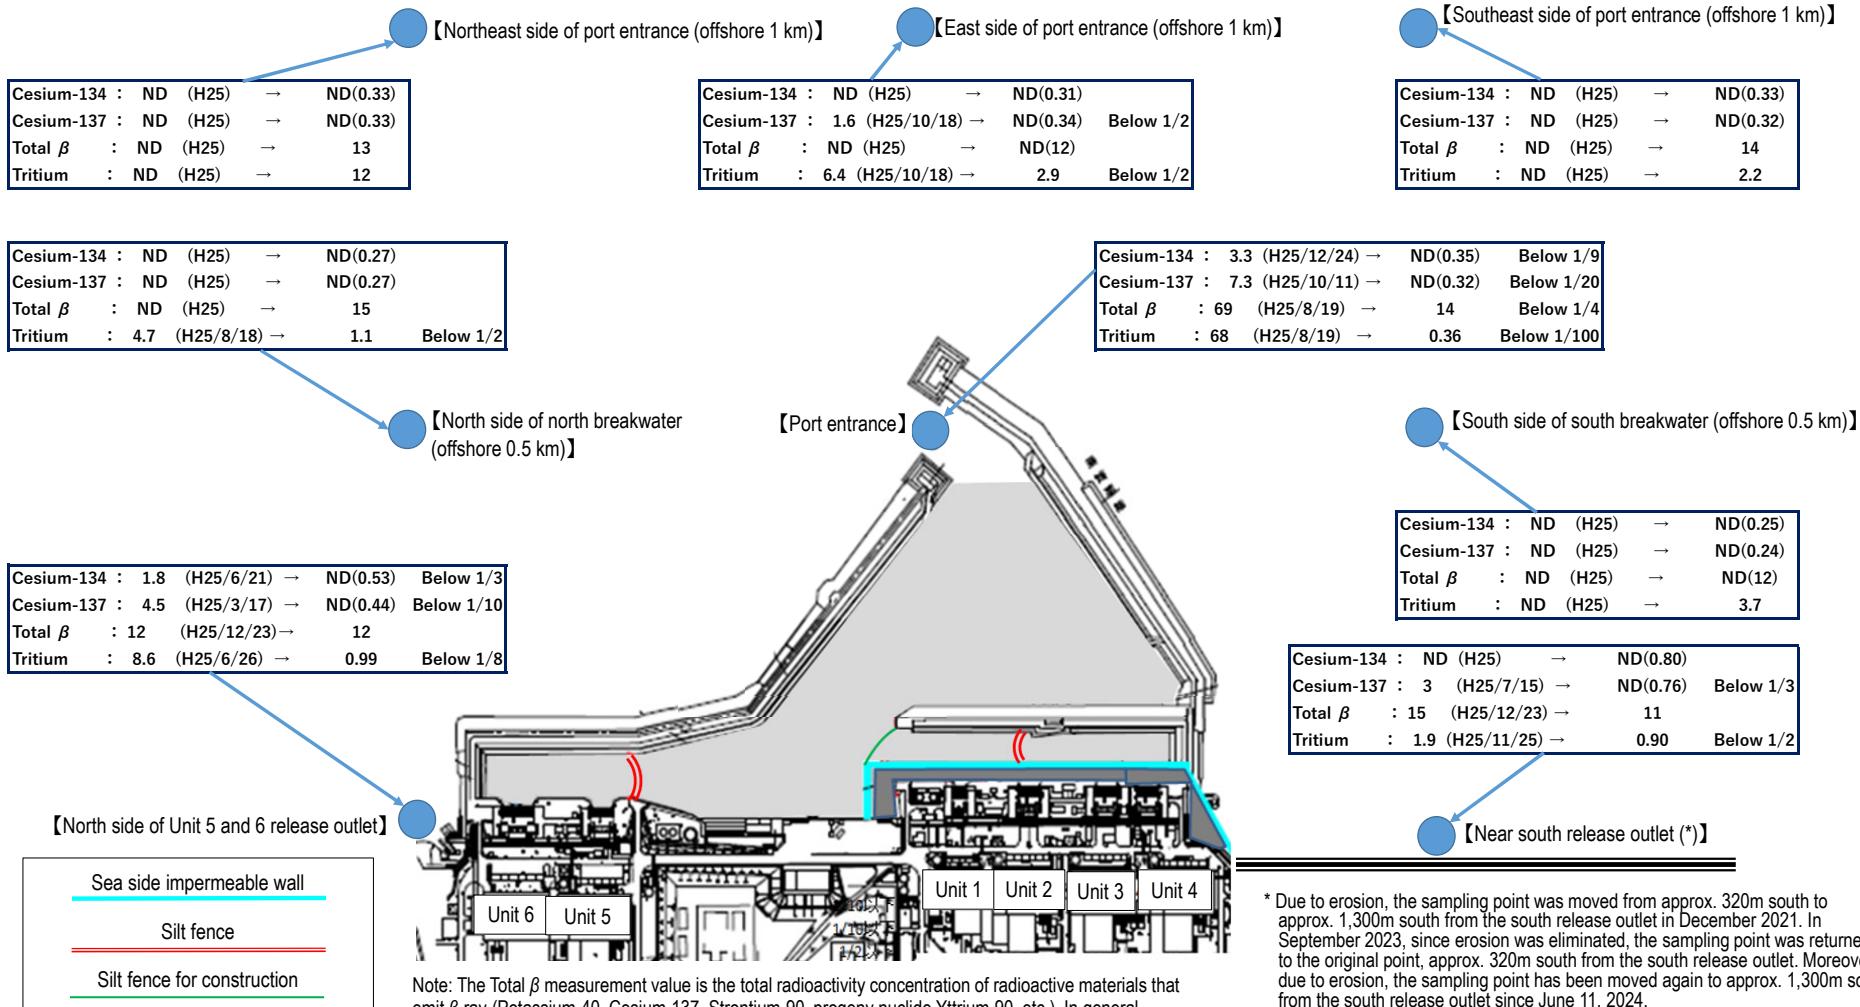
Legal discharge limit	WHO Guidelines for Drinking Water Quality
Cesium-134	60	10
Cesium-137	90	10
Strontium-90	30	10
Tritium	60,000	10,000

* Due to erosion, the sampling point was moved from approx. 320m south to approx. 1,300m south from the south release outlet in December 2021. In September 2023, since erosion was eliminated, the sampling point was returned to the original point, approx. 320m south from the south release outlet. Moreover, due to erosion, the sampling point has been moved again to approx. 1,300m south from the south release outlet since June 11, 2024.

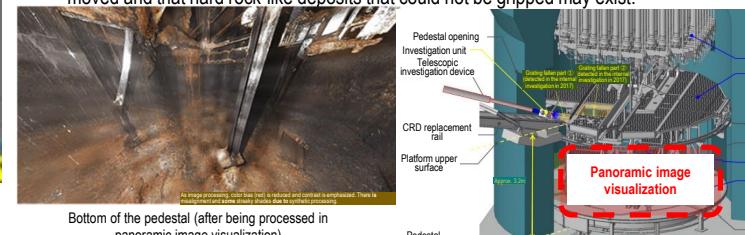
- In February 2019, an investigation touching the deposits at the bottom of the pedestal and on the platform was conducted and confirmed that the pebble-shaped deposits, etc. could be moved and that hard rock-like deposits that could not be gripped may exist.

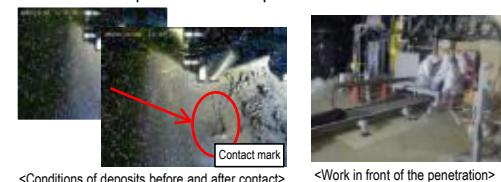
- In October 2020, a deposits contact investigation at the PCV penetration (X-6 penetration) was conducted. This confirmed that deposits inside the penetration had not deformed and come unstuck.

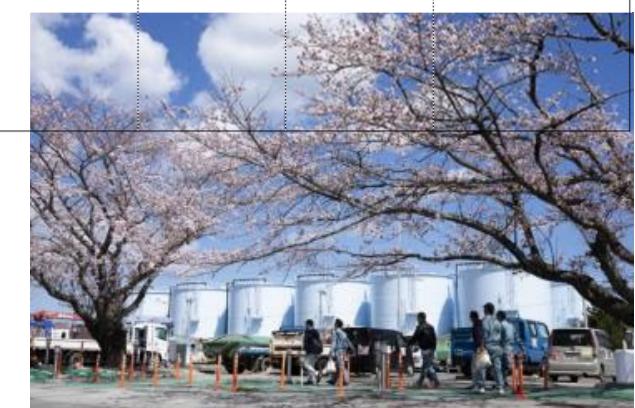
Regarding the site-wide reduction in the radiation dose and prevention of contamination spreading, the radiation dose on site was reduced by removal of rubble, topsoil and facing. Moreover, the operation was improved to use environmentally-improved areas as a Green Zone, within which workers are allowed to wear general work clothes and disposable dust-protective masks which are less of a physical burden.
