# Outline of Decommissioning, Contaminated Water and Treated Water Management

October 30, 2025

Secretariat of the Team for Countermeasures for  
Decommissioning, Contaminated Water and Treated Water

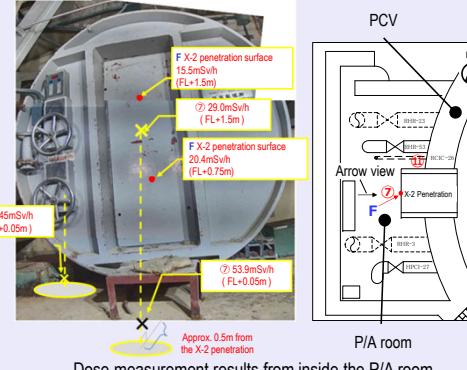
For full-scale fuel debris retrieval from Unit 3, we are deliberating accessing the fuel debris from the X-6 penetration, the X-1B penetration and the TIP room. To examine the feasibility of using any other penetrations, from August 19 to September 19, 2025, we investigated the personnel access lock room (P/A room)\*1 outside the Primary Containment Vessel (PCV). Remotely operated quadruped robots (SPOT) and crawler robots (Packbot) were used for the investigation, for visual inspection using cameras, dose measurements and point cloud data acquisition.

By the visual inspection, no molten material adhering to the surface of the X-2 penetration flange in the P/A chamber, nor any signs of leakage or deformations, like those found in the front chamber of the Unit 2 X-6 penetration were confirmed. Moreover, no abnormality such as deformation was found in the P/A chamber. Dose measurement results show hot spots existing on the floor.

\* 1 Before the accident, used as passage through which persons enter into PCV during inspection.

In addition to the hotspots identified during this investigation, contamination may also exist elsewhere, so G/I measurement results will be analyzed to create a more detailed radiation source distribution. Dose reduction measures inside the P/A room are necessary if it is to be used for fuel debris retrieval, but there are also obstructions such as a piping system and the air dose rates are high. Accordingly, the process of reducing doses in the P/A room may take considerable time.

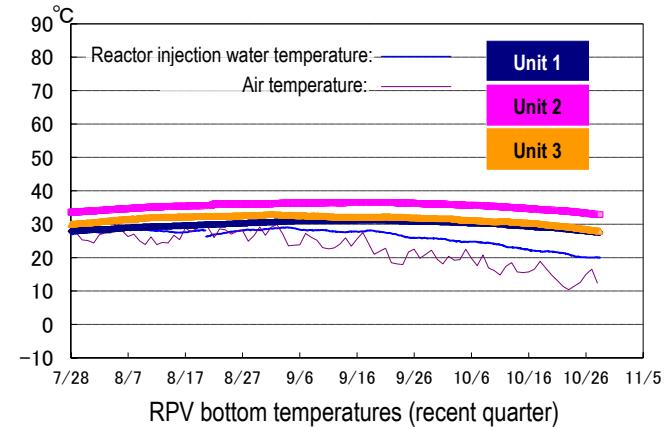
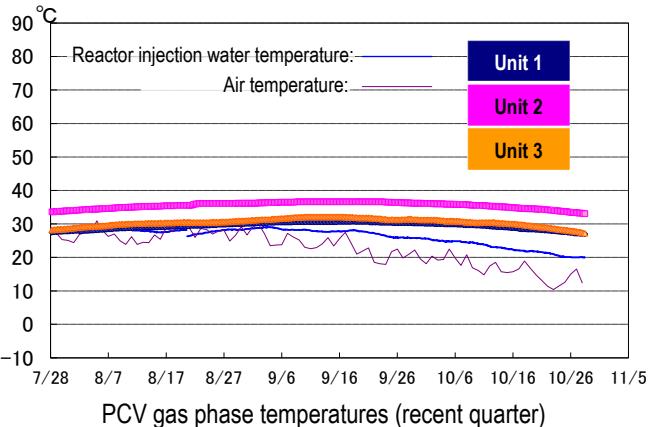
Through continuous reactor cooling by water injection, the temperatures of the Reactor Pressure Vessel (RPV) bottom and the Primary Containment Vessel (PCV) gas phase were maintained as shown below for recent, though they varied depending on the unit and location of the thermometer.

\*1 The trend graphs show part of the temperature data measured at multiple points.

\*2 A part of data could not be measured due to maintenance and inspection of the facility and other work.

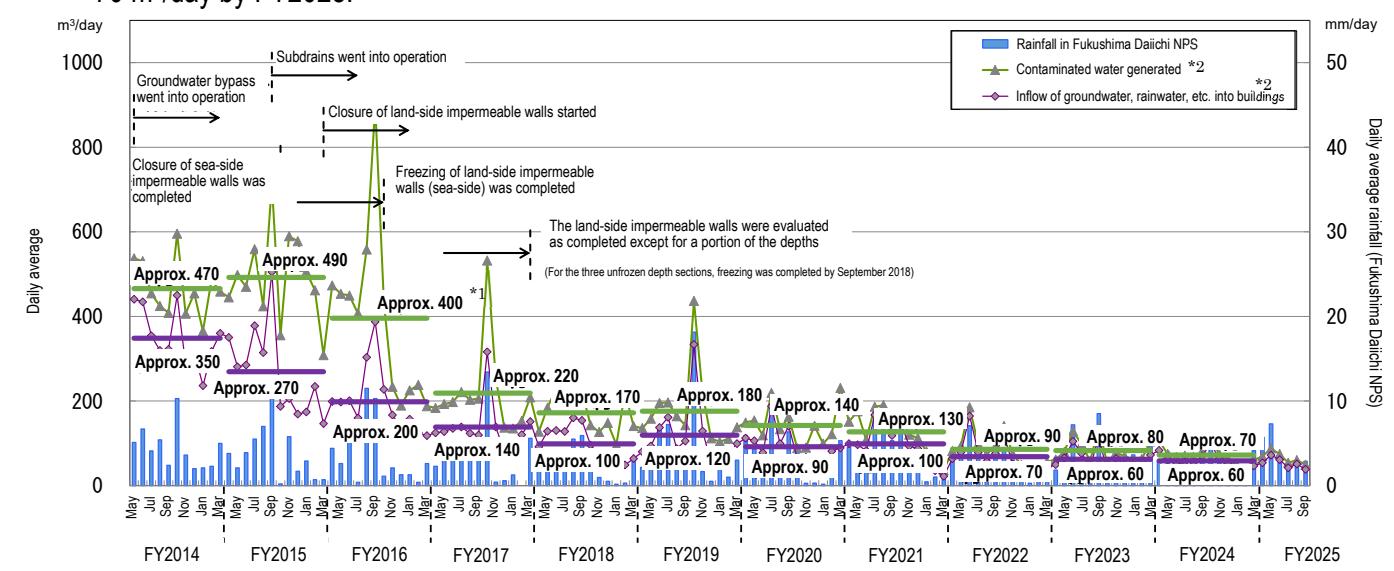
Figure 1: Changes in contaminated water generated and inflow of groundwater and rainwater into buildings

- Multi-layered contaminated water management measures, including land-side impermeable walls and subdrains, have stabilized the groundwater at a low level and the increased contaminated water generated during rainfall is being suppressed by repairing damaged portions of building roofs facing onsite. Through these measures, the generation of contaminated water has been suppressed and reduced from approx. 540 m<sup>3</sup>/day (in May 2014) before implementing measures to approx. 70 m<sup>3</sup>/day (in FY2024). It was confirmed that the milestone of "suppressing the amount of contaminated water generated to 100 m<sup>3</sup>/day or less during average rainfall within FY2025," which was achieved in FY2023, has been maintained in FY2024.
- Measures will proceed to further reduce the amount of contaminated water generated and suppress to approx. 50-70 m<sup>3</sup>/day by FY2028.

\*1 Values differ from those announced at the 20<sup>th</sup> Committee on Countermeasures for Contaminated Water Treatment (held on August 25, 2017) because the method of calculating the contaminated water volume generated was reviewed on March 1, 2018. Details of the review are described in the materials for the 50<sup>th</sup> and 51<sup>st</sup> meetings of the Secretariat of the Team for Countermeasures for Decommissioning and Contaminated Water Treatment.  
\*2: The monthly daily average is derived from the daily average from the previous Thursday to the last Wednesday, which is calculated based on the data measured at 7:00 on every Thursday

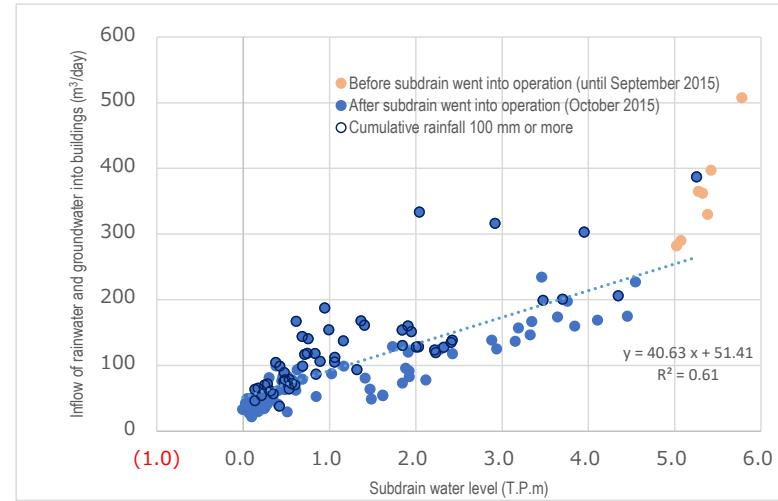
Figure 2: Correlation between inflow such as groundwater and rainwater into buildings and the water level of Units 1-4 subdrains

- Operation of the Water-Treatment Facility Special for Subdrains & Groundwater drains
  - At the Water-Treatment Facility Special for Subdrains & Groundwater drains, release started from September 14, 2015, and up until October 21, 2025, 2795 release operations had been conducted.

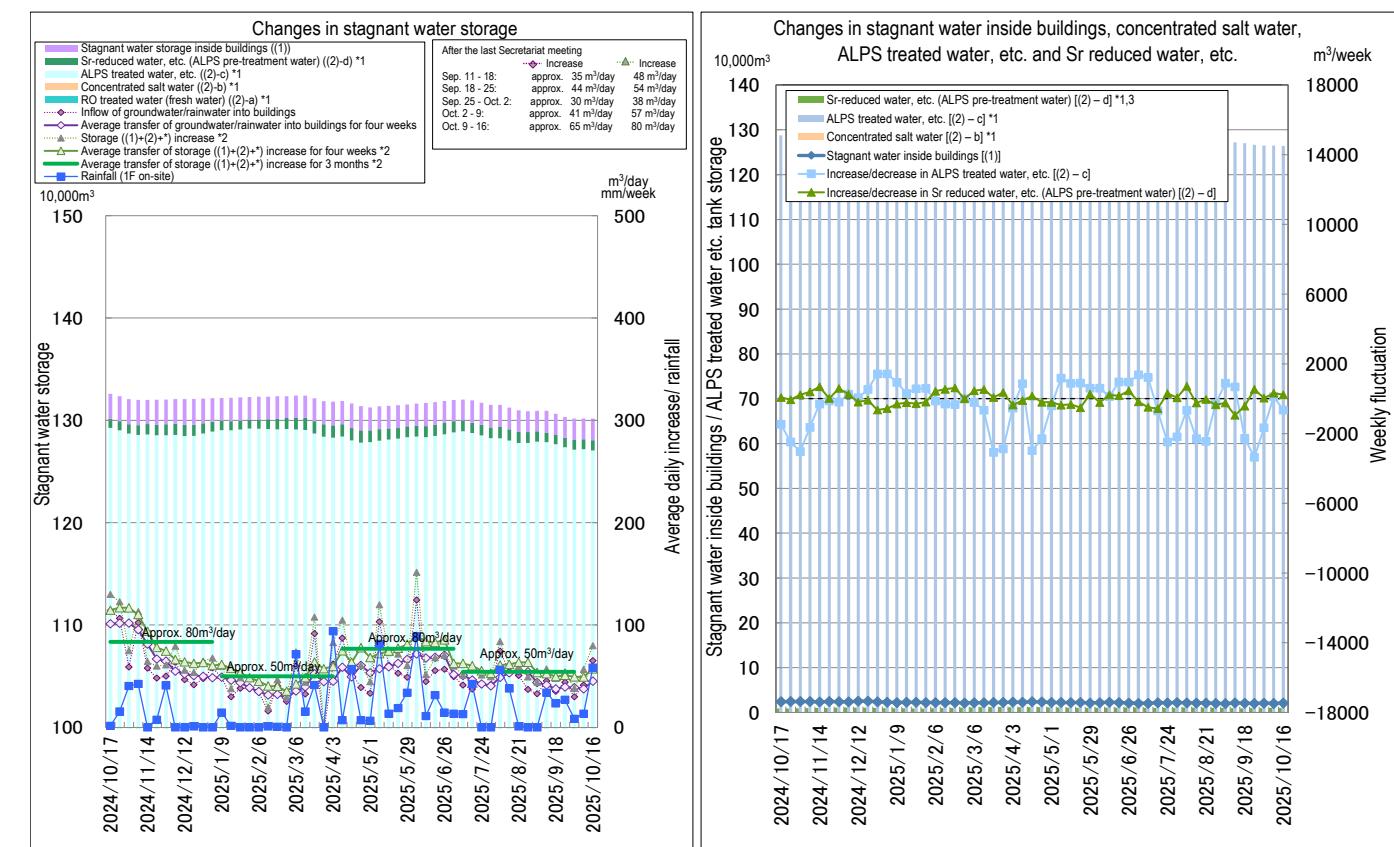
As of October 16, 2025

(1): Stagnant water storage inside buildings (Units 1-4, Process Main Building, High Temperature Incinerator Building, Waste Liquid Supply Tank, SPT (A), SPT (B), Units 1-3 CST, buffer tank)

(2): Units 1-4 tank storage [(2)-a RO-treated water (fresh water)] + [(2)-b Concentrated salt water] + [(2)-c ALPS treated water, etc.] + [(2)-d Sr-reduced water, etc. (ALPS pre-treatment water)]  
 \*: Water amount from tank bottom to water-level gauge 0% (DS)  
 \*1: Water amount for which the water-level gauge indicates 0% or more  
 \*2: Calculated in the method of contaminated water generated [(Inflow of groundwater/rainwater into buildings) + (other transfer) + (chemical injection into ALPS)], amount of ALPS treated water discharged was not taken into account.  
 \*3: Amount of Sr-reduced water and others increased and decreased depending on the operation status of facilities due to clog of the cross-flow filter for the multi-nuclide removal system.

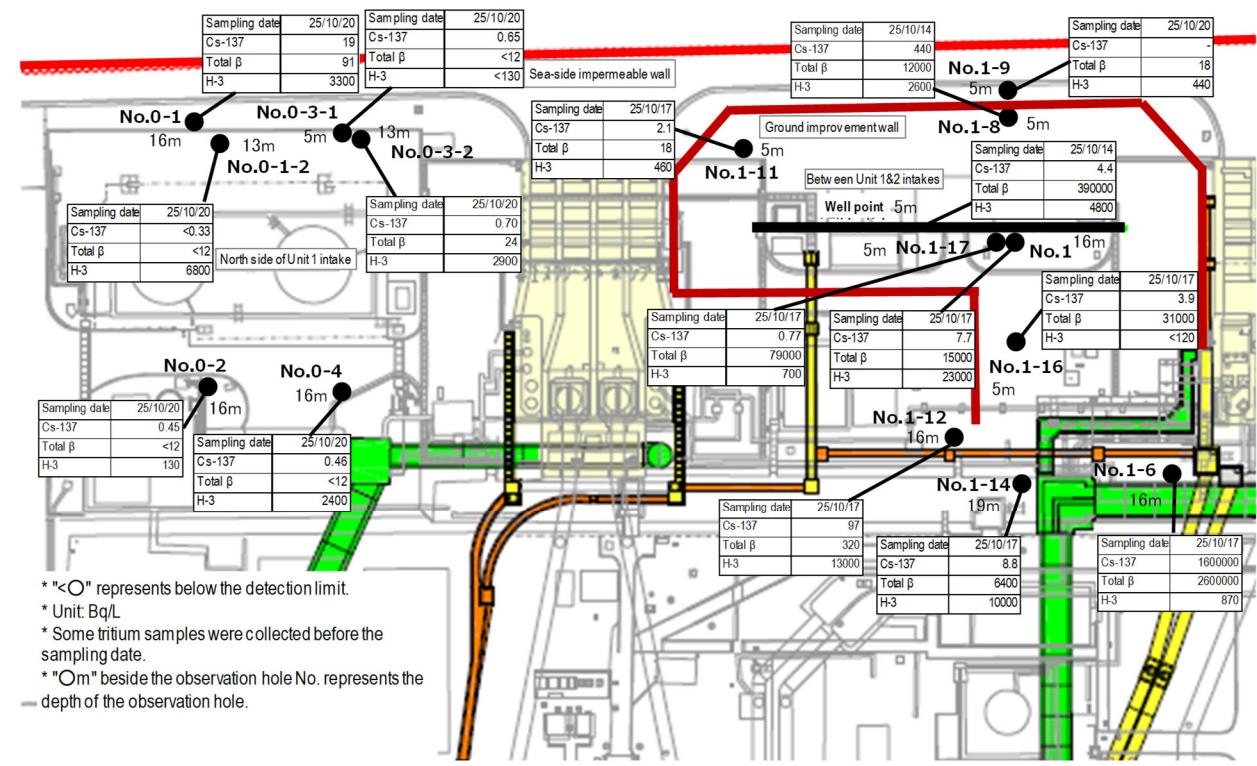
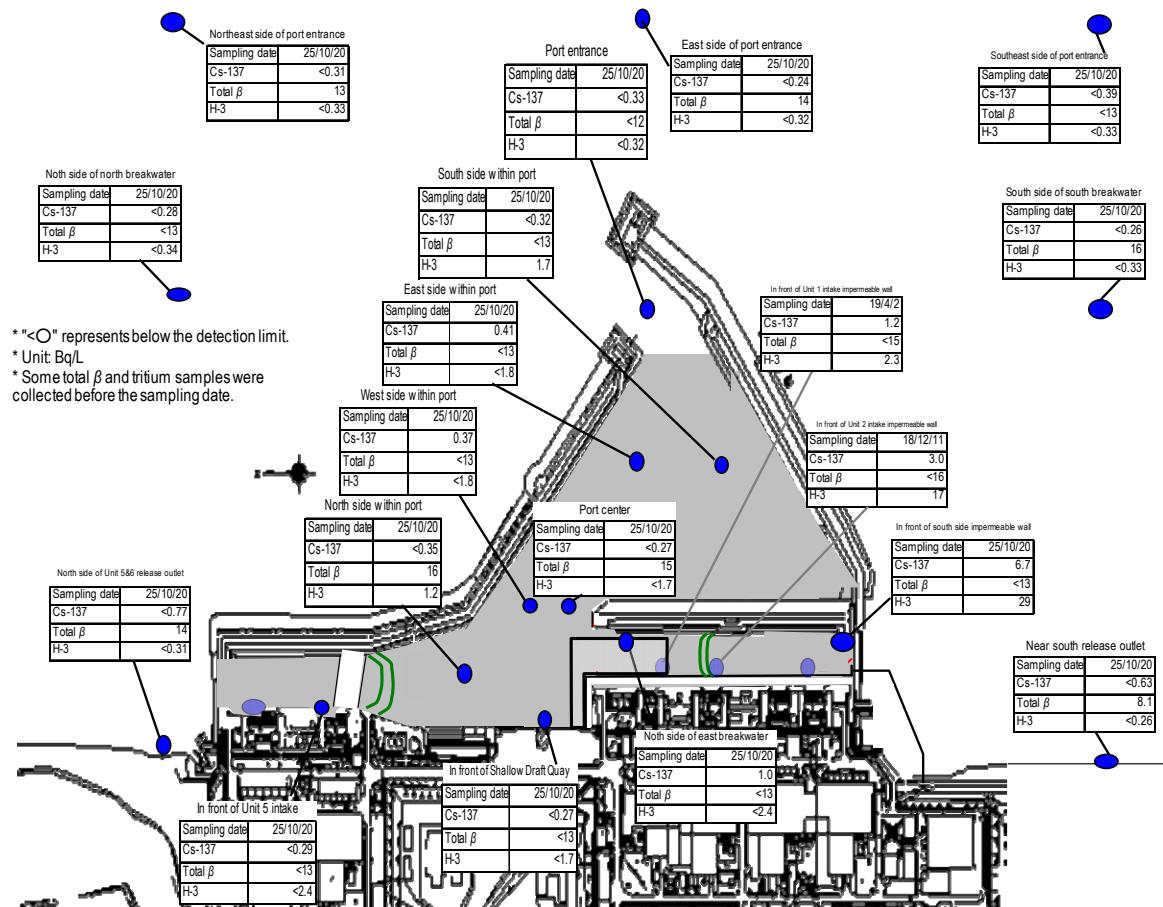
Figure 5: Seawater concentration around the port

- In the open channel area of the seawater intake for Units 1 to 4, the concentration of radioactive materials in seawater has remained below the legal discharge limit and been declining long term, despite the temporary increases in Cs-137 and Sr-90 observed during rainfall. They have also been declining following the completed installation and the connection of steel pipe sheet piles for the sea-side impermeable walls. The concentration of Cs-137 remained slightly higher in front of the south-side impermeable walls and slightly lower on the north side of the east breakwater since March 20, 2019, when the silt fence was transferred to the center of the open channel due to mega float-related construction.

- In the port area, the concentration of radioactive materials in seawater has remained below the legal discharge limit and been declining long term, despite temporary increases in Cs-137 and Sr-90 observed during rainfall. They have remained below the level of those in the Units 1-4 intake open channel area and been declining following the completed installation and connection of steel pipe sheet piles for the sea-side impermeable walls.

- In the area outside the port, regarding the concentration of radioactive materials in seawater, those of Cs-137 and Sr-90 declined and remained low after steel pipe sheet piles for the sea-side impermeable walls were installed and connected. Regarding the concentration of Cs-137, a temporary increase was sometimes observed on the north side of the Units 5 and 6 outlets and near the south outlet due to the influence of weather, marine meteorology and other factors. Regarding the concentration of Sr-90, variation was observed in FY2021 in the area outside the port (north and south outlets). Monitoring of the tendency continues, including the potential influence of weather, marine meteorology and others. During the period for which ALPS treated water was discharged, the tritium concentration increased at the sampling point near the discharge outlet, but this was considered within the assumed range based on the oceanic dispersion simulation results.

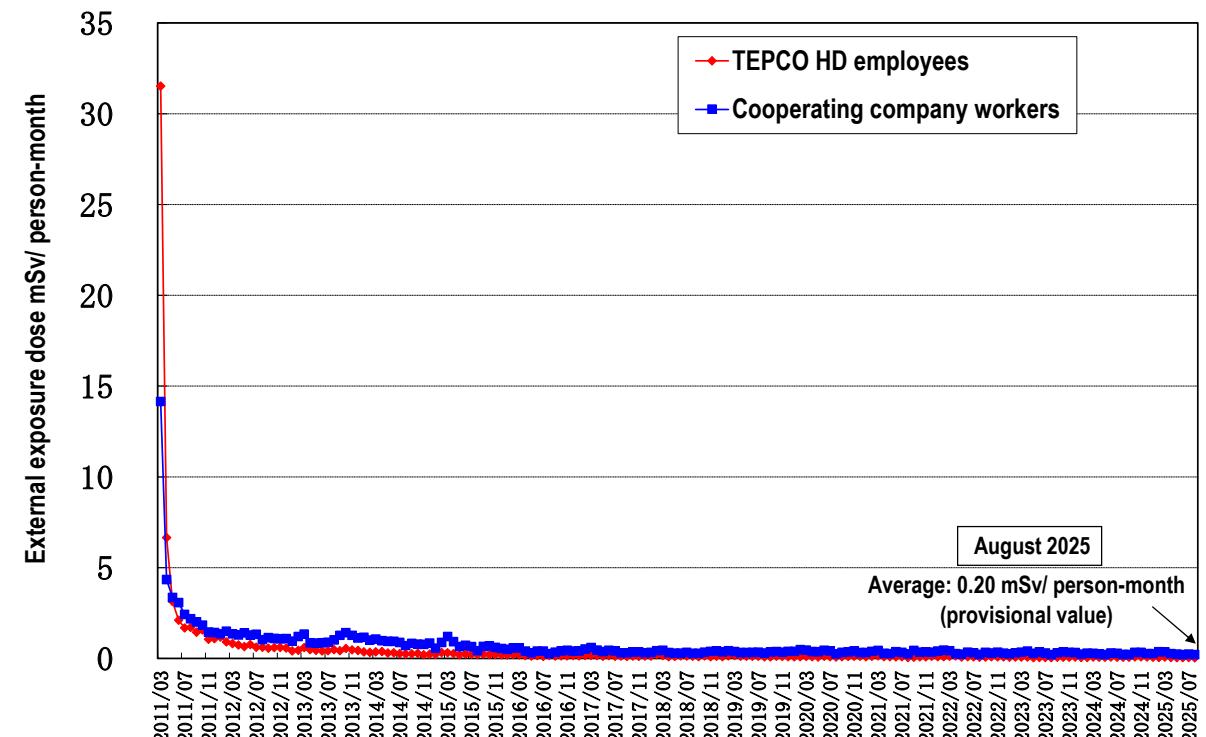
Figure 7: Changes in monthly average exposure dose of individual worker (monthly exposure dose since March 2011)

- The average exposure doses of workers were approx. 2.16, 2.18 and 2.08 mSv/person-year during FY2022, 2023 and 2024, respectively (The legal exposure dose limits are 100 and 50 mSv/person-year respectively over five years, the TEPCO HD management target is 20 mSv/person-year).

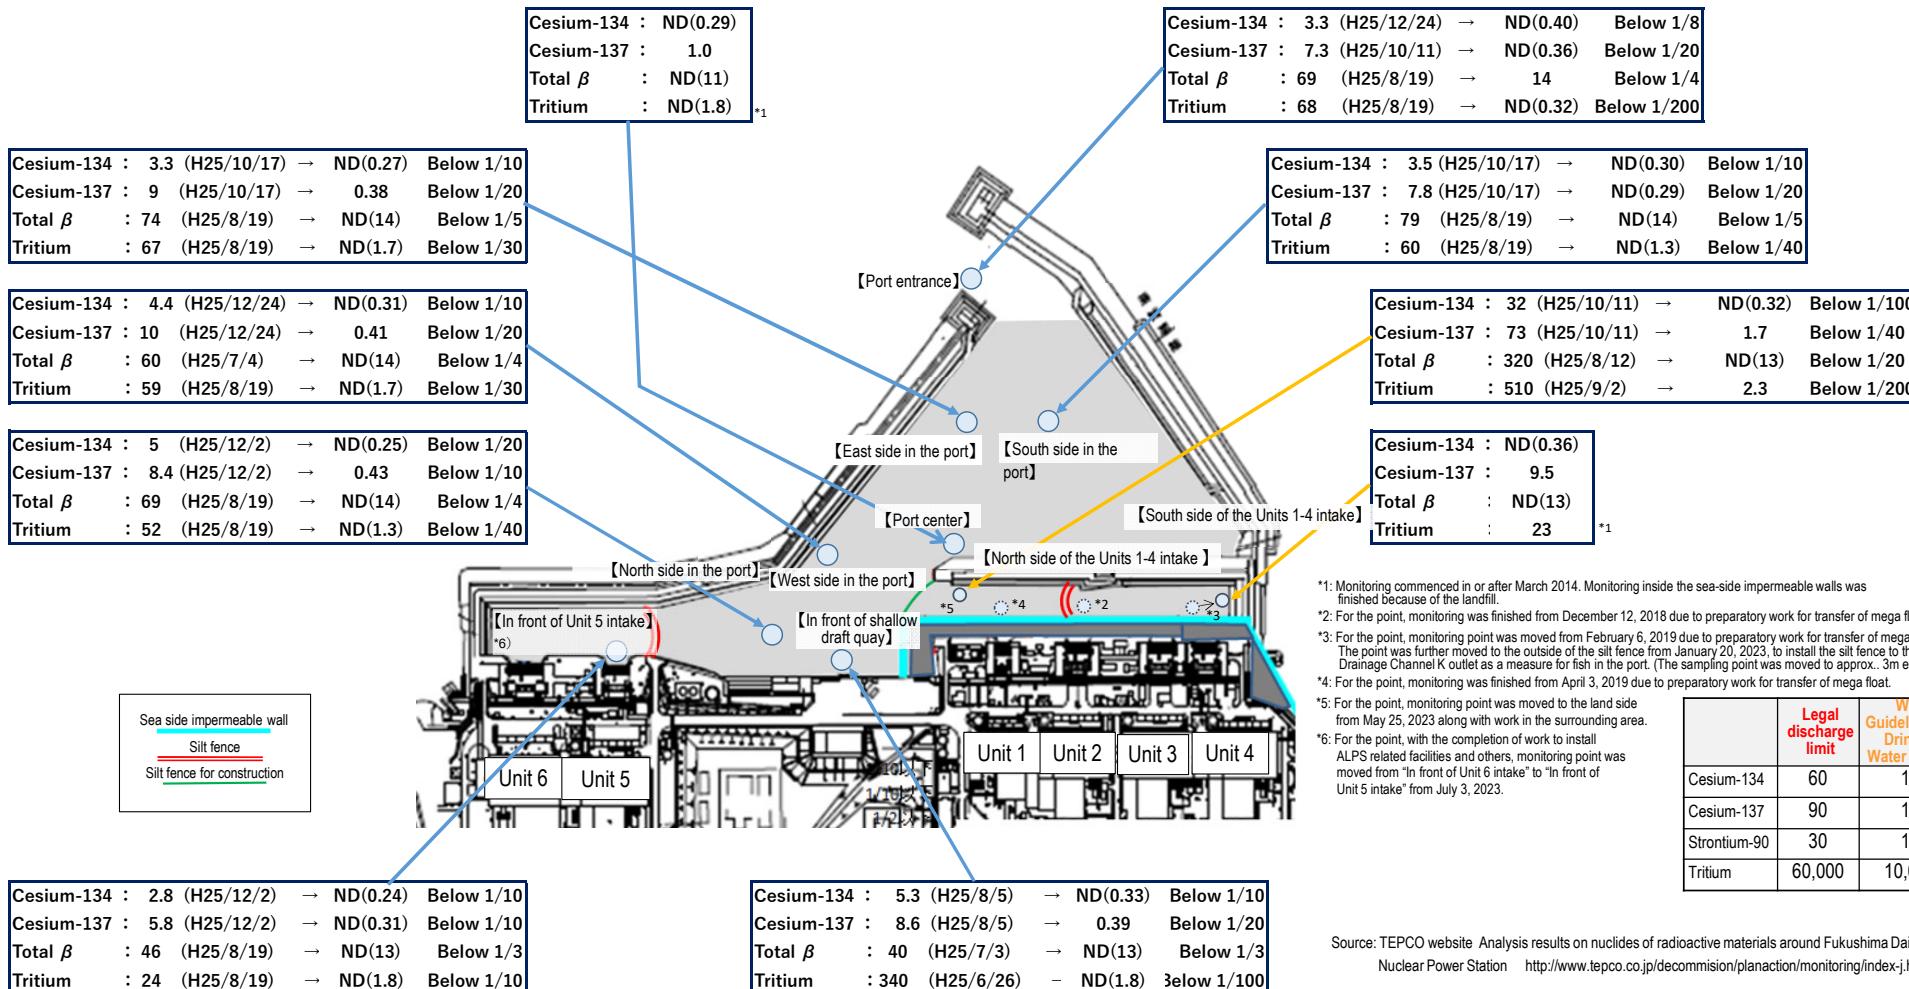
Note: The Total  $\beta$  measurement value is the total radioactivity concentration of radioactive materials that emit  $\beta$ -ray (Potassium-40, Cesium-137, Strontium-90, progeny nuclide Yttrium-90, etc.). In general, approx. 12 Bq/L of natural nuclide Potassium-40 is included in seawater.

\*1: Monitoring commenced in or after March 2014. Monitoring inside the sea-side impermeable walls was finished because of the landfill.

\*2: For the point, monitoring was finished from December 12, 2018 due to preparatory work for transfer of mega float.

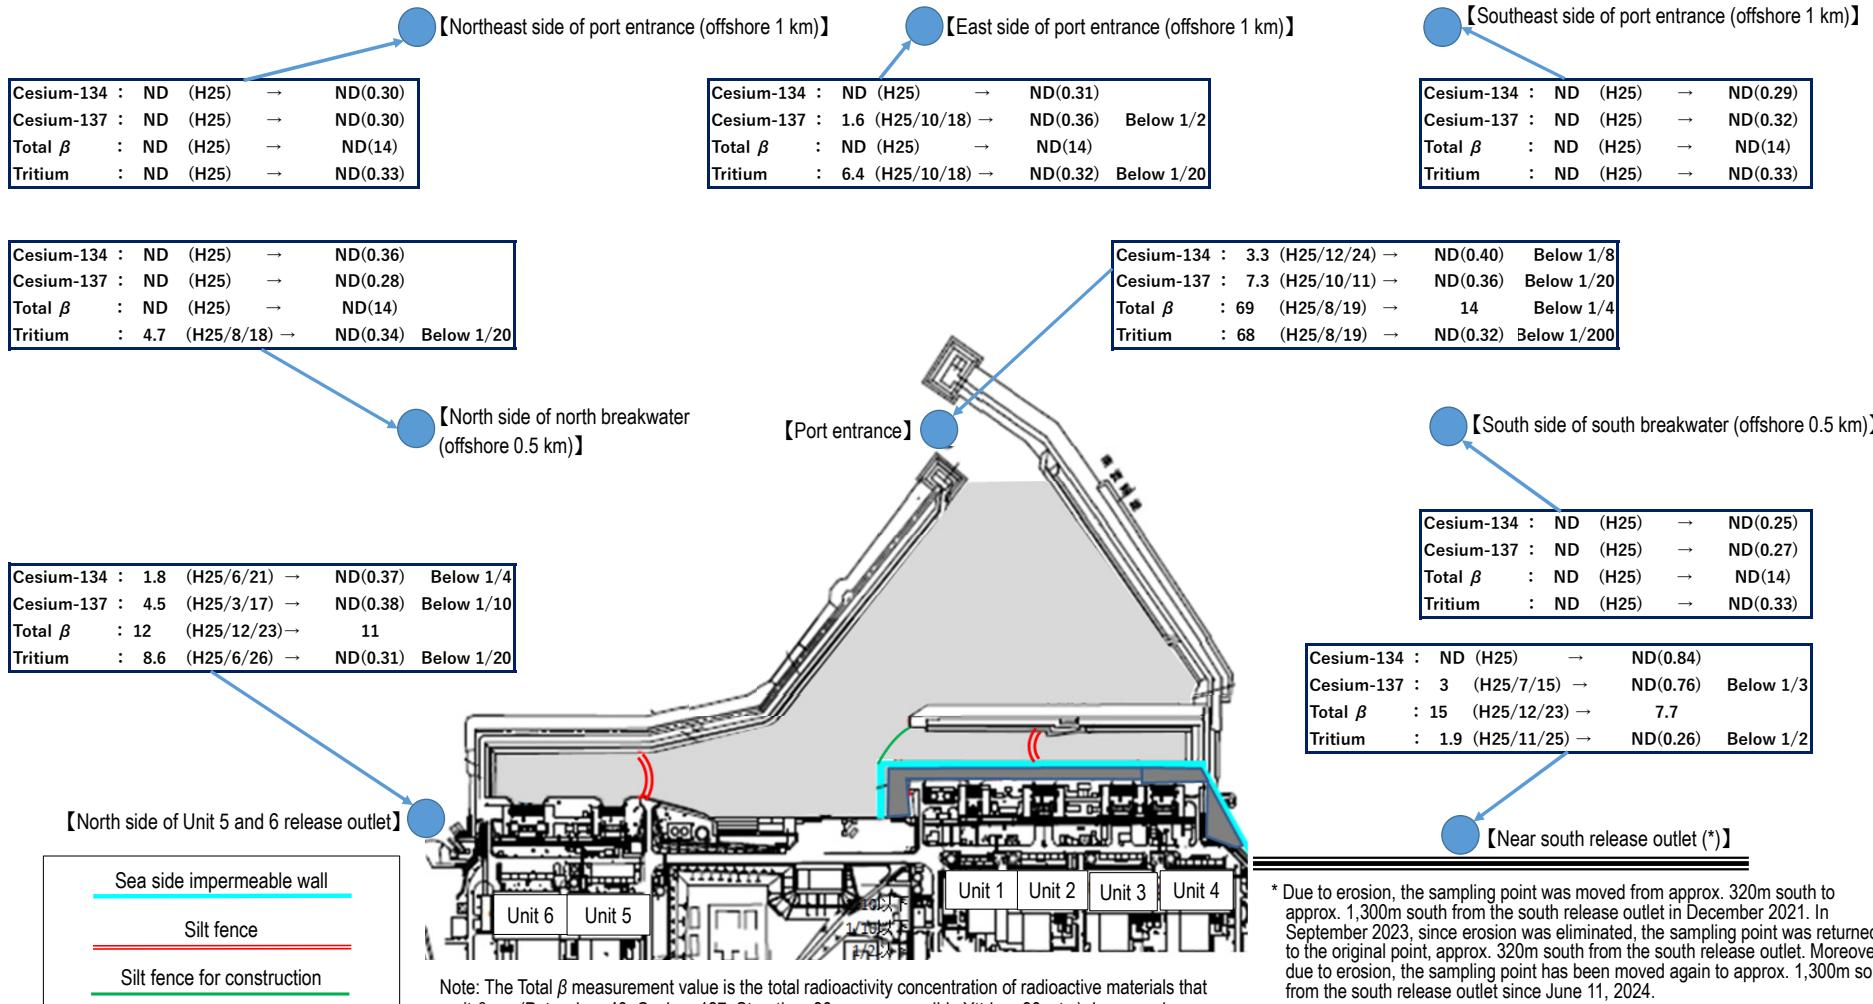
Legal discharge limit	WHO Guidelines for Drinking Water Quality
Cesium-134	60	10
Cesium-137	90	10
Strontium-90	30	10
Tritium	60,000	10,000

\* Due to erosion, the sampling point was moved from approx. 320m south to approx. 1,300m south from the south release outlet in December 2021. In September 2023, since erosion was eliminated, the sampling point was returned to the original point, approx. 320m south from the south release outlet. Moreover, due to erosion, the sampling point has been moved again to approx. 1,300m south from the south release outlet since June 11, 2024.

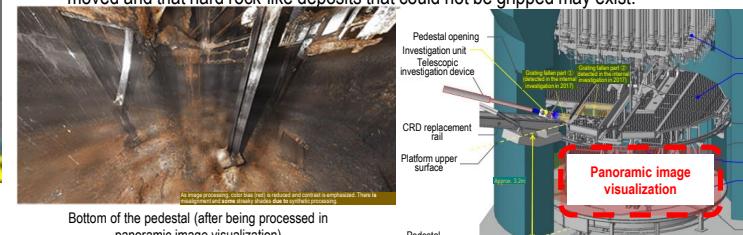
- In February 2019, an investigation touching the deposits at the bottom of the pedestal and on the platform was conducted and confirmed that the pebble-shaped deposits, etc. could be moved and that hard rock-like deposits that could not be gripped may exist.

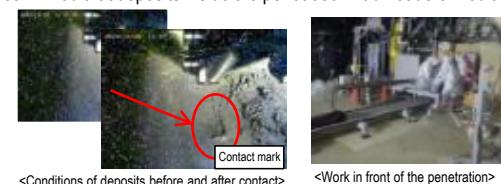
- In October 2020, a deposits contact investigation at the PCV penetration (X-6 penetration) was conducted. This confirmed that deposits inside the penetration had not deformed and come unstuck.

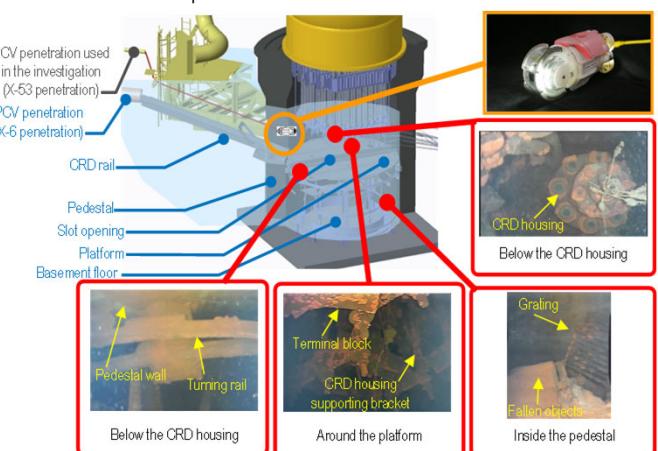
## &lt;Conditions inside the pedestal&gt;

- In July 2017, the inside of the PCV was investigated using the underwater ROV (remotely operated underwater vehicle) to inspect the inside of the pedestal. Analysis of the imagery obtained in the investigation identified damage to multiple structures and the supposed core internals.
