# Outline of Decommissioning, Contaminated Water and Treated Water Management

## Main decommissioning work and steps

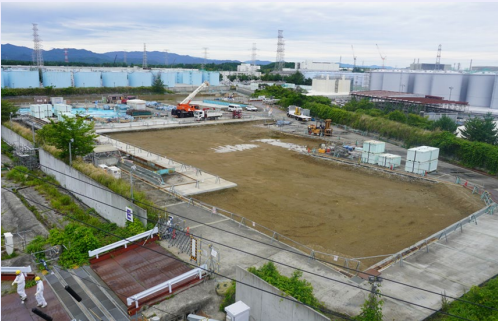
< E area after D1 tank was dismantled (photo taken on June 15, 2026) >

Completion of the dismantling of flanged tanks in E Area

Replacement of flanged tanks used to store contaminated water from Units 1-4 right after the accident with welded tanks that have a lower risk of leaking has been underway. Dismantling of those tanks began in May 2015, and 333 out of a total of 334 tanks had been dismantled until July 2024. The last remaining tank, D1 tank in E area, had been used to store residual water from the bottoms of the other tanks during the dismantling process, which led to the accumulation of sludge with high concentrations of radioactive materials. Therefore, removal of the sludge from this tank was conducted carefully and completed in November 2025. The inside of the tank was cleaned and decontaminated, after which dismantling was completed on June 15, 2026.

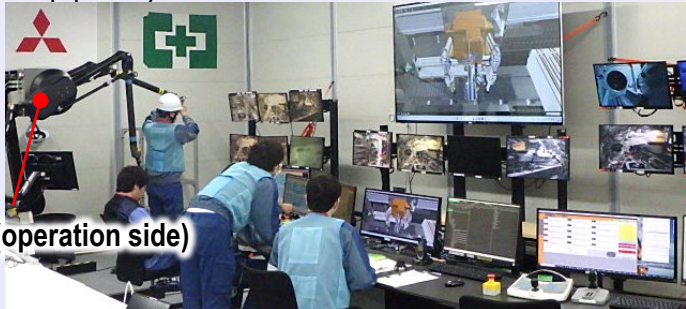
Manipulator (operation side)

< Operation verification >

Operation verification of each piece of equipment inside the enclosure, where the robotic arm is stored, is underway. After confirming their integrity, removal of obstructions inside the PCV and establishment of an access route will commence.

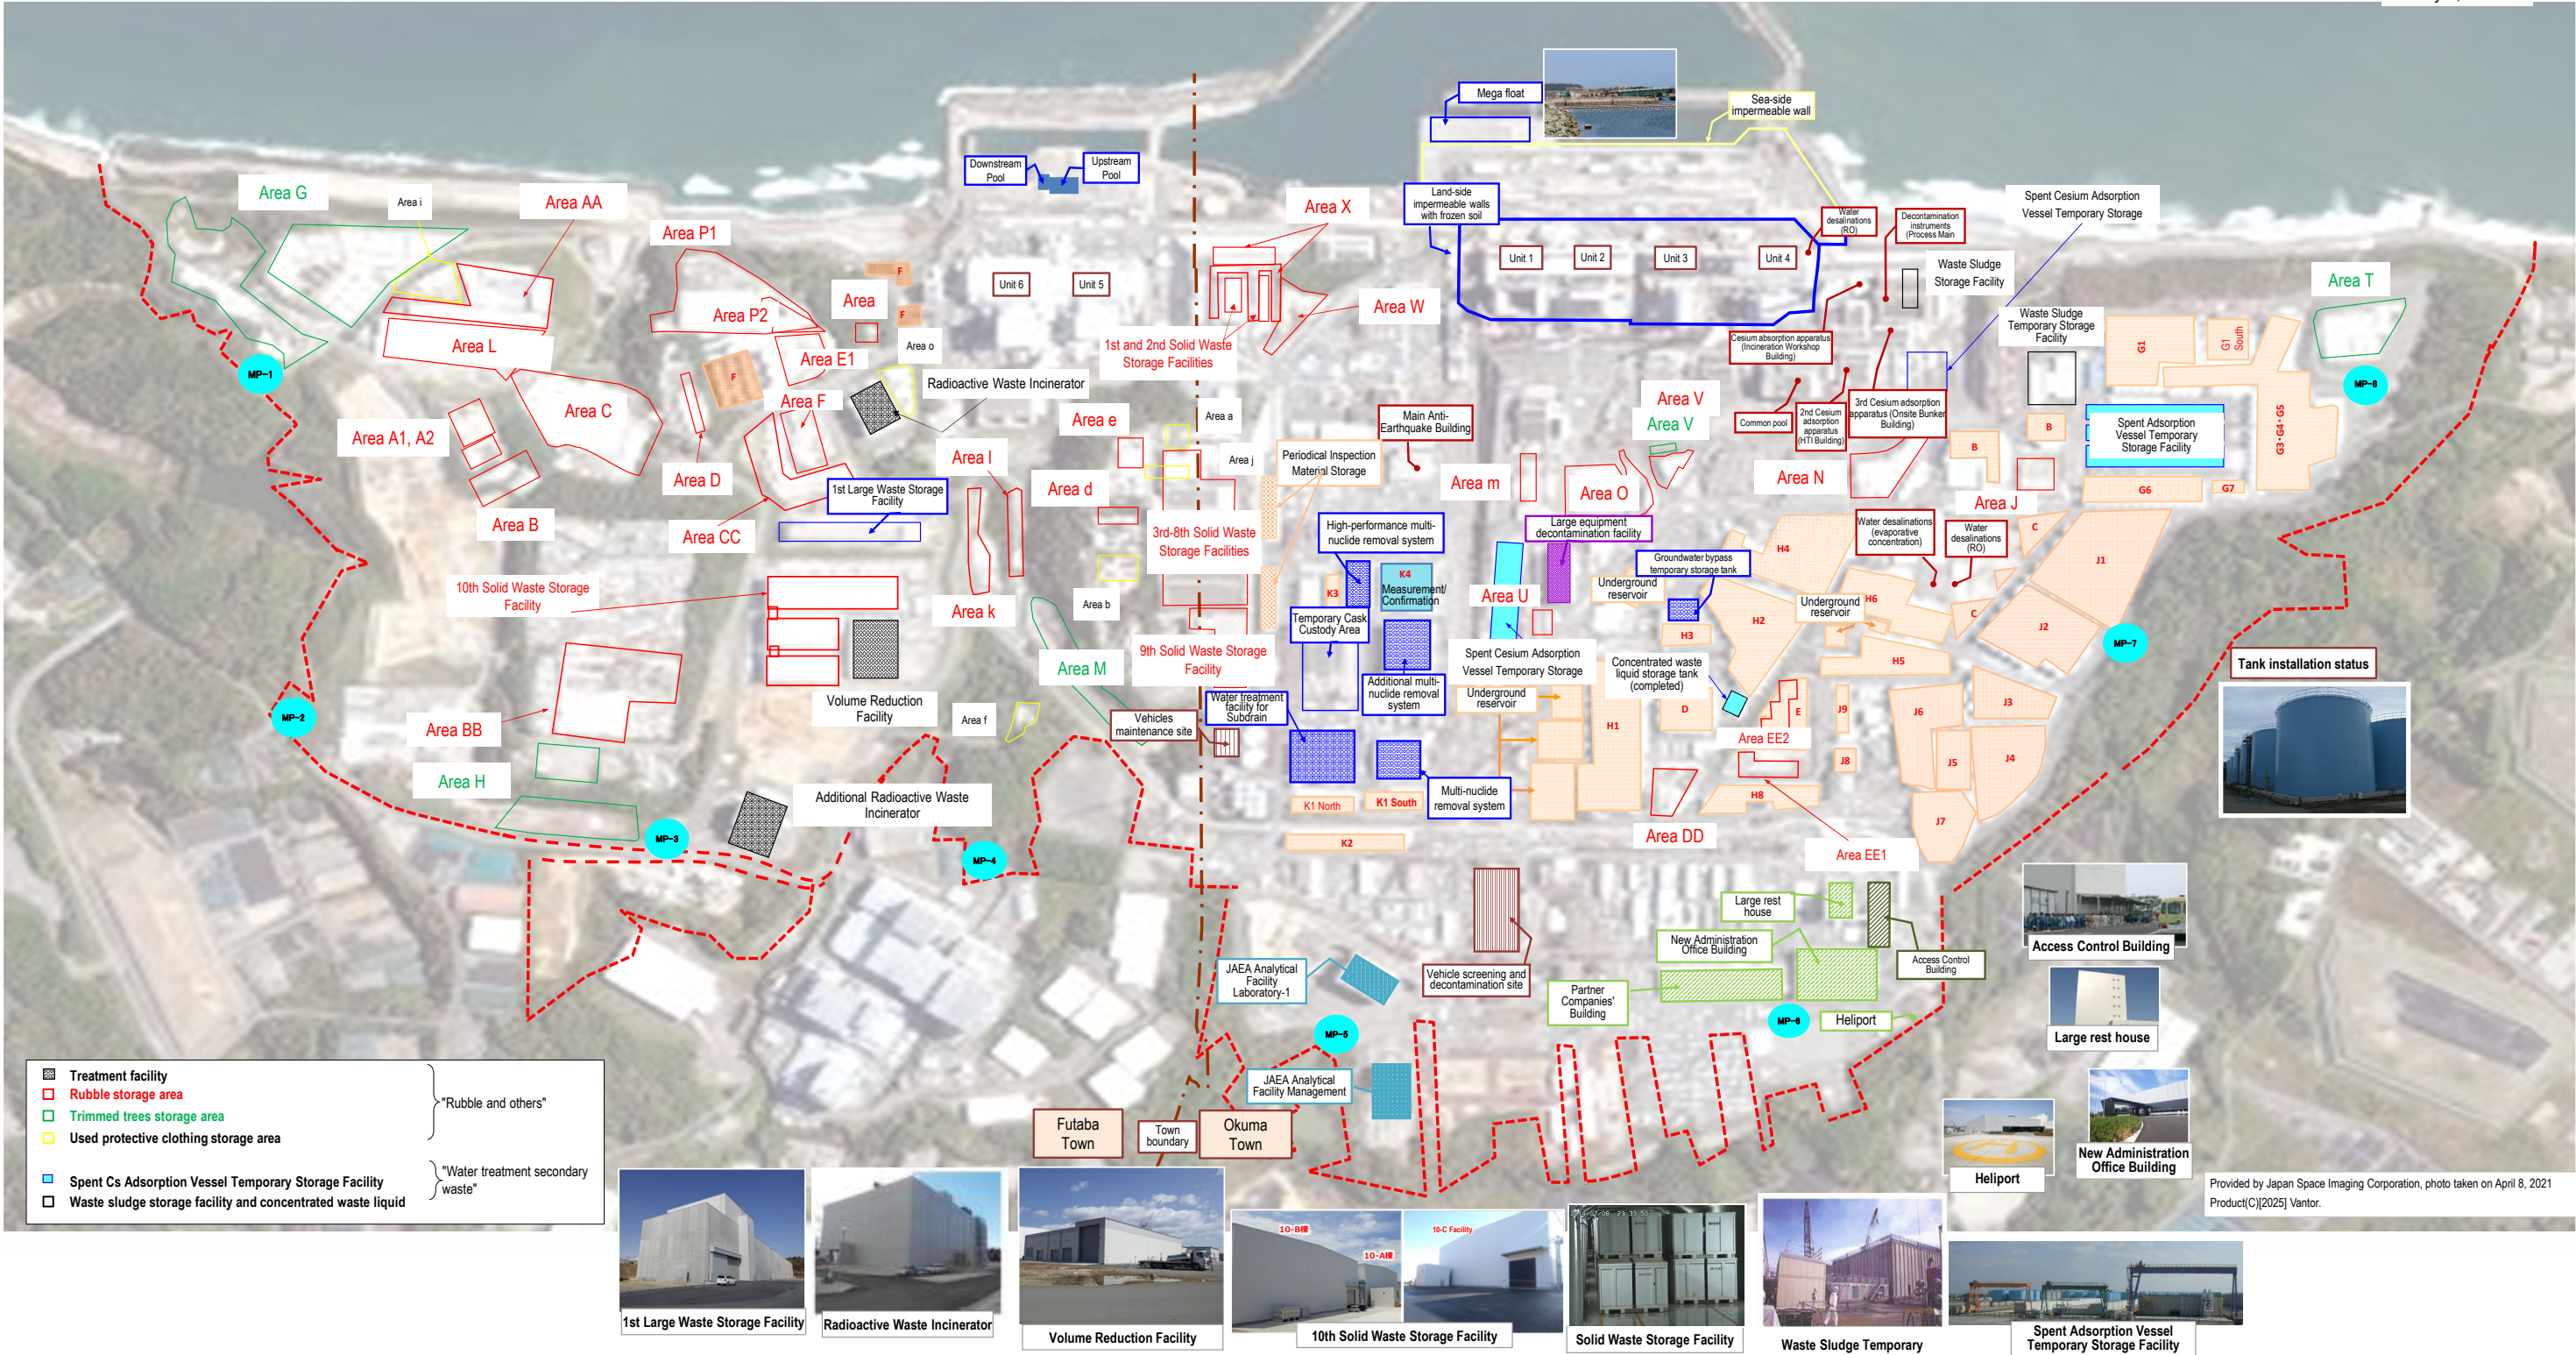
- Efforts to promote contaminated water management based on three basic policies:

① "Removing" the contamination source ② "Redirecting" groundwater from the contamination source  
③ "Preventing leakage" of contaminated water
