# Estimation of amount of radioactivity that leaked from the notch tanks

# Status of measures to suppress entry of radioactive materials into temporary storage area P batch basin and drain ditch

# Cause of overflow from notch tanks (speculated)

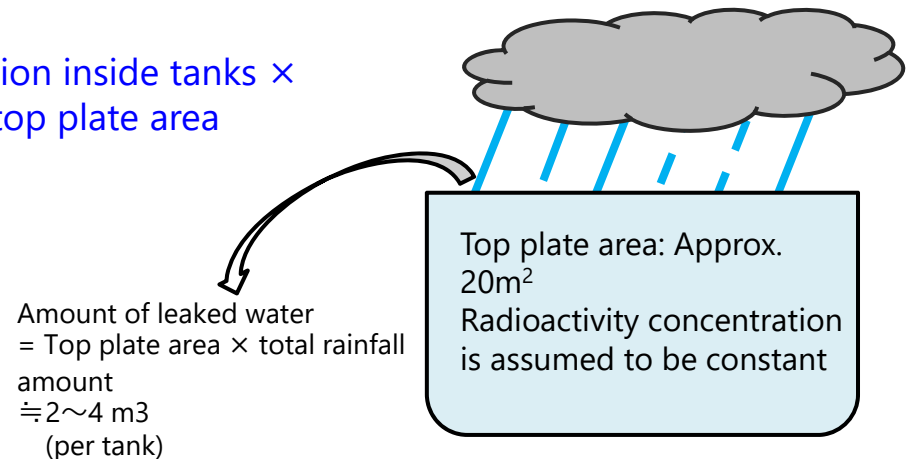
$$\text{Amount of leaked radioactivity} = \text{Radioactivity concentration inside tanks} \times \text{Total rainfall amount} \times \text{top plate area}$$

- Radioactive concentration inside tank (Sr-90)  
Notch tank (north): 60,000Bq/L  
Notch tank (south): 23,000Bq/L
- Total rainfall amount: ① 101.5mm (6/29 0:00~7/8 24:00)
- ② 201mm (5/21 0:00~7/8 24:00)
- Top plate area: Approx. 20m<sup>2</sup>

Estimated amount of radioactivity that leaked from the notch tanks (Sr-90)  
Notch tank (north): 120-240 million Bq  
Notch tank (south): 46-97 million Bq    ⇒ Total: 170-330 million Bq

\*2: Amount of overflow from the notch tanks was assessed by conservatively assuming that all rainwater that entered the tanks overflowed in the term from June 29 or May 21 until leakage prevention measures were implemented on July 8. As a result, the amount of radioactivity (estimated value) that leaked from the two notch tanks was assessed as 170-330 million Bq.

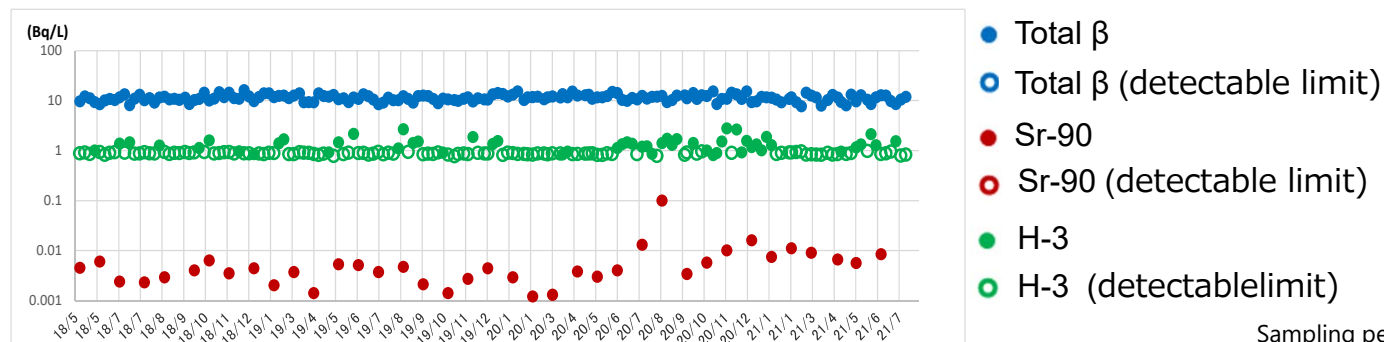
Units 5 and 6 outlet north-side point (sampling point closest to Jinbazawa River)

- No significant rise of total  $\beta$  radioactive concentration has been observed at the temporary storage area P catch basin and Jinbazawa River estuary (river part) after covering the subject notch tanks and temporary storage area ground surface.

Sampling period:  
May 1, 2018 ~ July 14, 2021

- Amount of radioactivity that leaked from the two notch tanks is estimated to be 170-330 million Bq in Sr-90.
- It is assessed as having no impact on the environment, since some of the water that leaked from the tanks remains in the soil near the tanks, some of notch tank water flows into the temporary storage area P catch basin and Jinbazawa River after its radioactive concentration decreases as the water passes through said catch basin and grit chamber, and the radioactive concentration of nearby seawater is within the normal fluctuation range (\*1).

(\*1) Units 5 and 6 outlet north-side point (sampling point closest to Jinbazawa River), north breakwater north-side point, monitoring points on the northeast side of the port

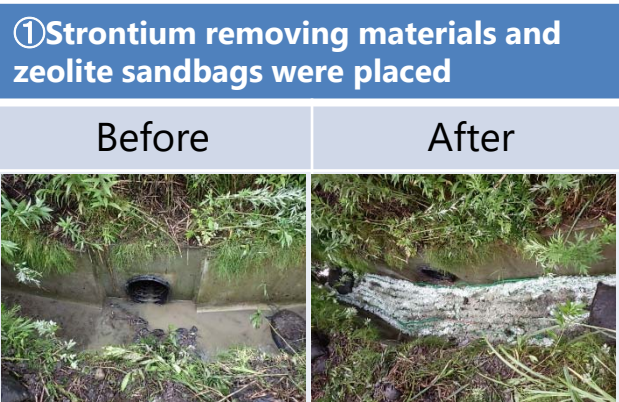
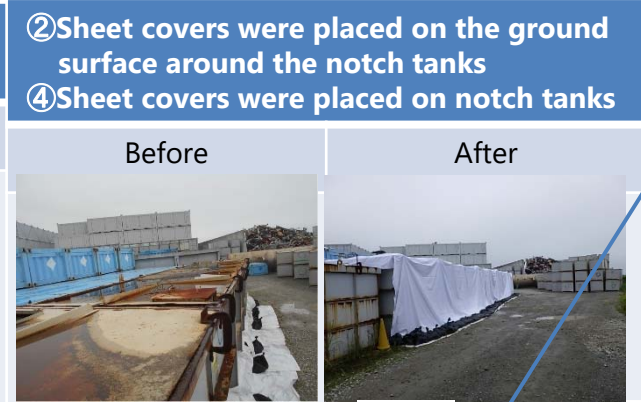
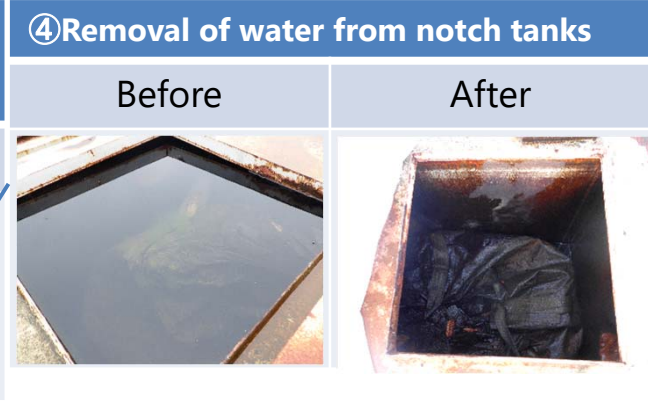
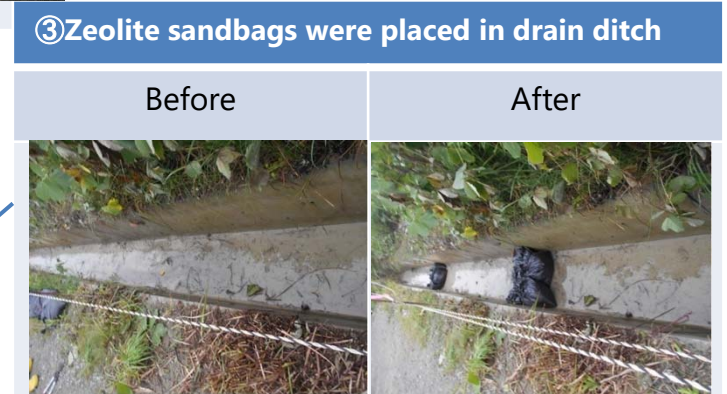
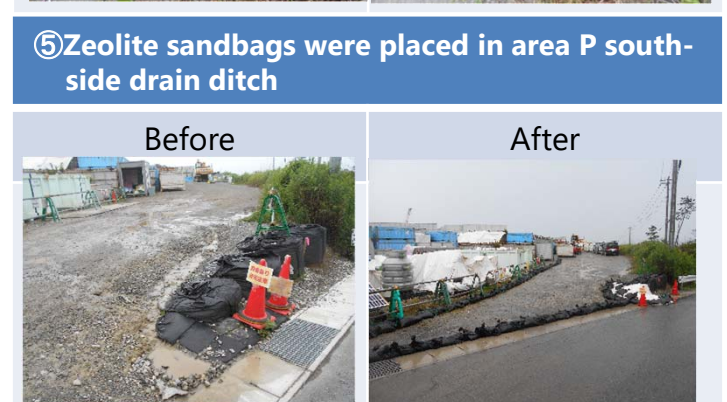
[Reference] Situation of measures to suppress entry of radioactive materials into temporary storage area P batch basin and drain ditch

- ① Strontium removing materials and zeolite sandbags were placed in the catch basin (July 5)
- ② Sheet covers were placed on the ground surface around the notch tanks (July 6)
- ③ South-side drain ditch and drain ditch of the east-side flow-in point (upstream) were cleaned and zeolite sandbags were placed (July 7)
- ④ Sheet covers were placed on two notch tanks and zeolite sandbags were placed around the tanks (July 8)
- ⑤ As much water as possible was removed from the two notch tanks which were filled with water, using a pump truck (July 11)
- ⑥ Zeolite sandbags were placed in the south-side drain ditch so that rainwater would not enter (July 11)
- ⑦ Sandbags are being removed from the area around the two notch tanks since July 16

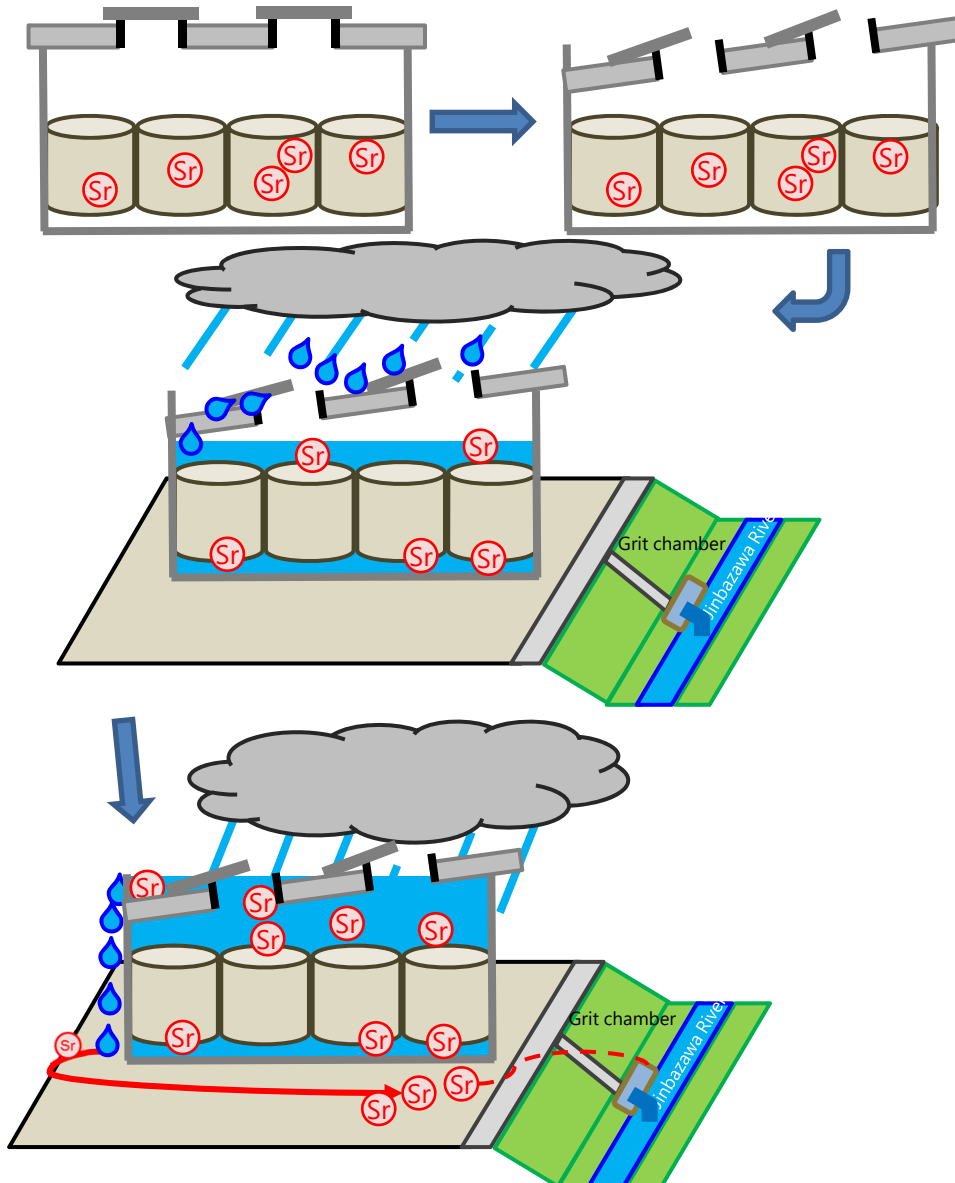
High  $\beta$  contaminated soil is stored in notch tanks

Hatch lid opened due to some kind of reason and the end of the top place slipped into the notch tank

Rainwater that fell on the top plate and hatch entered the notch tank

High  $\beta$  radiation source dissolved into rainwater inside the notch tank (hereinafter referred to as notch tank water)

Notch tank water overflowed during a rainfall after May 21\* \*Previous sampling date

Some of the notch tank water reached the temporary storage area P catch basin via the side ditch

6/29 Tptal  $\beta$  of temporary storage area P drain ditch significantly increased

Some of the notch tank water that remained in P catch basin flowed into Jinbazawa River via the grit chamber

- Based on the aforementioned investigation result, it is presumed that total  $\beta$  value of the temporary storage area P catch basin temporarily increased due to the following scenario: Rainwater on the top plate and hatch entered the tank from the gap between the notch tank top plate and tank due to said top plate being displaced for some kind of reason; Later, rainwater eluted the tank content containing radioactive materials and the rainwater overflowed (\*2) from the tank at some point after May 21 (\*1); Some of said rainwater flowed to the east-side flow-in point.

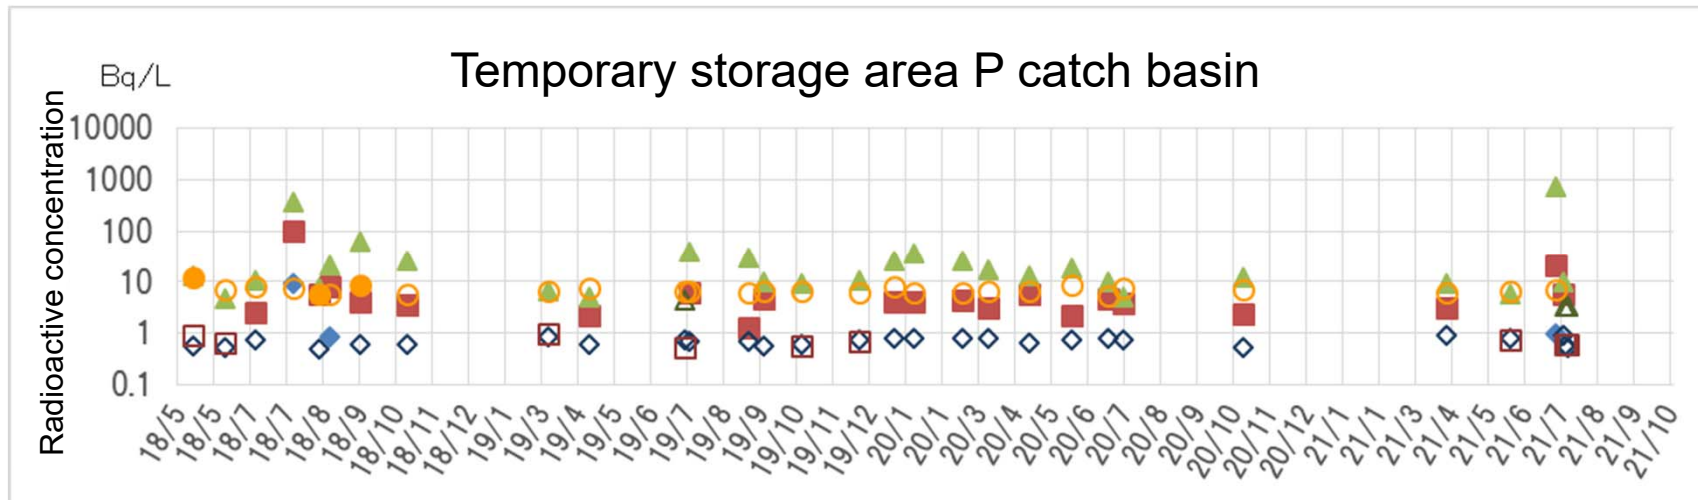
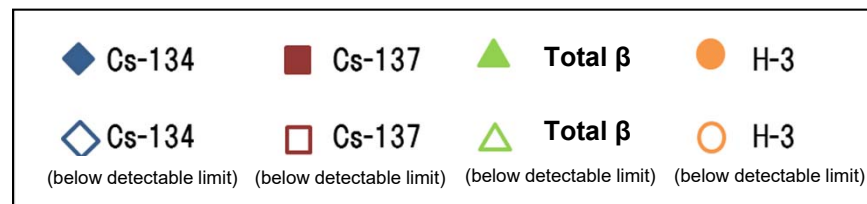
[Reference result] Water analysis result of temporary storage area P and Jinbazawa River

Sampling period:  
May 1, 2018 ~ July 14, 2021

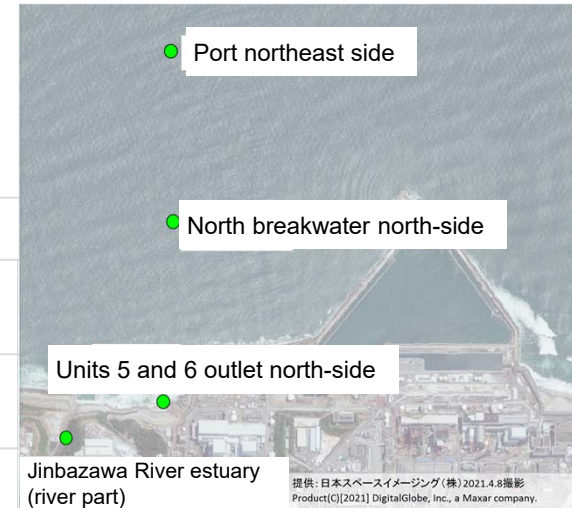
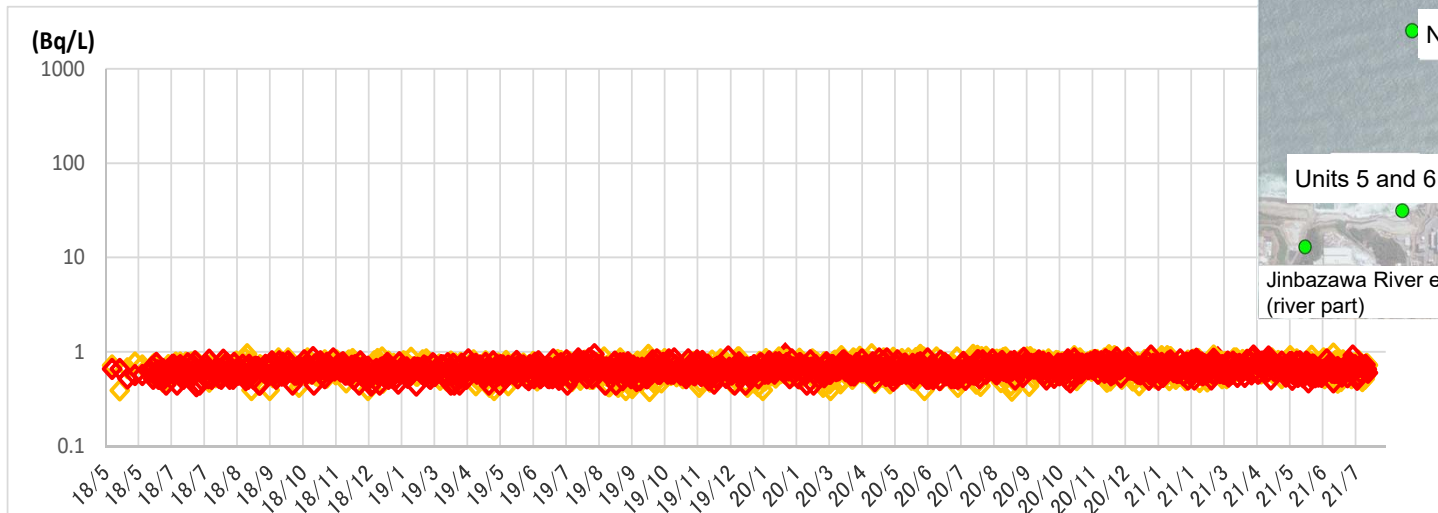
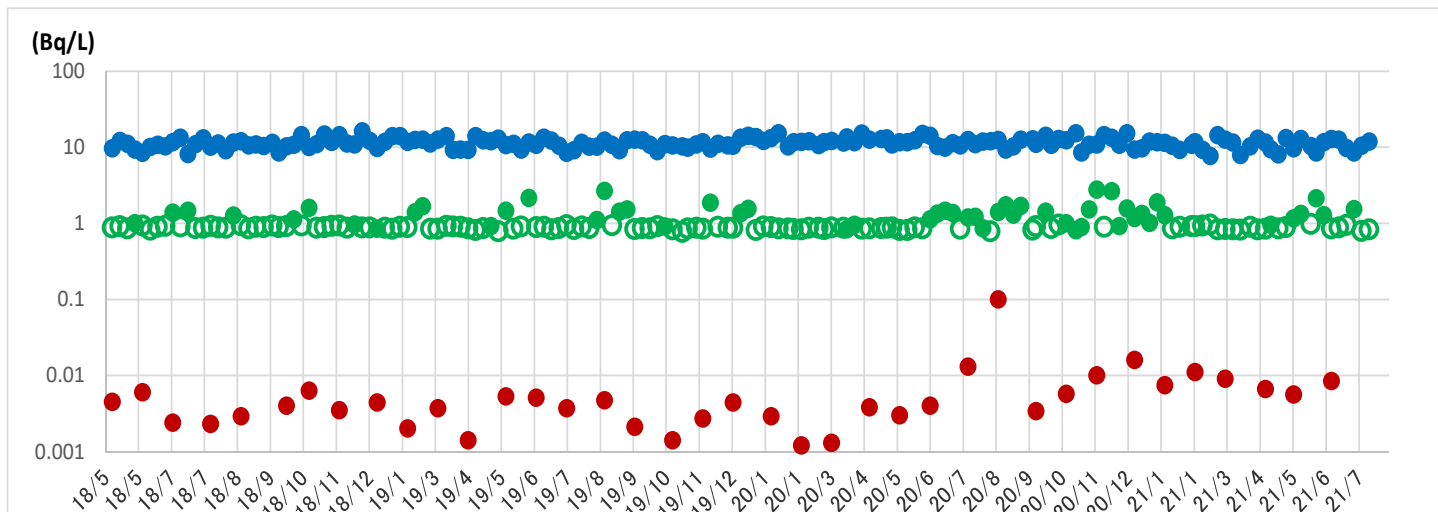
# [Reference] Analysis result of Units 5 and 6 outlet north-side seawater

Analysis result of Units 5 and 6 outlet north-side seawater did not find any significant increase

- ◆ Cs-134
- ◇ Cs-134 (Detectable limit)
- ◆ Cs-137
- ◇ Cs-137 (Detectable limit)

- Total β
- Total β (Detectable limit)
- Sr-90
- Sr-90 (Detectable limit)
- H-3
- H-3 (Detectable limit)

Sampling period:  
May 1, 2018 ~ July 14, 2021

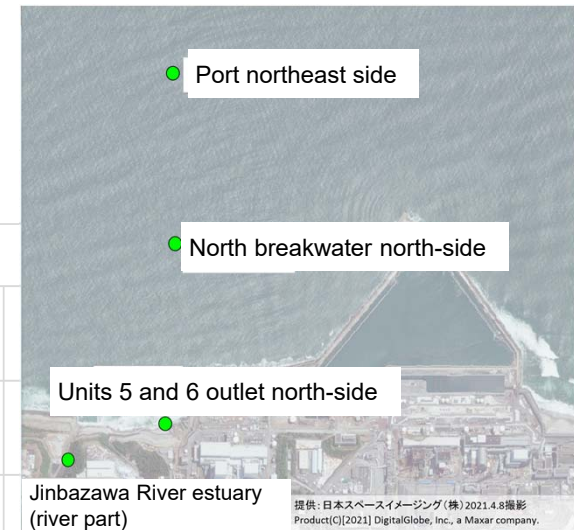
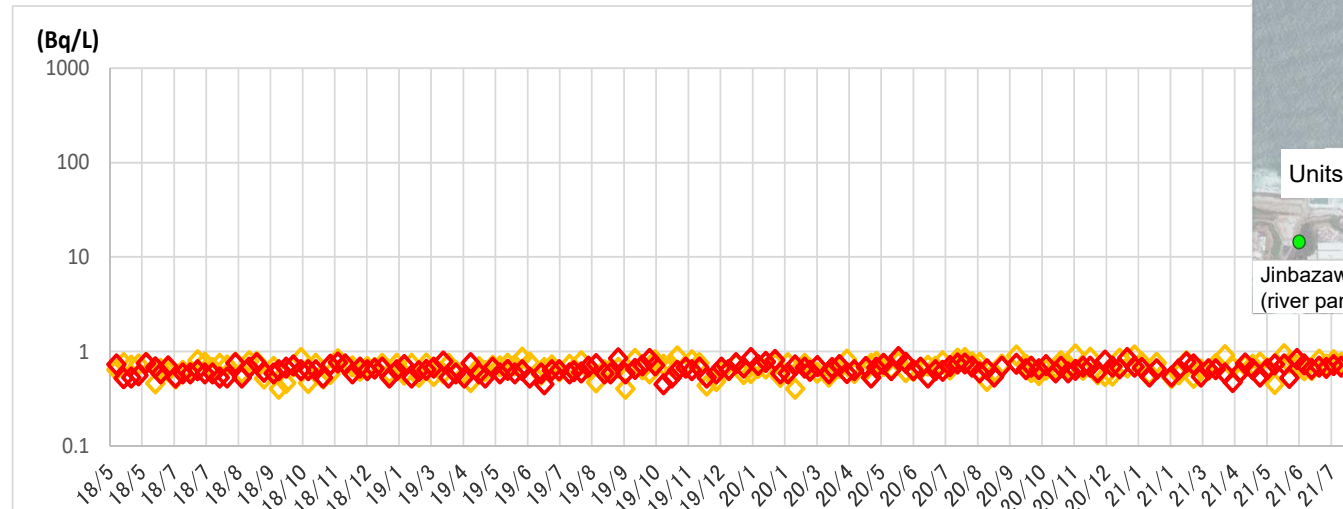
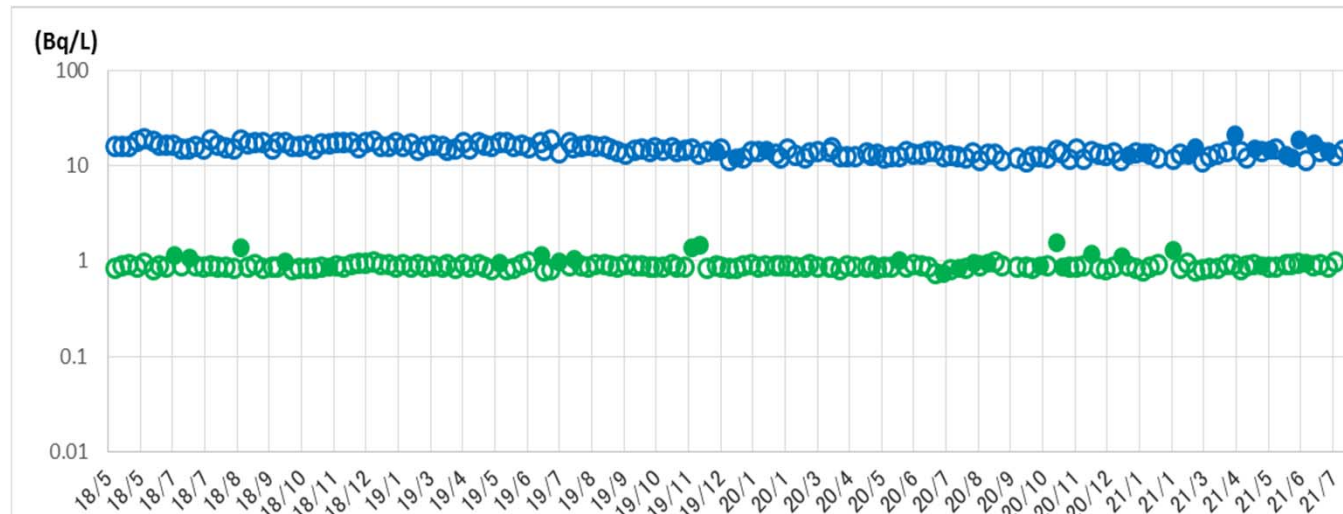
# [Reference] Analysis result of north breakwater north-side seawater

Analysis result of north breakwater north-side seawater did not find any significant increase

- ◆ Cs-134
- ◇ Cs-134 (Detectable limit)
- ◆ Cs-137
- ◇ Cs-137 (Detectable limit)

- Total β
- Total β (Detectable limit)
- H-3
- H-3 (Detectable limit)

Sampling period:  
May 1, 2018 ~ July 14, 2021

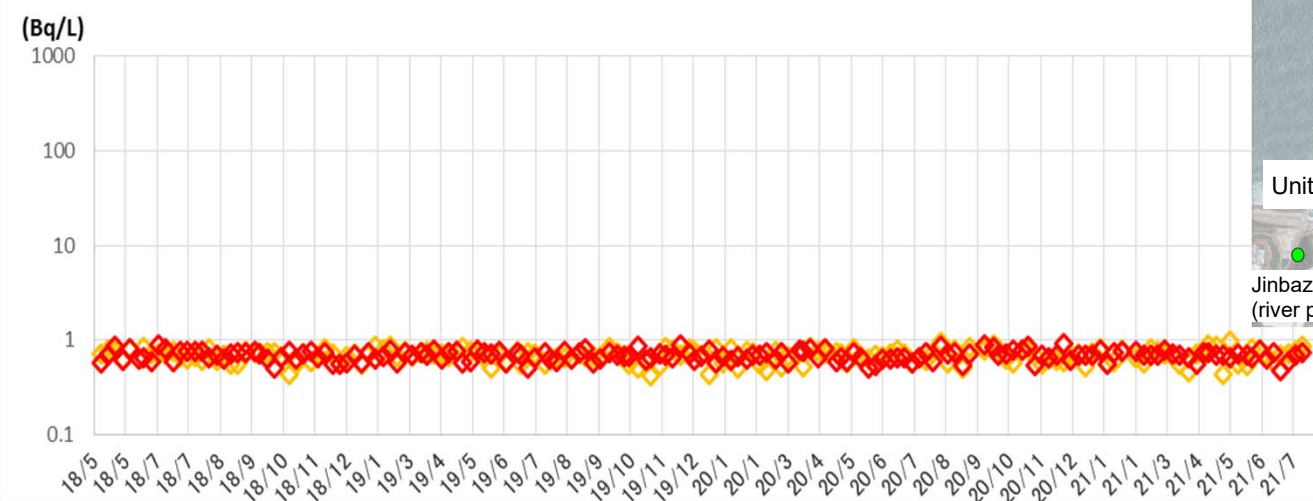
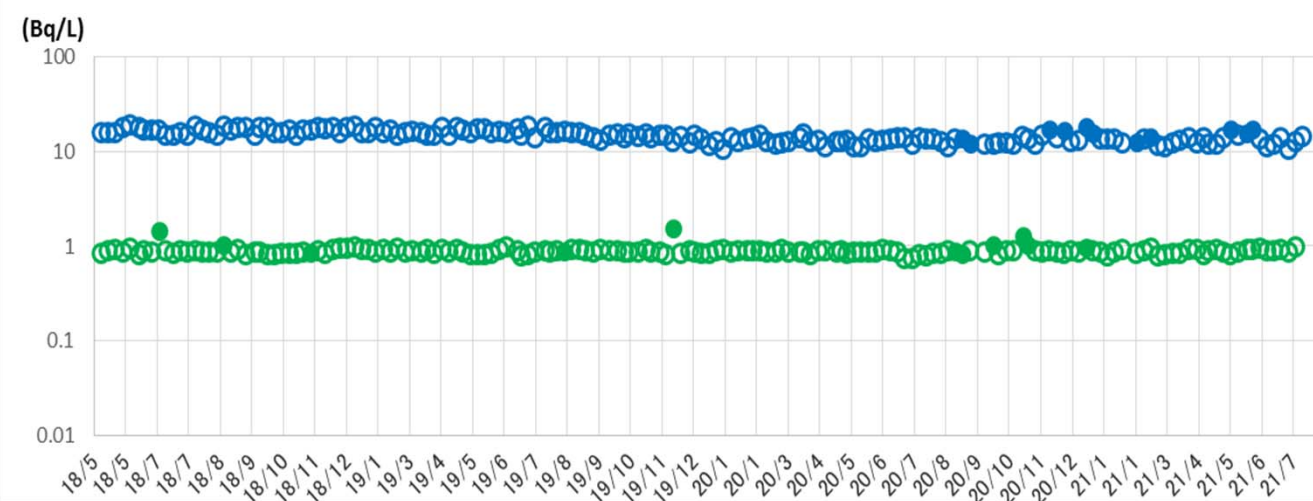
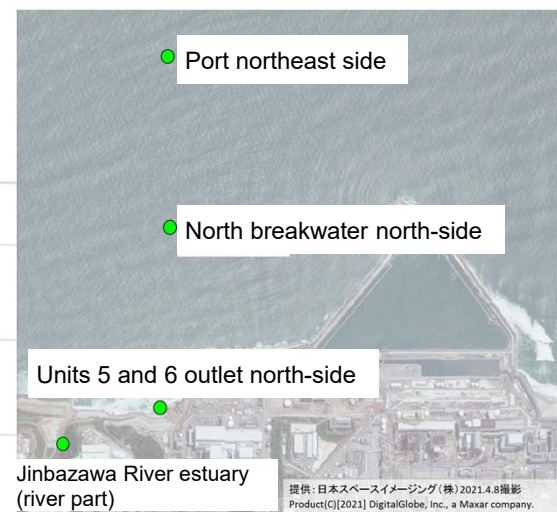
# [Reference] Analysis result of port northeast-side seawater

Analysis result of port northeast-side seawater did not find any significant increase

- ◆ Cs-134
- ◇ Cs-134 (Detectable limit)
- ◆ Cs-137
- ◇ Cs-137 (Detectable limit)
- Total β
- Total β (Detectable limit)
- H-3
- H-3 (Detectable limit)

Sampling period:  
May 1, 2018 ~ July 14, 2021

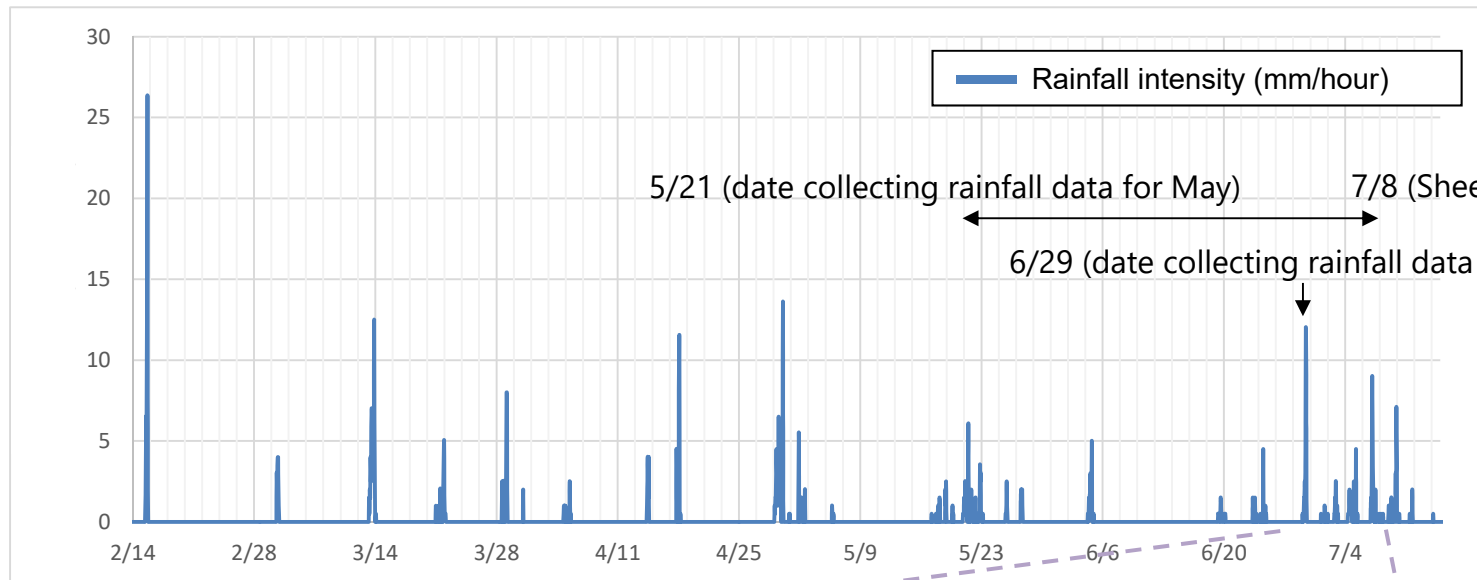
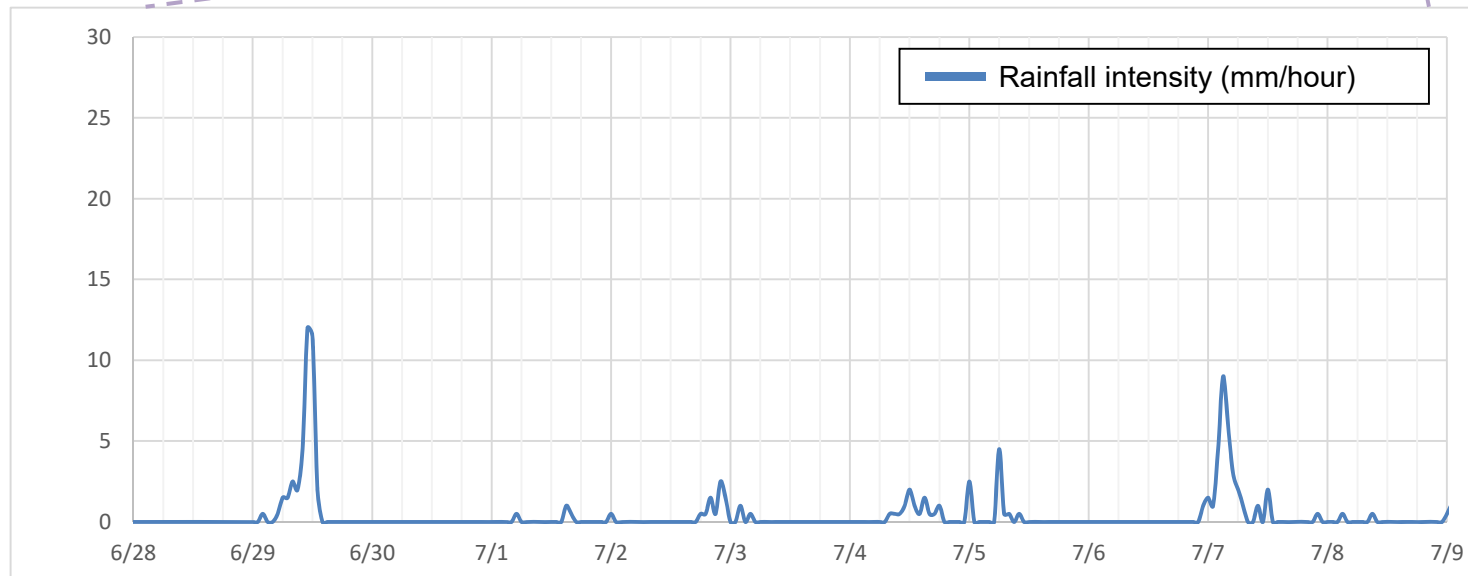
# [Reference] Rainfall

Data period: 2021/2/14~2021/7/14

Enlarged data  
for 6/28 0:00 to  
7/9 0:00

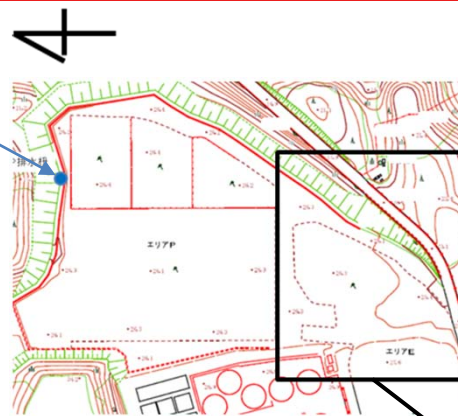
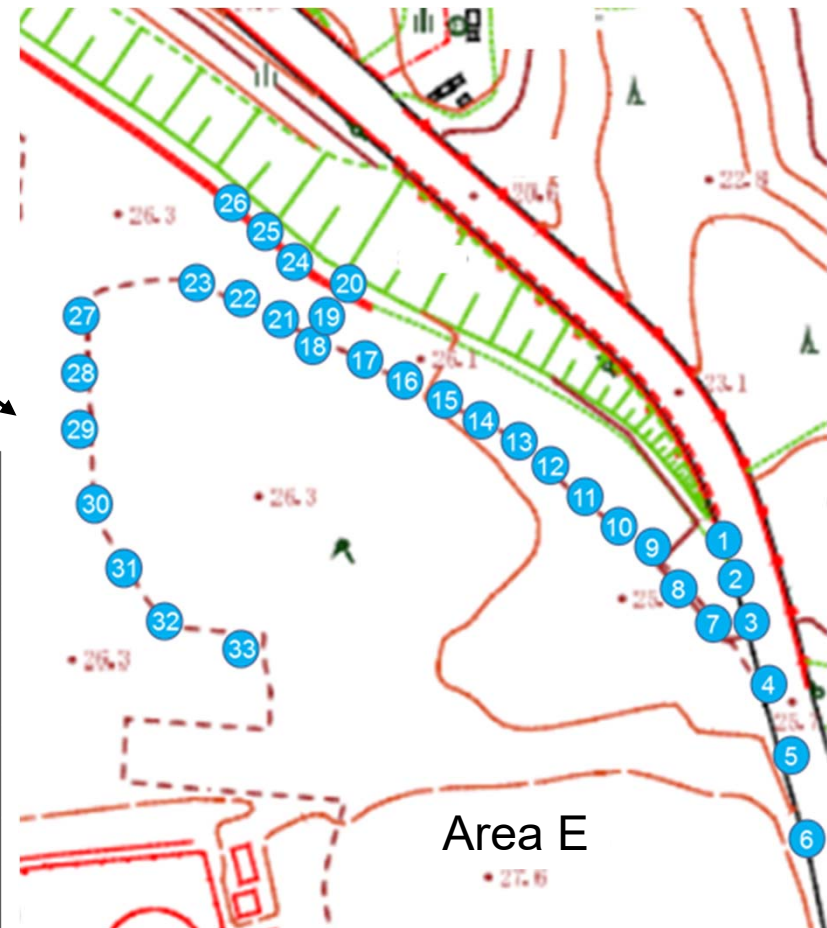
Enlarged view

Measured date: July 6, 2021

Regular sampling point  
(catch basin)

Point	1cm dose equivalent rate	70 $\mu\text{m}$ dose equivalent rate
1	4	5
2	4	10
3	4	6
4	6	15
5	7	9
6	17	18
7	5	11
8	6	13
9	5	22
10	5	8
11	5	7
12	6	7
13	5	5
14	5	5
15	5	5
16	5	7
17	5	7
18	5	130
19	4	4
20	4	12

Point	1cm dose equivalent rate	70 $\mu\text{m}$ dose equivalent rate
21	4	150
22	4	170
23	4	20
24	3	4
25	3	4
26	3	3
27	8	10
28	10	15
29	13	20
30	14	15
31	14	15
32	9	10
33	13	28

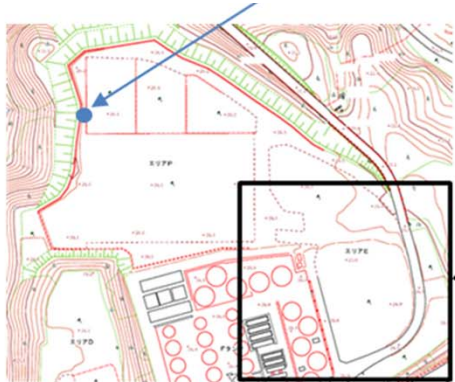
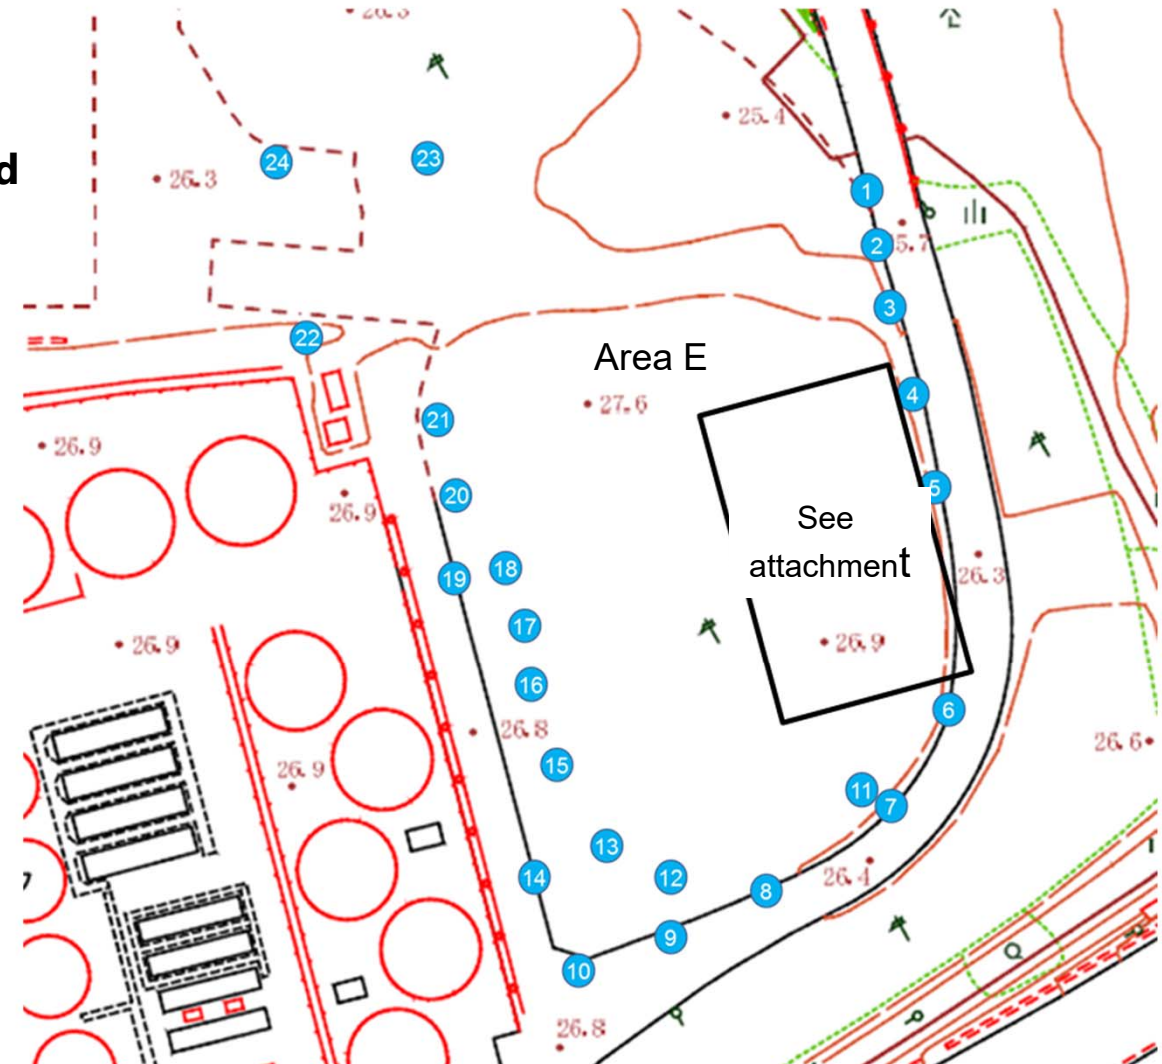
**Enlarged view**

Regular sampling point (catch basin)

Measured date: July 8 and 16, 2021

Point	1cm dose equivalent rate	Point	70 $\mu\text{m}$ dose equivalent rate
1	10	13	45
2	7	14	5
3	25	15	40
4	17	16	35
5	30	17	90
6	21	18	75
7	19	19	10
8	27	20	60
9	19	21	23
10	10	22	20
11	60	23	16
12	50	24	50

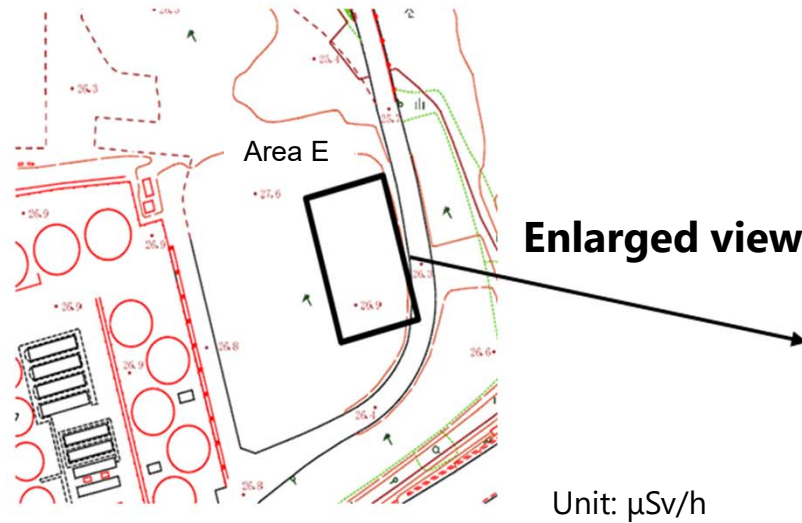
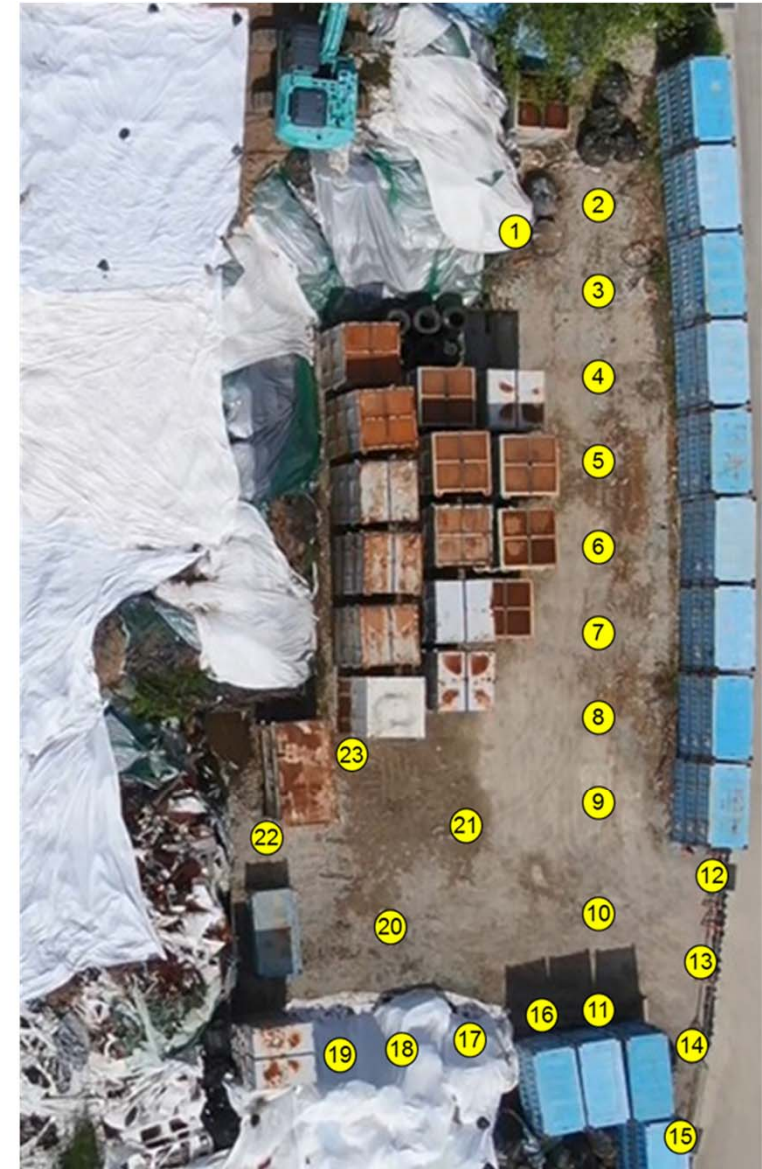
# [Reference] Survey result near temporary storage area E

Point	1cm dose equivalent rate	70 $\mu\text{m}$ dose equivalent rate	Point	1cm dose equivalent rate	70 $\mu\text{m}$ dose equivalent rate
①	130	250	⑬	11	17
②	43	70	⑭	13	15
③	40	60	⑮	15	19
④	50	75	⑯	20	30
⑤	35	60	⑰	60	75
⑥	23	40	⑱	70	120
⑦	18	25	⑲	100	300
⑧	17	25	⑳	21	30
⑨	12	18	㉑	14	22
⑩	14	22	㉒	15	24
⑪	14	28	㉓	16	25
⑫	11	17

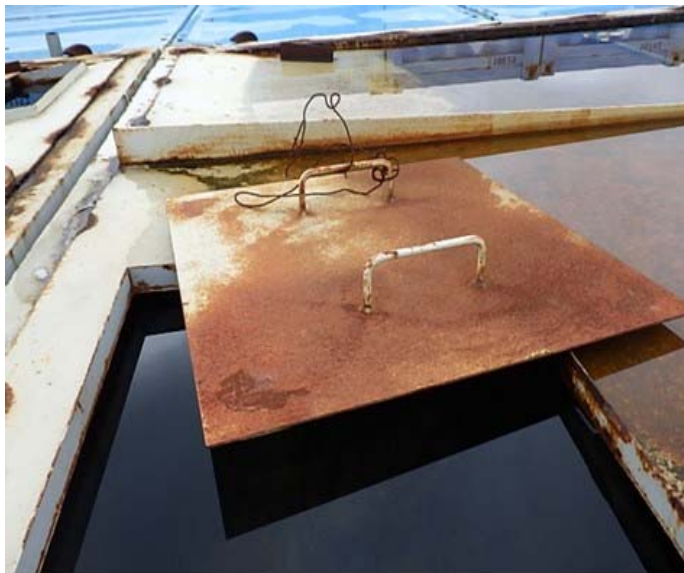
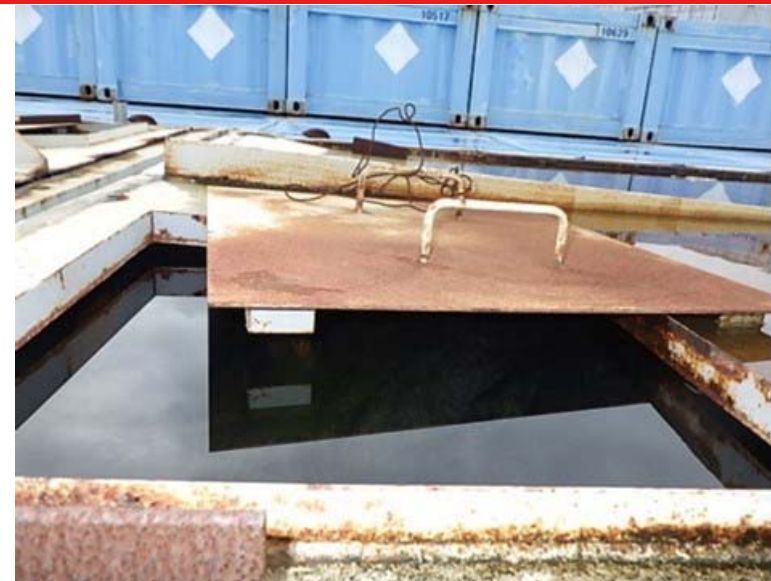
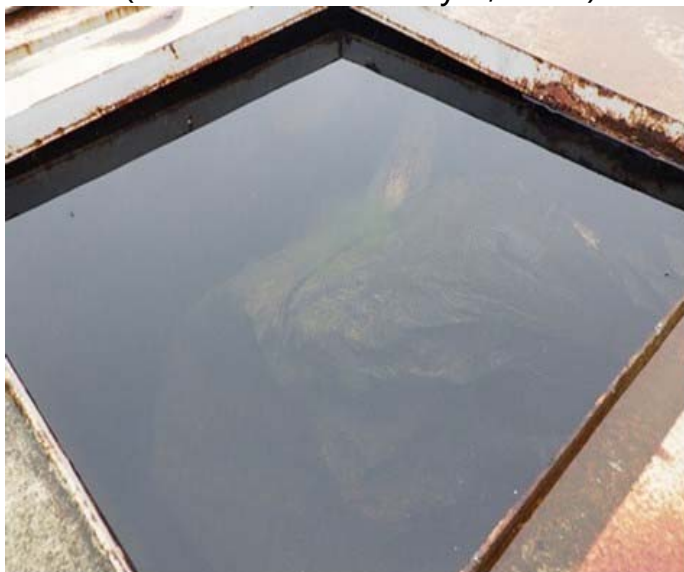
[Reference] Situation of notch tanks (before outflow prevention measures)

- On the same day (July 7), the aforementioned notch tank was investigated, and it was found that four points of the top plate hatch lid and the top plate itself were displaced at two notch tanks and rainwater had entered and filled said tanks to full capacity. Water inside the notch tank and tank top plate was analyzed and their respective total  $\beta$  values were 79,000Bq/L and 71,000Bq/L at maximum (cesium 137 and cesium 134 were below the detectable limit value). On July 11, water inside the notch tanks was removed as much as possible, and the remaining content was flexible container bags containing high  $\beta$  contaminated soil.

(Photo taken on July 8, 2021)

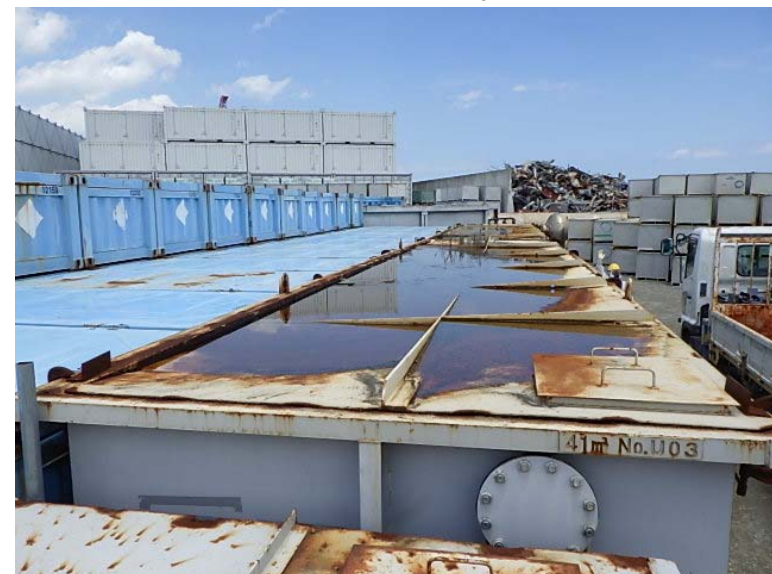
After closing front hatch lid  
(Photo taken on July 6, 2021)
