# (Report) Progress of Necessary Improvements in the Surroundings for Construction of ALPS Treated Water Dilution/Discharge Facilities

March 31, 2022

Tokyo Electric Power Company Holdings, Inc.

## 2. Progress of land improvements in the surroundings and future plans

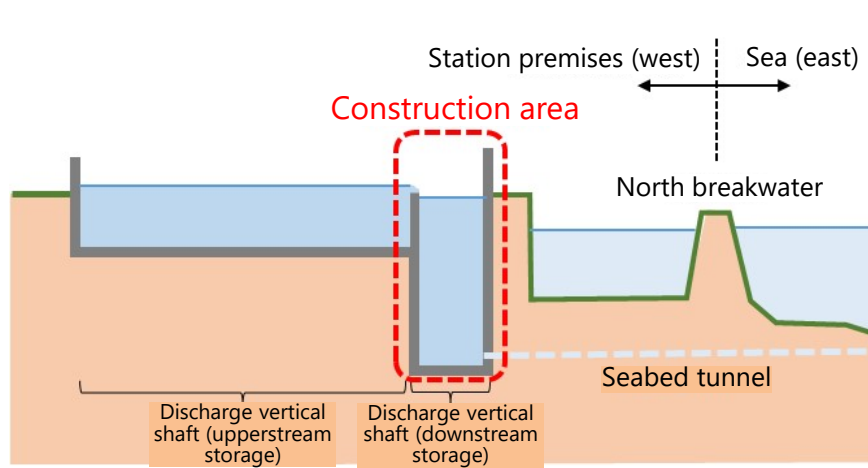
Cross-section view of construction area

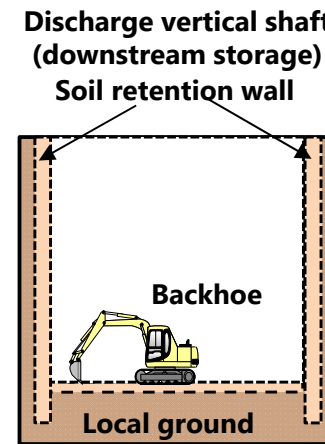
Construction image

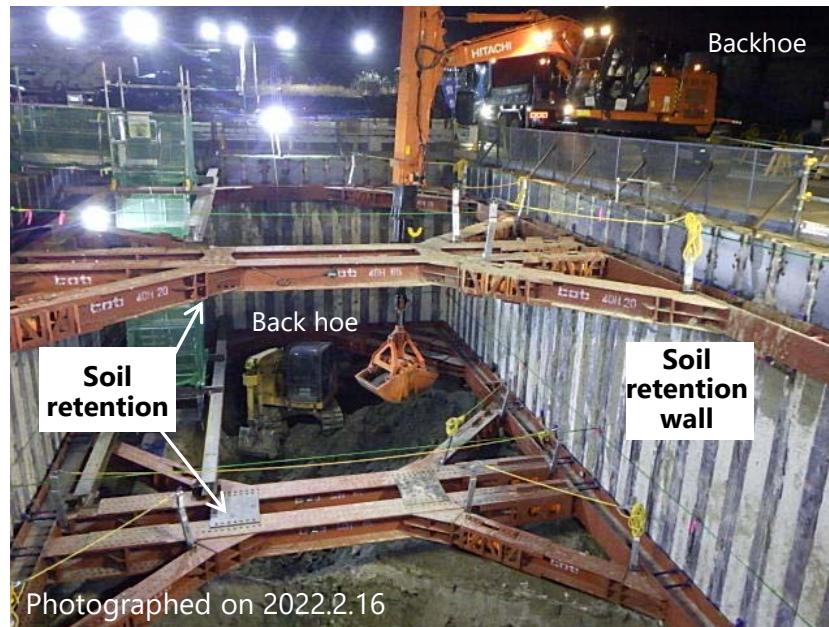
Photo ① Excavation of the vertical shaft

- In land improvements in the surroundings near the Units 5/6 intake, the establishment of the seabed tunnel and installation of the soil retention for the vertical shaft (downstream storage) necessary for discharge began on December 4, 2021. After said works were completed on January 22, 2022, excavation of the vertical shaft areas began on February 7.

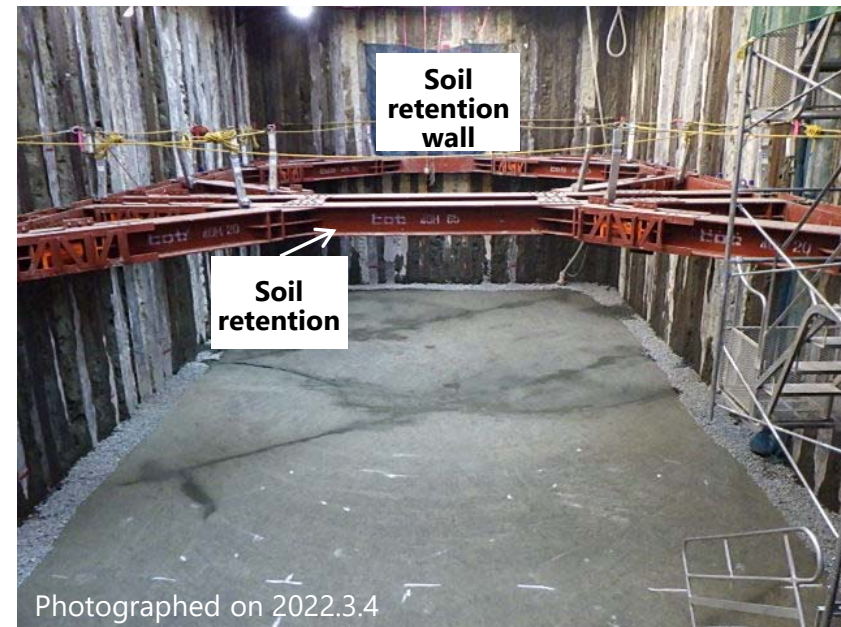
- Of land improvements in the surroundings near Units 5/6 intake, excavation of the vertical shaft (downstream storage) was completed on March 4, and work is now underway to clear the bottom of the vertical shaft.
- The 3.16 Fukushima Prefectural offshore earthquake did not cause any damage to the inside of the vertical shaft under construction of the land improvements in the surroundings area. The earthquake caused cracks and subsidence on some ground surfaces in the surrounding area.
- As soon as we restore the cracks in the ground and we are ready, we will implement soil retention and excavation for the vertical shaft (upstream storage).
- We will continue to monitor weather conditions and proceed with the construction with safety first.

Photo ② Excavation of the vertical shaft completed

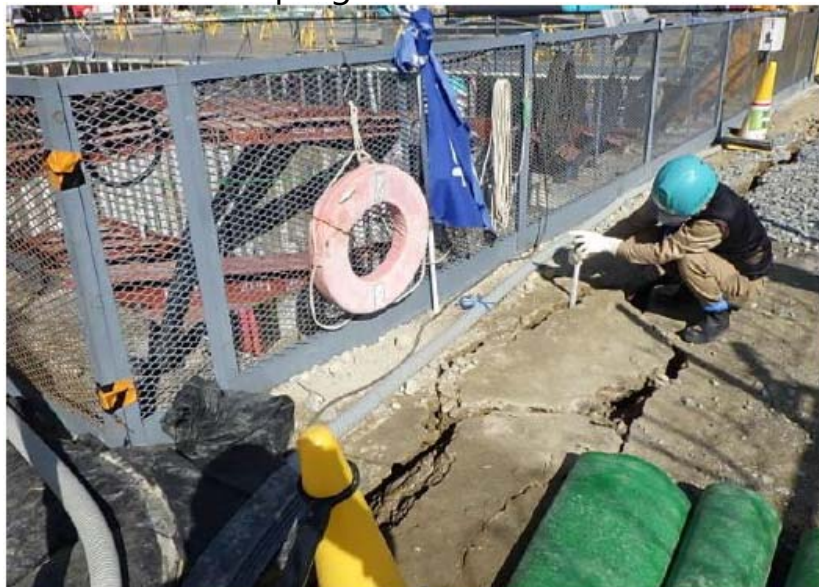
- No damage was caused on the inside of the vertical shaft (downstream storage) under construction in the land improvements in the surroundings area.
- The earthquake caused cracks and subsidence on some ground surfaces in the surrounding area.

Photo ① Cracks on the ground after the earthquake (near the downstream storage)

- In order to mitigate the effects of the earthquake, slurry materials will be filled into the cracks and ground improvement will be implemented.

- In order to mitigate damages to facilities caused by earthquakes, appropriate measures will be implemented according to the construction progress.

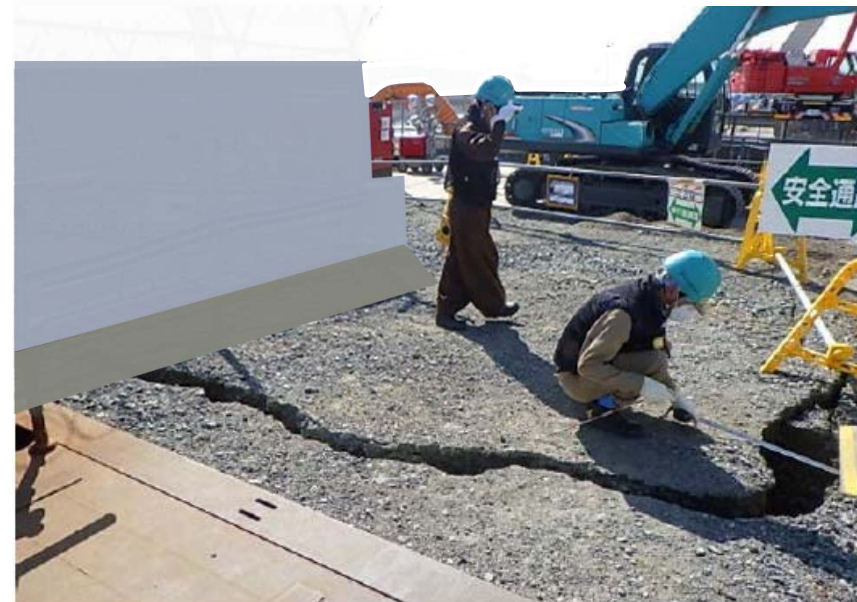
Photo ② Cracks on the ground after the earthquake (around the downstream storage)
