# Status of Progress of the installation of ALPS treated water dilution/discharge facility and related facilities

April 27, 2023

Tokyo Electric Power Company Holdings, Inc.

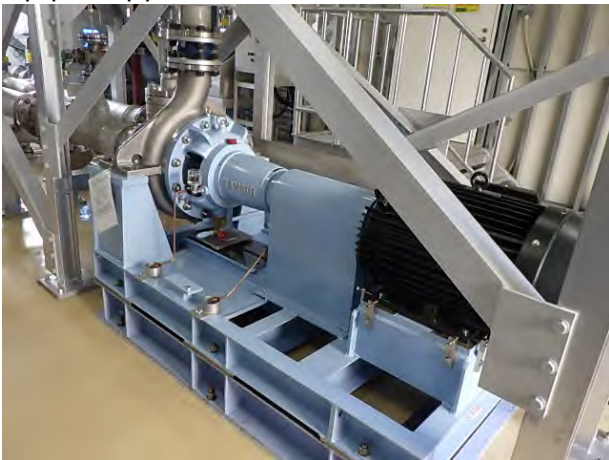
Installing circulation pipes and pipe supports

Circulation pump

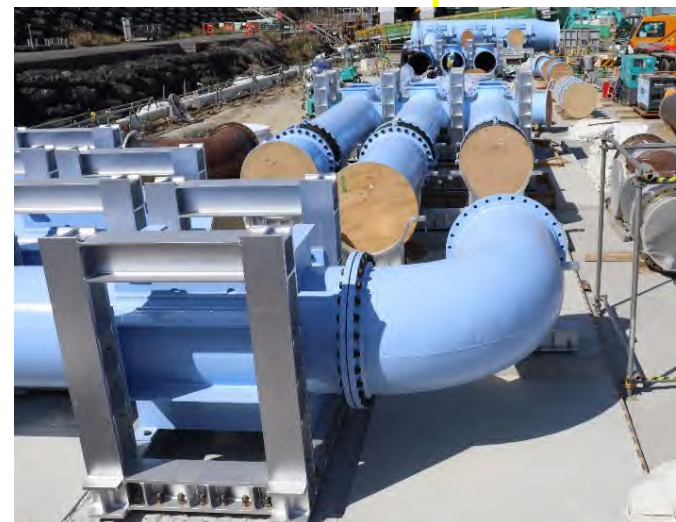
The driving of piles for the foundation and construction of the foundation frame for the seawater transfer pipes have been completed. Installation of pipes and other equipment are currently underway.

Building the seawater transfer pipes foundation and installing the seawater pipe header

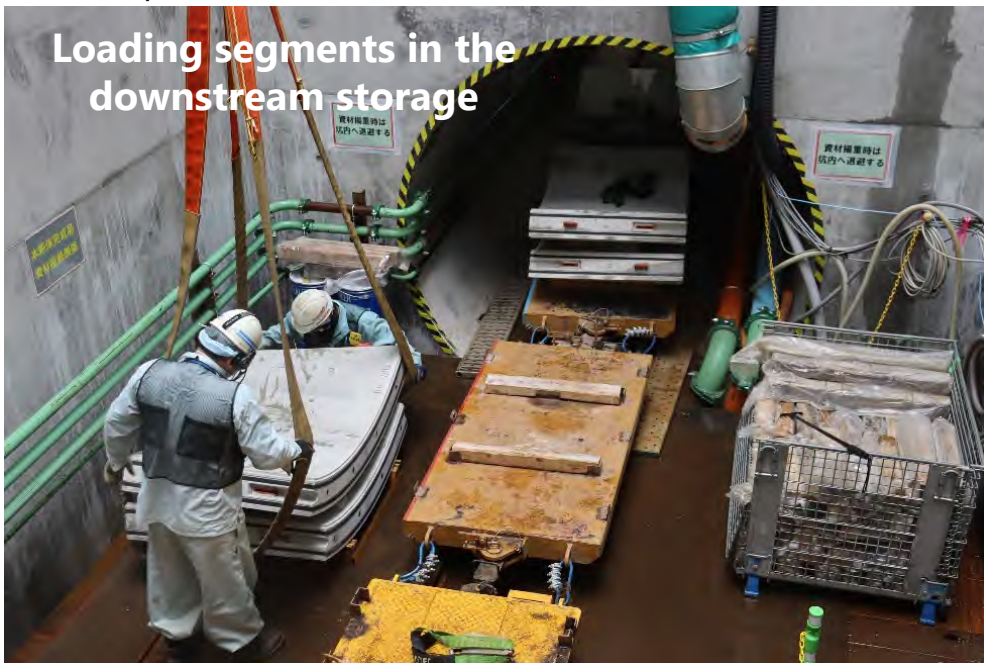
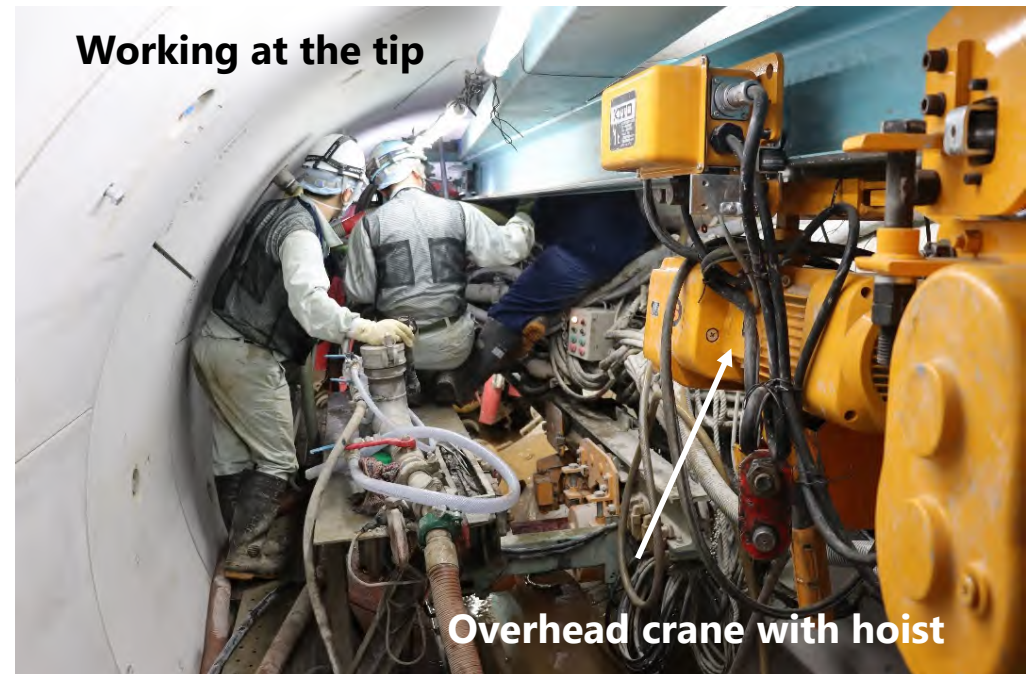
Date	Item (progress)
April 1	Started digging the remaining 200m of the tunnel
April 22	Main tunneling (tunneling of the bedrock) is completed. Started tunneling the arrival areas (connection to the discharge port caisson)*
April 25	Arrived at the tip of the fluidized soil inside the arrival tube. Started fixing the shield machine in place.
April 26	Tunneling complete

- Discharge tunnel: Tunneling complete (tunnel length: 1031 m)  
<As of April 26>

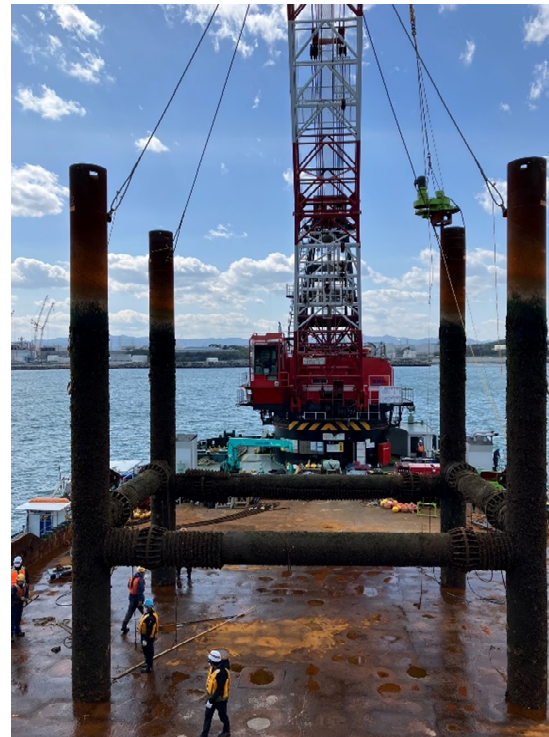
The temporary guiding scaffolds\* that were attached to the caisson were removed. It was separated into the upper and lower halves, and the upper half was removed on April 9 and the lower half on April 13.

Guiding scaffolds (upper half) being removed

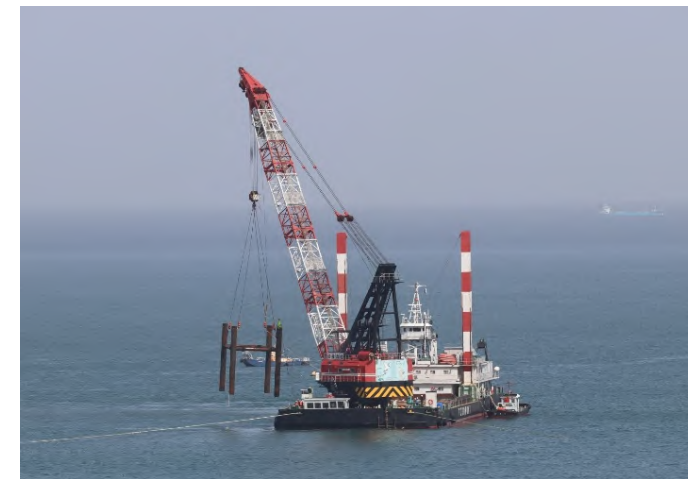
Guiding scaffolds (lower half) being removed

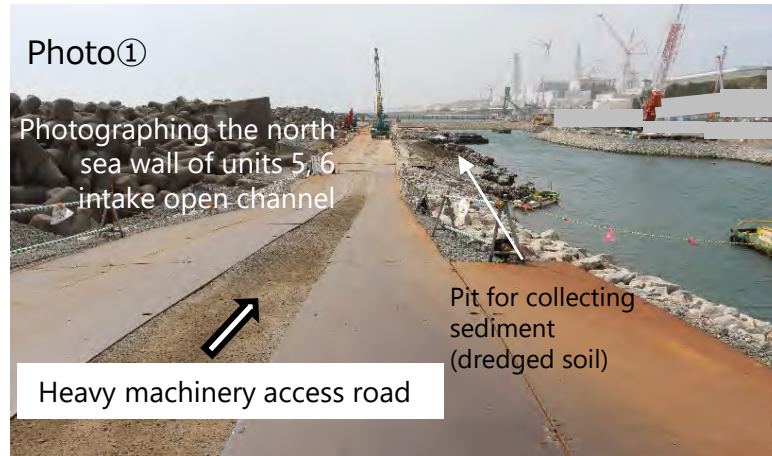
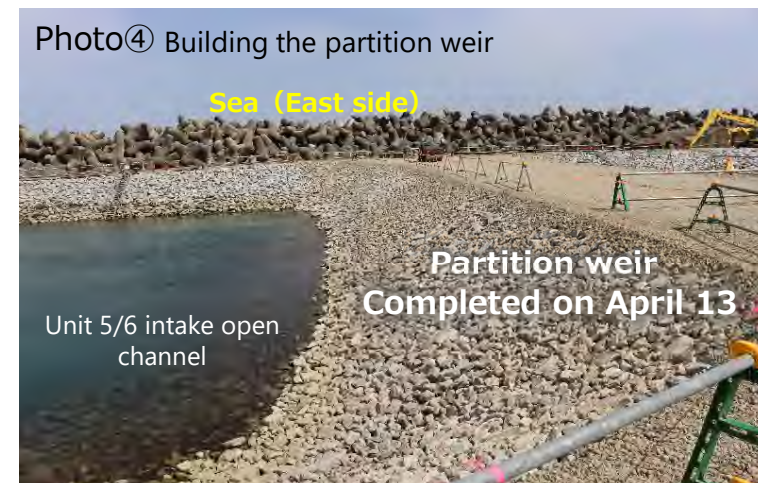
Work area on the sea side of Unites 5/6

In the Units 5 and 6 sea-side construction area, the heavy machinery scaffolding was completed on December 29. The scaffolding has been in use for building the upper-stream storage since January 5. The removal of silt from the open intake channel (dredging) and the building of the partition weir (completed on April 13) are being done simultaneously. Partial removal of permeation prevention wall was started on April 18.

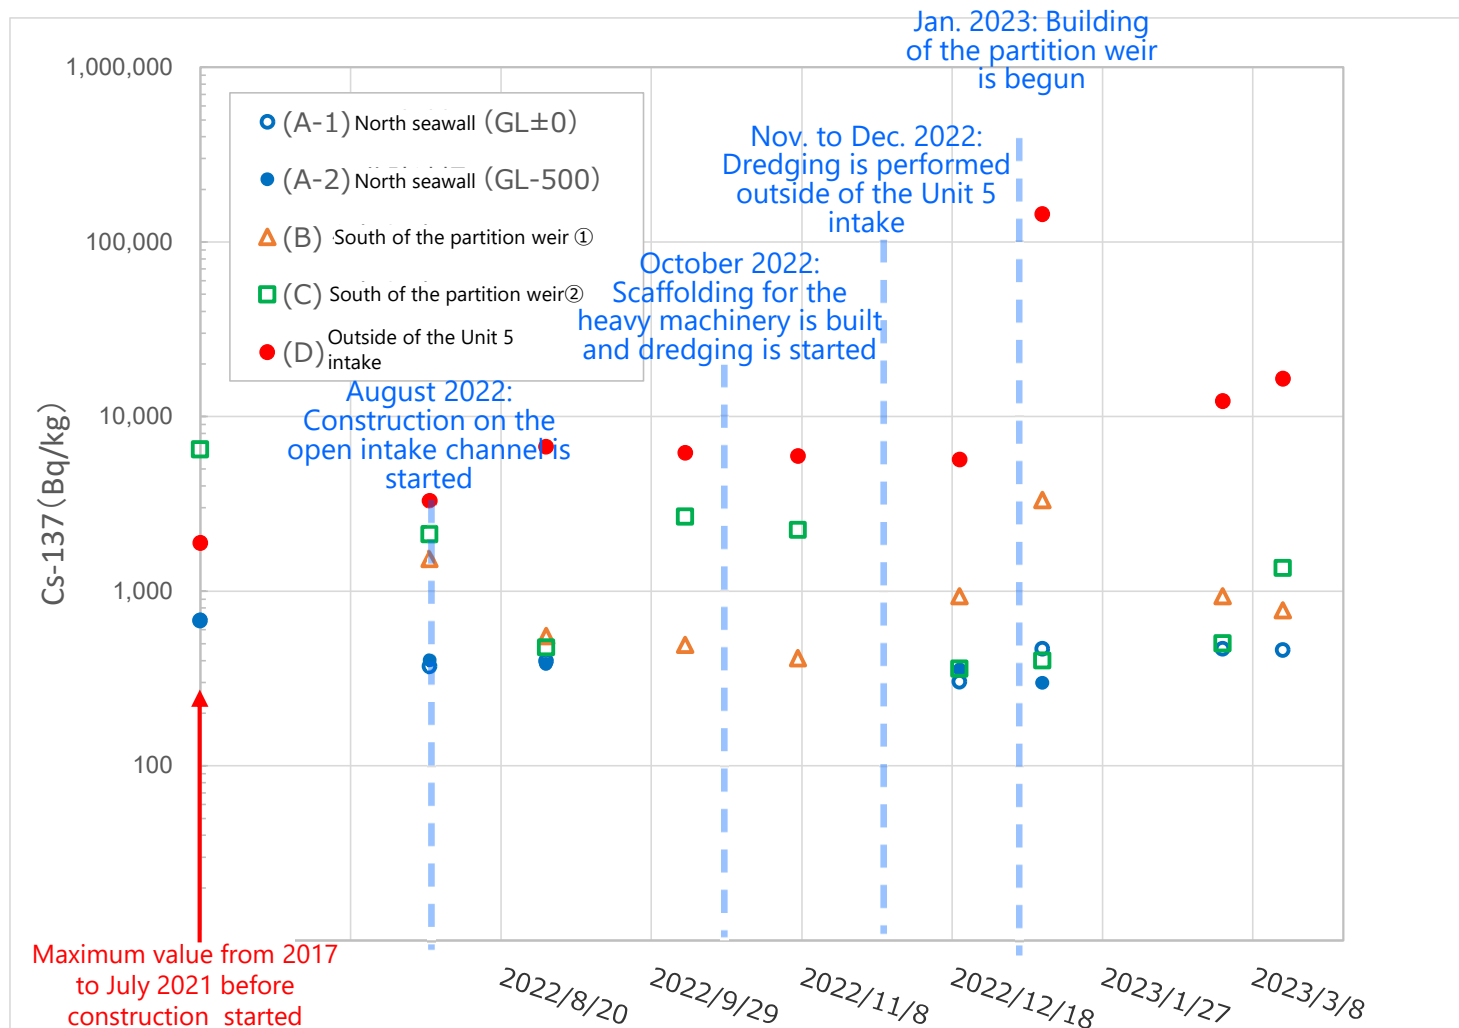
- Results of the seabed soil monitoring performed from before construction was started is shown below.
- While there had been no significant fluctuations in measurements taken near the Unit 5 intake until December 2022 after construction was started, values increased in January 2023 and has been high since. There have been no significant change in the seawater values measured in the same period.
- Prior to 2021, measurements taken near the silt fence (where the partition weir current is) used to show similarly high figures.

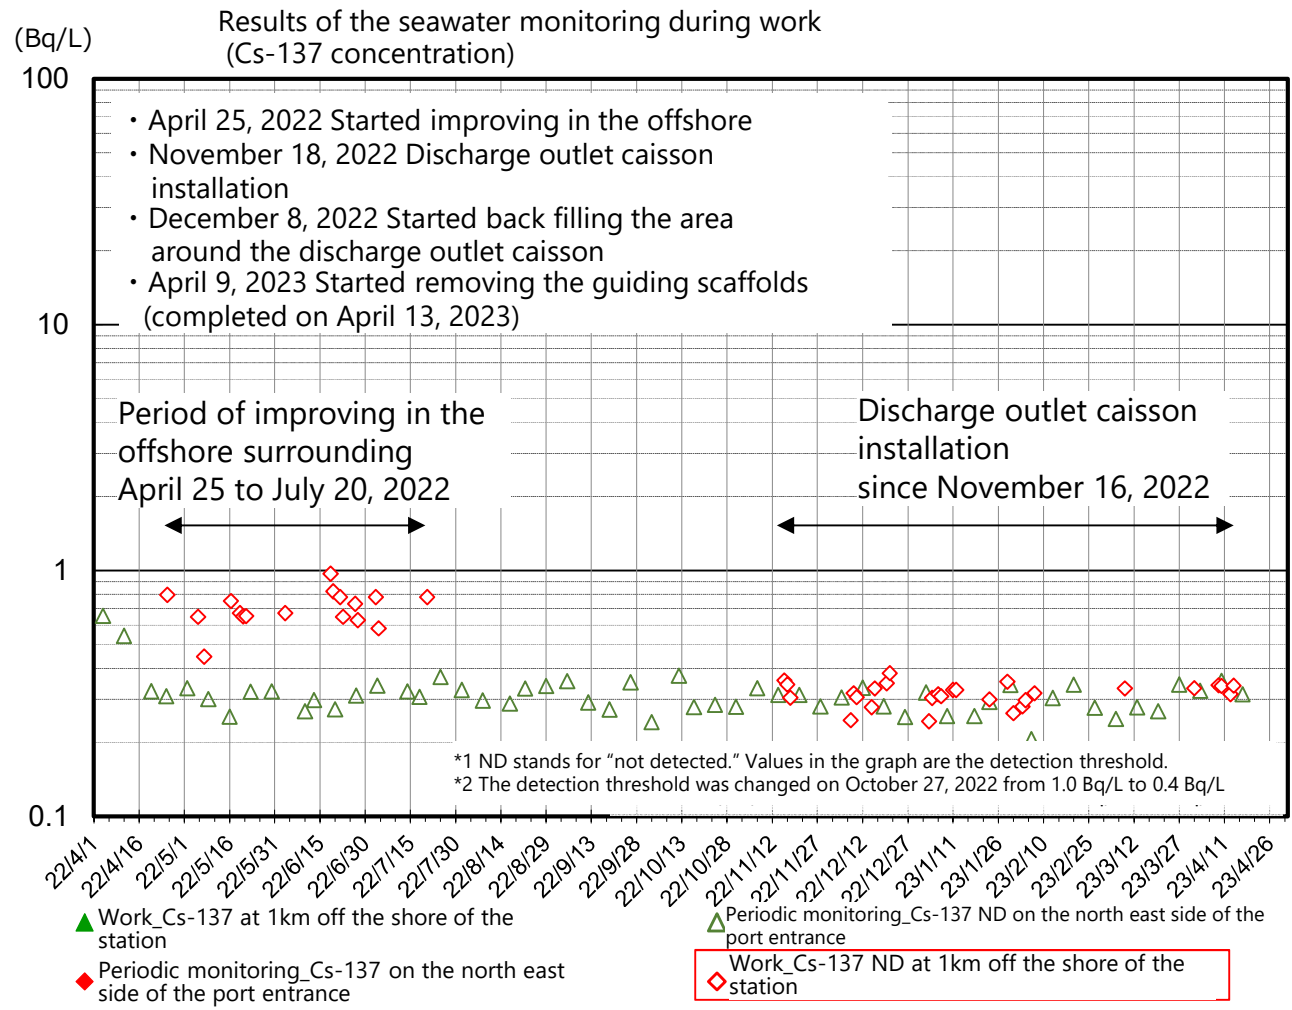
Cesium up to the most recent samples taken April 23, 2023 have not been detected (ND) and there have been no significant fluctuations in seawater cesium concentrations. We will continue to appropriately monitor the seawater during the plant offshore work.

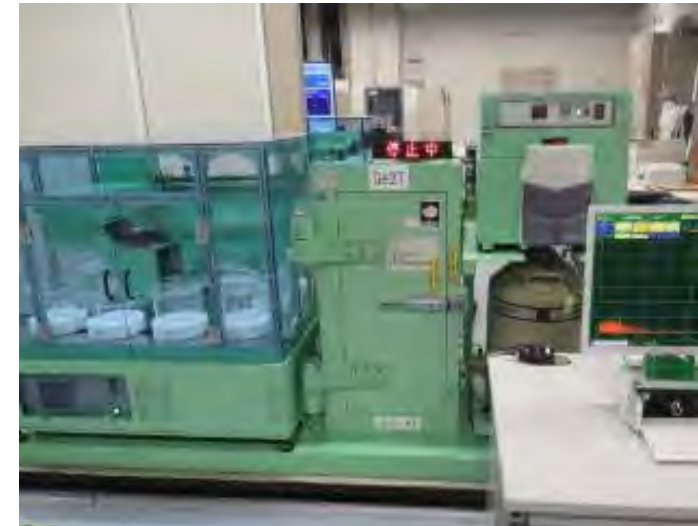
**Reference: existing germanium semiconductor detector**  
(Photo of the device in the chemical analysis building measurement room)
