Status of Progress with the Installation of ALPS Treated Water Dilution/Discharge Facility and Related Facilities

May 25, 2023

Tokyo Electric Power Company Holdings, Inc.

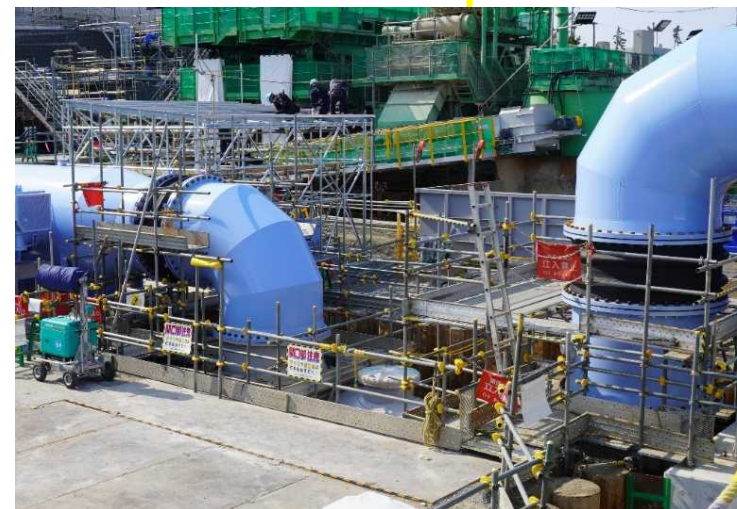
Building the seawater transfer pipe foundation and installing the seawater pipe header

The driving of foundation piles and construction of the foundation frame for the seawater transfer pipes have been completed. Installation of pipes and other equipment are currently underway.

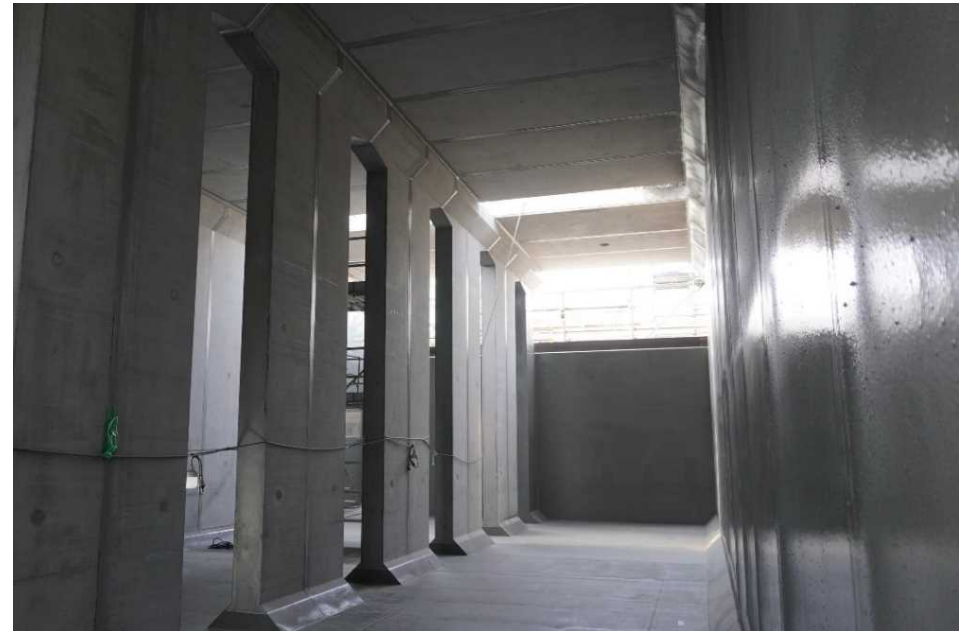
Picture of the inside (After applying waterproof sealant)

- Dilution facility: Discharge vertical shaft (upper-stream storage)
The assembly and installation of blocks (manufactured off-site) began on January 12, and concrete pouring for the bottom began on February 9. Assembly and installation, concrete pouring and waterproofing have been completed and the storage have been filled with water. The weirs will be built next.

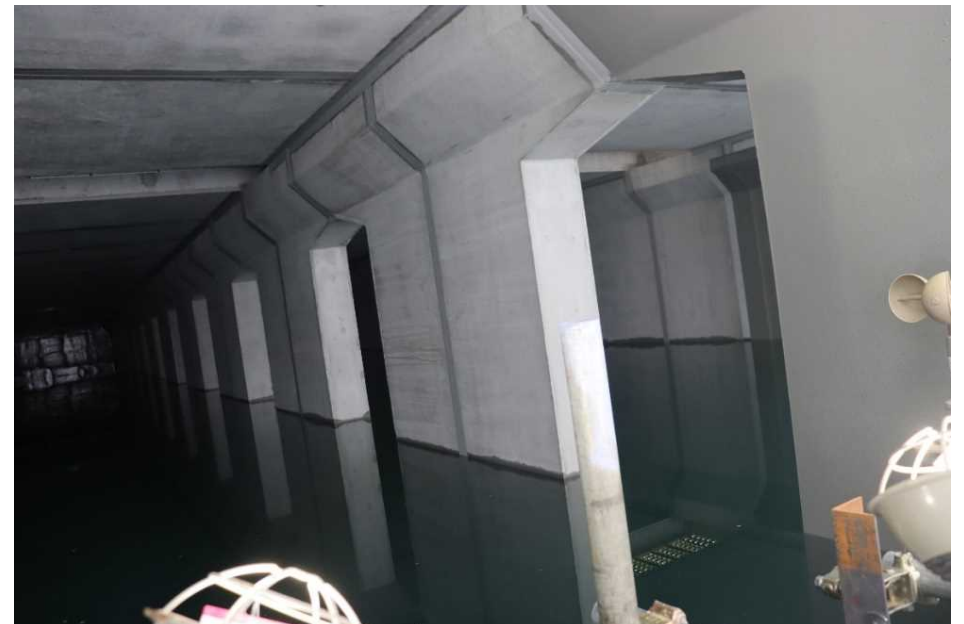
Picture of inside (After filling water)

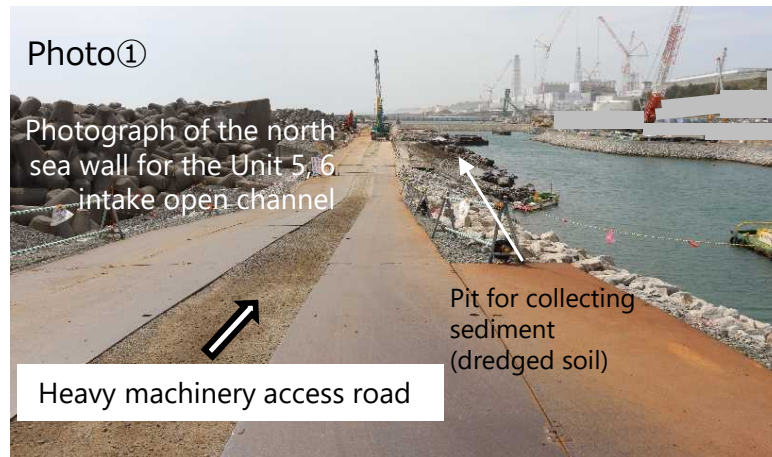
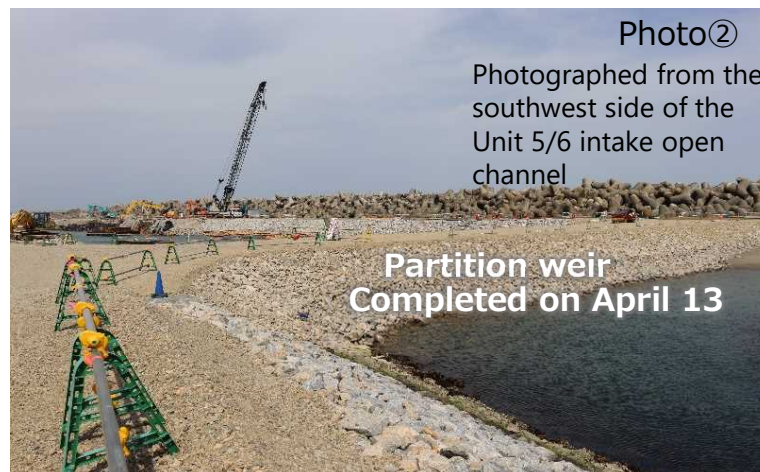
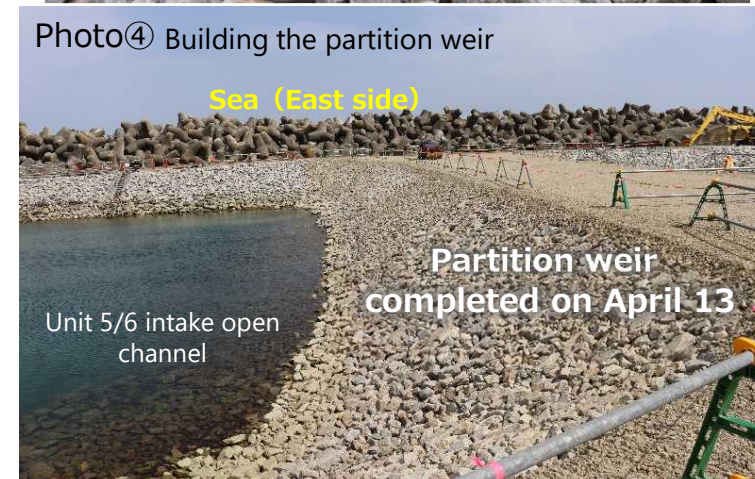
Work area on the sea-side of Units 5/6

In the Unit 5/6 sea-side work area, sediment was removed from the open intake channel (dredging), and construction of the partition weir was completed on April 13. Since April 18, we have been removing a portion of the permeation prevention barrier. Sediment removal (dredging) should be completed by the middle of June.

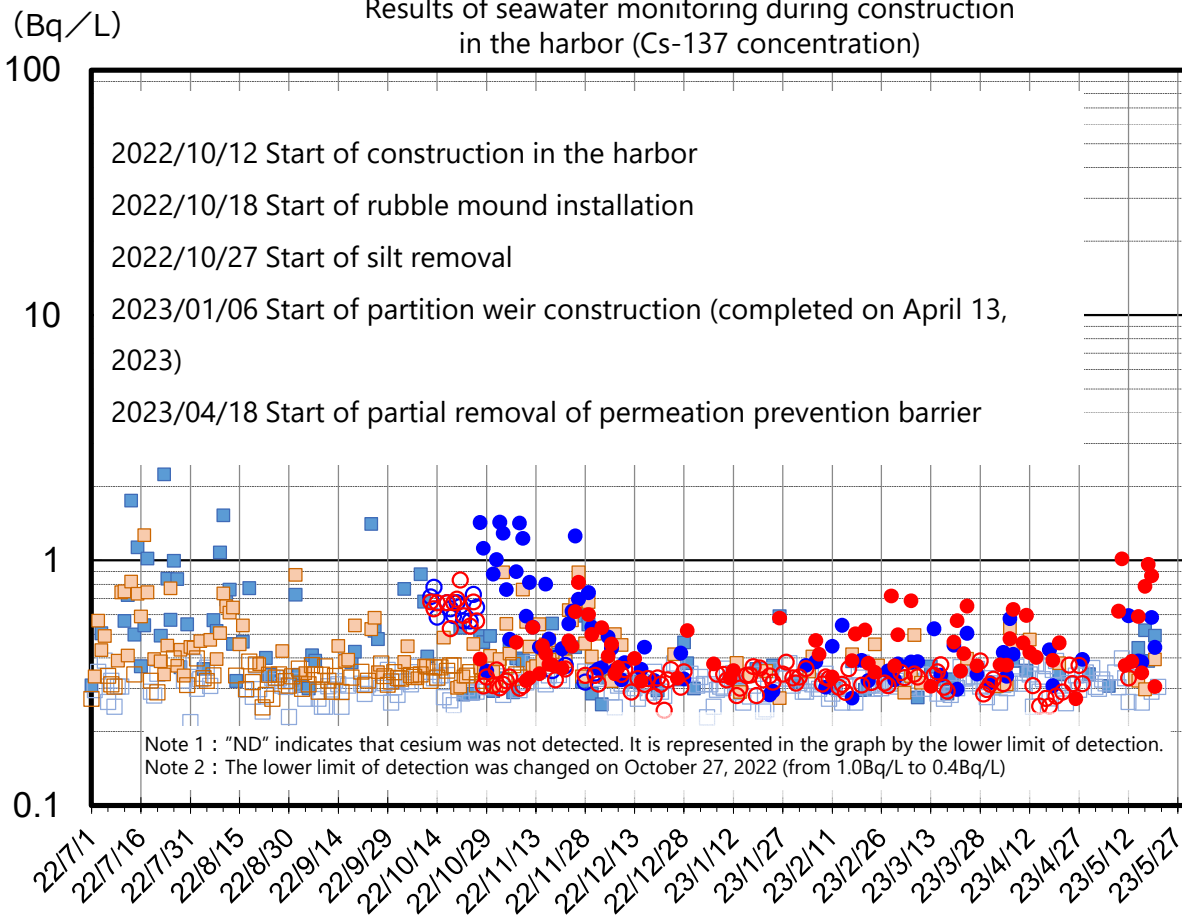
Updated on May 20, 2023

Results of seawater monitoring during construction in the harbor (Cs-137 concentration)

- Regular: North side of the inside of the harbor (a)
- Regular: North side of the inside of the harbor ND (b)
- Regular: In front of the Unit 6 intake (c)
- Regular: In front of the Unit 6 intake ND (d)
- During construction in front of the Unit 5 intake (e)
- During construction in front of the Unit 5 intake ND (f)
- During construction on the south side of the partition weir (g)
- During construction on the south side of the partition weir ND (h)

As of May 20, 2023, no significant fluctuation in the cesium concentration in seawater has been found. We will continue to suitably monitor seawater while working on the Unit 5/6 open intake channel.

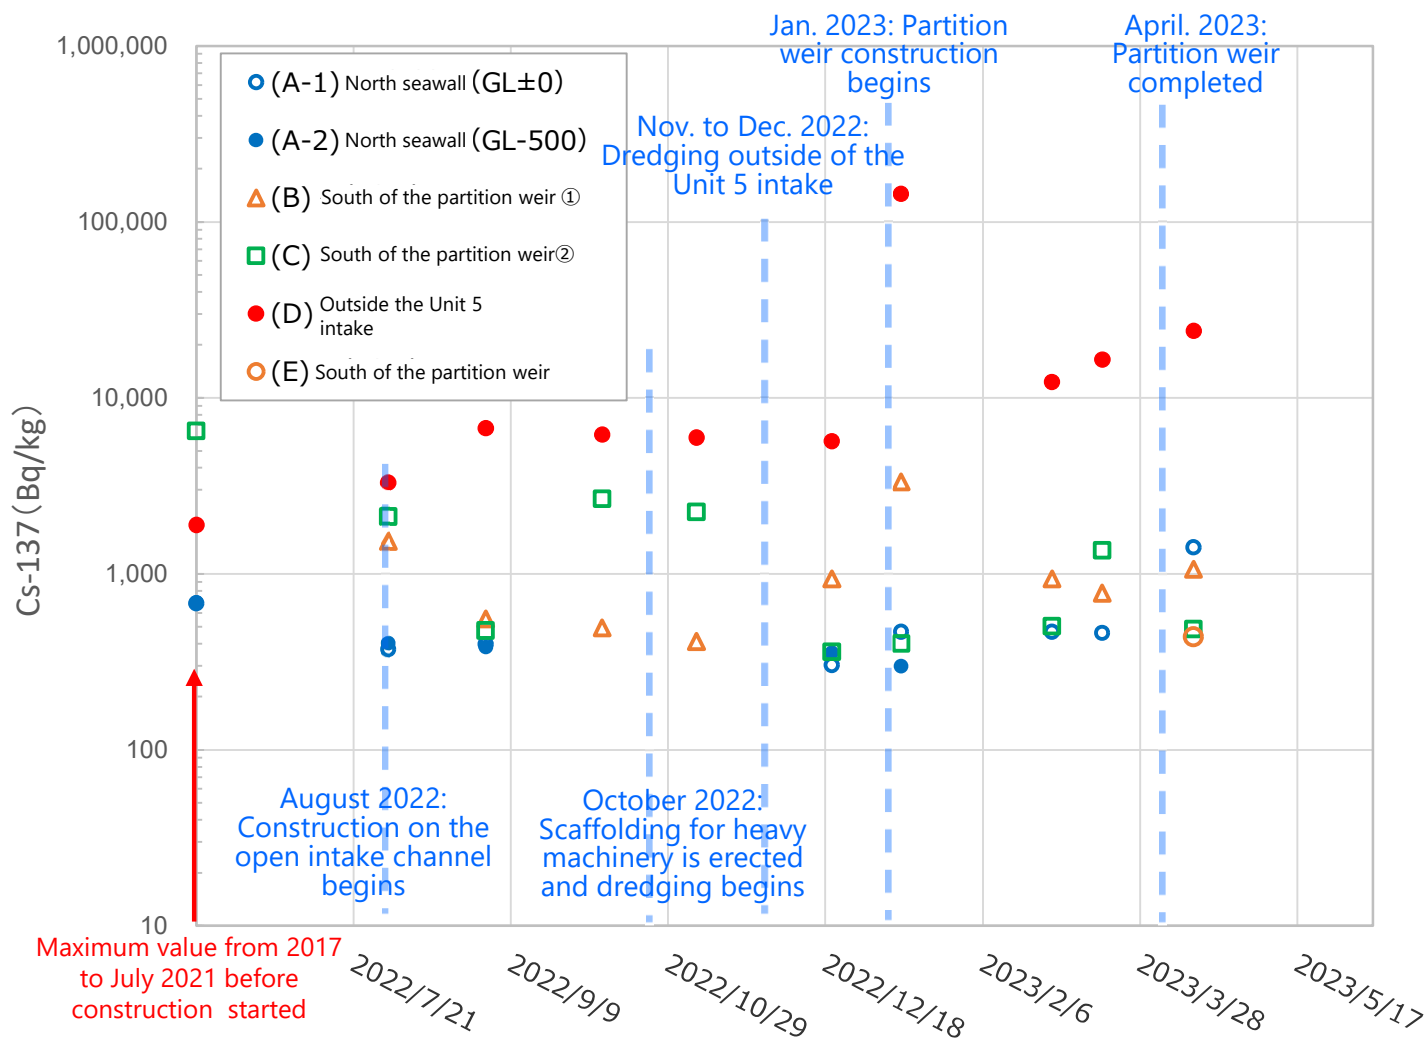
- Results from seabed soil monitoring performed before and during construction are shown below.
- While there had been no significant fluctuations in measurements taken near the Unit 5 intake until December 2022, after construction began values increased in January 2023 and have been high ever since.
- There have been no significant change in the seawater values measured in the same period.

- : Seabed soil sampling location
- : Silt fence (now)
- : Silt fence (before the partition weir was built)
- : Pollution prevention fence
