# Status of Progress with the Installation of ALPS Treated Water Dilution/Discharge Facility and Related Facilities

June 29, 2023

Tokyo Electric Power Company Holdings, Inc.

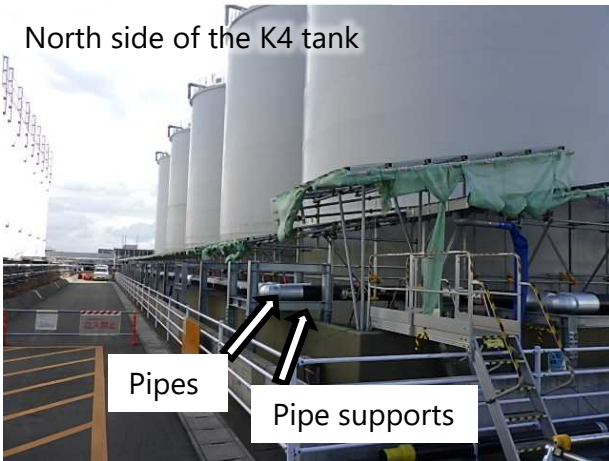
North side of the K4 tank

Pipes  
Pipe supports

Installing circulation pipes and pipe supports

The Installation of pipe supports, and piping and other works for the measurement/confirmation facility and the transfer facility has been completed.

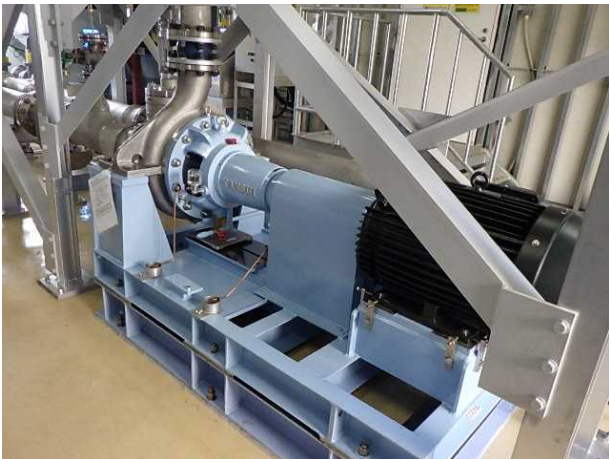
Circulation pump

Installing the piping supports/pipes [Measurement/confirmation facility] completed

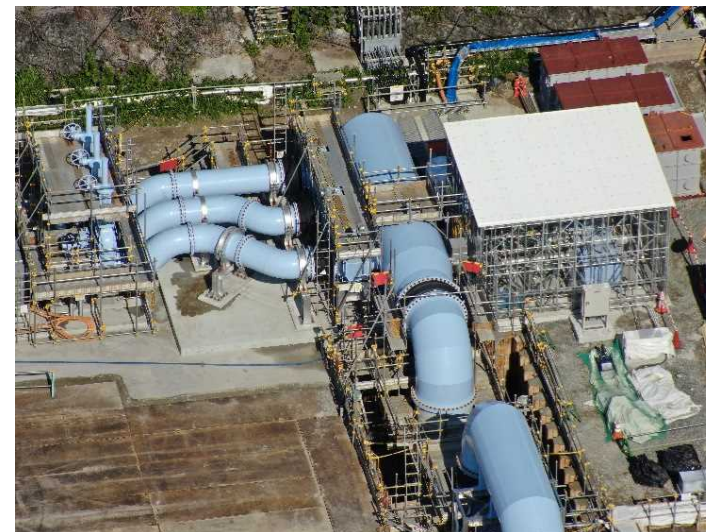
Building the seawater transfer pipe foundation and installing the seawater pipe header

The driving of foundation piles and construction of the foundation frame for the seawater transfer pipes have been completed. Installation of pipes and other equipment have been completed.

- Pipe foundation construction  
11 out of 11 completed
- Support facility  
Approx. 320m out of 320m completed
- Pipe facility  
Approx. 320m out of 320m completed

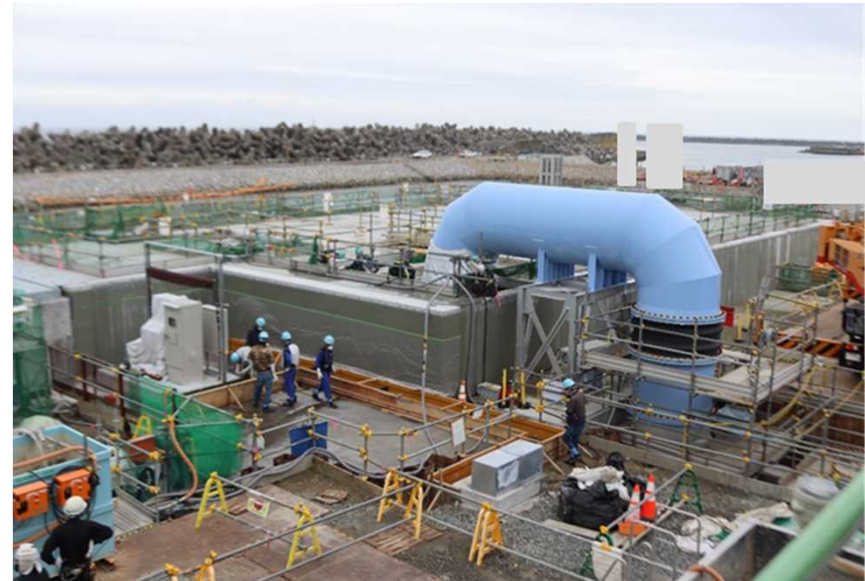
Discharge vertical shaft (upper-stream storage)

- Dilution facility: Discharge vertical shaft (upper-stream storage)  
The installation assembly and concrete pouring, waterproof painting, water filling in the storage and construction of the weir were completed by June 9.
- Discharge facility : Discharge vertical shaft (down-stream storage)  
Frame construction was completed on March 23, and water filling into the down-stream storage was completed on June 6.

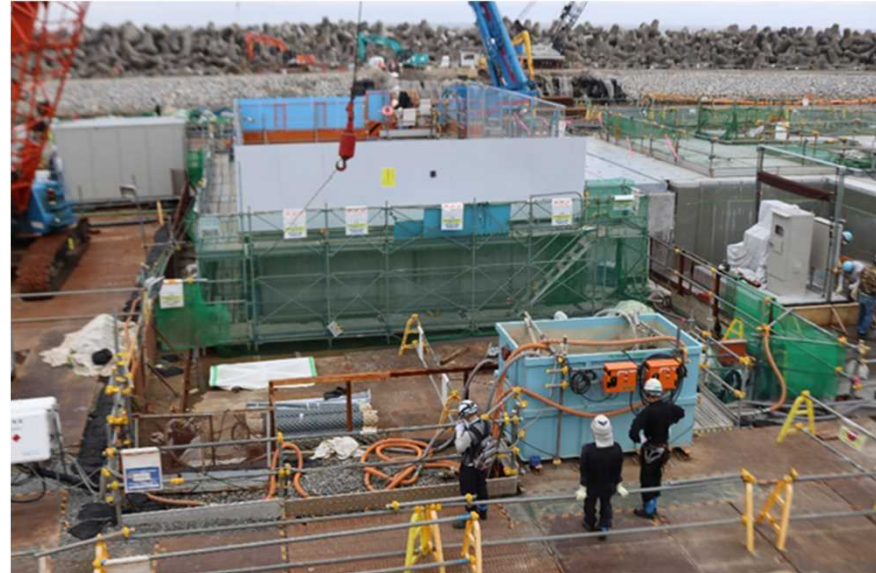
Discharge vertical shaft (down-stream storage)

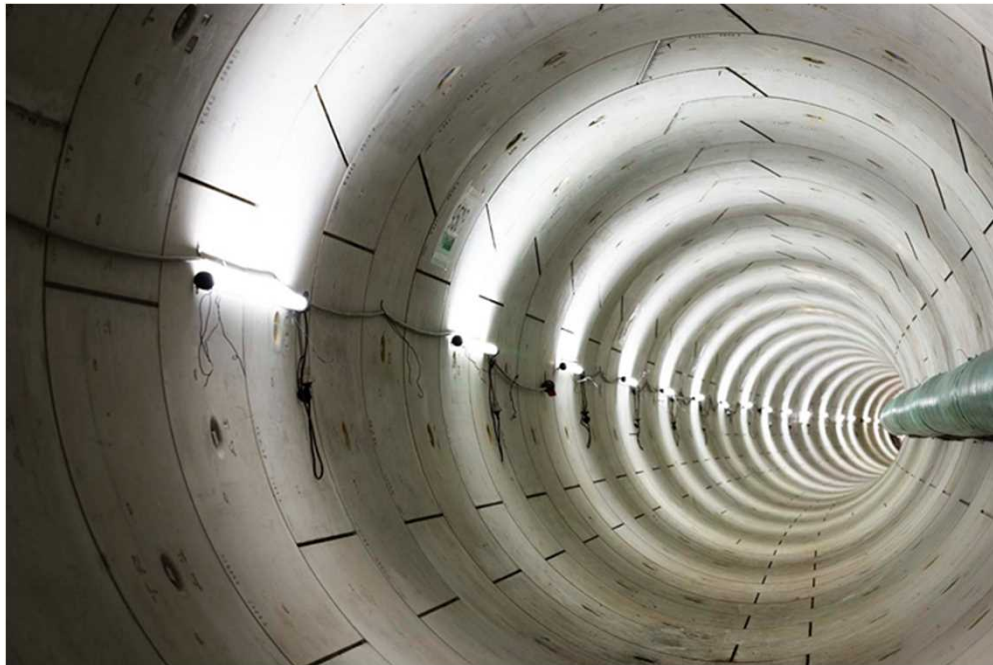
Inside the tunnel

Date	Task (progress)
Apr 1	Recommencement of tunneling
Apr 22	Main tunneling (bedrock portion) completed
Apr 25	Tunneling machine arrives at end point
Apr 26	Tunneling completed

Date	Task (progress)
May 7	Equipment removal completed
May 21	Waterproofing completed
June 5	Clean-up completed
June 6	Water injection completed

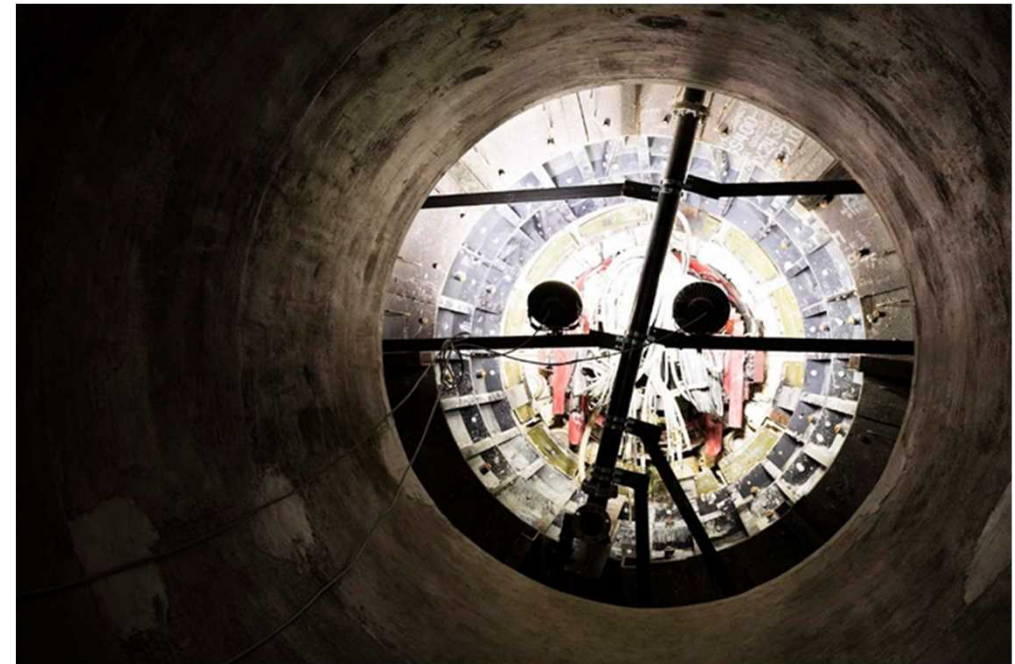
Tunnel endpoint

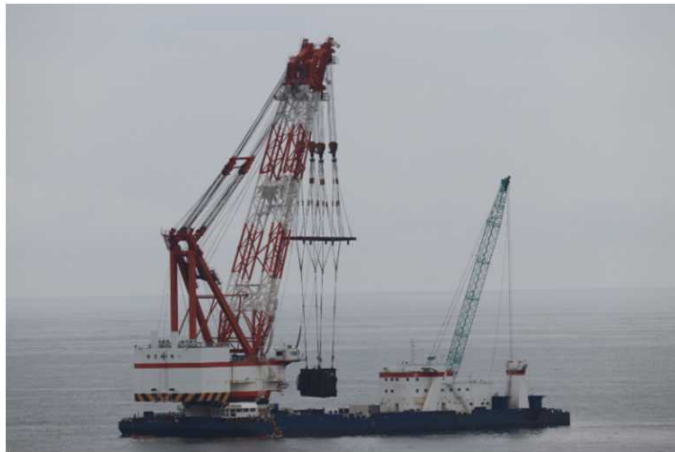
Arrival tube removal ①

The removal of the arrival tube and the installation of the discharge lid (top cover of the discharge outlet caisson) were completed on June 26. It marks the completion of the installation of all facilities required for pre-service inspection by the Nuclear Regulation Agency at the ALPS treated water dilution/discharge facility and related facilities.

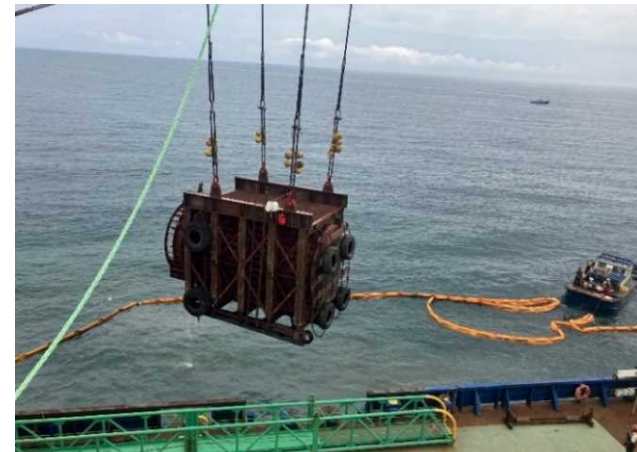
Arrival tube removal ②

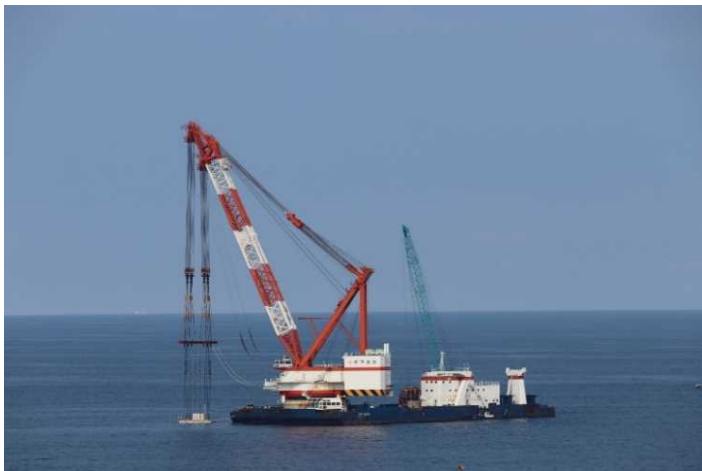
Discharge lid installation ①

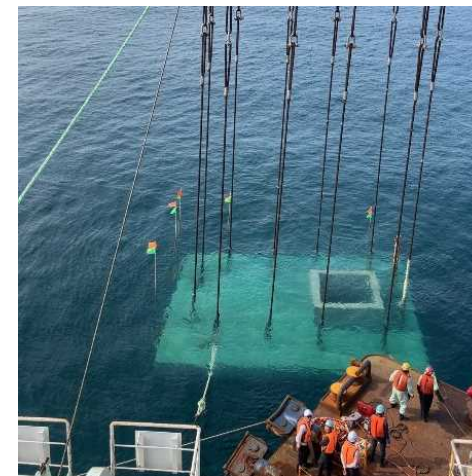
Discharge lid installation ②

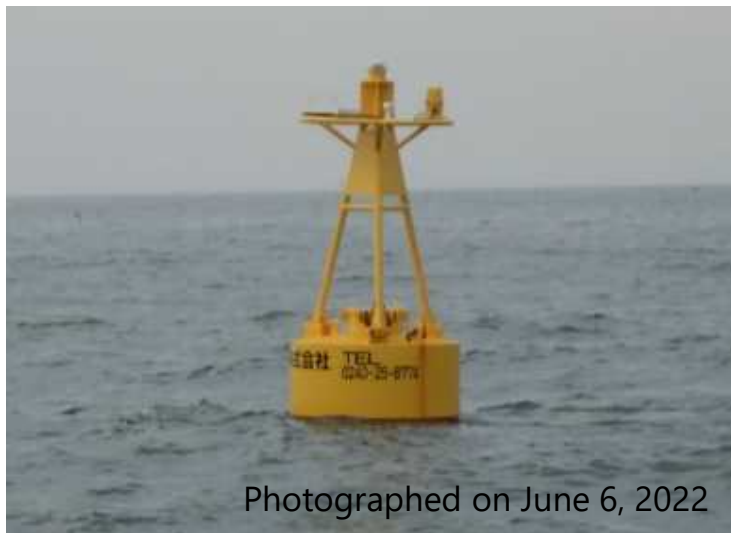
Light buoy

- At the ALPS treated water dilution/discharge facility, the following work will be carried out for offshore construction after the installation of the facilities listed on the previous page is completed.
- If a gap between the discharge lid and the caisson is found during a dive investigation, the area around the discharge lid shall be fixed with mortar if necessary.
- The sinker blocks (110t) and light buoys (including steel sinker blocks) used in the construction will be removed by a crane ship by the end of the year after preparations have been made.

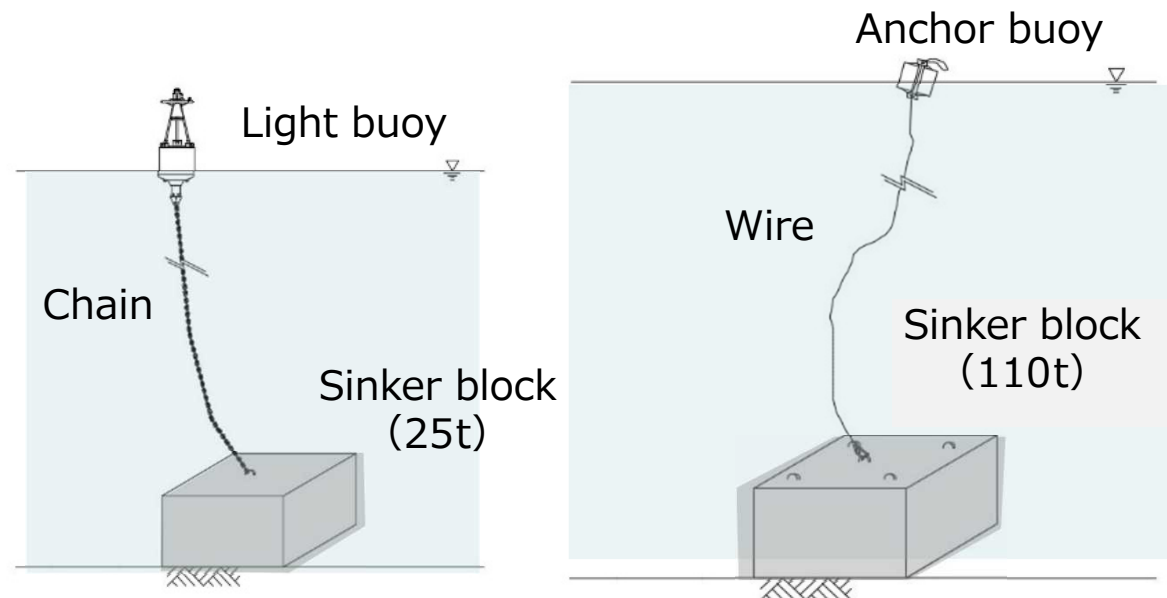
Concept drawing of light buoy and sinker block

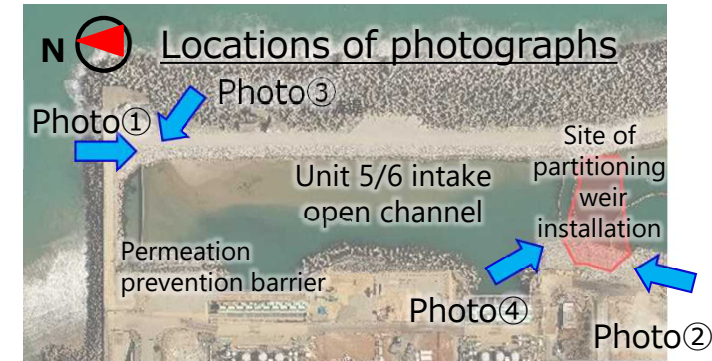
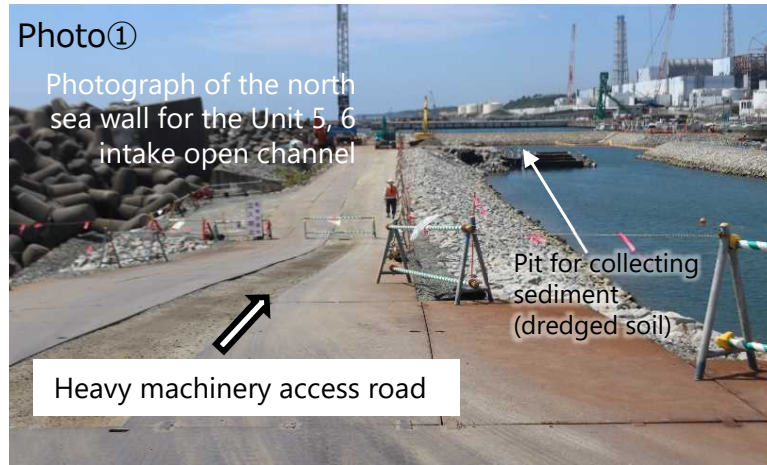
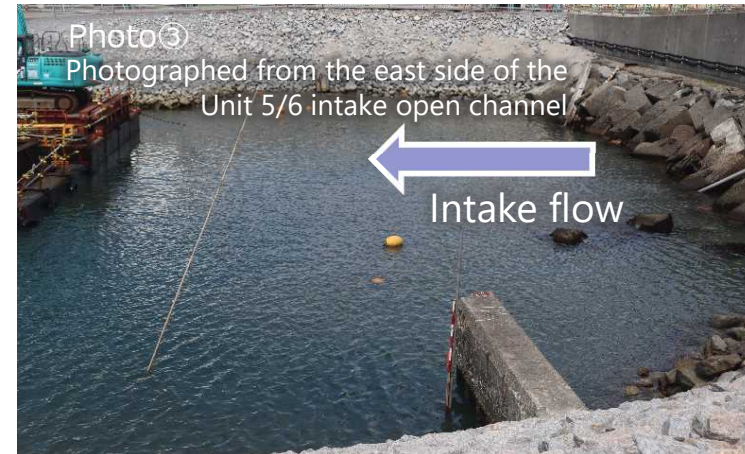
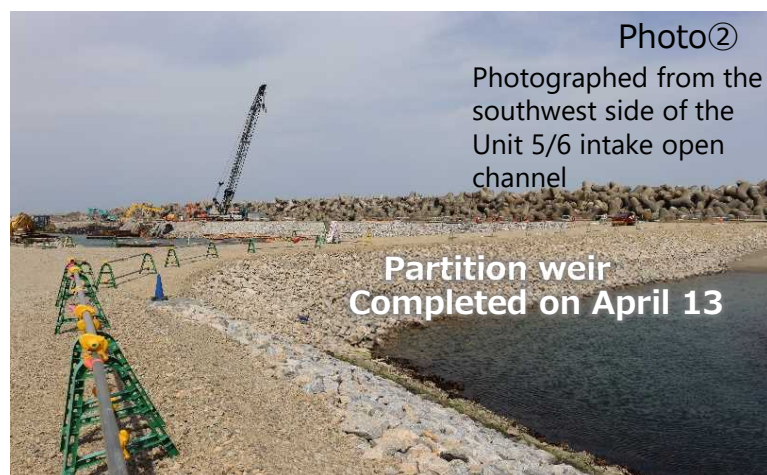
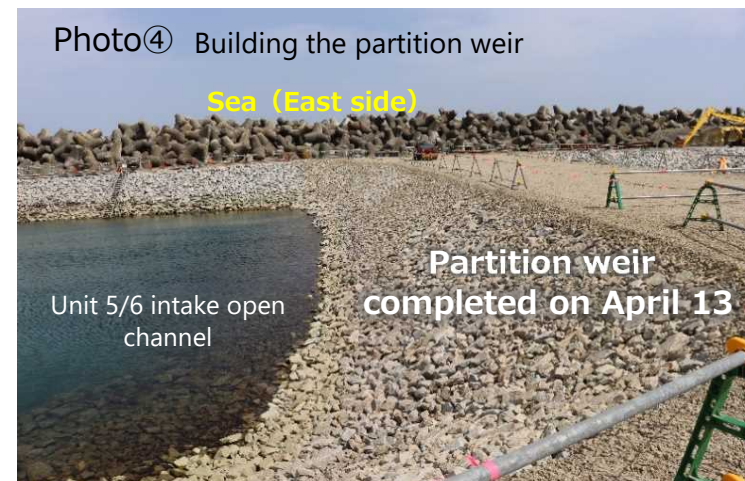
Work area on the sea-side of Units 5/6

In the Unit 5/6 sea-side work area, sediments were removed from the open intake channel (dredged soil), and construction of the partition weir was completed on April 13. The removal of a portion of the permeation prevention barrier began on April 18 and was completed on May 26. The removal of sediments (dredged soil) that affect the water intake was completed on June 22.
