Unit 2 PCV Internal Investigation/ Preparation Status of Fuel Debris Trial Retrieval

January 25, 2024

IRID **TEPCO**

1. PCV internal investigation and trial retrieval plan overview

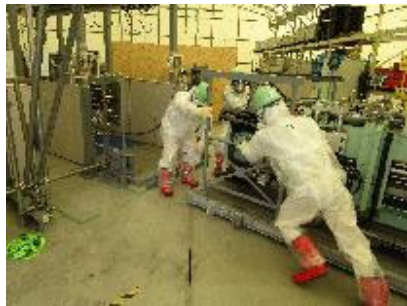
Installation of deposit removal equipment (low pressure water)

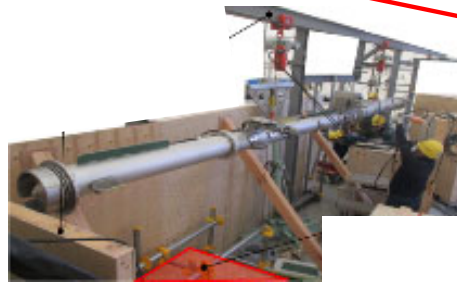
Spray jig installation
※Connected to X-53 penetration

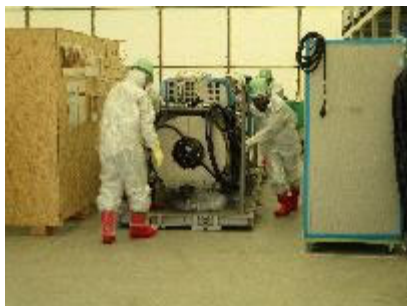
Installation of deposit removal equipment (high pressure water, abrasive water jet)

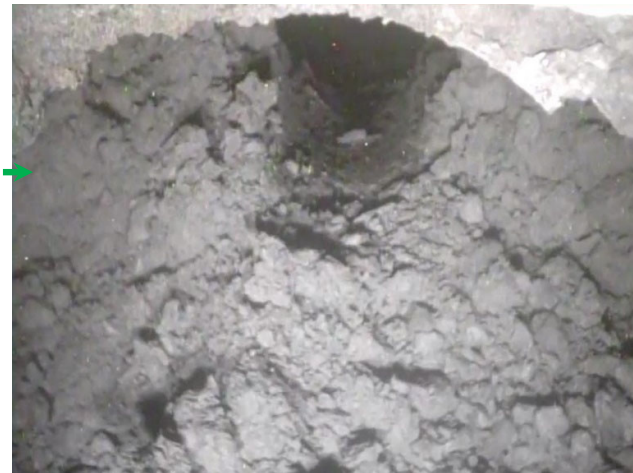
- After completing collapsing deposits using the dozer rod, we sprayed low pressure water to remove the deposits.
- Although it took more time to remove deposits compared with the results of mockup performed earlier, deposits are gradually being removed, revealing cables. Also, mud-like deposits are remaining at the bottom of the penetration.

Before the work on January 17

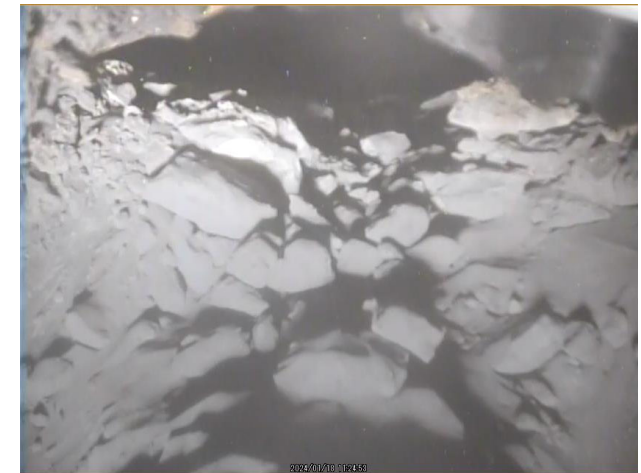
After the work on January 18

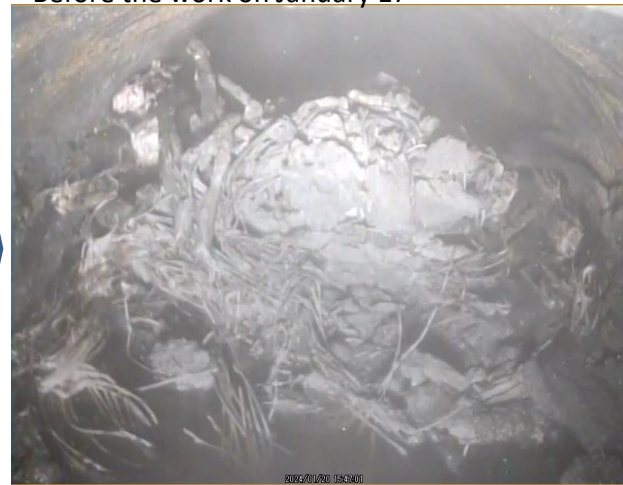
After the work on January 20

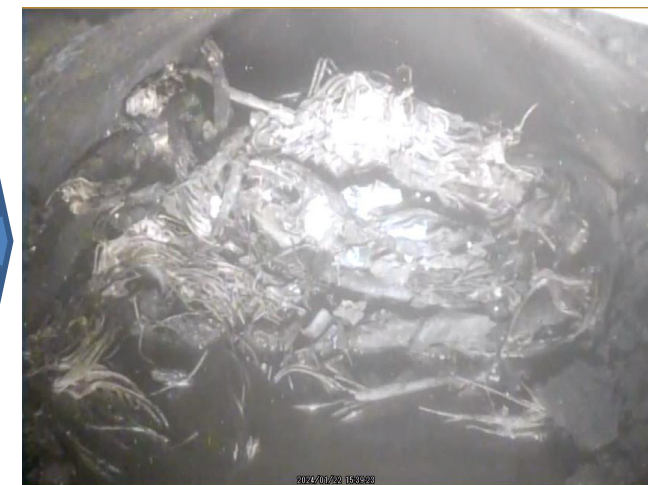
After the work on January 22

- Although it is taking time to remove the deposits compared to prior tests performed on the mockup, they are gradually being removed and we can see the cables. Starting in February, the remaining deposits and cables will be removed using the high pressure water and abrasive water jet.

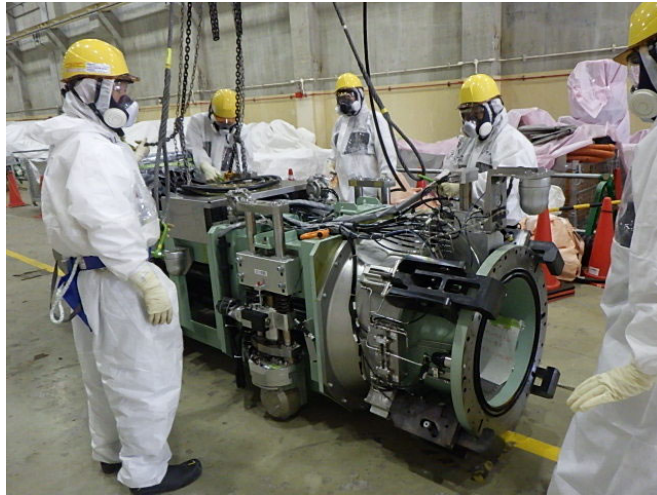
Exterior view of the deposit removal equipment (low pressure water)

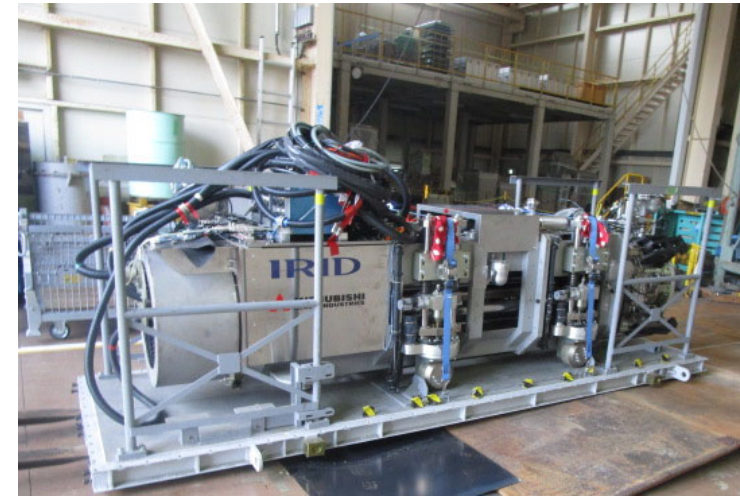
Exterior view of the deposit removal equipment (high pressure water/abrasive water jet)

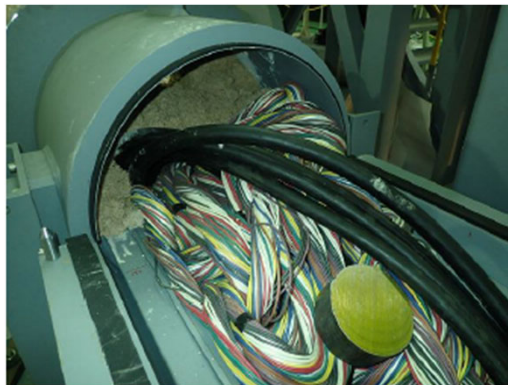
Conditions inside the X-6 penetration (mockup)

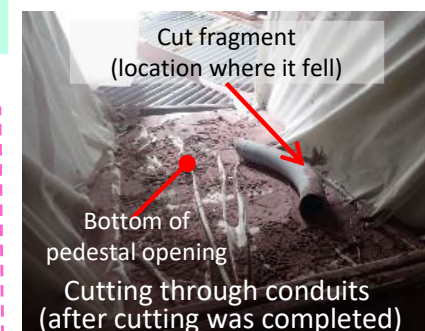
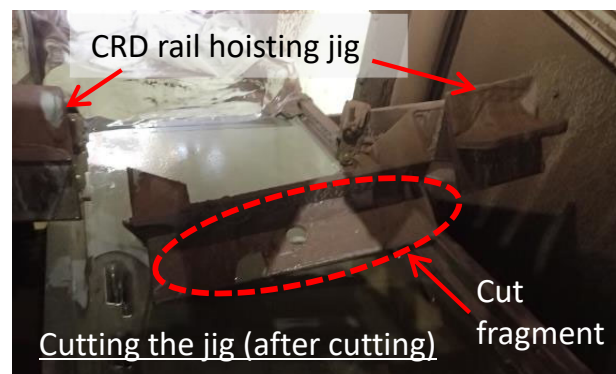
- The abrasive water jet tool was attached to the arm and tests on cutting away the CRD rail hoist jig and electrical wire conduits inside the opening of the pedestal, which are obstructions to passing the arm through, were performed.
- The work could be **seen through the camera** attached to the end of the arm, and we confirmed that the **CRD rail hoist jig and electric wire conduits can be cut away as planned**.
- Furthermore, we've also confirmed that it takes time to adjust the angle and position of the abrasive water jet nozzle as with cutting away the CRD rails, thereby **confirming through these tests that it will take time to construct an access route after the robotic arm has been inserted**. Therefore, we continue to deliberate work efficiency (how to shorten work times).
