Fukushima Daiichi Nuclear Power Station Unit 2 PCV Internal Investigation/ Preparation Status of Fuel Debris Trial Retrieval

February 29, 2024

International Research Institute for Nuclear Decommissioning
Tokyo Electric Power Company Holdings, Inc.

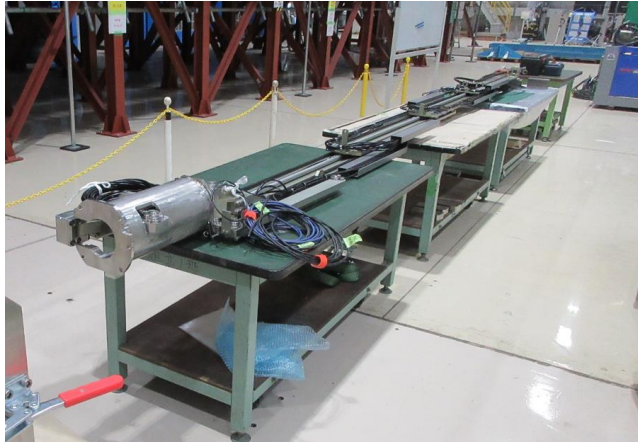
Telescopic arm (being assembled)

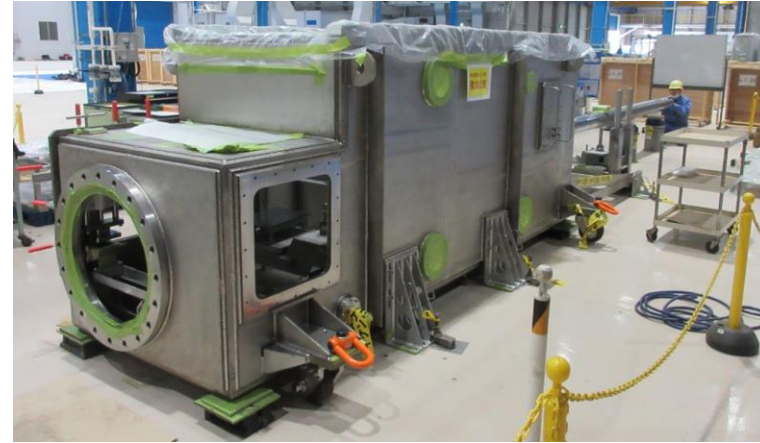
Enclosure (being assembled)

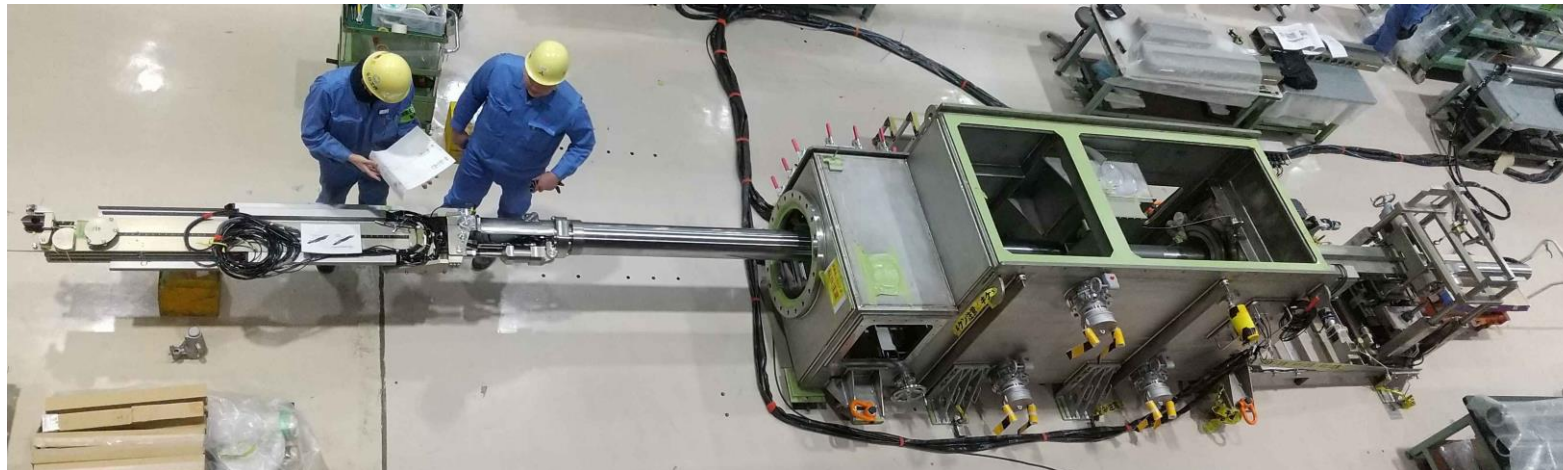
Telescopic trial retrieval equipment (photo taken from above the equipment)

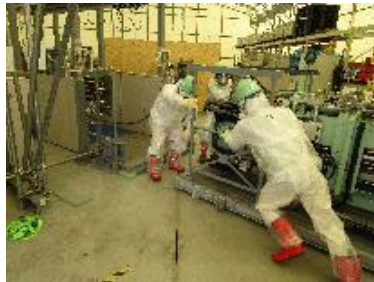
Installation of deposit removal equipment (low pressure water)

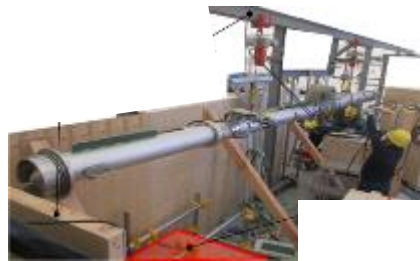
Spray jig installation
※Connected to X-53 penetration

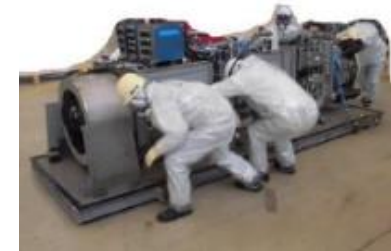
Removal of deposit removal equipment (low pressure water)

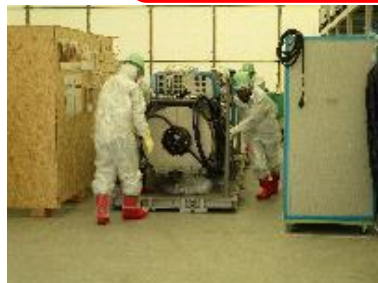
Installation of deposit removal equipment (high pressure water, abrasive water jet)

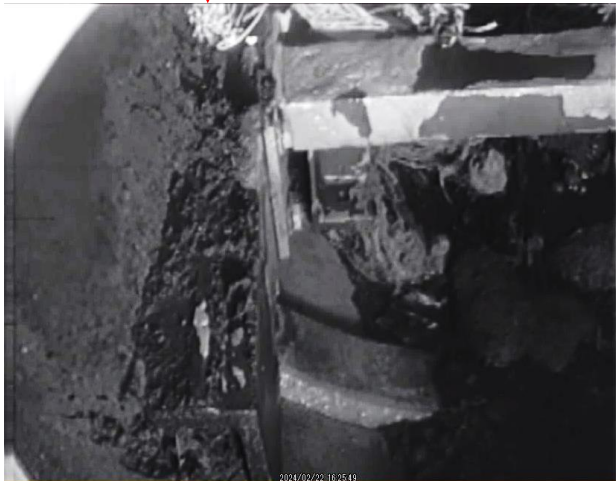
After spraying with high-pressure water (bottom left of the X-6 penetration)

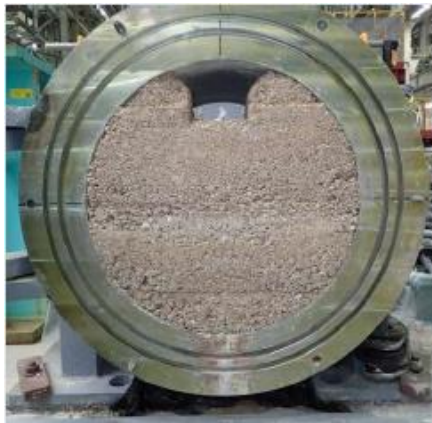
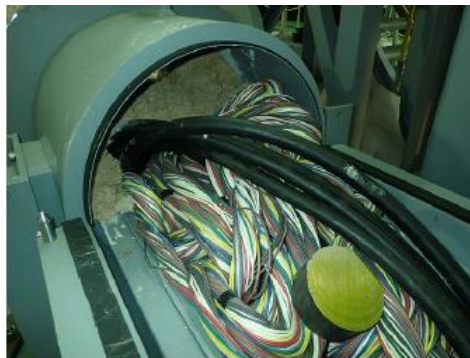
- Suppression of dust dispersion inside the PCV using a spray jig
- Removal of deposits inside the X-6 penetration using a deposit removal equipment (low pressure water/dozer rod)
- Removal of deposits inside the X-6 penetration using a deposit removal equipment (high pressure water/abrasive water jet/dozer rod)

Conditions inside the X-6 penetration (mockup)

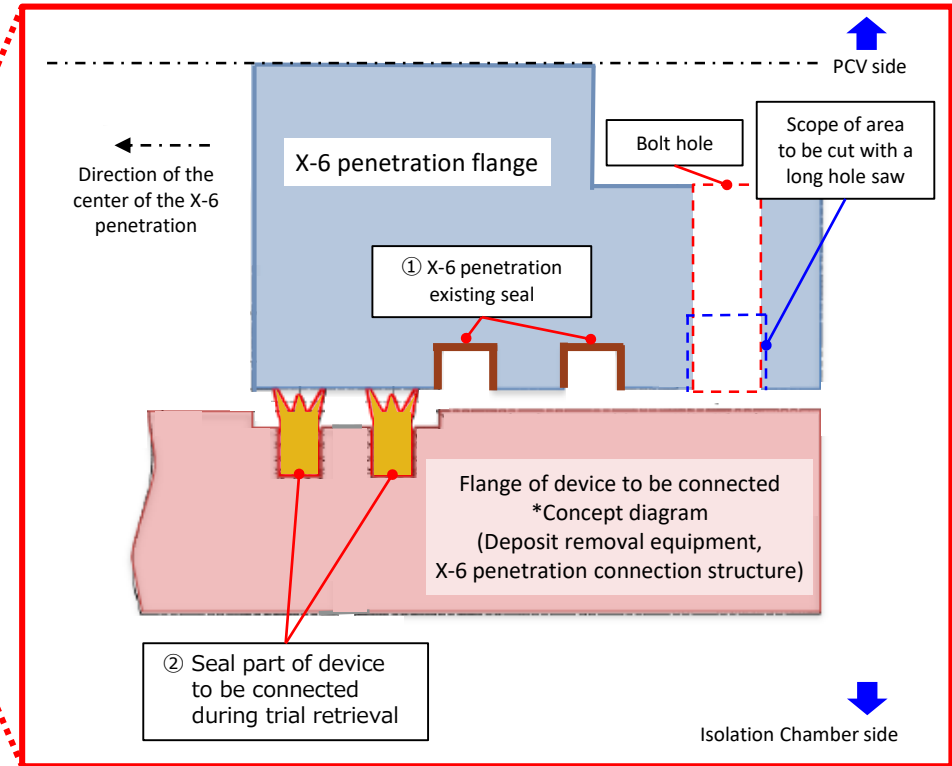
Location of seals when connecting devices to the X-6 penetration (as seen from above)

: ① X-6 penetration existing seal
	: ② Seal of the devices connected to during trial retrieval
	* Deposit removal equipment, X-6 penetration connection structure

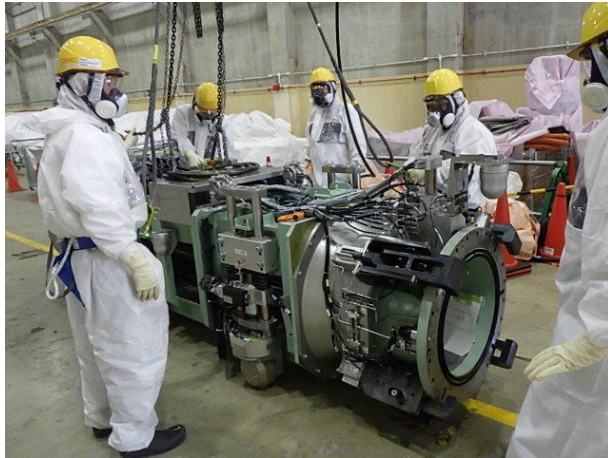
Exterior view of the deposit removal equipment (low pressure water)

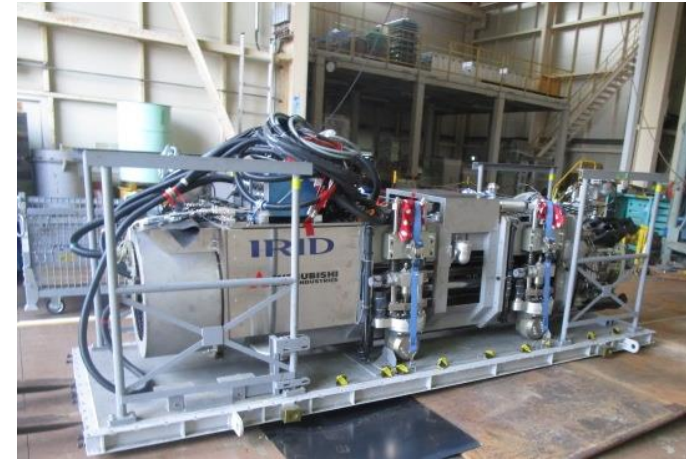
Exterior view of the deposit removal equipment (high pressure water/abrasive water jet)

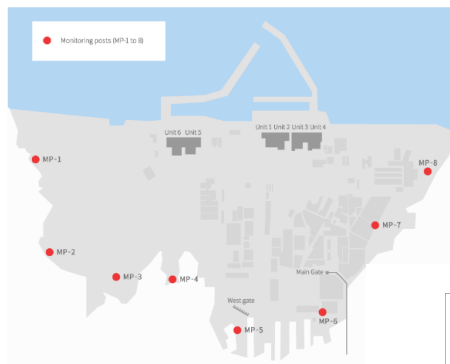
Monitoring points

The following is the radiation doses of the air measured by the monitoring posts (MP1-8) at Fukushima Daiichi Nuclear Power Station.

MP Unit : µSv/h Wind Velocity Unit : m/s
=Measurement value (2024/01/25 09:50)

MP-1	MP-2	MP-3	MP-4	MP-5	MP-6	MP-7	MP-8	Wind Direction	Wind Velocity	Rain
0.502	0.758	0.478	0.959	0.670	0.309	0.554	0.522	west-northwest	12.4	No

- The removal of deposits from inside the Unit 2 X-6 penetration has been ongoing since January 10, and we have not seen any radiological impact on the surrounding environment.
- During investigations, gases from inside the primary containment vessel have been prevented from leaking to the outside environment through the construction of a boundary.
- There have been no significant fluctuations in data from monitoring posts or dust monitors neither prior to or after work.
- Data from monitoring posts/dust monitors near site borders can be found on TEPCO's website
Reference URL: https://www.tepco.co.jp/en/hd/decommission/data/monitoring/monitoring_post/index-e.html
<https://www.tepco.co.jp/en/hd/decommission/data/monitoring/dustmonitor/index-e.html>

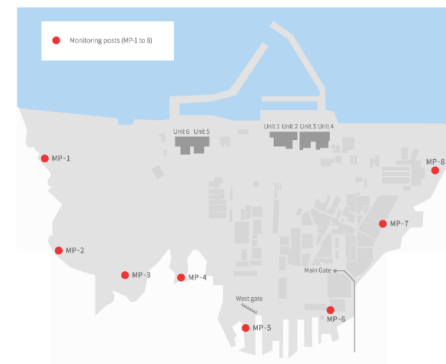
Monitoring points

The following are radioactive concentrations in the air measured near the monitoring posts (MP1-8) at the site boundary of Fukushima Daiichi Nuclear Power Station.
