Fukushima Daiichi Nuclear Power Station Unit 2 PCV Internal Investigation/ Preparation Status of Fuel Debris Trial Retrieval

March 28, 2024

International Research Institute for Nuclear Decommissioning
Tokyo Electric Power Company Holdings, Inc.

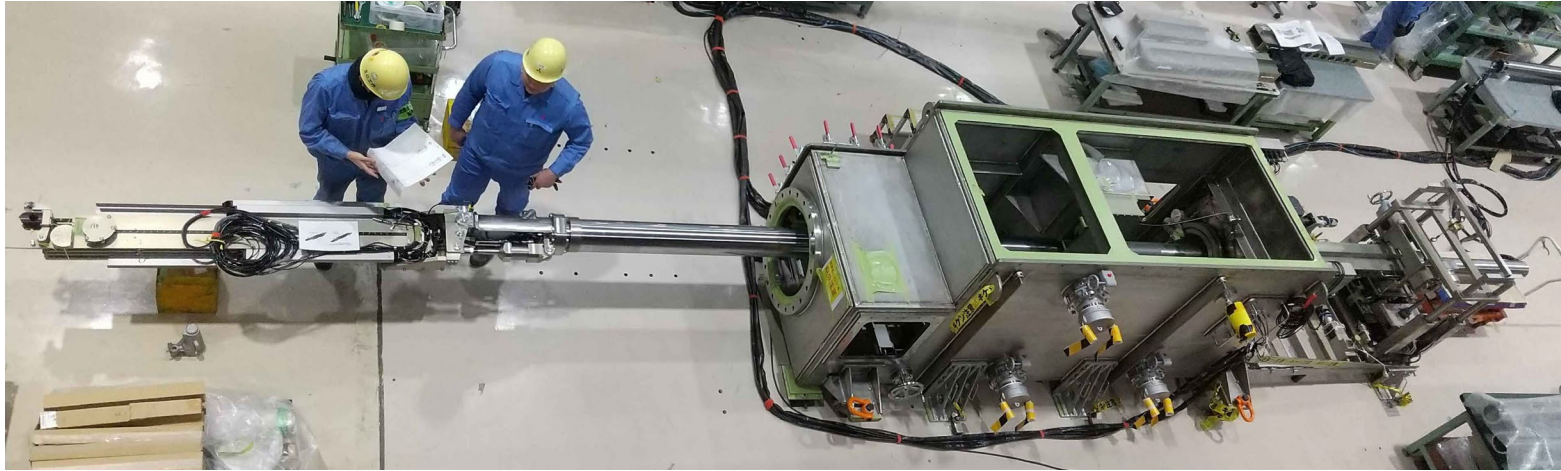
- Manufacturing of primary components has been completed, and mockup testing is currently underway at the manufacturer's factory.

Telescopic trial retrieval equipment (photo taken from above the equipment)

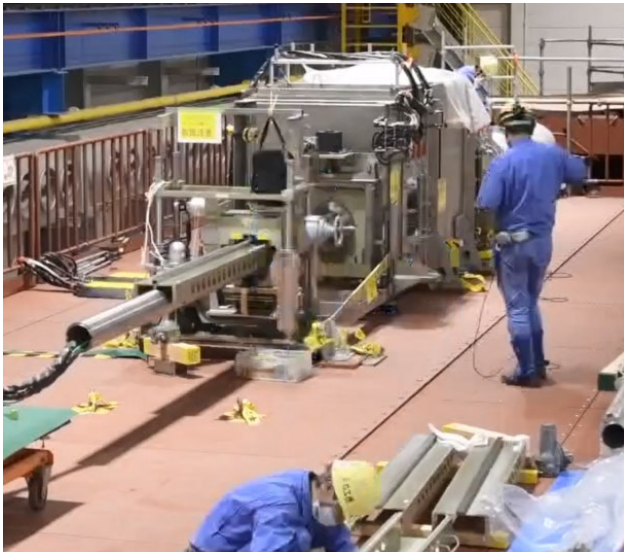
Inserting the guide pipe

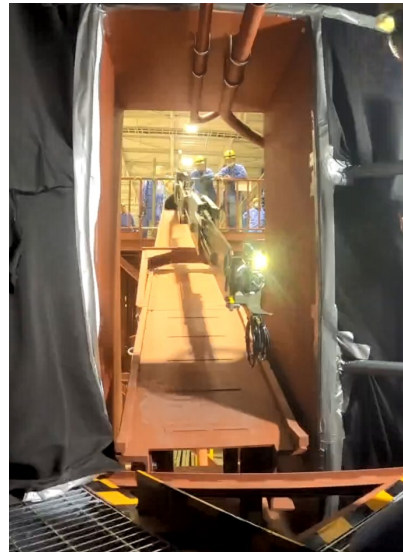
Inserting the equipment into the pedestal opening

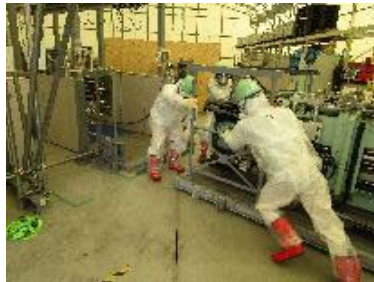
Installation of deposit removal equipment (low pressure water)

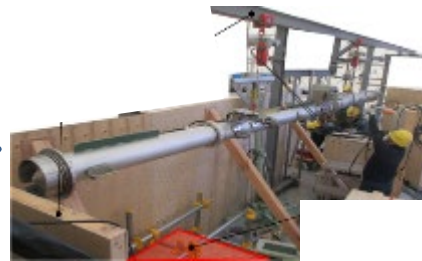
Spray jig installation
※Connected to X-53 penetration

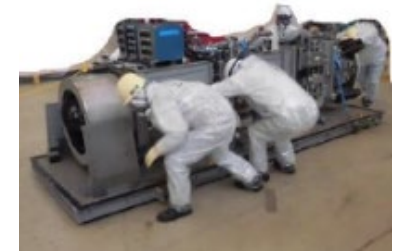
Removal of deposit removal equipment (low pressure water)

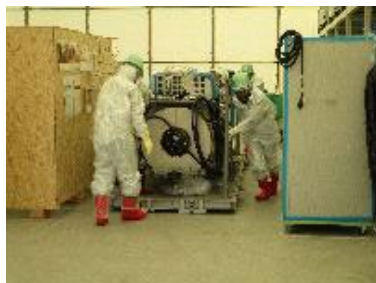
Installation of deposit removal equipment (high pressure water, abrasive water jet)

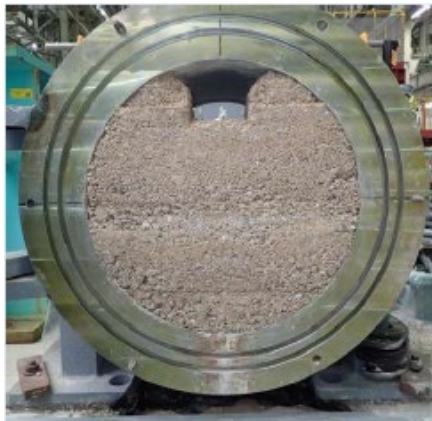
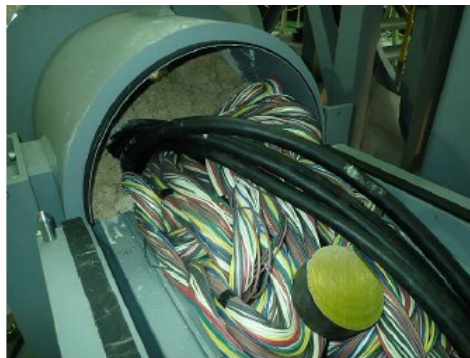
Conditions inside the X-6 penetration (mockup)

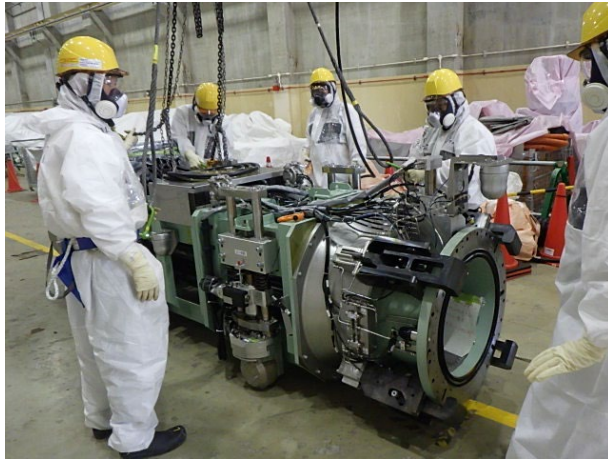
Exterior view of the deposit removal equipment (low pressure water)

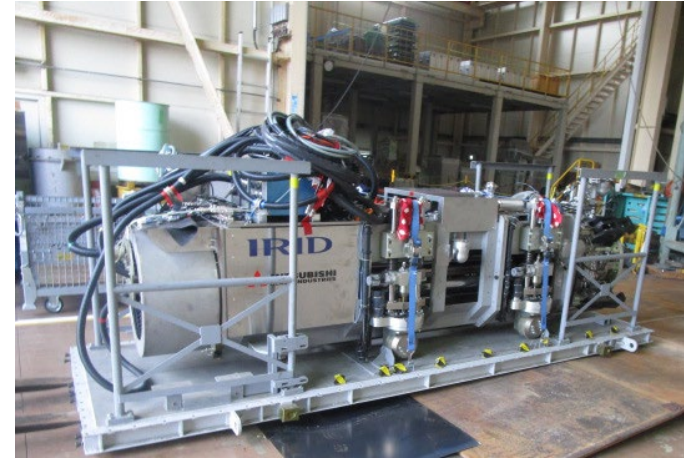
Exterior view of the deposit removal equipment (high pressure water/abrasive water jet)
