Fukushima Daiichi Nuclear Power Station Unit 2 PCV Internal Investigation/ Preparation Status of Fuel Debris Trial Retrieval

May 30, 2024

International Research Institute for Nuclear Decommissioning
Tokyo Electric Power Company Holdings, Inc.

1. PCV internal investigation and trial retrieval plan overview

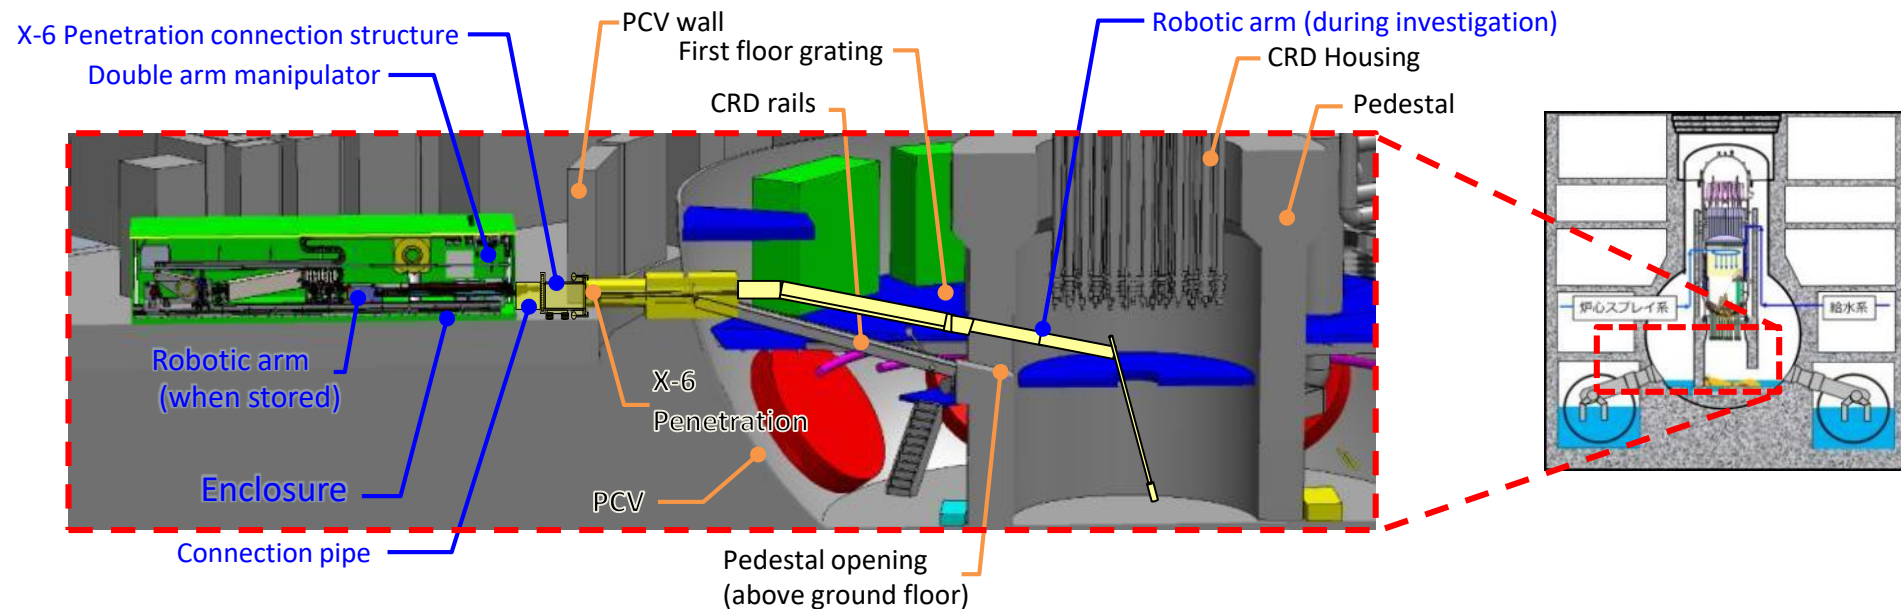
- In order to guarantee work safety and prevent the spread of contamination, the following equipment will be installed at the penetration to the Unit 2 primary containment vessel (hereinafter referred to as, "X-6 penetration") that will be used for the PCV internal investigation and also as a preparatory stage of trial retrieval.
 - The X-6 Penetration connection structure isolates the inside of the PCV from the outside
 - The connection pipe shields radiation
 - A metal box that contains the telescopic device and the robotic arm (enclosure)
- After installation of the aforementioned equipment, the robotic arm shall be fed into the PCV through the X-6 penetration to remove obstacles inside the PCV while also conducting internal investigations and moving forward with the trial retrieval of fuel debris.

Unit 2 internal investigation/trial retrieval plan overview

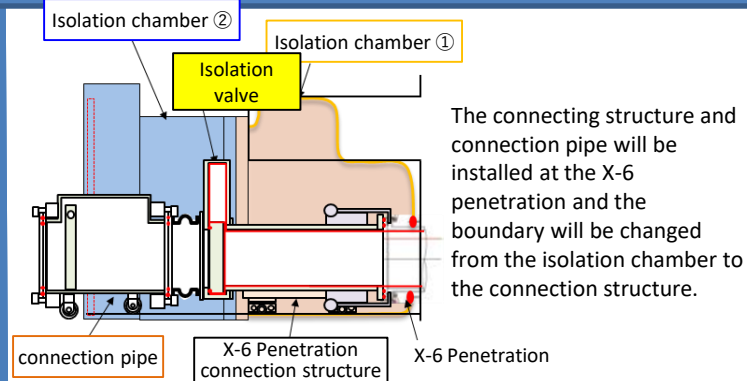
4. Installation of X-6 penetration connection structure and connection pipe

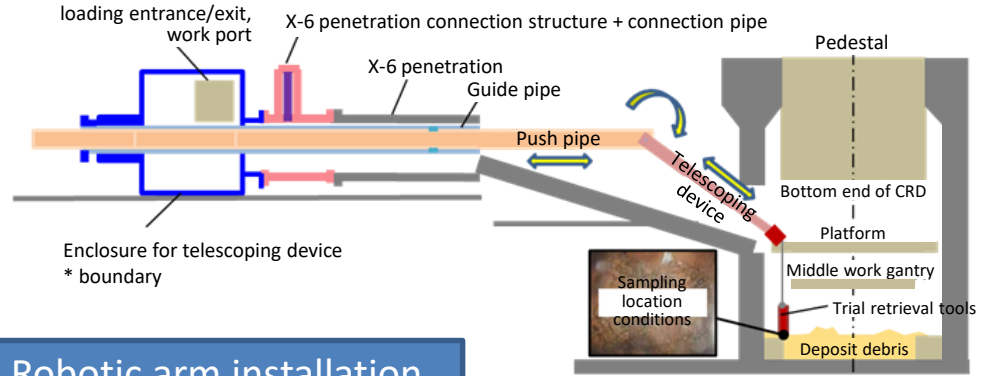
6. Trial retrieval (debris sampling using telescopic device)

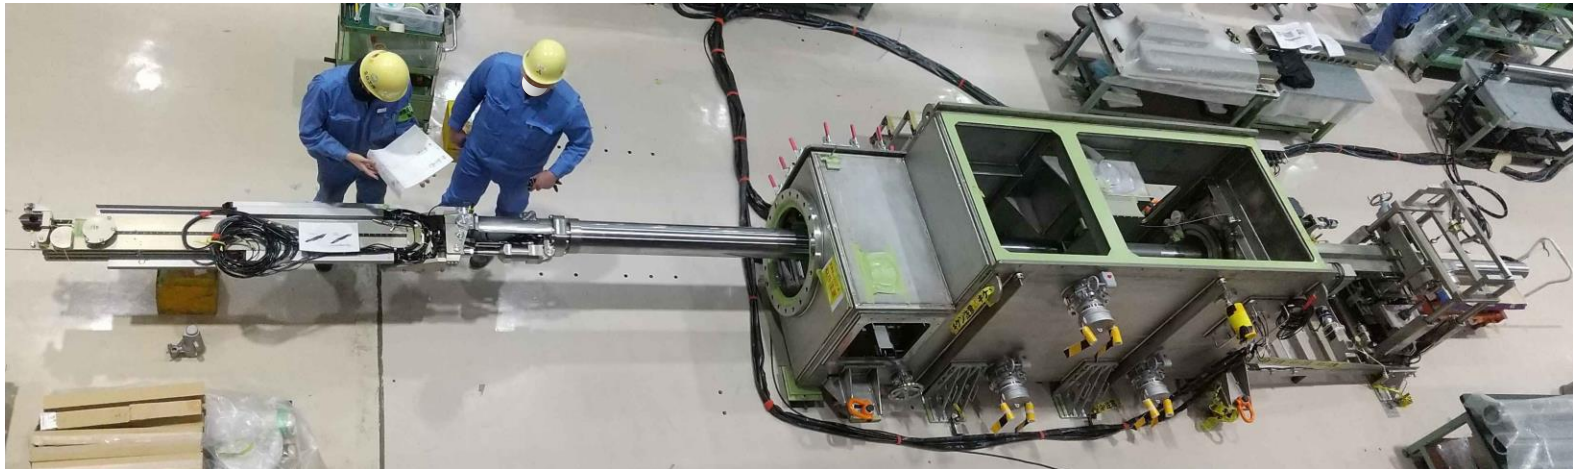
Telescopic trial retrieval equipment (photo taken from above the equipment)

- Mockup testing is currently underway at the manufacturer's factory in preparation for the Unit 2 fuel debris trial retrieval .

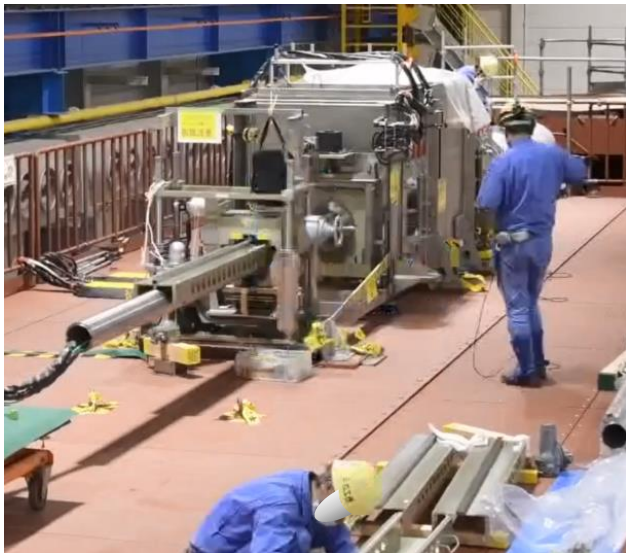
Inserting the guide pipe

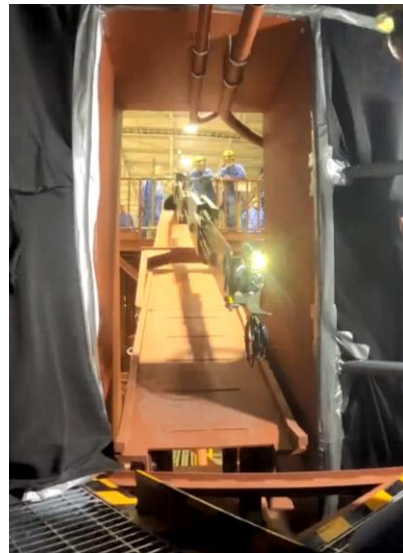
Inserting the equipment into the pedestal opening

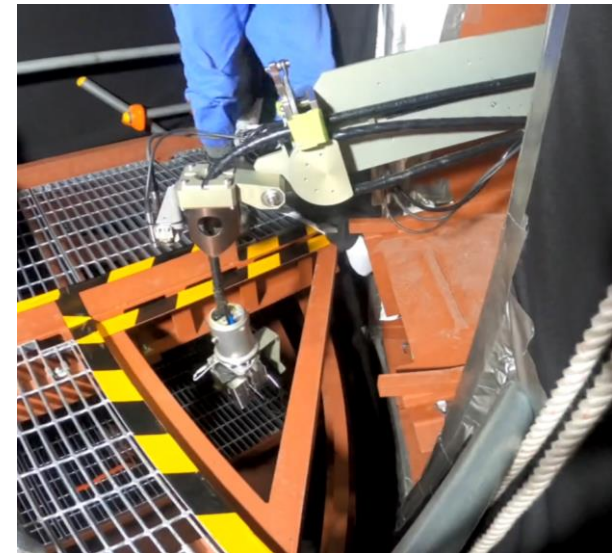
Suspending and lowering the end jig through the grating opening

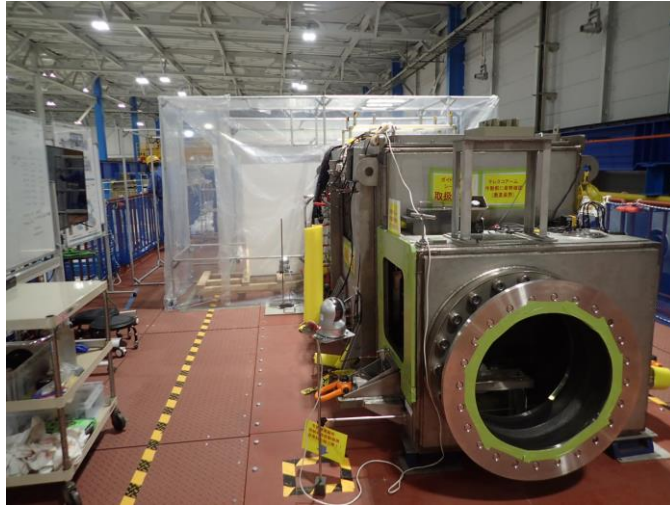
Enclosure and rear house

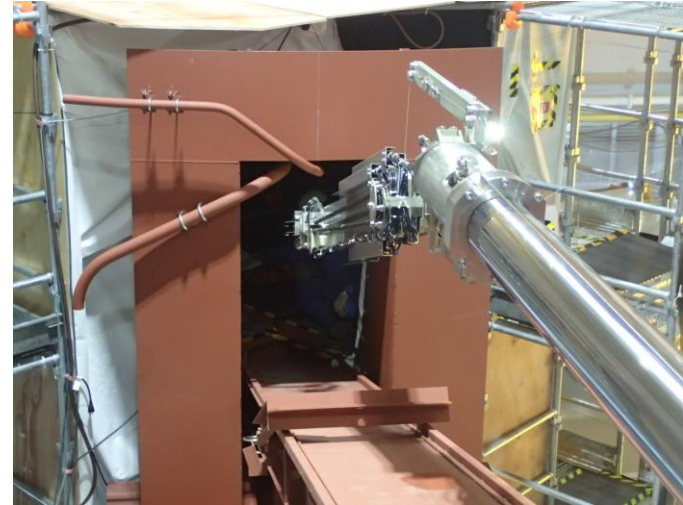
Inserting the equipment into the pedestal opening

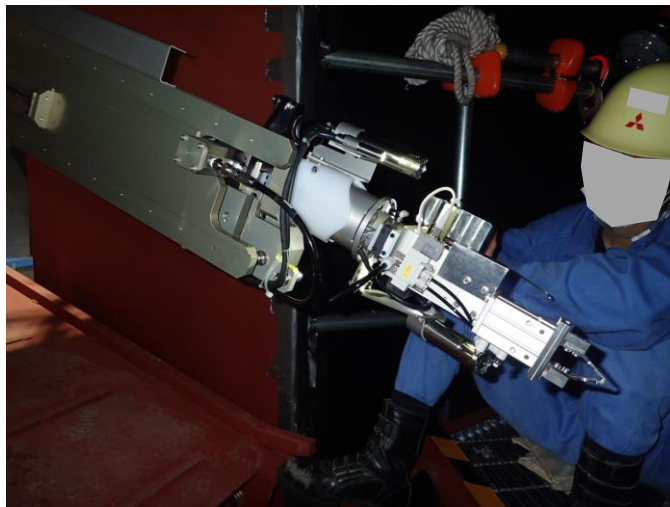
Inserting end jig into the pedestal

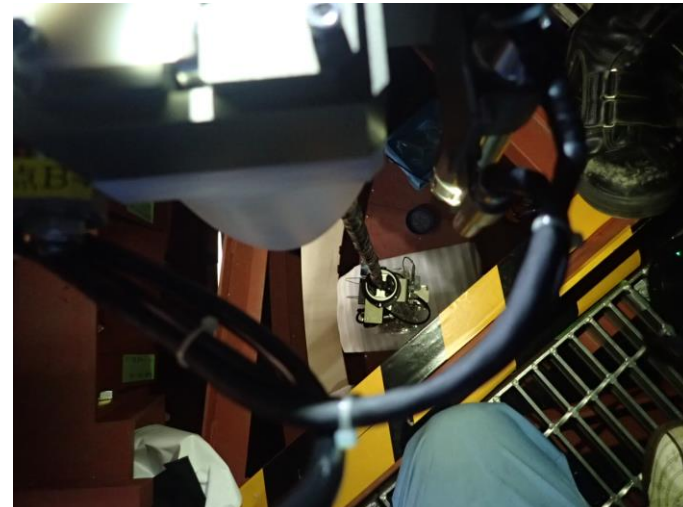
Suspending and lowering the end jig through the grating opening

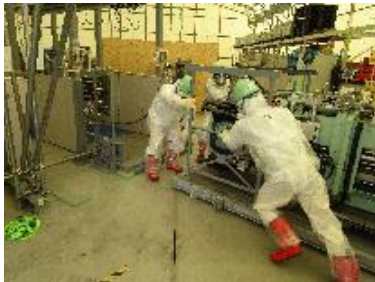
Installation of deposit removal equipment (low pressure water)

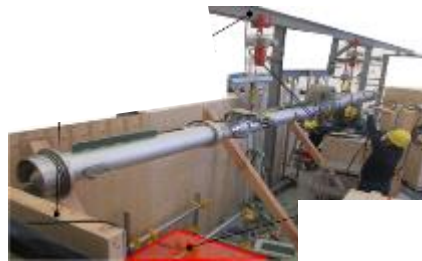
Spray jig installation
※Connected to X-53 penetration

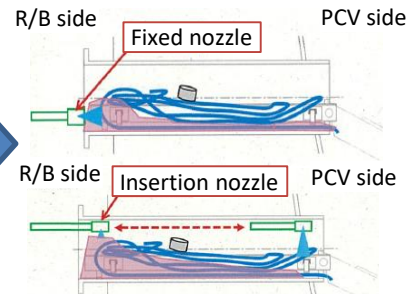
Deposit removal equipment (low pressure water)

※Remotely operated
Deposits are pushed with the dozer rod after which low pressure water is sprayed to remove the deposits

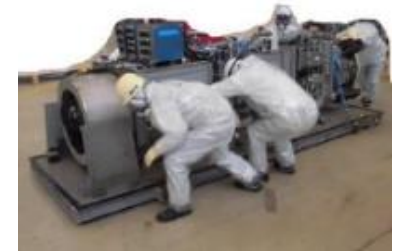
Removal of deposit removal equipment (low pressure water)

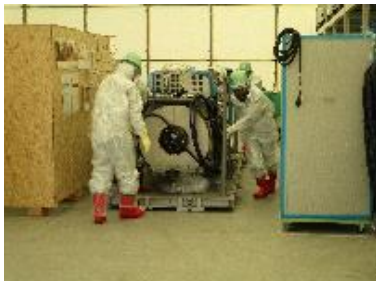
Installation of deposit removal equipment (high pressure water, abrasive water jet)

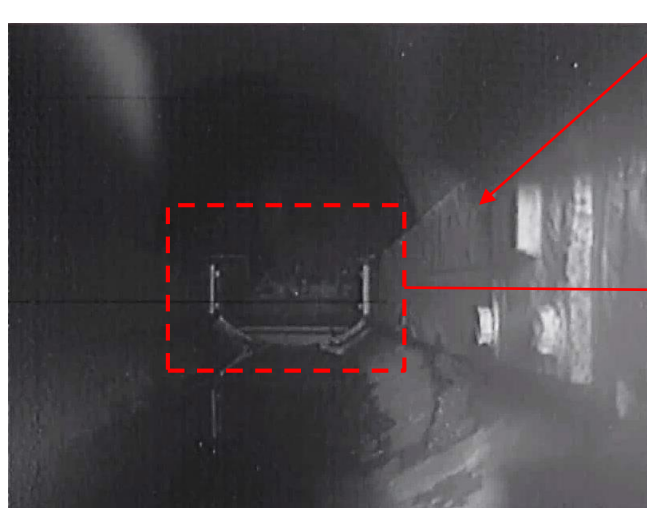
- The removal of deposits inside the X-6 penetration has been completed and we have confirmed that there is no significant hindrance to accessing the PCV with the telescopic device and the robotic arm.

Condition of the X-6 penetration after the deposit removal (from the front to the back)

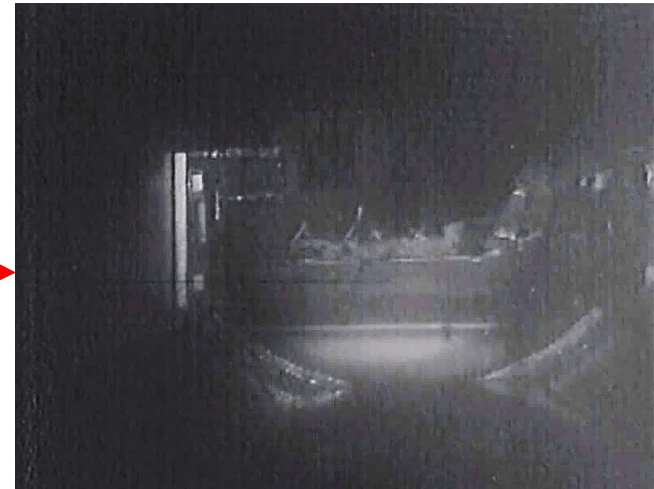
Condition of the X-6 penetration after the deposit removal (in the back)

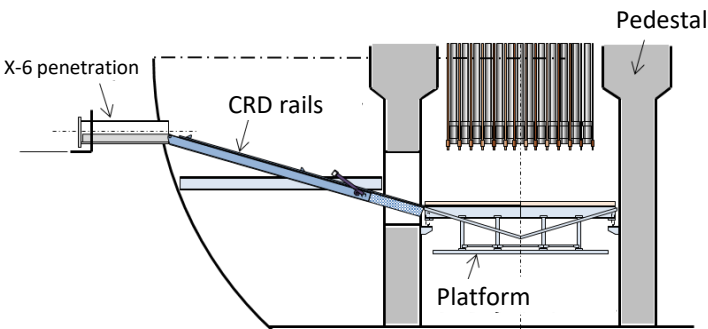
Cross-sectional view of the X-6 penetration/reactor pressure vessel pedestal

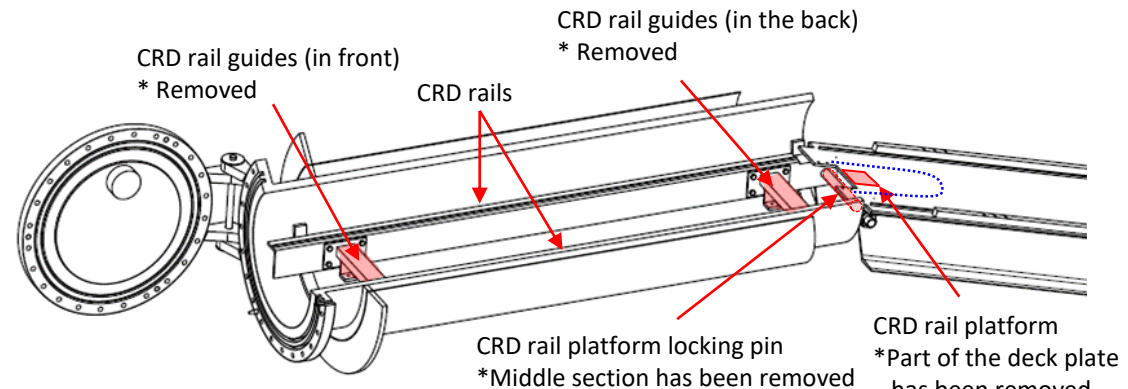
Birds eye view of the X-6 penetration

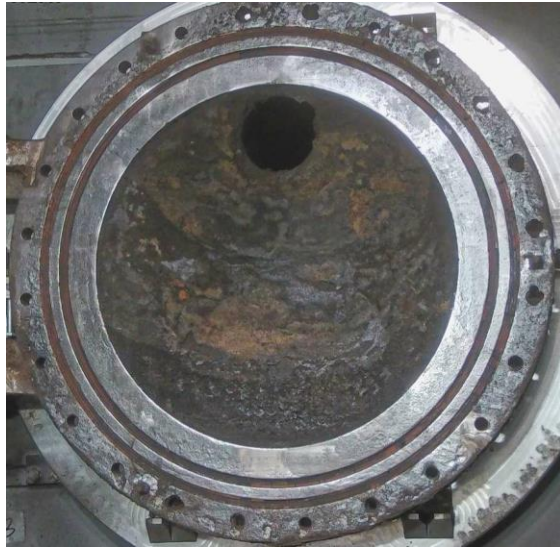
X-6 penetration
(before the removal of deposits)

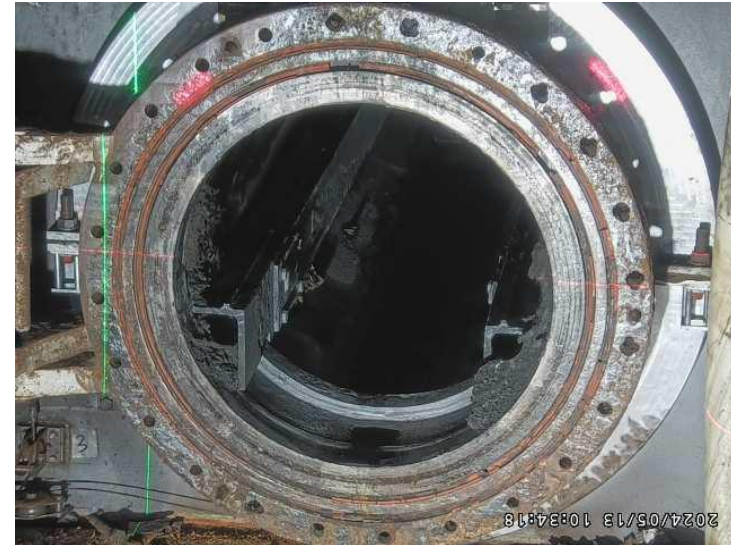
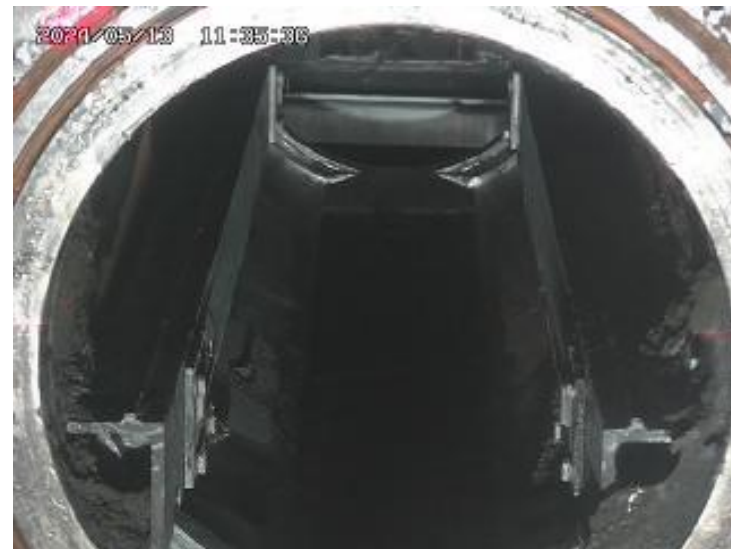
X-6 penetration (after the removal of deposits)

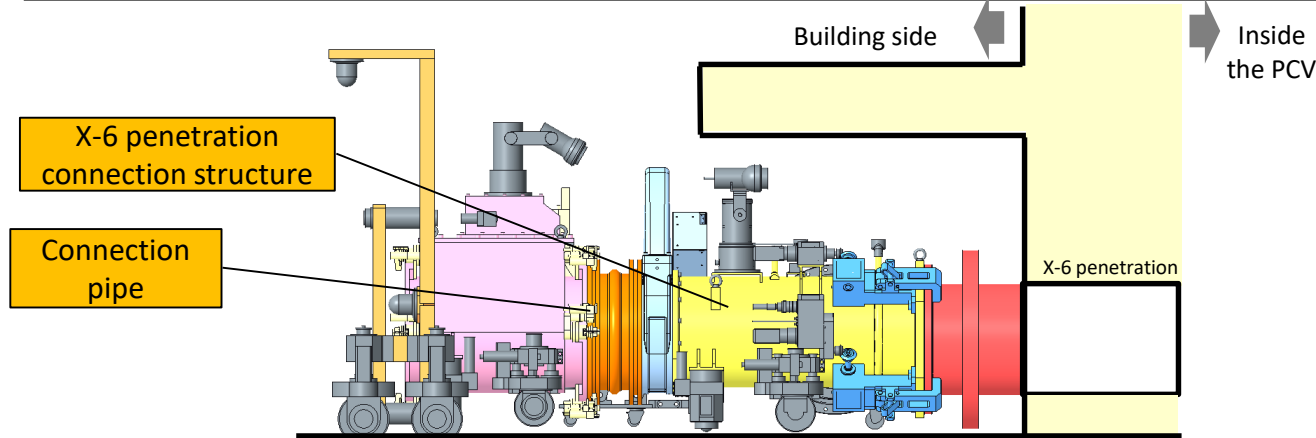
The following mechanism is being installed in order to construct an access route for trial retrieval and to create a PCV boundary

- X-6 penetration connection structure: Connected to the X-6 penetration in order to create a PCV boundary by using an isolation valve to isolate the PCV
- Connection pipe: Used to shield radiation from inside the PCV and reduce dose levels in front of the X-6 penetration

➤ Connection pipe

➤ X-6 penetration connection structure

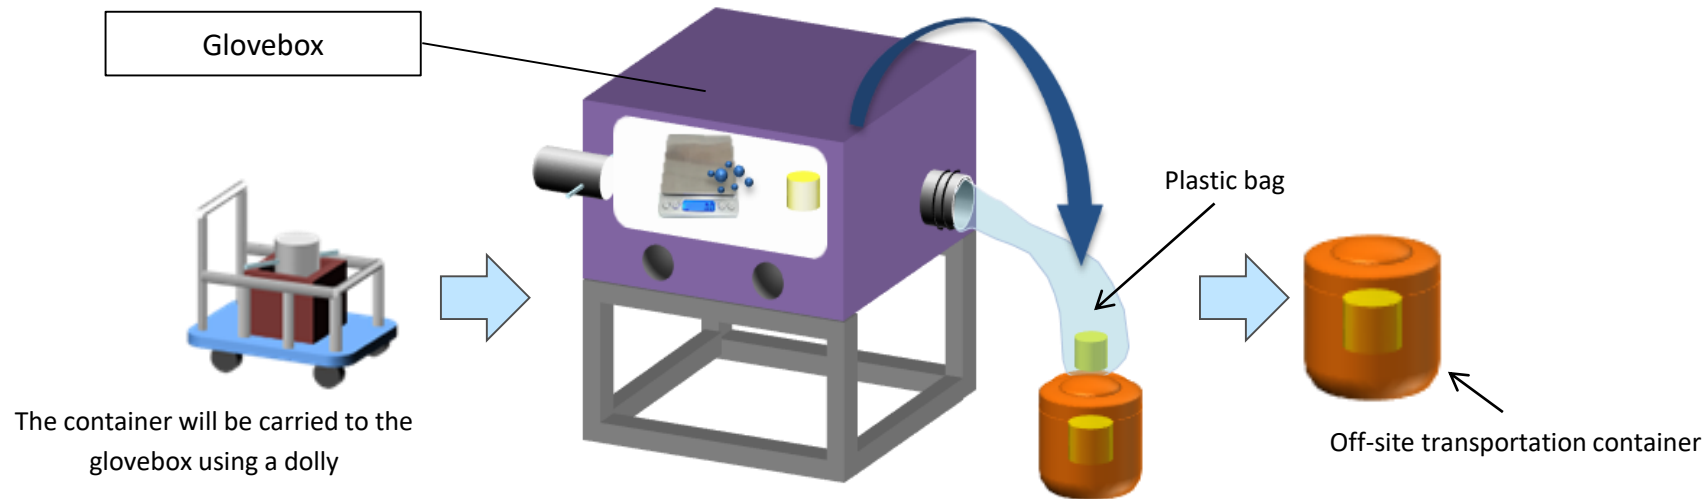
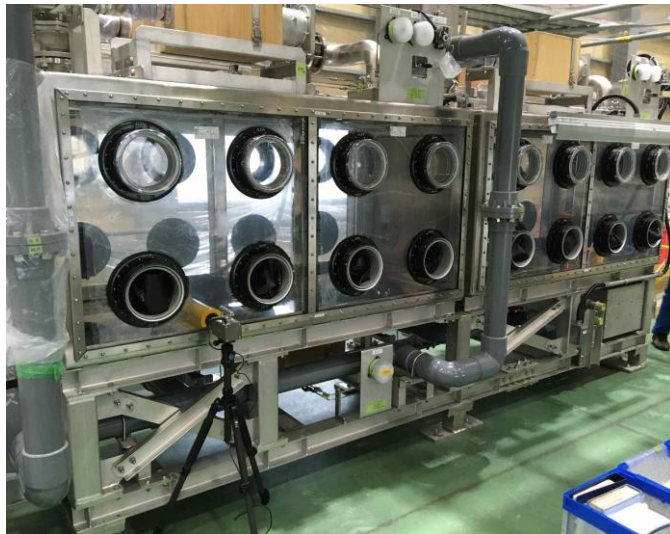
- The sampled fuel debris will be subjected to dose measurements when it is taken out from the enclosure of the telescopic device or the robotic arm, and then transported to a glovebox inside the reactor building where it will be subjected to various measurements. After measurements have been taken, measures to prevent the spread of contamination shall be implemented and it will be transported off-site

- The collected samples will be put into a negative pressure glovebox
- The samples will be subjected to various measurements inside the glovebox and then put into a container
- The container will be removed from the glovebox while preventing the spread of contamination by using a plastic bag
- The container will then be inserted into an off-site transportation container and loaded onto a transport vehicle

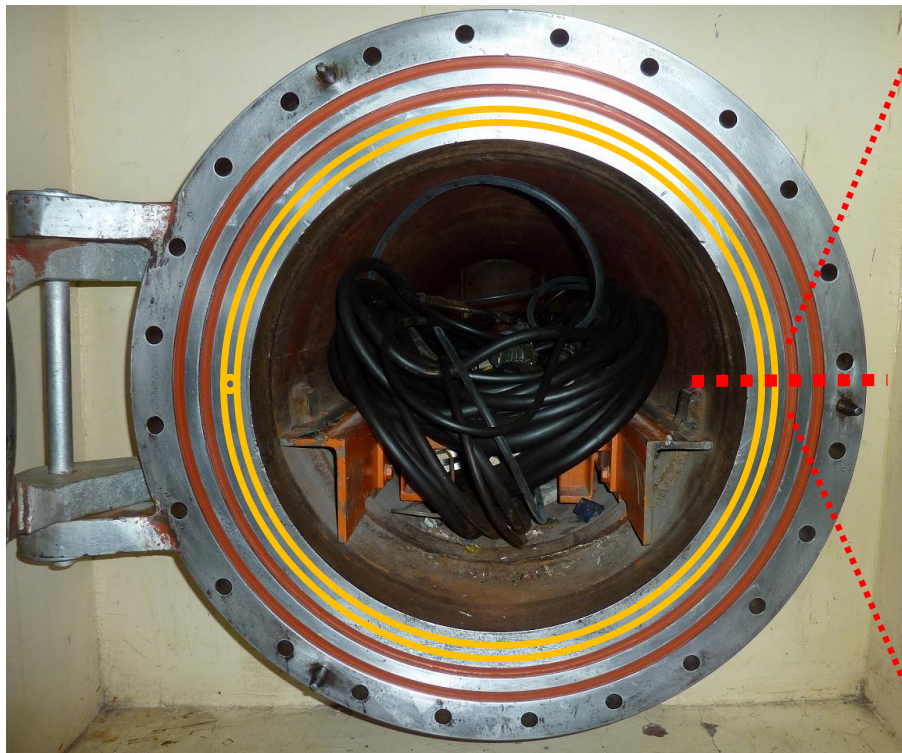
X-6 penetration hatch prior to the accident (open)

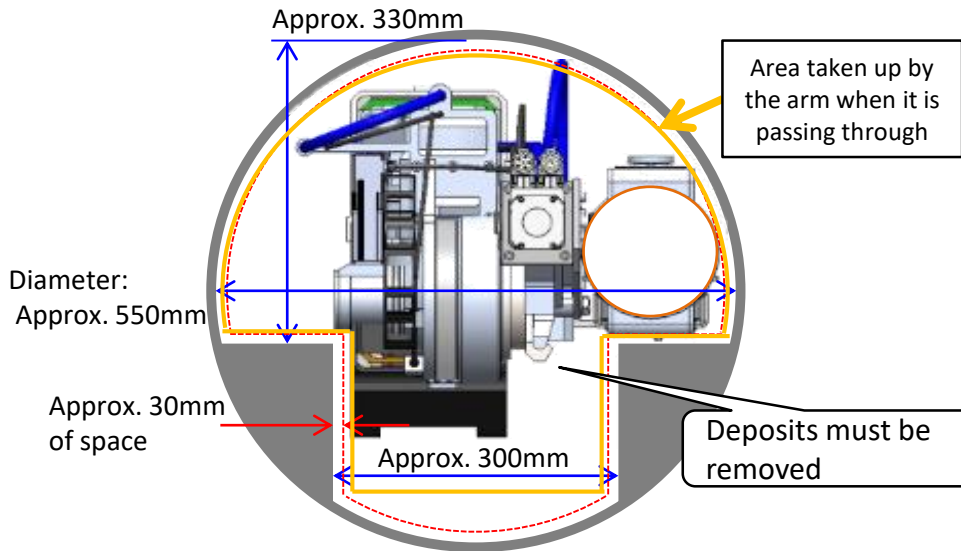
Robotic arm

(cross-section of the X-6 penetration when the arm is passing through)

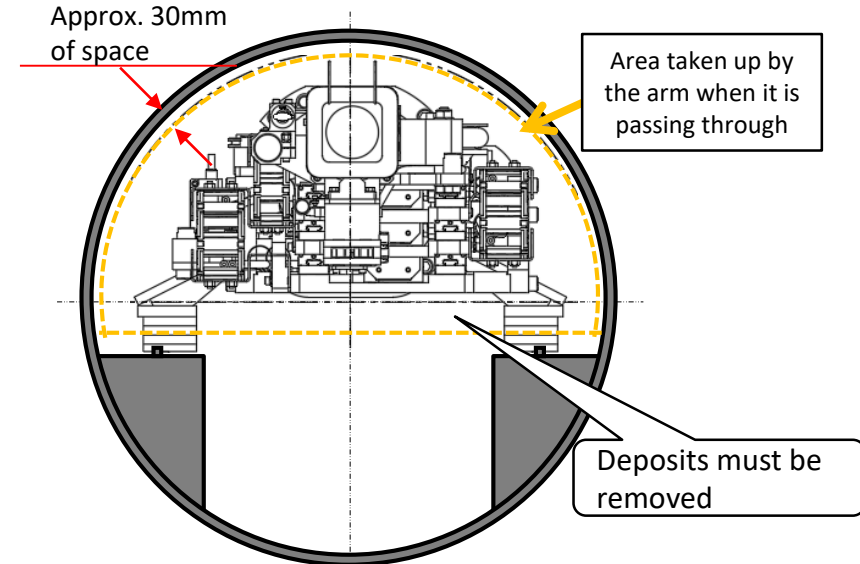
Telescopic arm

(cross-section of the X-6 penetration when the arm is passing through)

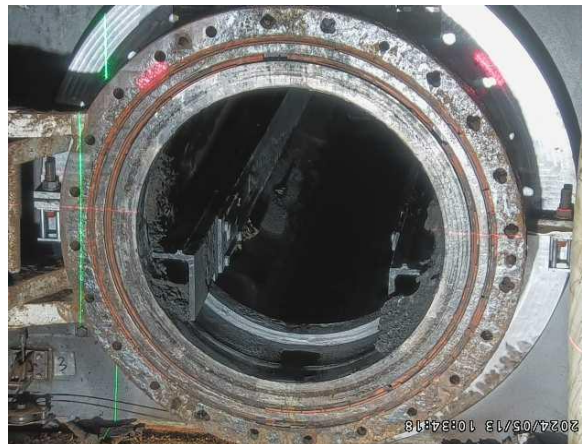
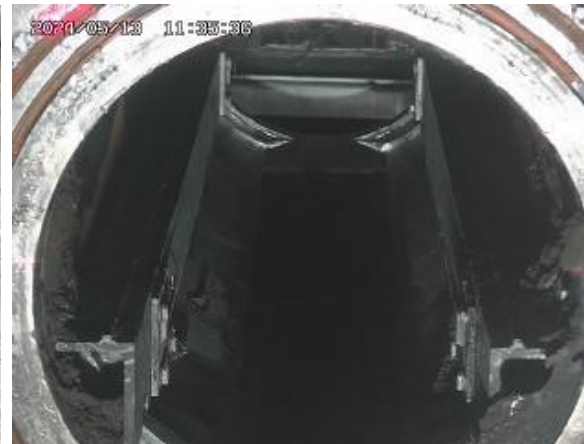
X-6 penetration after the removal of deposits
