Fukushima Daiichi Nuclear Power Station Unit 2 PCV Internal Investigation/ Preparation Status of Fuel Debris Trial Retrieval

June 27, 2024

International Research Institute for Nuclear Decommissioning
Tokyo Electric Power Company Holdings, Inc.

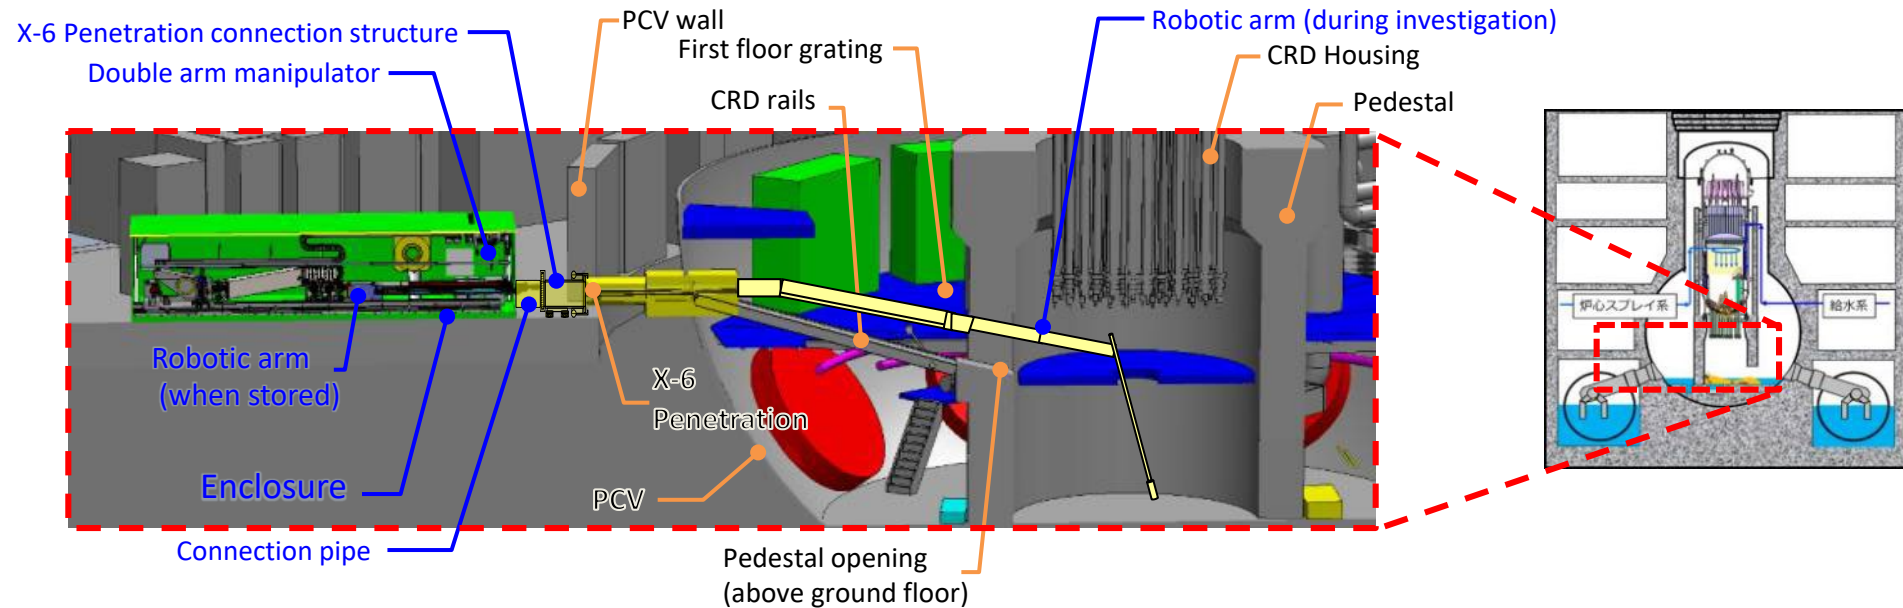
- In order to guarantee work safety and prevent the spread of contamination, the following equipment will be installed at the penetration to the Unit 2 primary containment vessel (hereinafter referred to as, "X-6 penetration") that will be used for the PCV internal investigation and also as a preparatory stage of trial retrieval.
 - The X-6 Penetration connection structure isolates the inside of the PCV from the outside
 - The connection pipe shields radiation
 - A metal box that contains the telescopic device and the robotic arm (enclosure)
- After installation of the aforementioned equipment, the robotic arm shall be fed into the PCV through the X-6 penetration to remove obstacles inside the PCV while also conducting internal investigations and moving forward with the trial retrieval of fuel debris.

Unit 2 internal investigation/trial retrieval plan overview

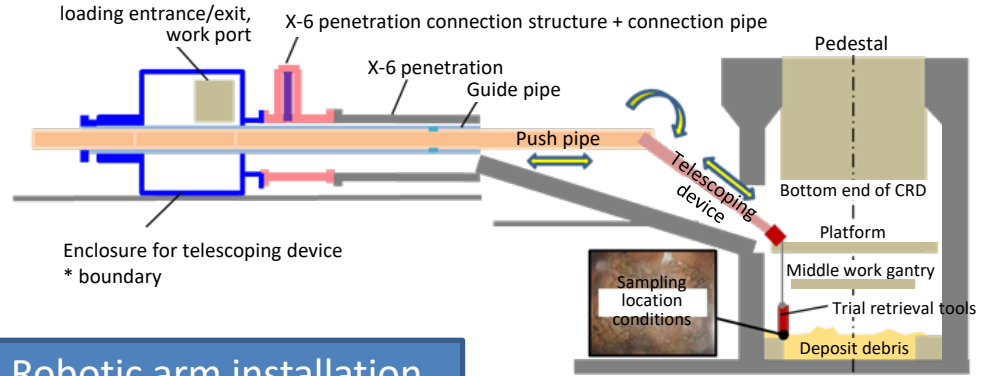
6. Trial retrieval (debris sampling using telescopic device)

5. Installation of telescopic device

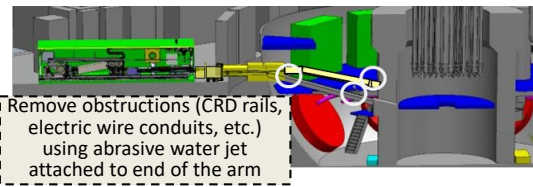
① Internal investigation

Isolation valve: Valve installed to separate the inside of the PCV from the outside

Abrasive Water Jet: Combines high pressure water with an abrasive to improve cutting ability

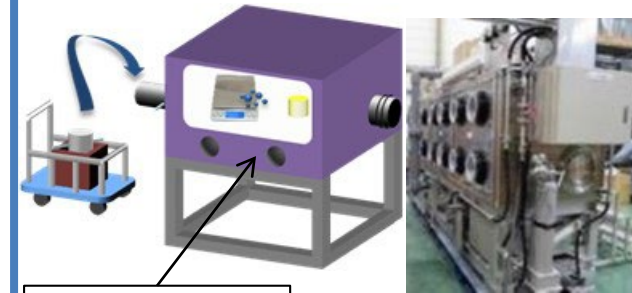
10. Insertion into glovebox/Measurement

- The collected sample will be put into a negative pressure glovebox
- The samples will be subjected to various measurements inside the glovebox and then put into a container

- The sampled fuel debris will be subjected to dose measurements when it is taken out from the enclosure of the telescopic device or the robotic arm, and then transported to a glovebox inside the reactor building where it will be subjected to various measurements. After measurements have been taken, measures to prevent the spread of contamination shall be implemented and it will be transported off-site

- The collected samples will be put into a negative pressure glovebox
- The samples will be subjected to various measurements inside the glovebox and then put into a container
- The container will be removed from the glovebox while preventing the spread of contamination by using a plastic bag
- The container will then be inserted into an off-site transportation container and loaded onto a transport vehicle

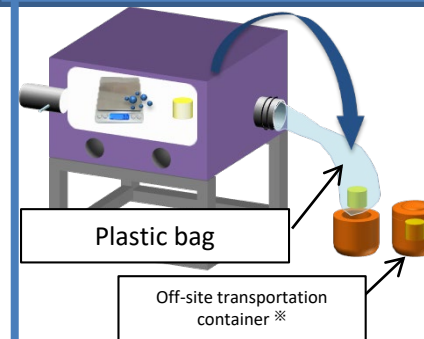
11. Container removal/Insertion into transportation container /Removal from premises

- The container will be removed from the glovebox while preventing the spread of contamination by using a plastic bag
- The container will then be inserted into an off-site transportation container and loaded onto a transport vehicle

※ Prior to transport, the surface dose/contamination density, etc. of the container shall be measured to ensure that it meets legal requirements

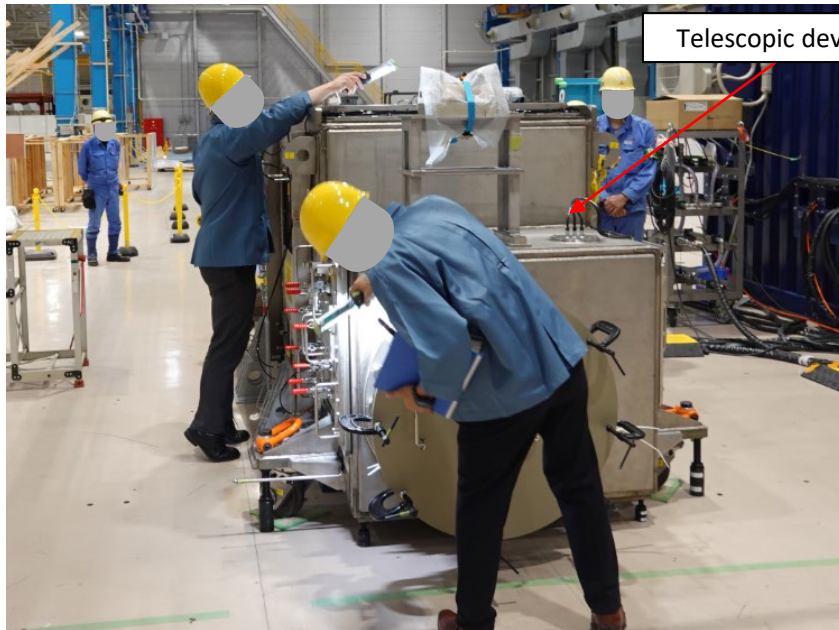
- The telescopic trial retrieval equipment was subject to pre-use inspections (pressure resistance check) at the manufacturer's factory on June 18, and was given "good" marks.
- Preparations for transport to the Fukushima Daiichi Nuclear Power Station are underway.

Pressure resistance check
(in-house inspection)

- The telescopic device was subject to pre-use inspections (pressure resistance check) at the manufacturer's factory on June 18, and was given "good" marks. Preparations for transport to the Fukushima Daiichi Nuclear Power Station are underway.
- In the field, the connection structure and the connection pipe have been connected to the X-6 penetration, and the PCV boundary has been changed from the isolation chamber to the X-6 penetration connection structure. We will proceed with preparations to install the telescopic device inside the reactor building.
- We are planning to begin the trial retrieval of fuel debris at some point between August and October 2024.
- We will continue to steadily move forward and prioritize safety during the trial retrieval of fuel debris.

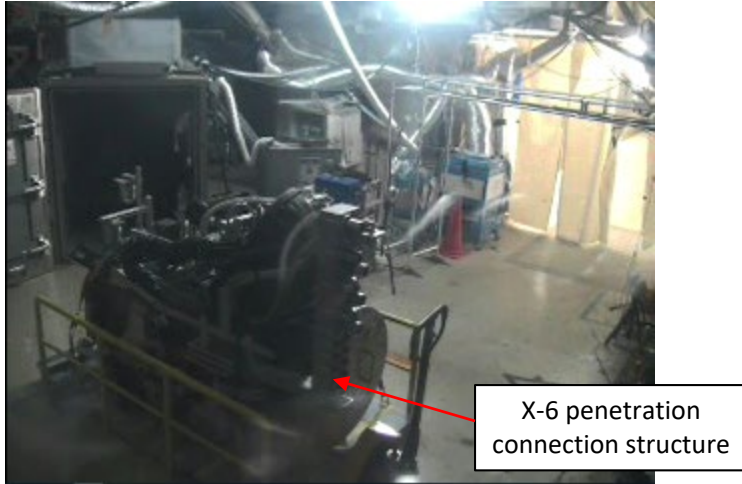
Transporting the X-6 penetration connection structure to the R/B northwest area

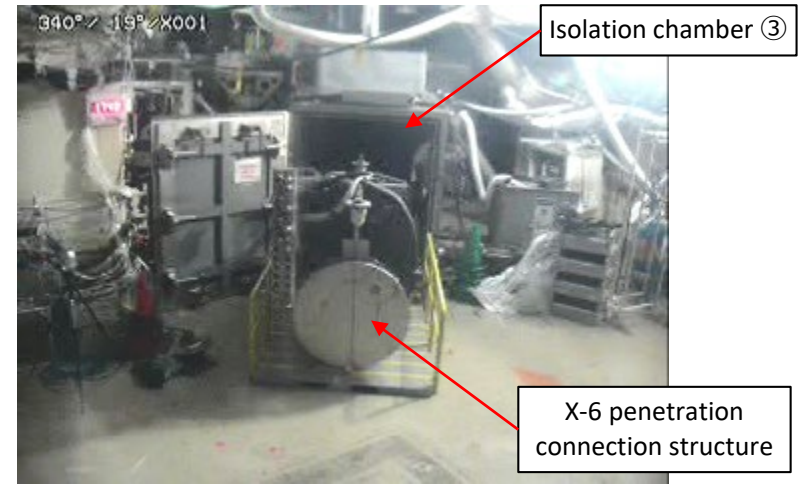
Carrying the X-6 penetration connection structure into the isolation chamber③

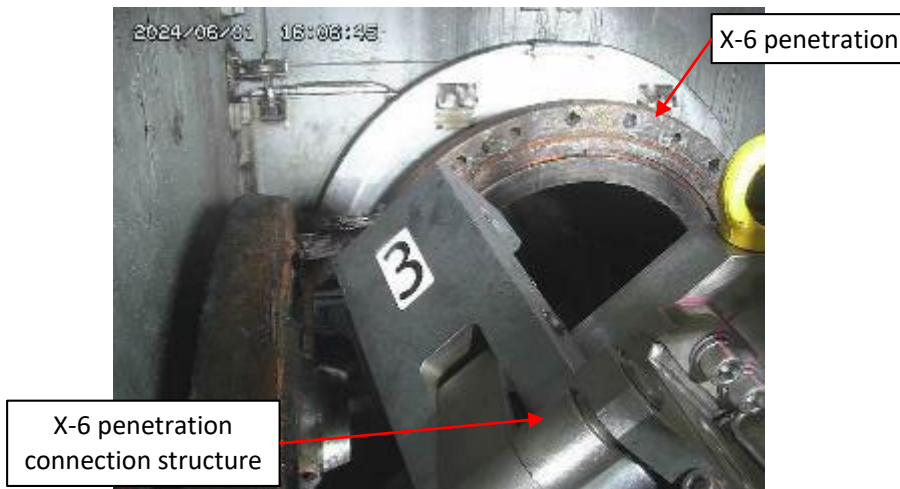
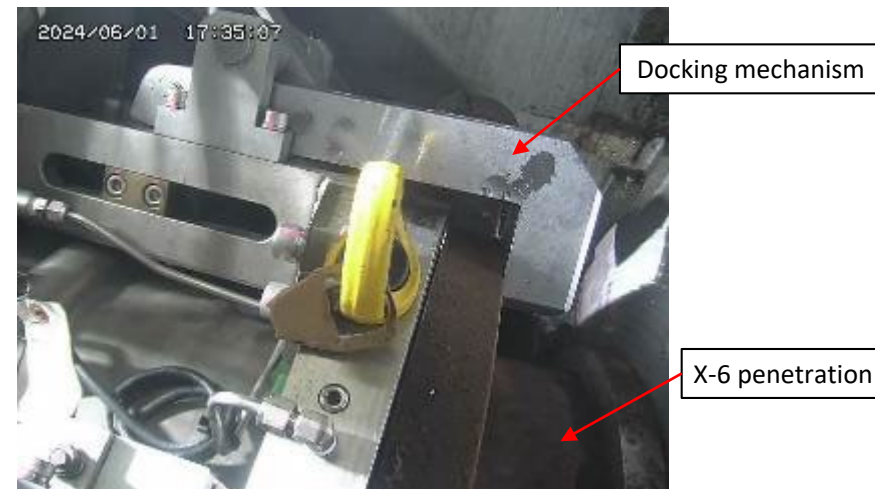
- The X-6 penetration connection structure (isolation valve) has been connected (docking) to the X-6 penetration flange. After connecting the structure, a pressure test was performed on the double flange seal and it was confirmed that there are no problems.
※ The PCV boundary was changed from the isolation chamber to the X-6 penetration connection structure

Connecting the X-6 penetration connection structure to the X-6 penetration

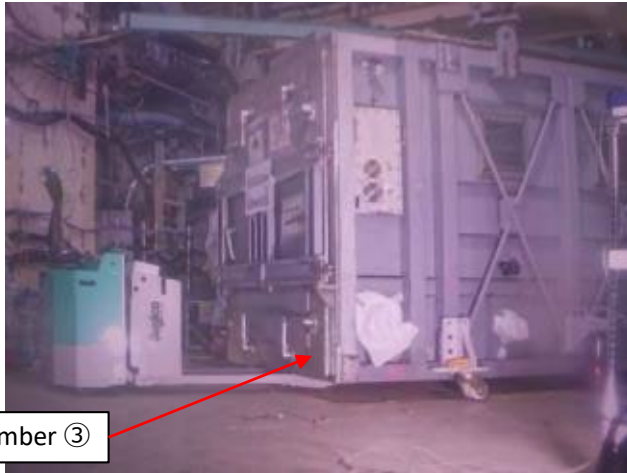
- After installation of the X-6 penetration connection structure, the isolation chamber ③ was removed and carried out of the reactor building.
- The connection pipe was installed and connected (docked) to the flange at the back of the X-6 penetration connection structure after which a pressure test of the double flange seal was conducted and it was confirmed that there are no problems.

Removing the isolation chamber③

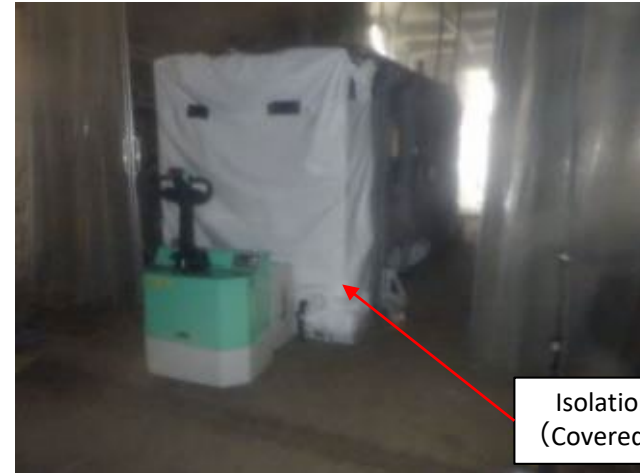
Carrying the isolation chamber ③ to the large freight entrance

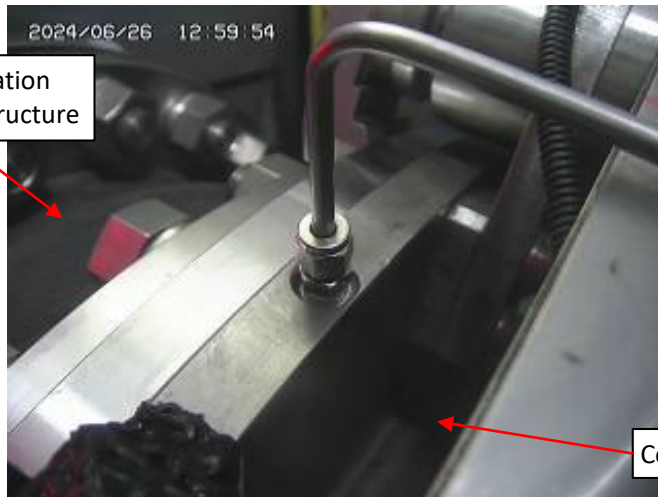
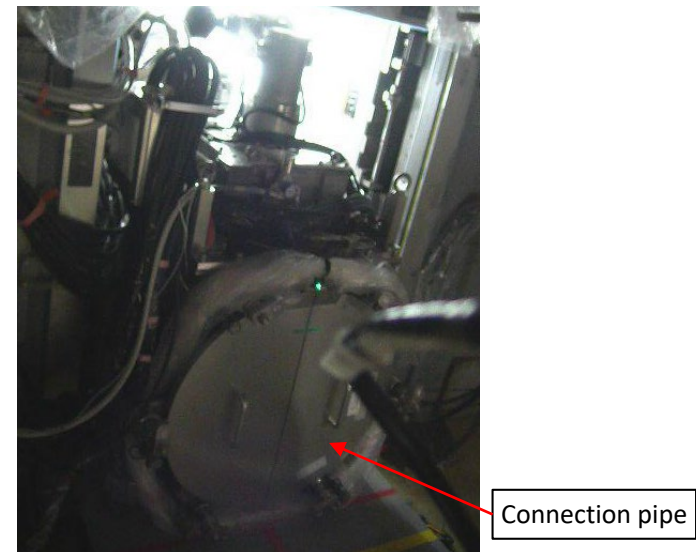
Connecting the connection pipe to the X-6 penetration connection structure

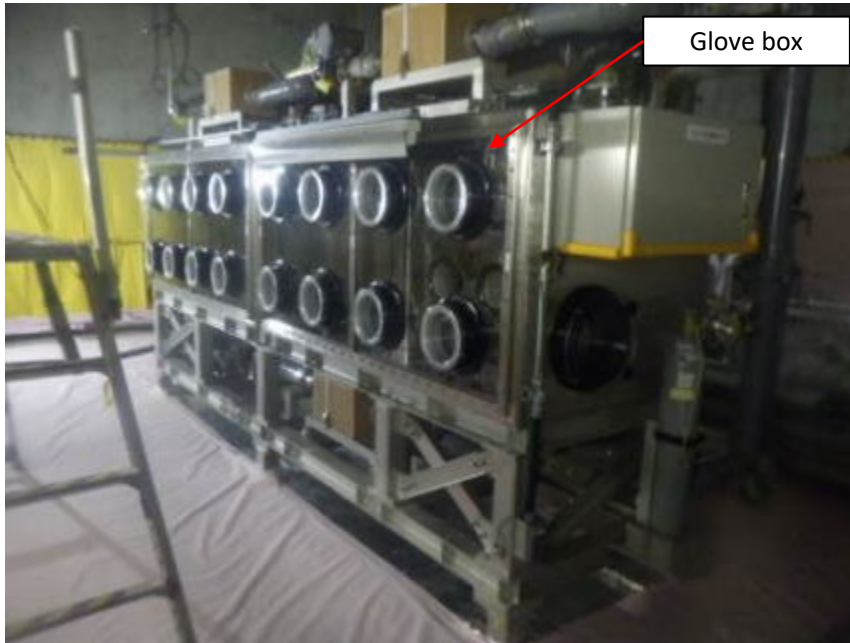
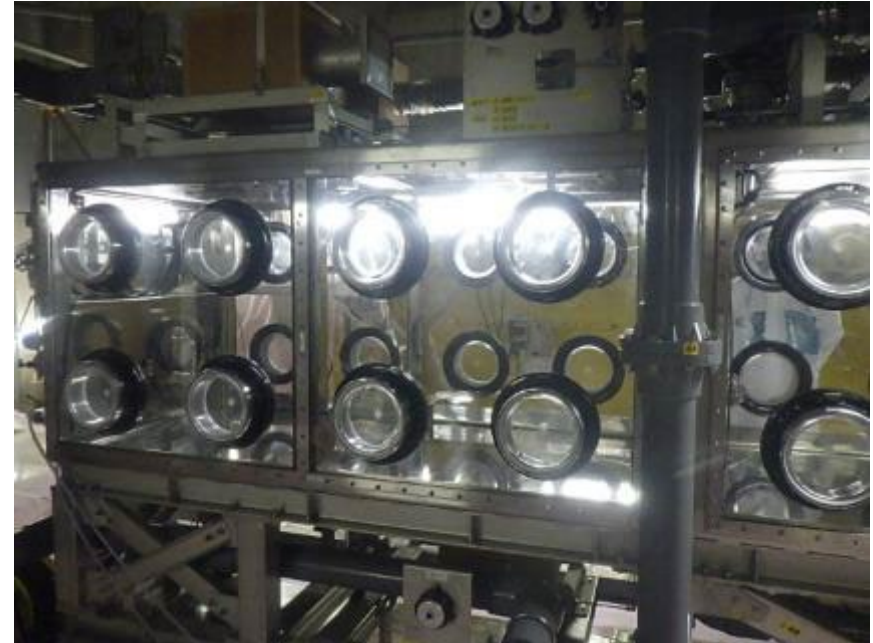
- A glove box is being installed inside the Unit 2 reactor building

Glove box installation status

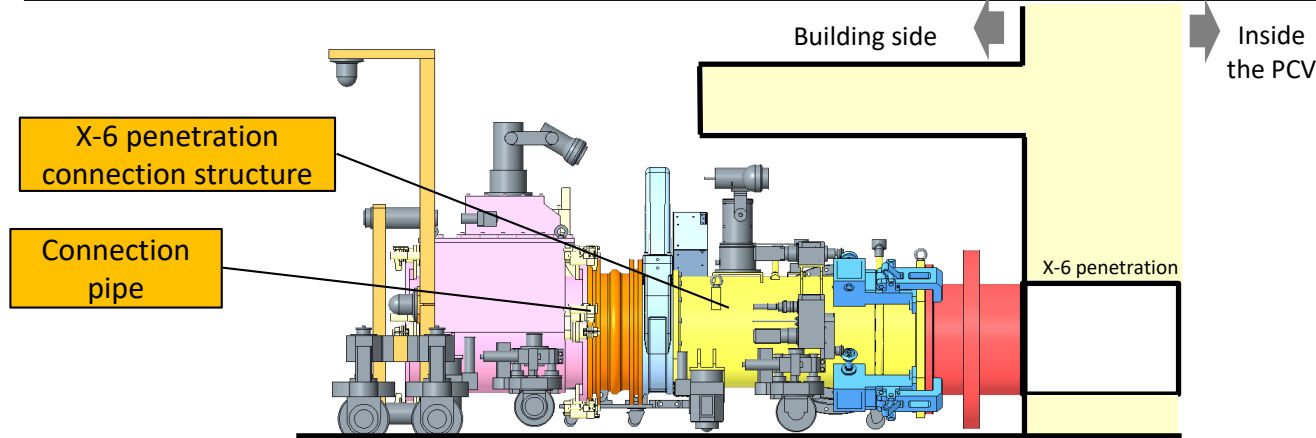
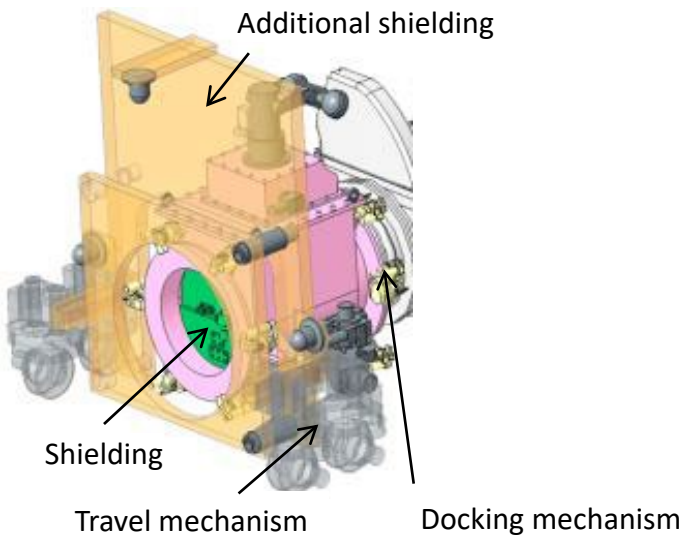
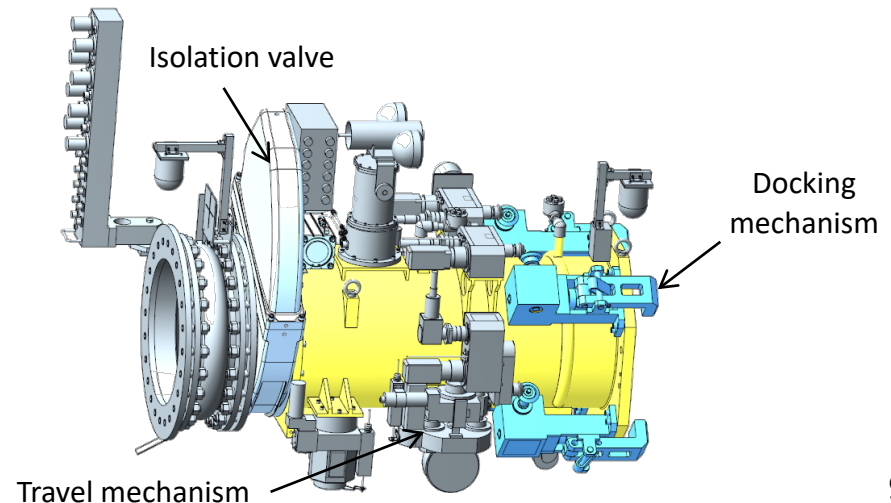
Reference. X-6 penetration connection structure and connection pipe

- X-6 penetration connection structure: Connected to the X-6 penetration in order to create a PCV boundary by using an isolation valve to isolate the PCV
- Connection pipe: Used to shield radiation from inside the PCV and reduce dose levels in front of the X-6 penetration

➤ Connection pipe

➤ X-6 penetration connection structure

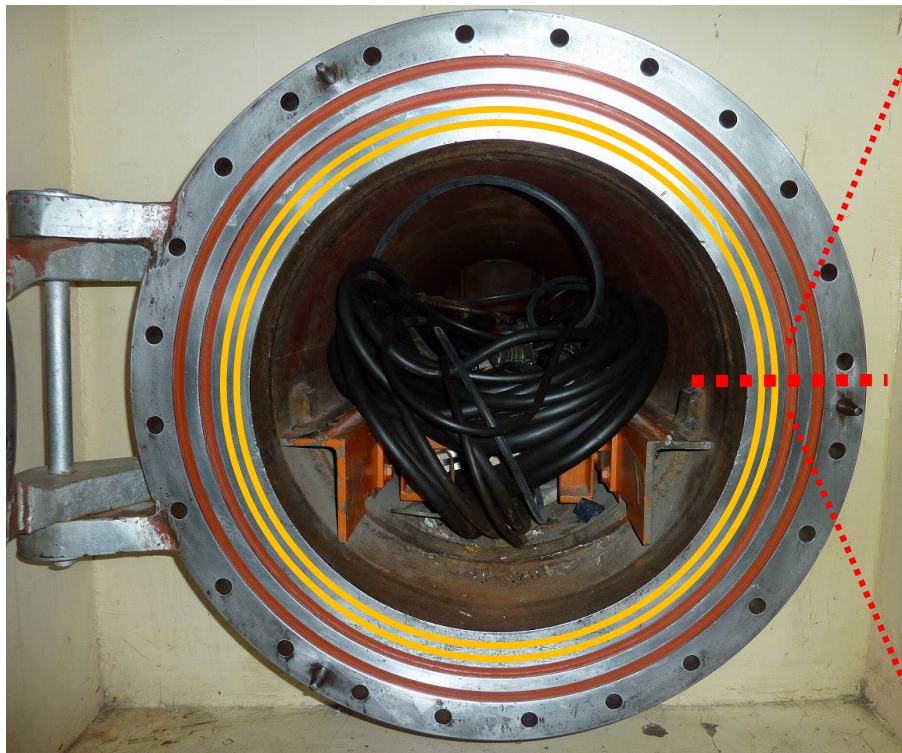
- A deposit removal equipment and X-6 penetration connection structure will be connected to the hatch flange after it is opened

X-6 penetration hatch prior to the accident (open)

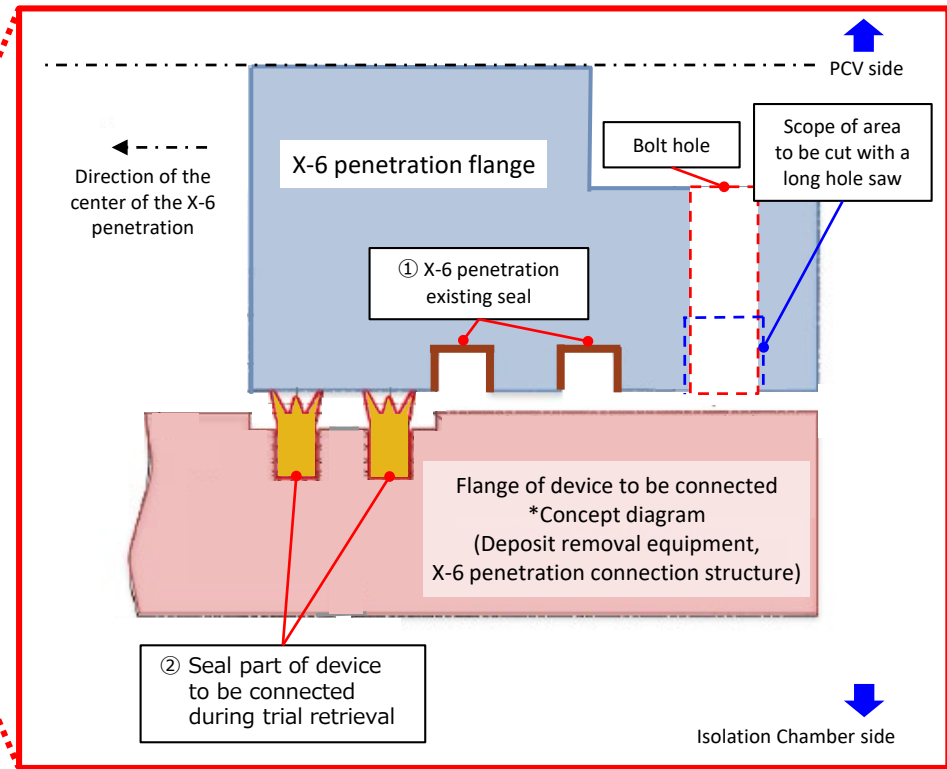
Location of seals when connecting devices to the X-6 penetration (as seen from above)

- : ① X-6 penetration existing seal
 - : ② Seal of the devices connected to during trial retrieval
- * Deposit removal equipment, X-6 penetration connection structure

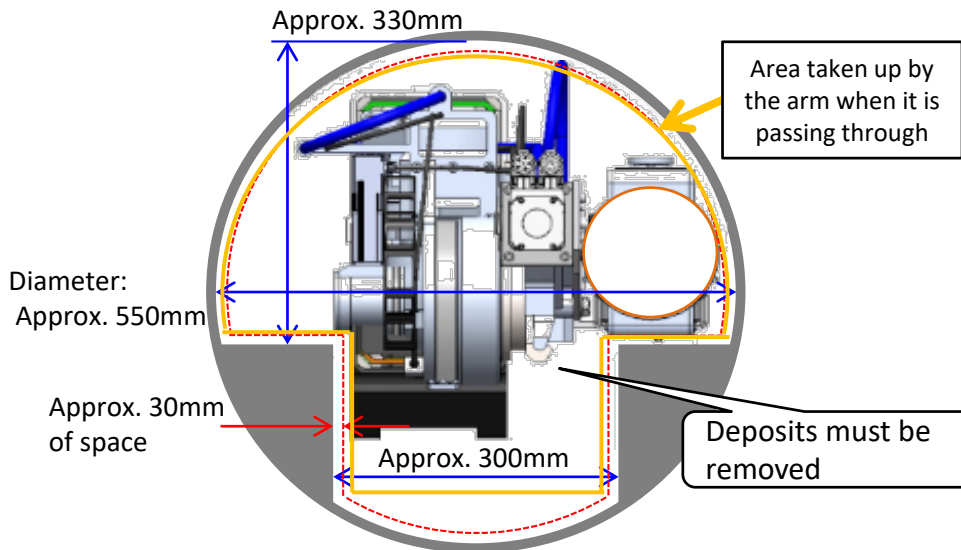
Robotic arm

(cross-section of the X-6 penetration when the arm is passing through)

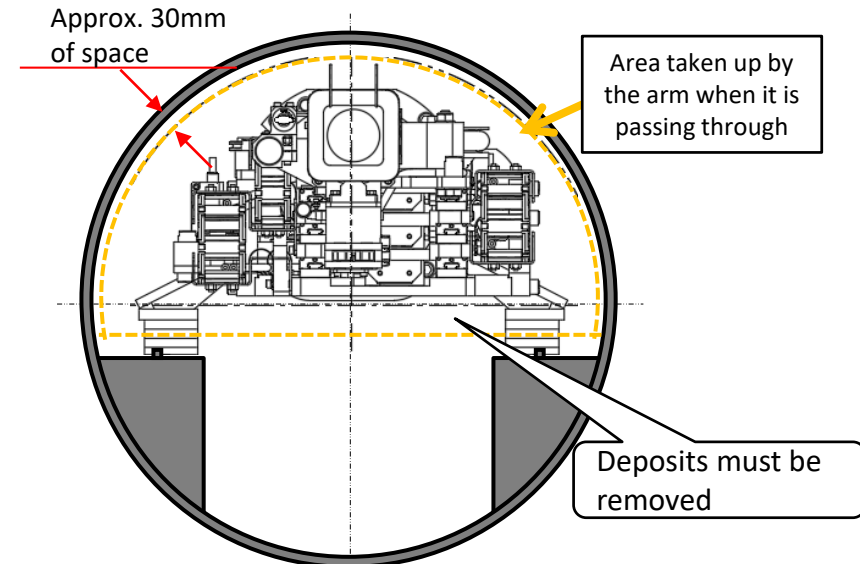
Telescopic arm

(cross-section of the X-6 penetration when the arm is passing through)

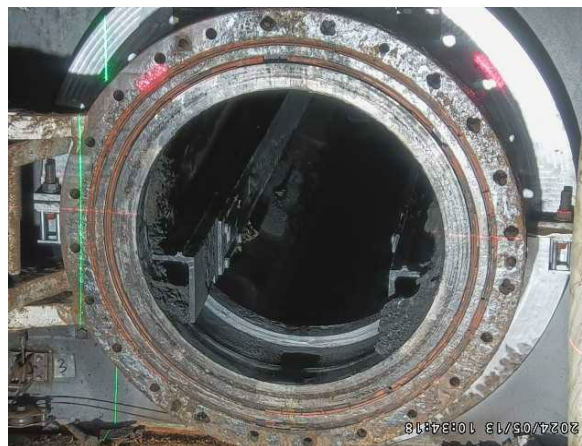
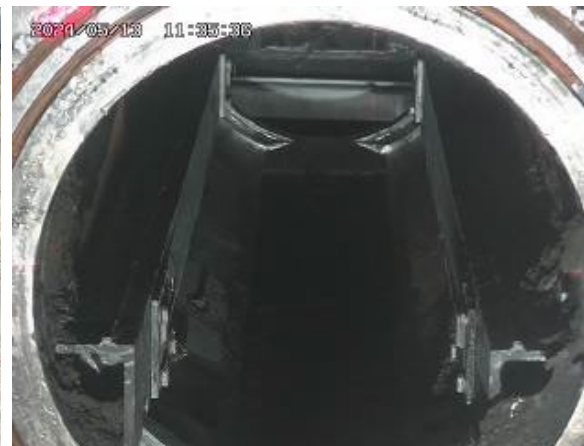
X-6 penetration after the removal of deposits

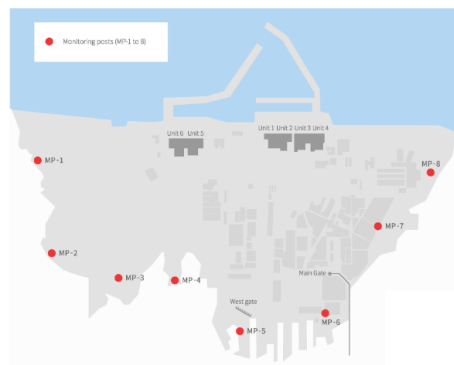
Monitoring points

Monitoring post (MP1 - MP8)

MP Unit : μSv/h Wind Velocity Unit : m/s
○ Measurement value (2024/01/12 18:00)

MP-1	MP-2	MP-3	MP-4	MP-5	MP-6	MP-7	MP-8	風向	風速	備考
0.317	0.783	0.490	0.987	0.703	0.315	0.566	0.530	北東風	1.4	晴

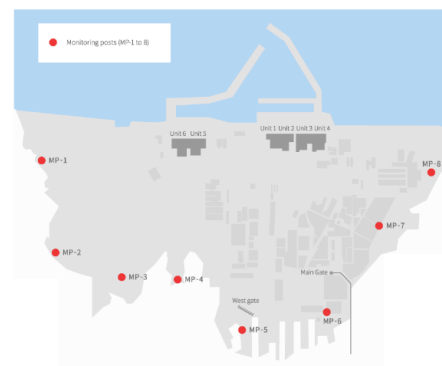
Monitoring points

The following are radioactive concentrations in the air measured near the monitoring posts (MP1-8) at the site boundary of Fukushima Daiichi Nuclear Power Station.

Radiation concentration
