- Today (August 22), guide pipe of the telescopic device was inserted at 7:49 a.m.
- Afterwards, guide pipe was inserted to the front of the isolation valve and the first push pipe (the first of five push pipes to be used) was prepared to be connected, and it was noticed during the final checking process at site that the order of the first push pipe was different from the planned order. Therefore, the work was completed up to the point before the isolation valve. (Work was done until 8:53 a.m.)
- At the site, it was confirmed the push pipe that should have been in the first position was in the fourth position.
- We are currently investigating the cause of the matter. We will confirm and organize the necessary work and procedures going forward.
- We will provide further information about the future actions.

Installation status of push pipes

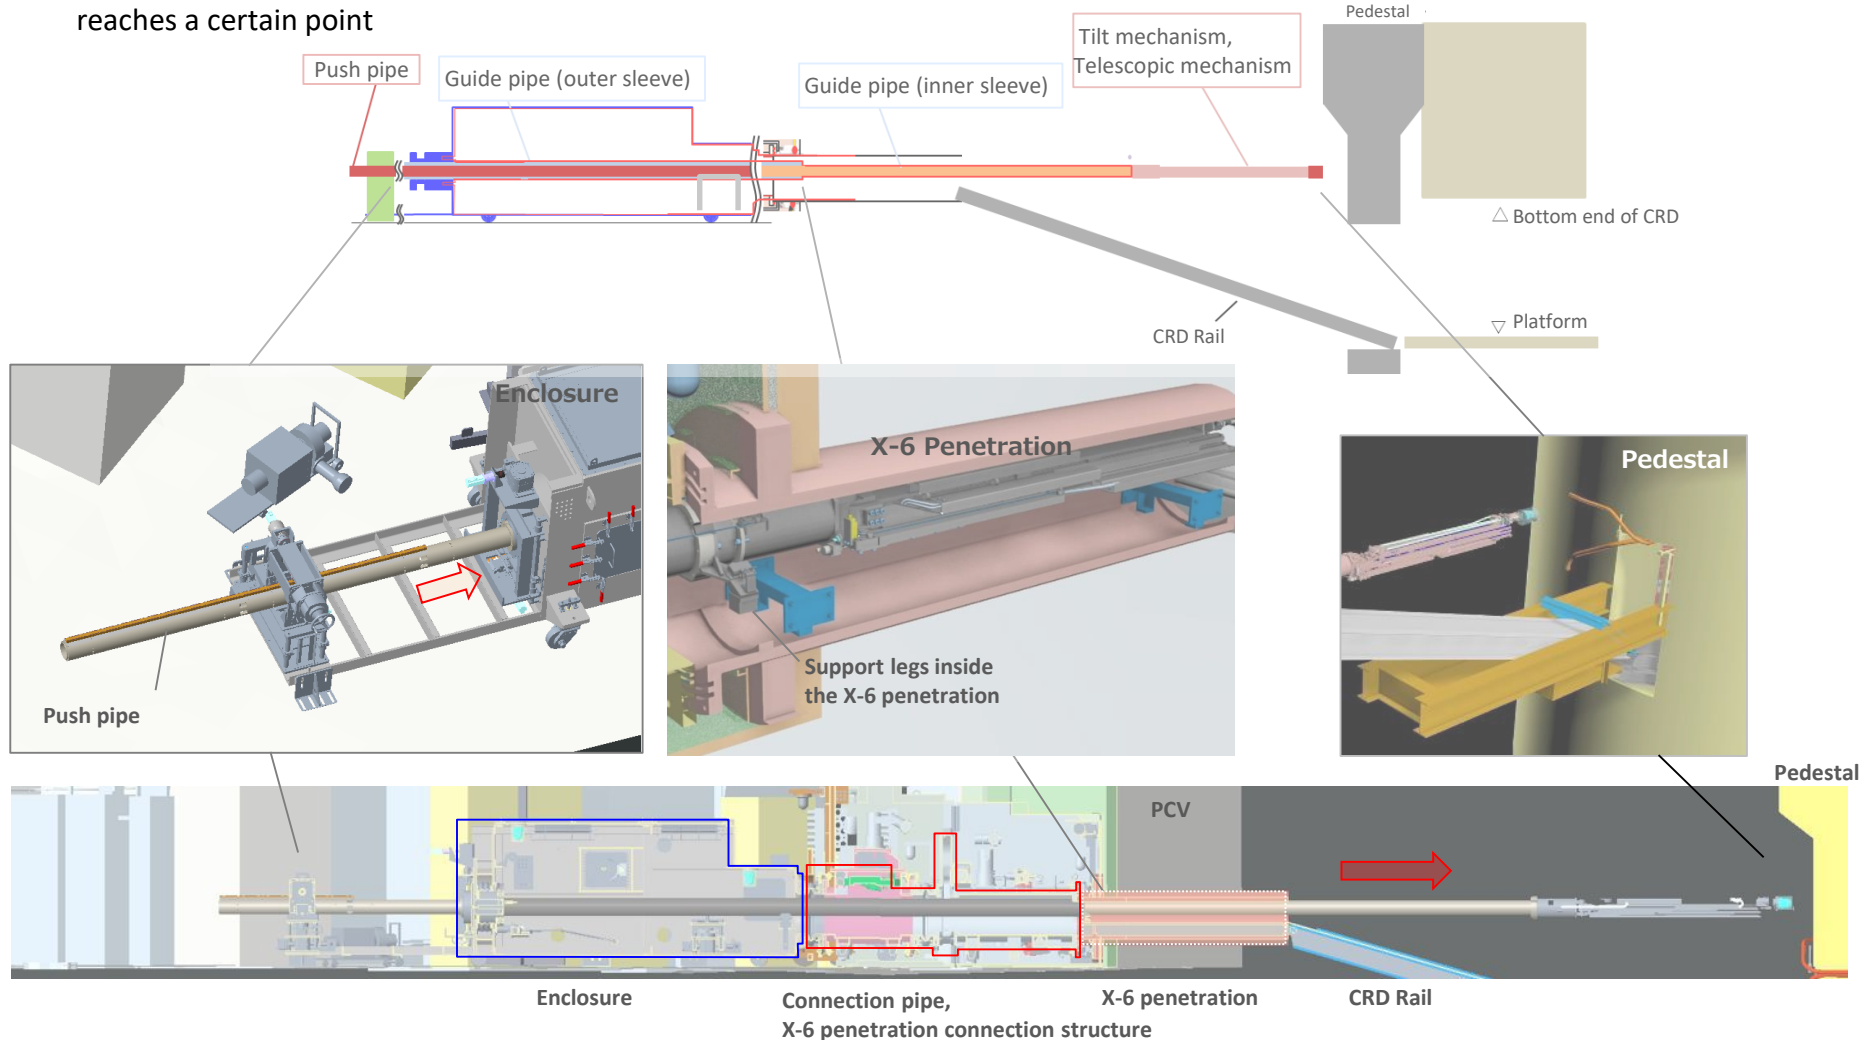
<Reference> Insertion of push pipes

- The push pipe will be manually connected to the inner sleeve of the guide pipe, and the support legs inside the X-6 penetration will be used to support the outer sleeve of the guide pipe
- The pipe feed mechanism will be used to push out the push pipe that was used to install the rack and the inner sleeve of the guide pipe will be inserted into the PCV
- Similarly, the rack will be manually removed before it makes contact with the enclosure, and the guide pipe gradually fed in until it reaches a certain point
