Fukushima Daiichi Nuclear Power Station Unit 2 PCV Internal Investigation/ Status of Fuel Debris Trial Retrieval

October 31, 2024

International Research Institute for Nuclear Decommissioning
Tokyo Electric Power Company Holdings, Inc.

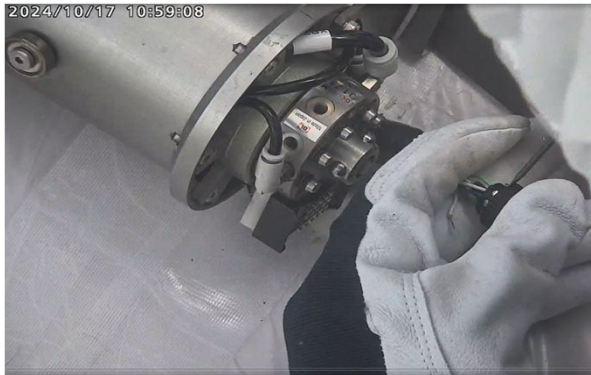
Working on the end jig monitoring camera (camera ①)

- After completing the final check of the camera replacement procedures, we commenced to replace the cameras on October 16, we conducted cable conduction tests for the end jig monitoring camera (camera ①) and the camera on the end of the arm (camera ②), and replaced cameras ① and ②. There were no problems with cable conductivity, and we have confirmed that the camera footage from both of the new cameras is being sent properly to the remote operations room.

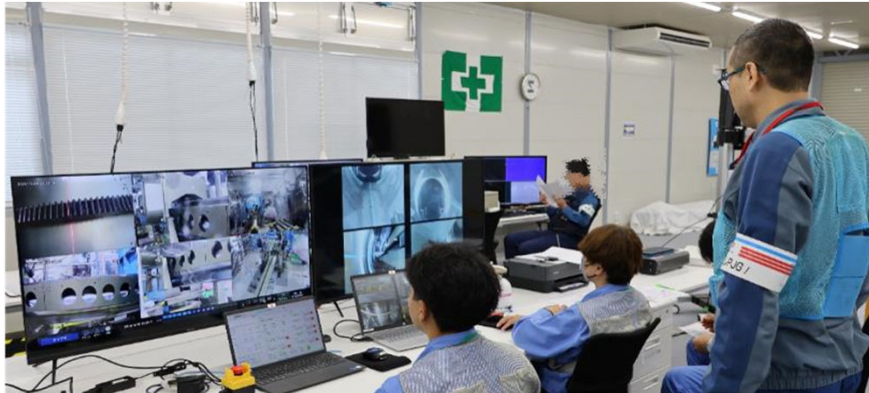
TEPCO witnessing the work in the remote operations room

- As the replacement of cameras, pre-consideration and final check of procedures for the recommencement of work have been completed, trial retrieval of fuel debris has recommenced since October 28. The isolation valve of X-6 penetration structure was opened, and the guide pipe were inserted.

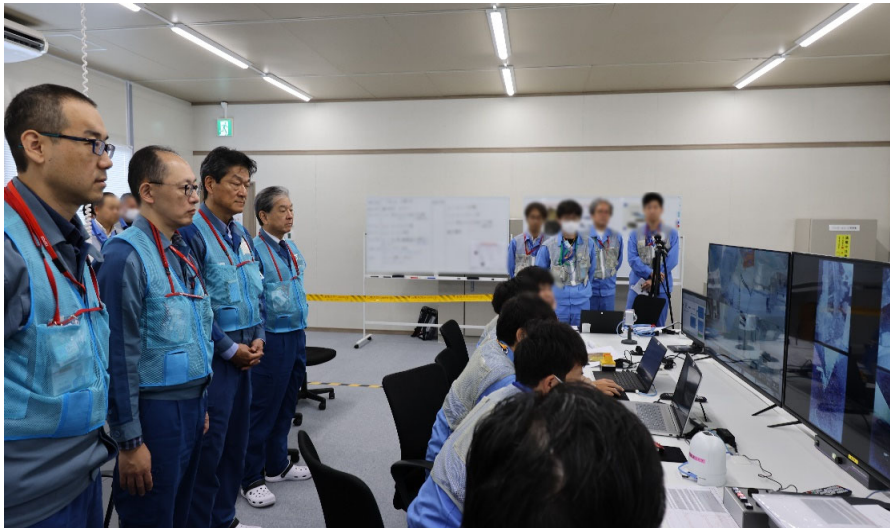
At the remote operations room

- On October 30, the end jig of the telescopic device was lowered to perform a fuel debris grasping work at the bottom of the pedestal.
- The end jig returned to the position before work starts while its gripper still holds the fuel debris and the grasping work was completed.
- The guide pipe is being removed, and radiation of the fuel debris will be measured after the end jig is returned inside the enclosure.

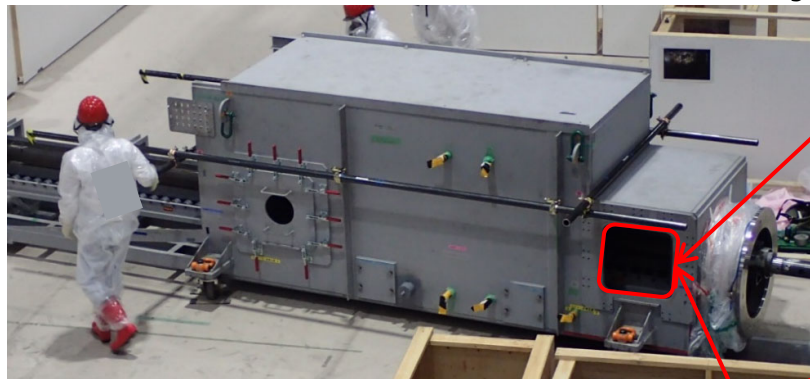
- A mockup of the enclosure was used to examine the accessibility and feasibility of camera replacement both within and outside the enclosure
- We checked if the cameras could be replaced wearing the same personal protective equipment (PPE) that was needed in the field (cotton gloves and three layers of rubber gloves)

A mockup of the enclosure
(Mitsubishi Heavy Industry Kobe Factor
Side hatch (same dimensions as on the actual enclosure))

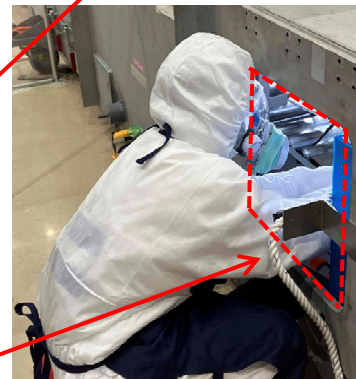
Reviewing accessibility
(Naraha Center for Remote Control
Technology Development)

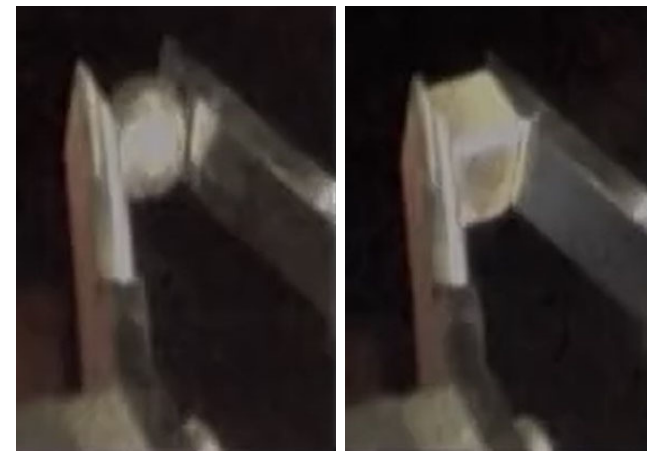
Camera footage of the gripper tool holding a sphere and a cube shaped mock debris (gripper tool)

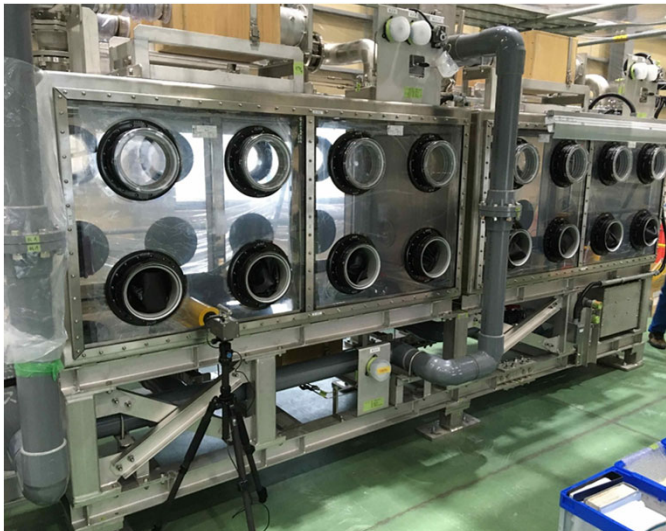
- The sampled fuel debris will be subjected to dose measurements when it is taken out from the enclosure of the telescopic device or the robotic arm, and then transported to a glovebox inside the reactor building where it will be subjected to various measurements. After measurements have been taken, measures to prevent the spread of contamination shall be implemented and it will be transported off-site

- The collected samples will be put into a negative pressure glovebox
- The samples will be subjected to various measurements inside the glovebox and then put into a container
- The container will be removed from the glovebox while preventing the spread of contamination by using a plastic bag
- The container will then be inserted into an off-site transportation container and loaded onto a transport vehicle

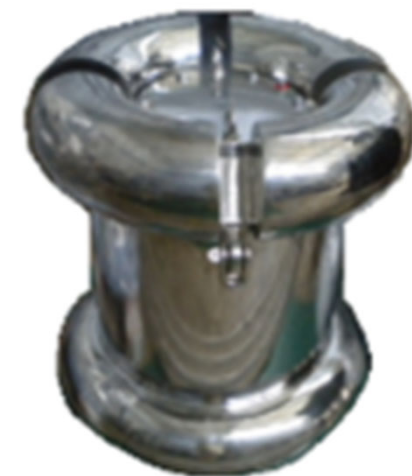
- The fuel debris placed inside the specimen container (polyethylene). Then it placed inside a vase-like container (polypropylene, lead). After that it will be sealed inside a bag made of polyvinyl chloride and placed inside the transport container.

A-type transport container
