# Fukushima Daiichi Nuclear Power Station Unit 2 PCV Internal Investigation/ Status of Fuel Debris Trial Retrieval

December 26, 2024

International Research Institute for Nuclear Decommissioning  
Tokyo Electric Power Company Holdings, Inc.

# 1. PCV internal investigation and trial retrieval plan overview

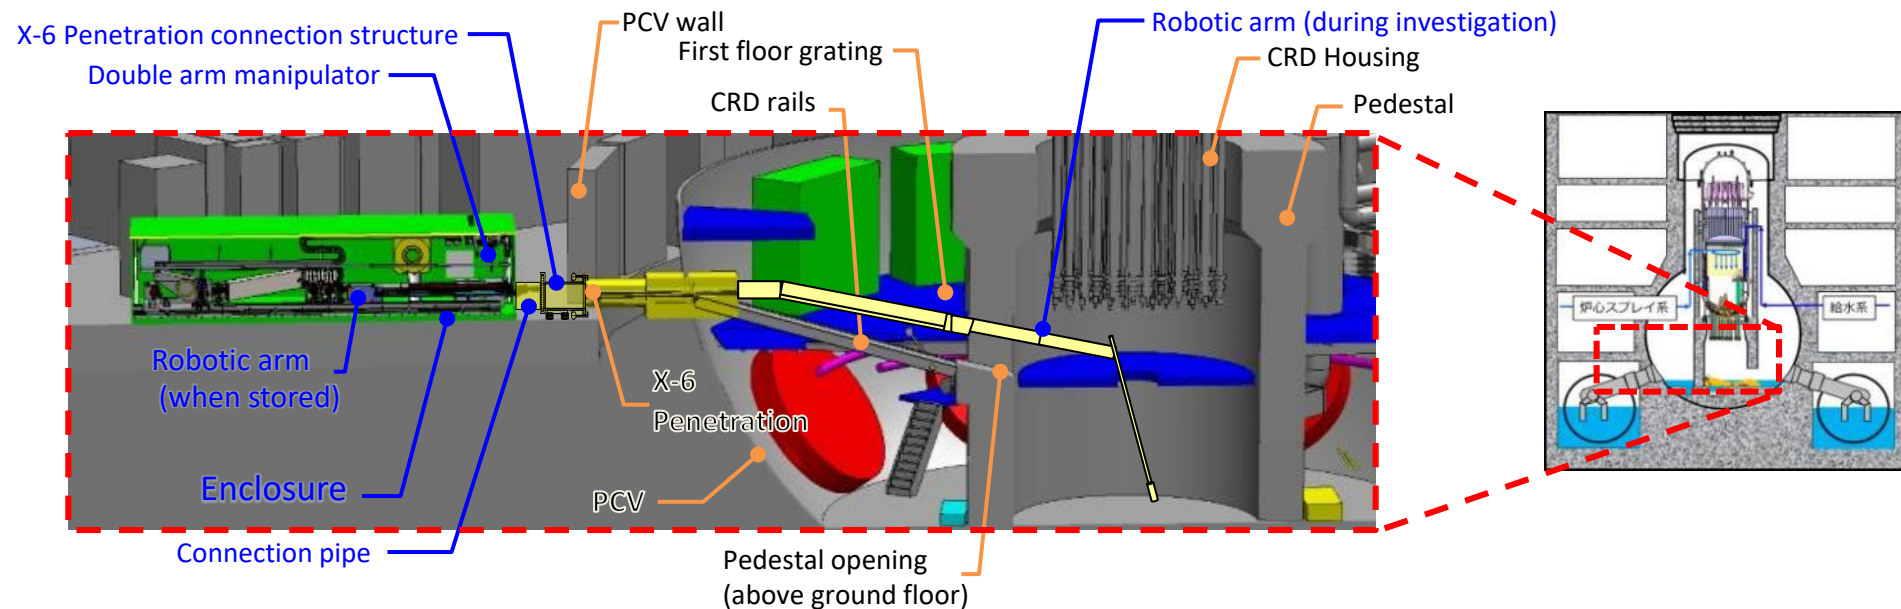
- In order to guarantee work safety and prevent the spread of contamination, the following equipment will be installed at the penetration to the Unit 2 primary containment vessel (hereinafter referred to as, "X-6 penetration") that will be used for the PCV internal investigation and also as a preparatory stage of trial retrieval.
  - The X-6 Penetration connection structure isolates the inside of the PCV from the outside
  - The connection pipe shields radiation
  - A metal box that contains the telescopic device and the robotic arm (enclosure)
- After installation of the aforementioned equipment, the robotic arm shall be fed into the PCV through the X-6 penetration to remove obstacles inside the PCV while also conducting internal investigations and moving forward with the trial retrieval of fuel debris.

Unit 2 internal investigation/trial retrieval plan overview

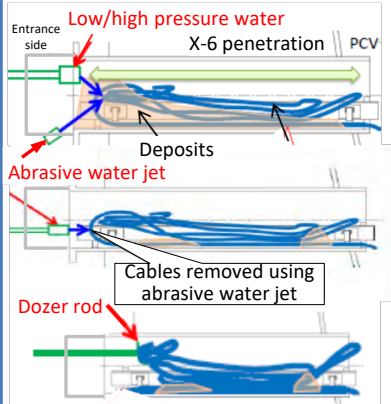
Removing deposits/cables from inside the X-6 penetration

- Deposits pushed with low/high-pressure water
- Cables removed with Abrasive water jet
- Cables pushed with dozer rod

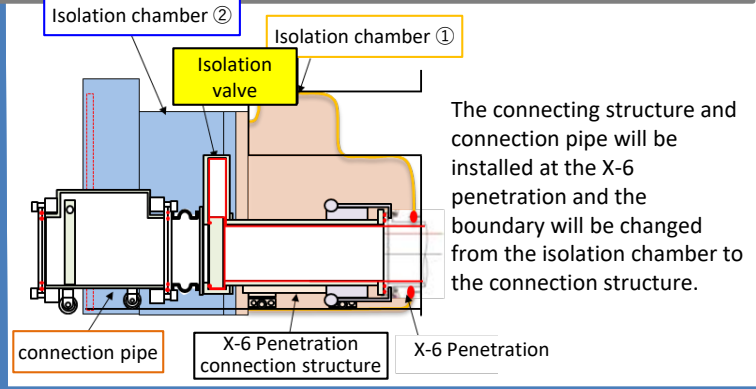
4. Installation of X-6 penetration connection structure and connection pipe

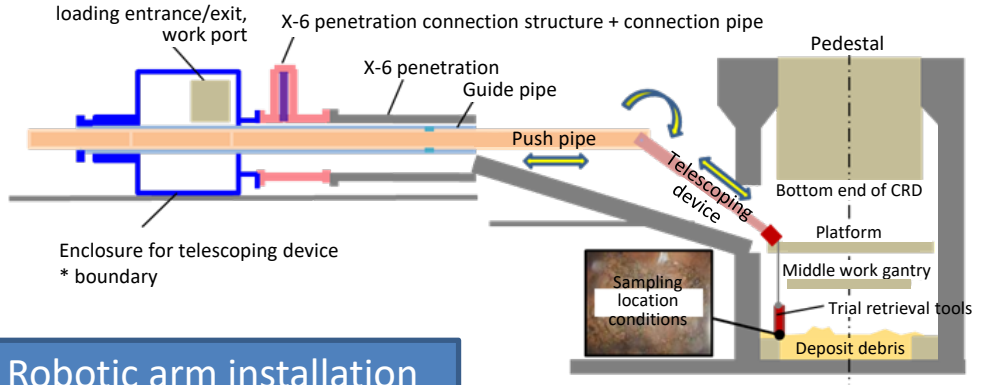
5. Installation of telescopic device  
6. Trial retrieval (debris sampling using telescopic device)

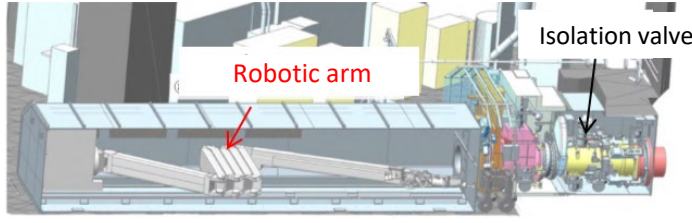
7. Robotic arm installation

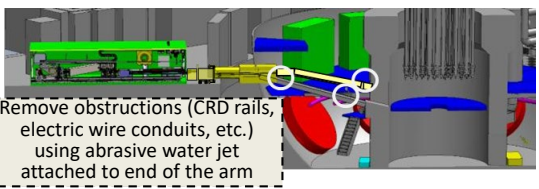
① Internal investigation

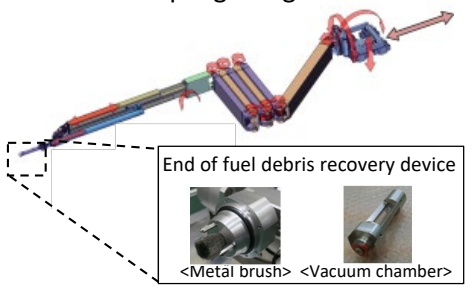
② debris sampling using robotic arm

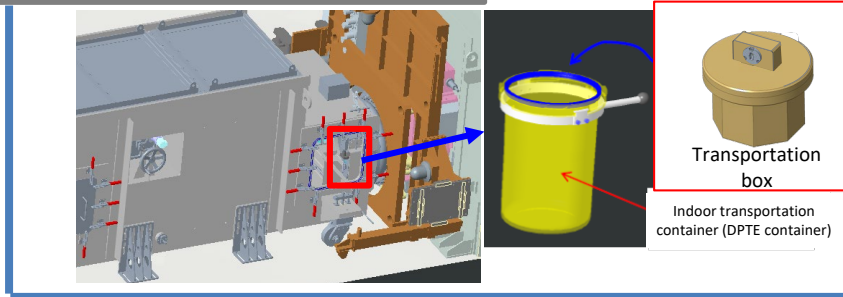
#### 9-1. Collection of fuel debris

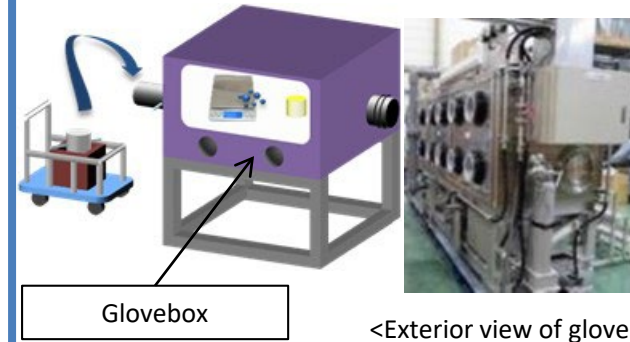
#### 10. Insertion into glovebox/Measurement

- The collected samples will be put into a negative pressure glovebox
- The samples will be subjected to various measurements inside the glovebox and then put into a container

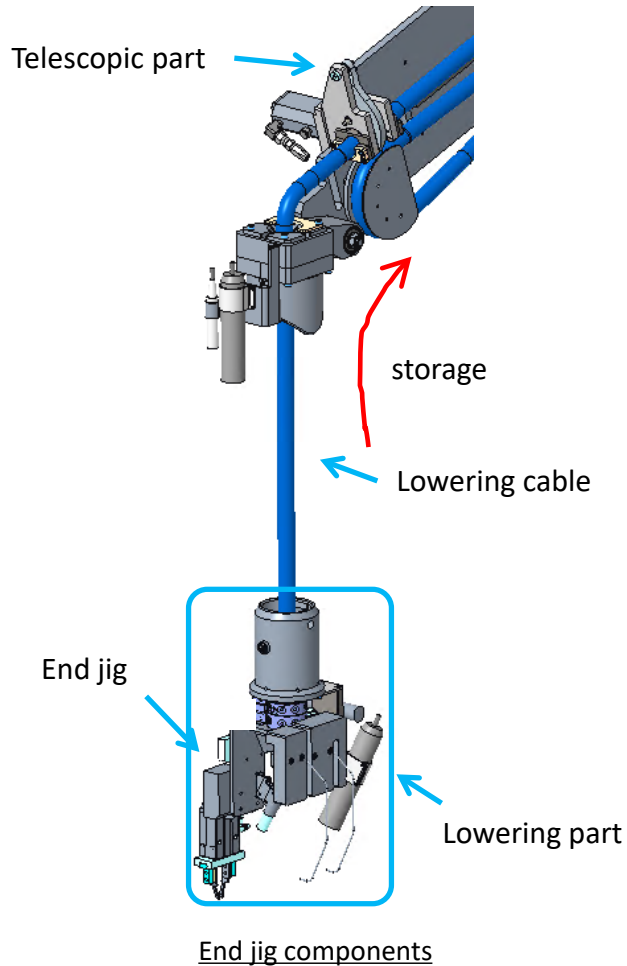
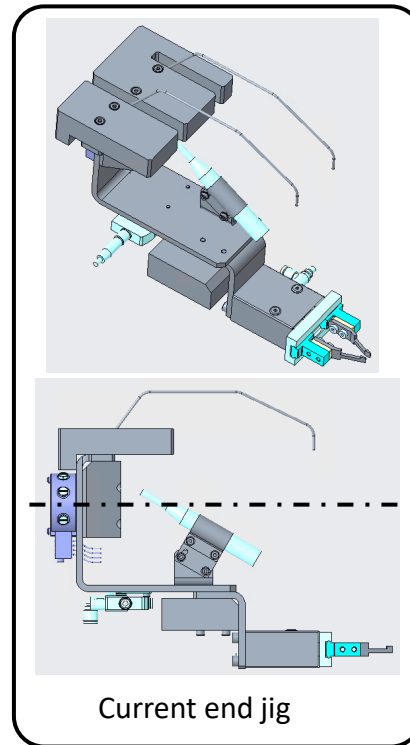
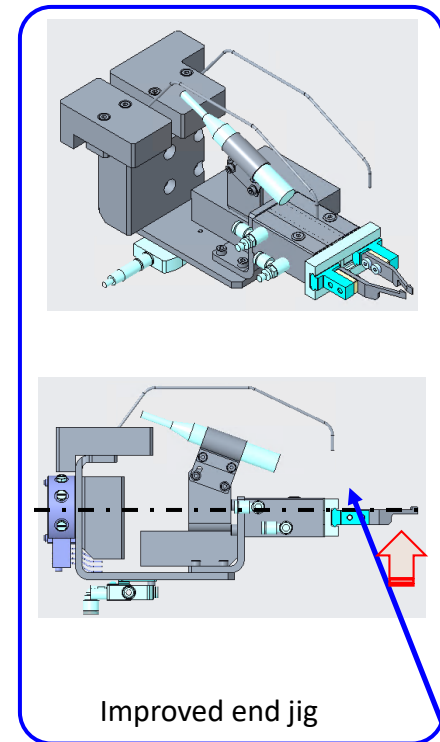
Concept diagram of end jig improvements

- During the first fuel debris sampling, time was required to maneuver the end jig because the lowering part was not stable. So we are deliberating how to improve the maneuverability of the end jig before sampling additional fuel debris.

Current end jig

Improved end jig

Stability has been improved by moving the location of the gripper to the center of rotation of the end jig

- In preparation to sample additional fuel debris with the telescopic device we will conduct improvements to replace camera attached to the end of the telescopic device and to stabilize lowering of the end jig at the end of the device and mastery training, etc., of workers which is based on previous work results as we aim to begin taking more samples in the spring of 2025.

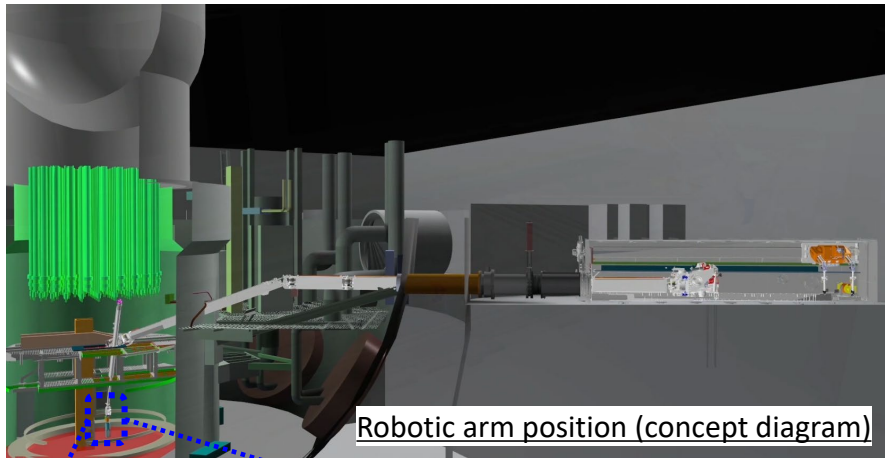
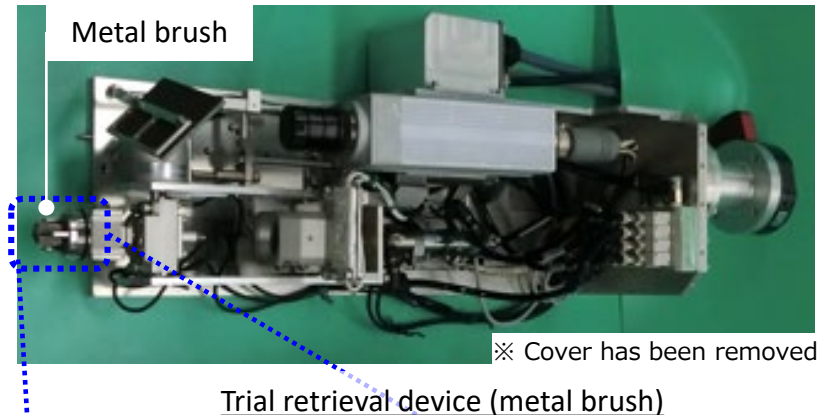
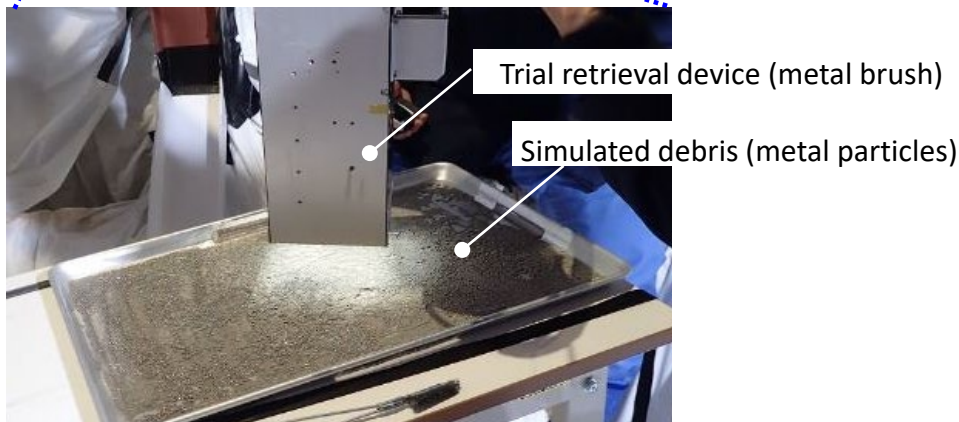
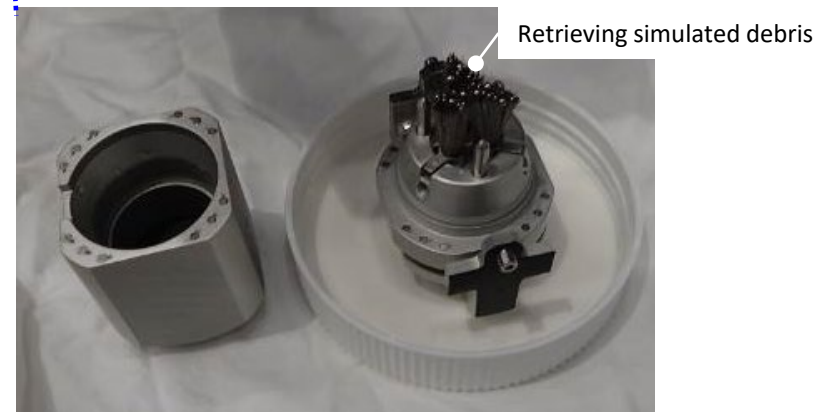
- Control program corrections are being made, arm maneuverability is being checked, and the device is being tuned.
- Retrieval devices (metal brush, vacuum chamber) are being attached to the end of the robotic arm and used to retrieve simulated fuel debris in mockup tests simultaneously with pedestal investigation tests.

Retrieving simulated debris

Metal brush (after retrieving simulated debris)

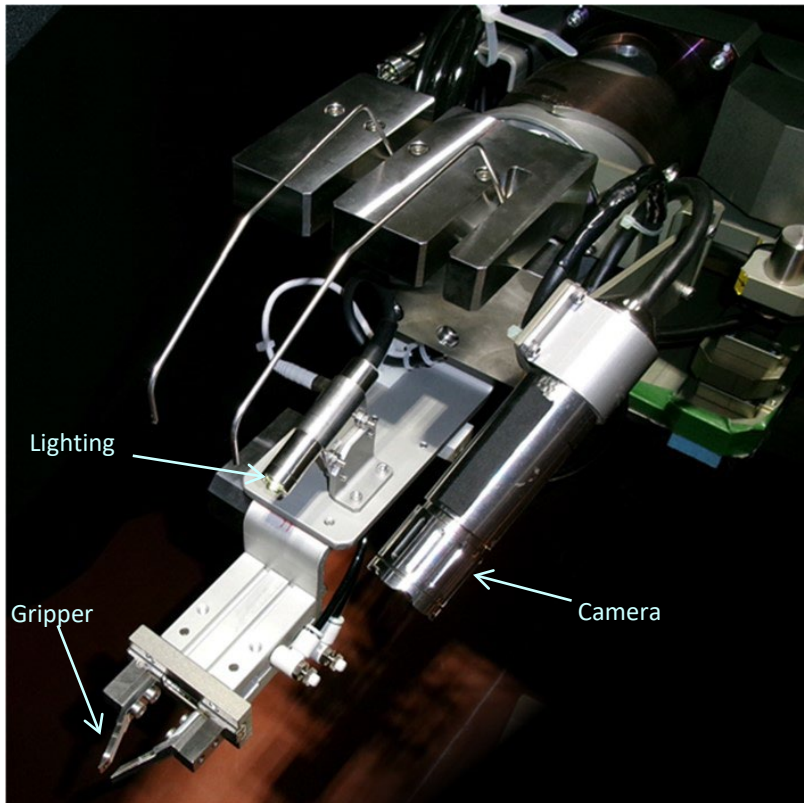
Gripper tool

- The gripper tool has been selected as the end jig that will be used during the trial retrieval of fuel debris with the telescopic device
- The end jig camera will be used to determine the size of the fuel debris sampled

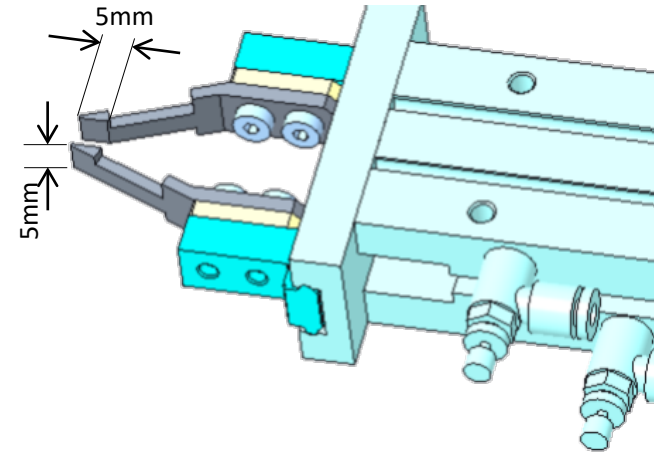
Gripper claws will be used to determine the size (gripper tool)

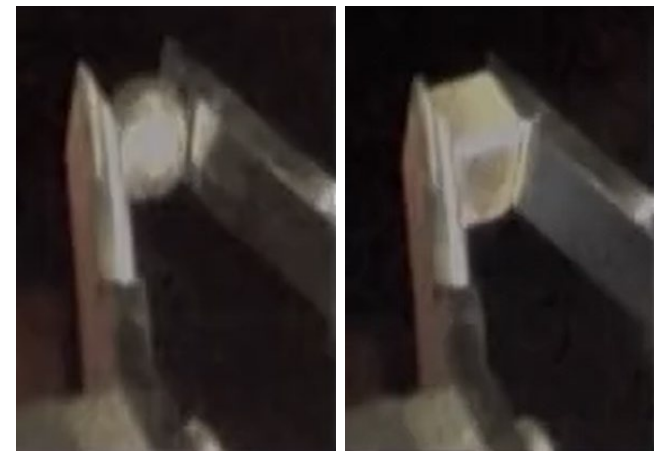
Camera footage of the gripper tool holding a sphere and a cube shaped mock debris (gripper tool)

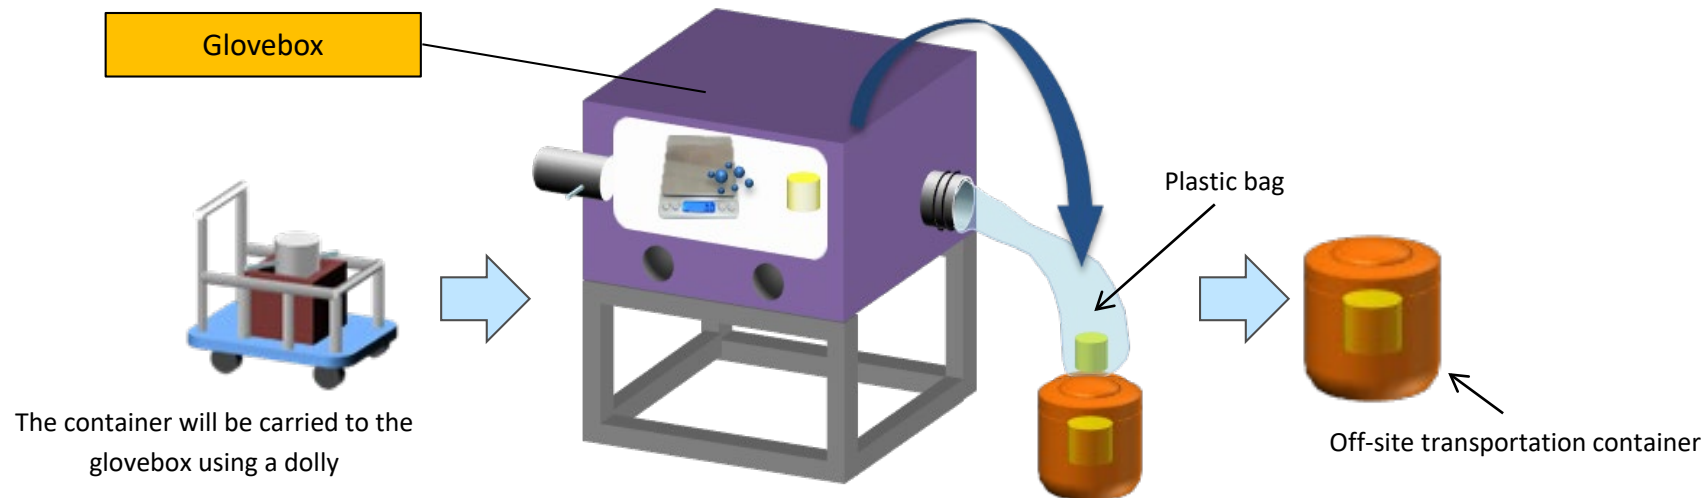
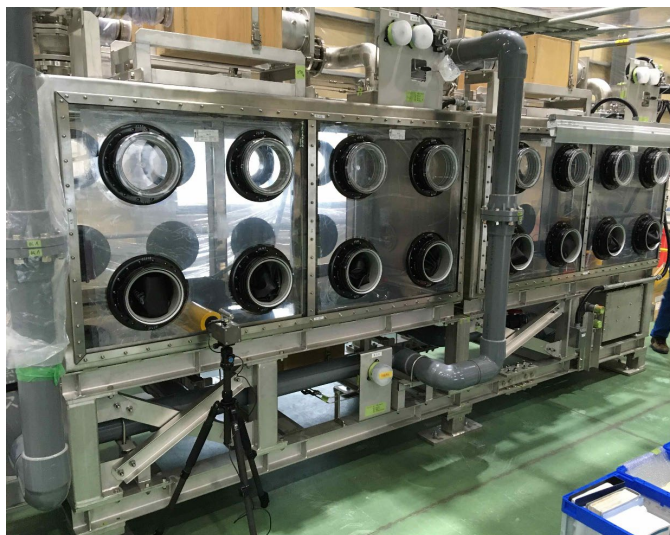
- The sampled fuel debris will be subjected to dose measurements when it is taken out from the enclosure of the telescopic device or the robotic arm, and then transported to a glovebox inside the reactor building where it will be subjected to various measurements. After measurements have been taken, measures to prevent the spread of contamination shall be implemented and it will be transported off-site

- The collected samples will be put into a negative pressure glovebox
- The samples will be subjected to various measurements inside the glovebox and then put into a container
- The container will be removed from the glovebox while preventing the spread of contamination by using a plastic bag
- The container will then be inserted into an off-site transportation container and loaded onto a transport vehicle

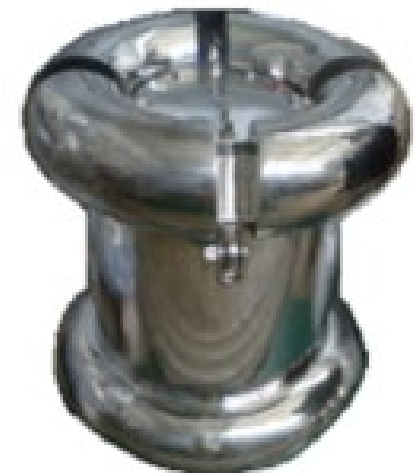
A-type transport container

- The fuel debris sampled during trial retrieval will be transported to an off-site analysis facility (JAEA Oarai)
- We have confirmed that the transport container will remain sealed even when subjected to various test conditions as legally required by law.

- The fuel debris placed inside the specimen container (polyethylene). Then it placed inside a vase-like container (polypropylene, lead). After that it will be sealed inside a bag made of polyvinyl chloride and placed inside the transport container.

Item	Standard
Amount of reactivity	Sum of A2 level ratios is below 1 (Approx. $3.7 \times 10^{10}$ Bq)
Dose equivalent rate	Surface of transported item: below 2mSv/h 1m from surface of transported item: 100 $\mu$ Sv/h
Surface contamination density	Alpha nuclide: 0.4Bq/cm <sup>2</sup> All other nuclides: 4Bq/cm <sup>2</sup>
Transport container test conditions	Freefall test, compression test, penetration test, etc.

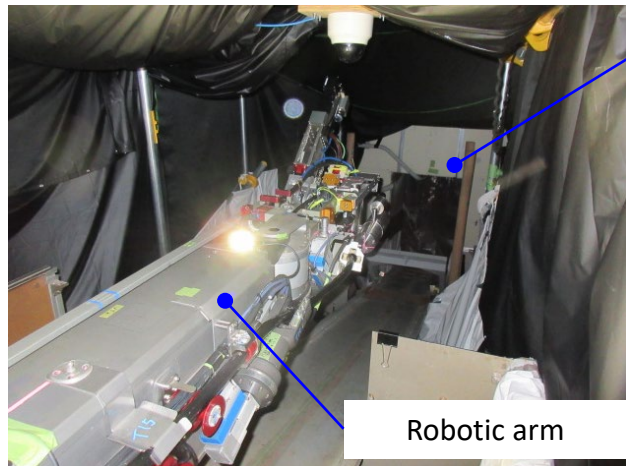
Pedestal opening  
(Simulated)

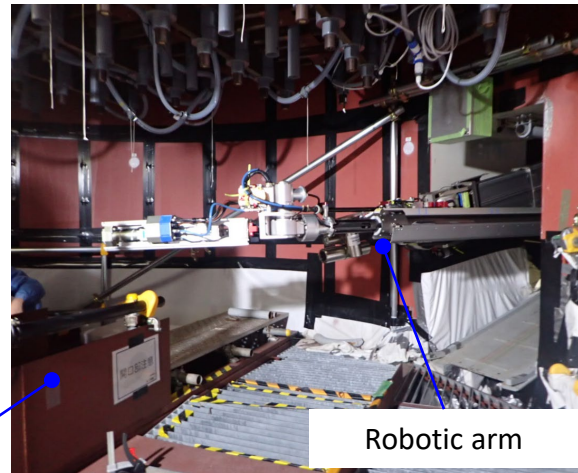
Inside of the pedestal  
(simulated)

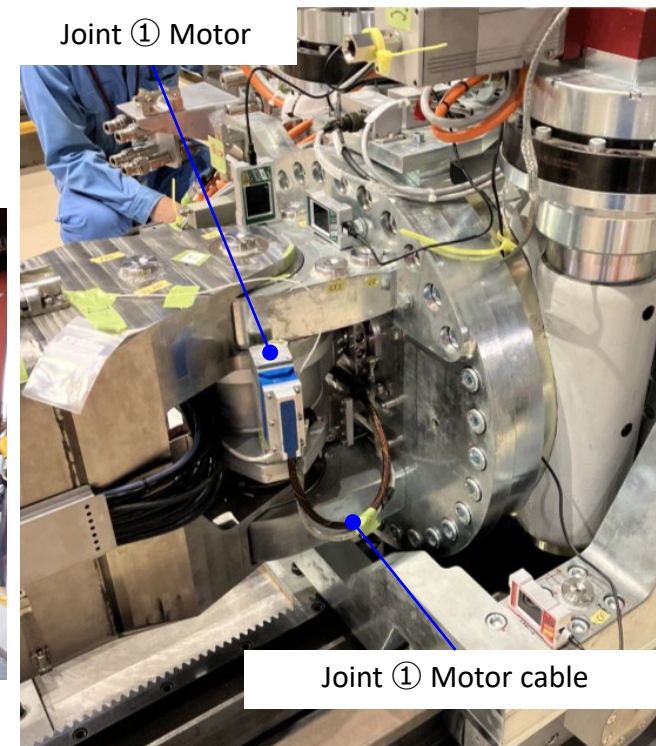
- Control program corrections are being made, arm maneuverability is being checked, and the device is being tuned.
- During robotic arm maneuverability tests it was found that the motor cable had been severed due to aging, so the cables and connectors were replaced and the tests are underway again.
- Going forward, other similar cables and connectors will be replaced. Maintenance will also be performed in preparation for use in the field.

Tests of the robotic arm at the Naraha facility

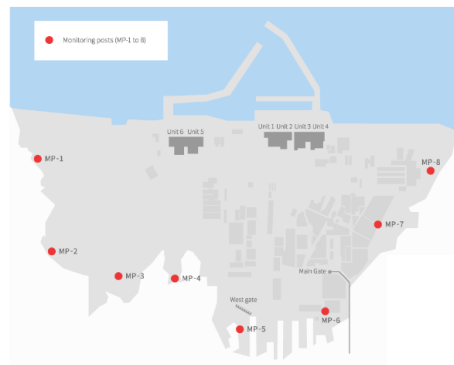
Monitoring points

The following is the radiation doses of the air measured by the monitoring posts (MP1-8) at Fukushima Daiichi Nuclear Power Station.

MP Unit : μSv/h Wind Velocity Unit : m/s  
○Measurement value (2024/01/12 18:00)

MP1	MP-2	MP-3	MP-4	MP-5	MP-6	MP-7	MP-8	Measurement value	Unit
0.517	0.793	0.490	0.987	0.703	0.315	0.566	0.530	Measurement value	μSv/h

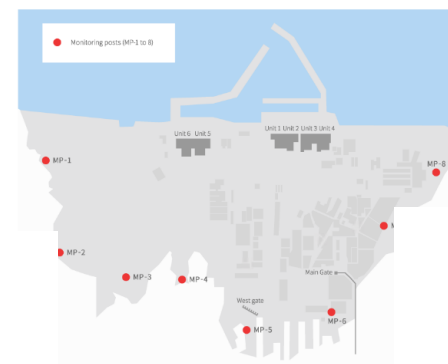
Monitoring points

The following are radioactive concentrations in the air measured near the monitoring posts (MP1-8) at the site boundary of Fukushima Daiichi Nuclear Power Station.

Radioactive Particles Monitor Unit : Bq/m³ Wind Velocity Unit : m/s  
■Measurement value (2024/01/25 09:50)

nearMP1	nearMP2	nearMP3	nearMP4	nearMP5	nearMP6	nearMP7	nearMP8	Wind Direction	Wind Velocity
1.0E-06	1.0E-06	1.0E-06	1.0E-06	1.0E-06	1.0E-06	1.0E-06	1.0E-06	northwest	4.4

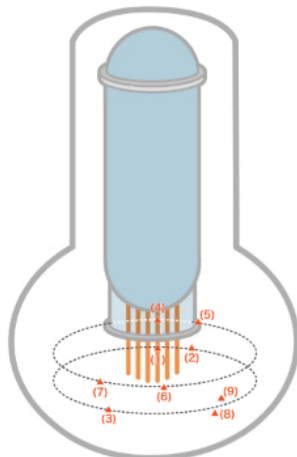
Unit 2 reactor containment vessel

Here are the measurement results of temperatures inside the Unit 2 Primary Containment Vessel at Fukushima Daiichi Nuclear Power Station.

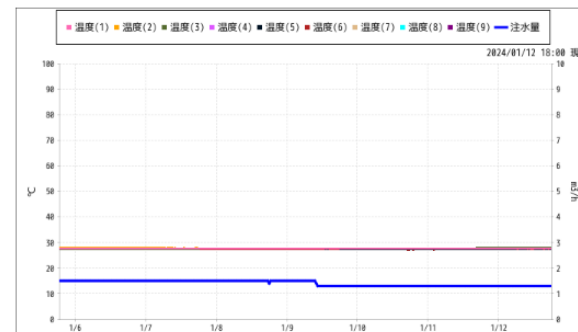
#### Temperature

Temperature Unit: °C. Water Injection Unit: m³/h  
 ○ Measurement value (2024/01/12 18:00)

温度(1)	温度(2)	温度(3)	温度(4)	温度(5)	温度(6)	温度(7)	温度(8)	温度(9)	注水量
27.5	27.8	27.9	27.7	27.4	27.3	27.2	-	-	1.3

- Although the removal of deposits from inside the Unit 2 X-6 penetration has been ongoing since January 10, and we are planning to begin the trial retrieval of fuel debris in the future, plant parameters are continuously monitored. We have seen **no significant fluctuations in primary containment vessel temperature neither prior to or after work**, and there's been **no change in the status of cold shutdown state**.
