Fukushima Daiichi Nuclear Power Station Unit 2 PCV Internal Investigation/ Status of Fuel Debris Trial Retrieval

January 30, 2025

International Research Institute for Nuclear Decommissioning
Tokyo Electric Power Company Holdings, Inc.

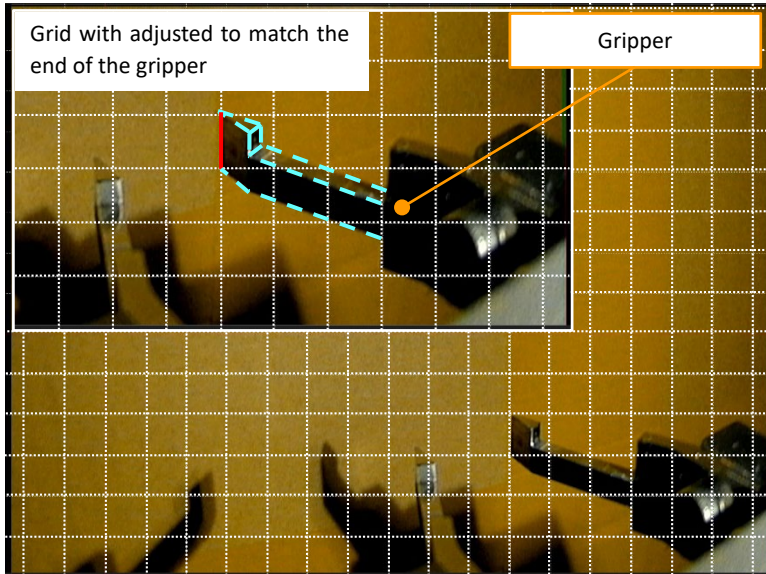
- Under after improvement dimensional conditions, a grid was laid over the camera footage to measure the size of simulated fuel debris that had been grabbed. We confirmed that there were no problems with grid adjustment or measuring the size of the simulated fuel debris that was grabbed.

Camera footage after adjusting grid width

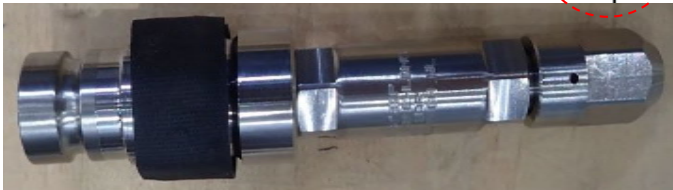
- We are deliberating how to remove deposits that still remain inside the X-6 penetration during the course of access route construction (removing obstructions with the mounted AWJ tool) (using high-pressure water that does not contain abrasives). Normally there is only one stream of water from the AWJ nozzle, but we found that the water branched three streams.
- It is assumed that for some reason a gap was created between the lance and the nozzle insert thereby splitting the stream.
- The AWJ nozzle has been replaced and verification tests are underway.

AWJ nozzle

Water stream from the AWJ nozzle

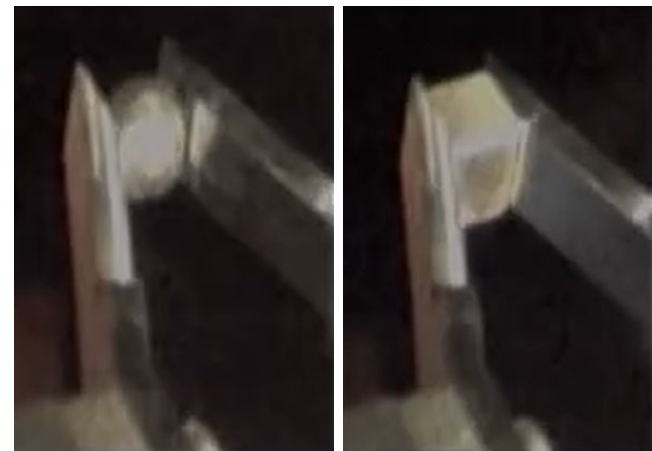
Camera footage of the gripper tool holding a sphere and a cube shaped simulated fuel debris (gripper tool)

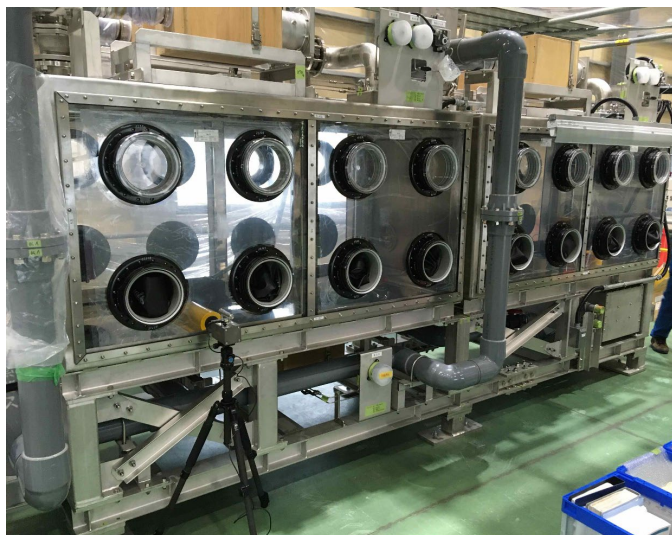
- The sampled fuel debris will be subjected to dose measurements when it is taken out from the enclosure of the telescopic device or the robotic arm, and then transported to a glovebox inside the reactor building where it will be subjected to various measurements. After measurements have been taken, measures to prevent the spread of contamination shall be implemented and it will be transported off-site

- The collected samples will be put into a negative pressure glovebox
- The samples will be subjected to various measurements inside the glovebox and then put into a container
- The container will be removed from the glovebox while preventing the spread of contamination by using a plastic bag
- The container will then be inserted into an off-site transportation container and loaded onto a transport vehicle

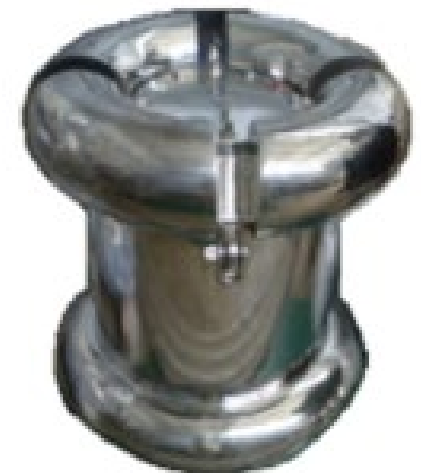
- The fuel debris placed inside the specimen container (polyethylene). Then it placed inside a vase-like container (polypropylene, lead). After that it will be sealed inside a bag made of polyvinyl chloride and placed inside the transport container.

A-type transport container

- The fuel debris sampled during trial retrieval will be transported to an off-site analysis facility (JAEA Oarai).
- We have confirmed that the transport container will remain sealed even when subjected to various test conditions as legally required by law.

- Furthermore, prior to transport we will confirm that surface dose rates and surface contamination density levels fall below legal limits with the fuel debris inside the container.

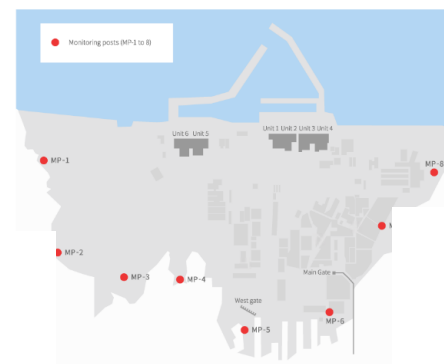
Monitoring points

Radioactive Concentration measured at Dust Monitors near the Site Boundary of Fukushima Daiichi Nuclear Power Station

The following are radioactive concentrations in the air measured near the monitoring posts (MP1-8) at the site boundary of Fukushima Daiichi Nuclear Power Station.
