# **Fukushima Daiichi Nuclear Power Station Unit 2 PCV Internal Investigation/ Status of Fuel Debris Trial Retrieval**

February 27, 2025

International Research Institute for Nuclear Decommissioning  
Tokyo Electric Power Company Holdings, Inc.

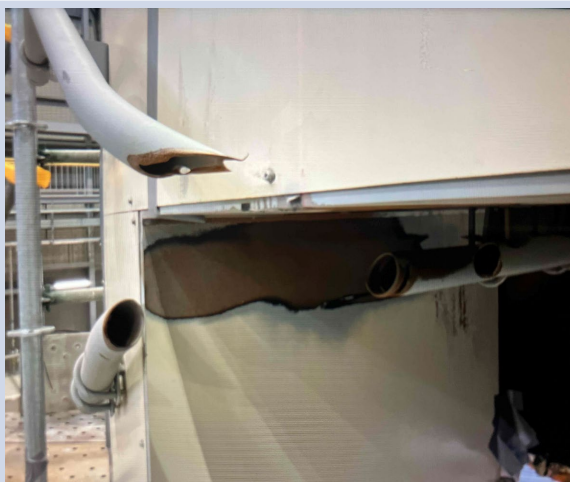
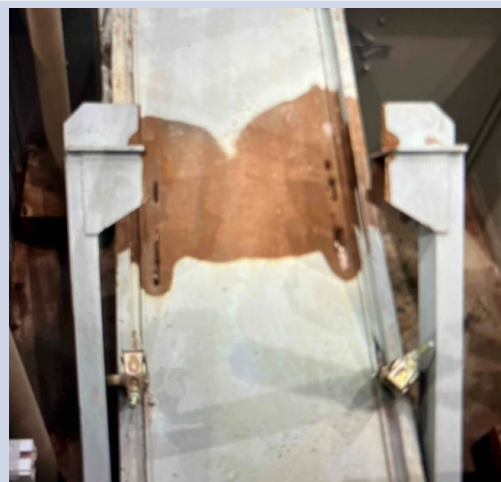
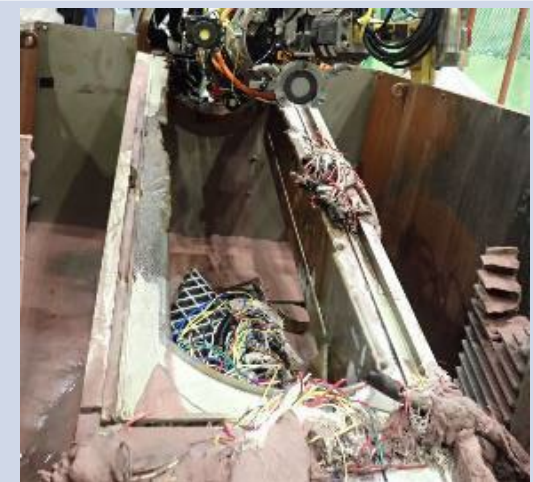
- A test was performed where the AWJ tool on the robotic arm was used cut through obstructions, such as the CRD rails, hoisting jig, and electrical conduits, etc., and the robotic arm was passed through the constructed access route. Results confirmed that the body of the robotic arm can pass through the access route without being hindered.

Electrical conduit removal(C)

Hoisting jig removal(B)

CRD rails Cut(A)

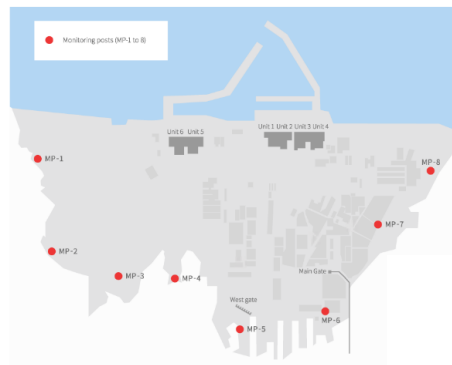
Monitoring points

- During fuel debris trial retrieval, the gas from inside the primary containment vessel was prevented from leaking to the outside environment through the construction of a boundary.
- There have been no significant fluctuations in data from monitoring posts or dust monitors neither prior to or after work.
- Data from monitoring posts/dust monitors near site borders can be found on TEPCO's website

Monitoring post (MP1 - MP8)
