Installing an additional cover over the Unit 1 spent fuel pool gate
 (photographed on June 27, 2025)

Method of installing the additional SFP gate cover

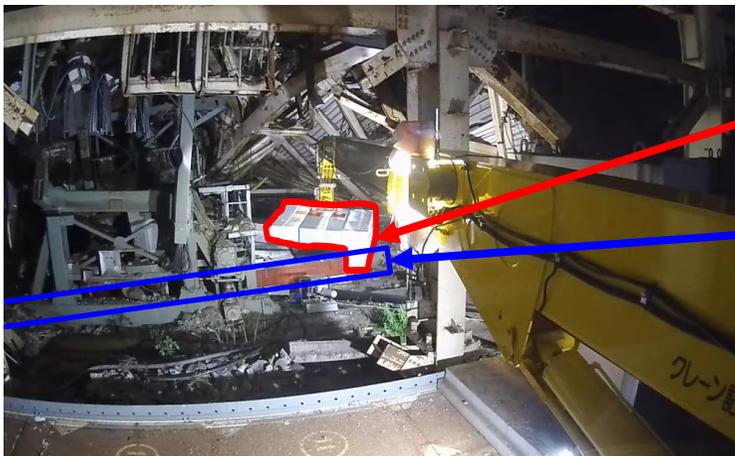
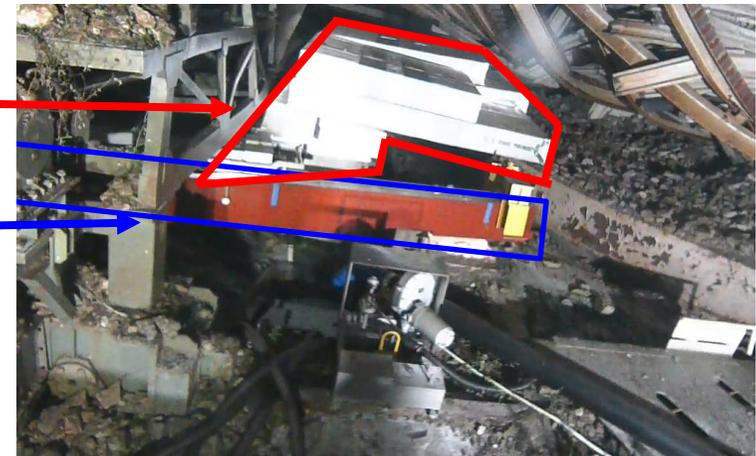
Installing an additional cover

Installed an additional cover

- There is the possibility that the auxiliary hoist※1 for the fuel handling machine (hereinafter referred to as, "FHM") may fall near the spent fuel pool (hereinafter referred to as, "SFP") in conjunction with rubble removal. As of March 2020, the SFP gate※2 cover to protect it from rubble falling near the SFP, and the SFP covering was installed in June 2020.
- There is the risk of damage to the SFP gate if the auxiliary hoist were to fall on top of the SFP gate cover. Therefore, an additional cover was installed over the SFP gate as a countermeasure to protect the SFP gate from being damaged if the auxiliary hoist falls which was commenced on June 26 and completed on June 27.
- We will move forward safely with these tasks so as to not impact the surrounding environment or workers with suitably monitoring dust concentrations.

※1: Hoist used to raise and lower objects. The aforementioned auxiliary hoist is currently wedged in between a section of the fallen roof and the FHM. It is currently in a stable position.
 ※2: Wall that separates the SFP from the reactor well. The SFP gate was installed during plant operation to prevent SFP water from flowing into the reactor well.

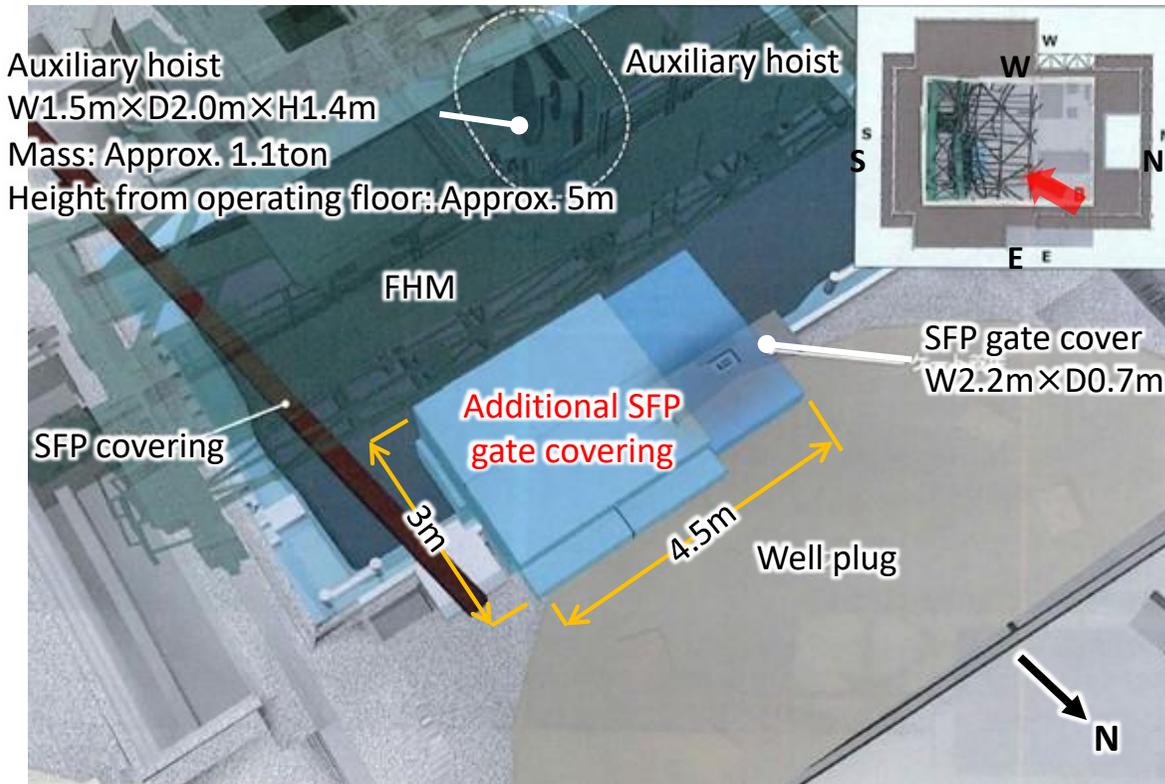
Birds eye view

- Polystyrene foam has been chosen as the main material for the additional SFP gate covering because it is light, can be easily fitted to match the shape of objects/rubble in the field, and can absorb/distribute shock. A crane will be installed on east side of the bottom framework of the large cover and used to place polystyrene foam pieces on top of the existing SFP gate cover.
- Element tests (basic performance tests of the covering material using a drop impact test machine) and mockup tests that simulate the mass of various objects and positional relationships have been used to confirm that even if the auxiliary hoist were to fall on top of the covering material to be installed this time, no damage would be incurred for the SFP gate.
