ALPS Treated Water Discharge Status Update

July 3, 2025

Tokyo Electric Power Company Holdings, Inc.

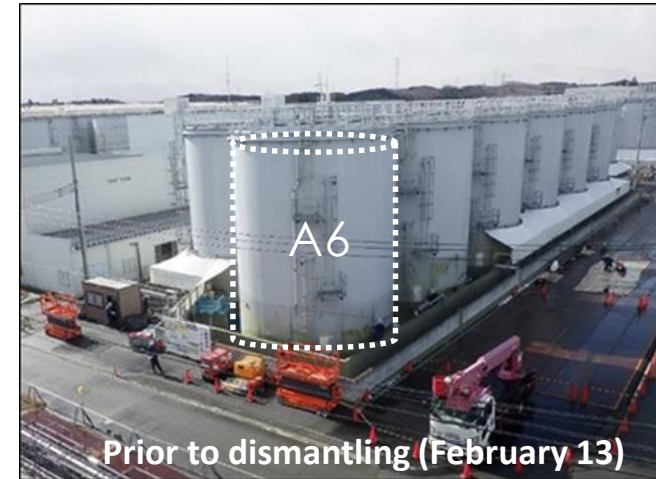
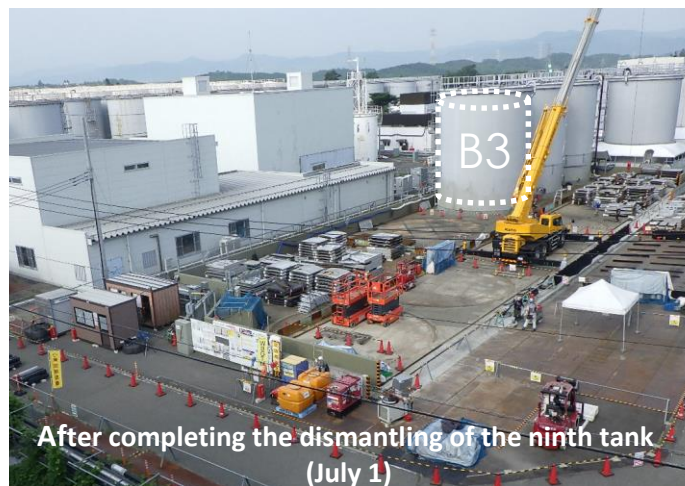
2. Status of dismantling of the J9 area tanks

- On February 13, 2025 the J9 area tanks were taken out of service and dismantling began on February 14, 2025.
- Dismantling of the ninth tank was completed on July 1, 2025.

Direction of photograph

○ : Dismantling completed
