Fukushima Daiichi Nuclear Power Station Unit 1 Progress of Fuel Removal from Spent Fuel Pool

November 27, 2025

Tokyo Electric Power Company Holdings, Inc.

1. Fuel removal from the spent fuel pool plan overview

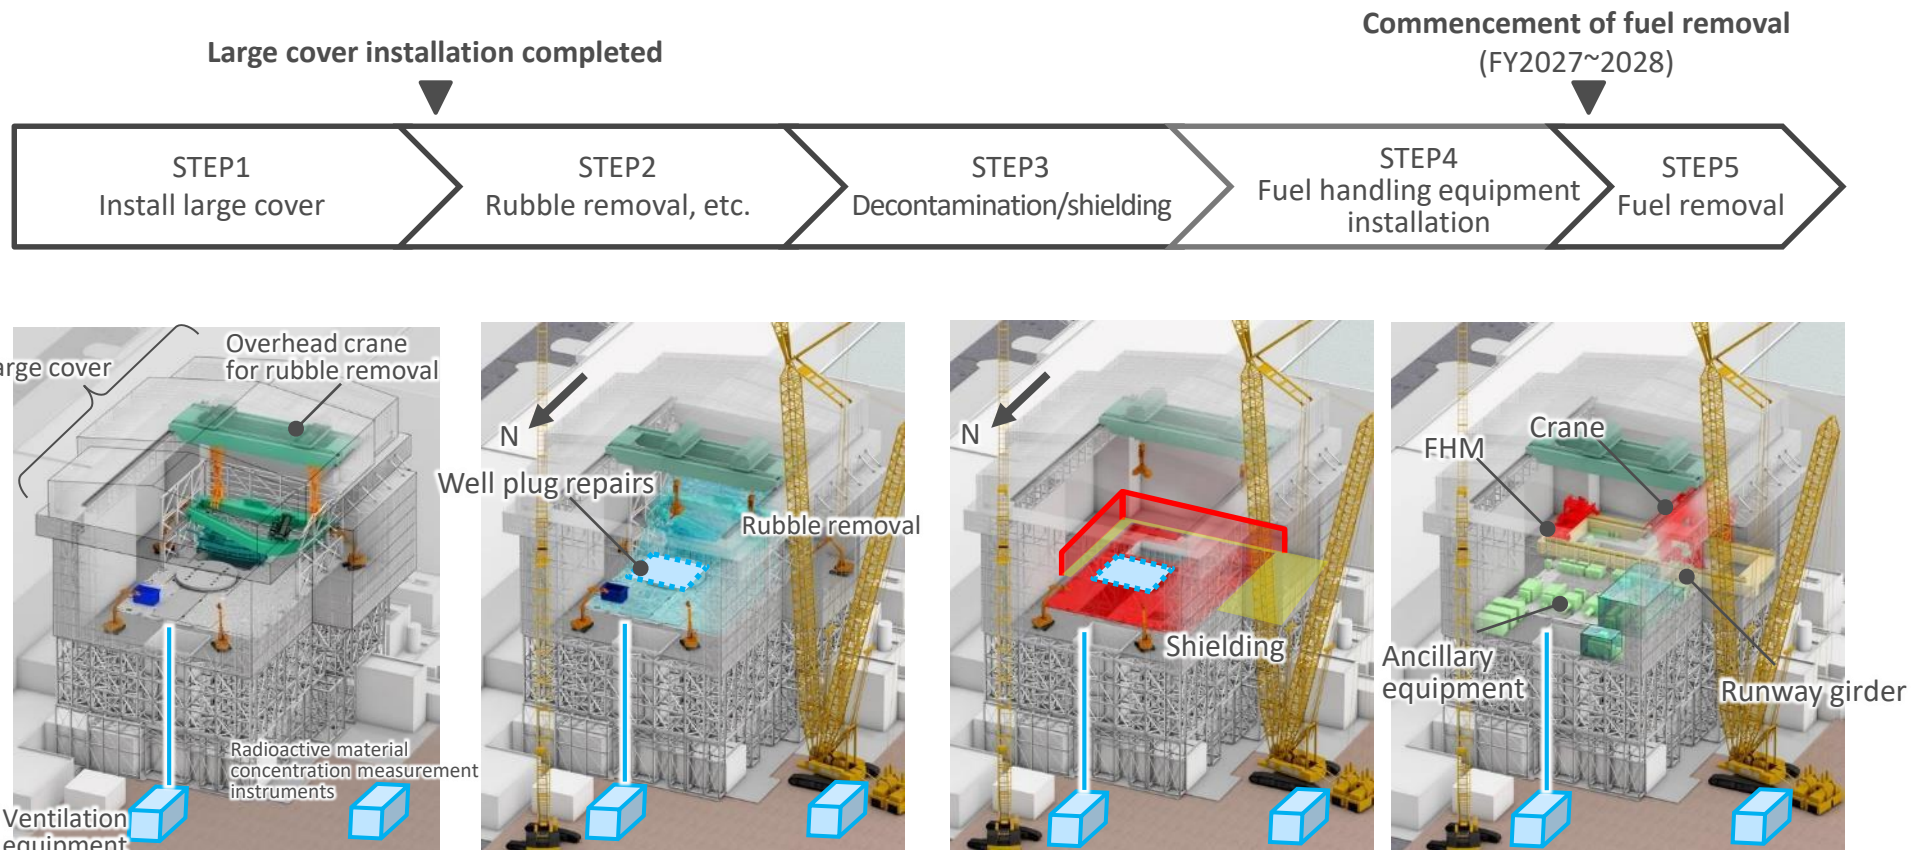
- Prior to fuel removal, a large cover that encompasses the entire reactor building will be built, rubble removed from under the large cover, the operating floor decontaminated/shielded, and fuel handling equipment (fuel handling machine (FHM) and crane) installed.

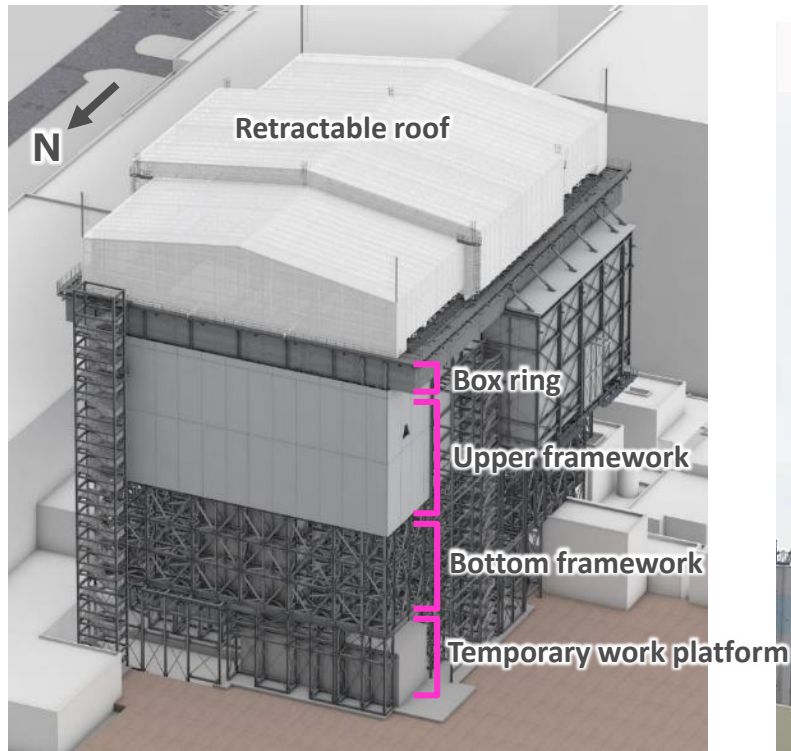
- Assembly of all 14 blocks of the box ring was completed on October 12, 2025.
- The first of a total of six blocks of the retractable roof was installed on November 7, 2025.

Diagram of the entire large cover

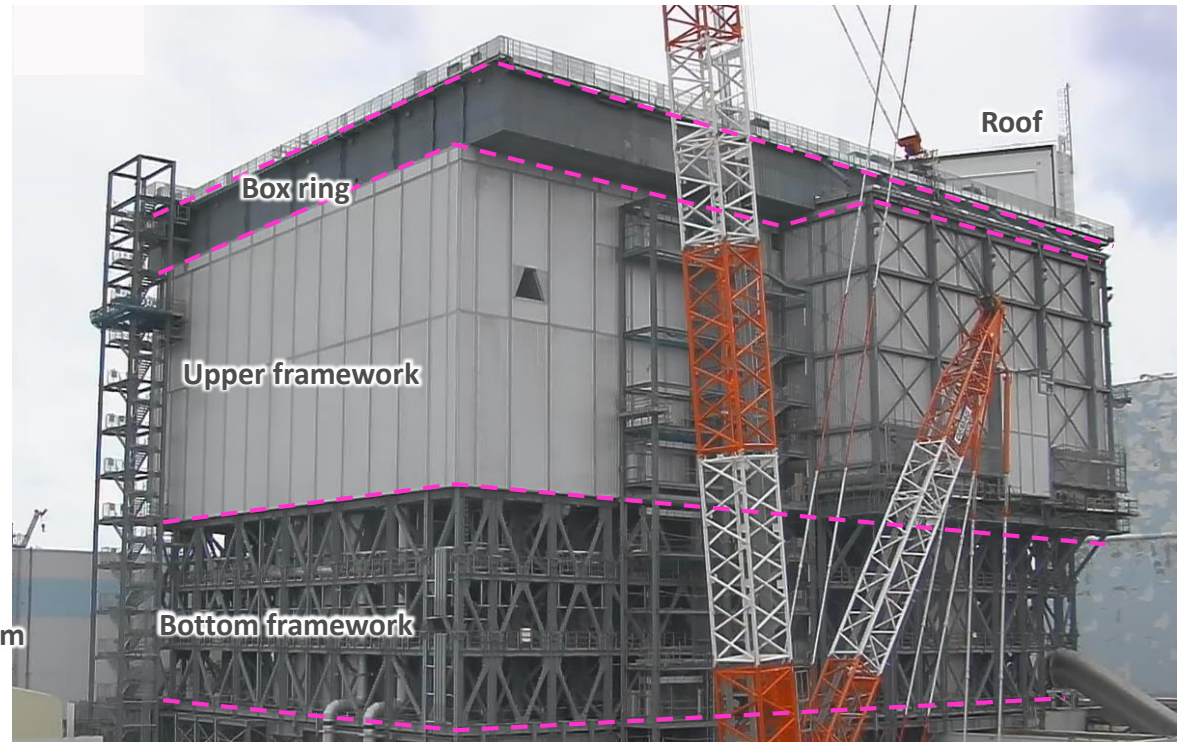
On-site conditions (Northwest side) (Photographed on November 25, 2025)

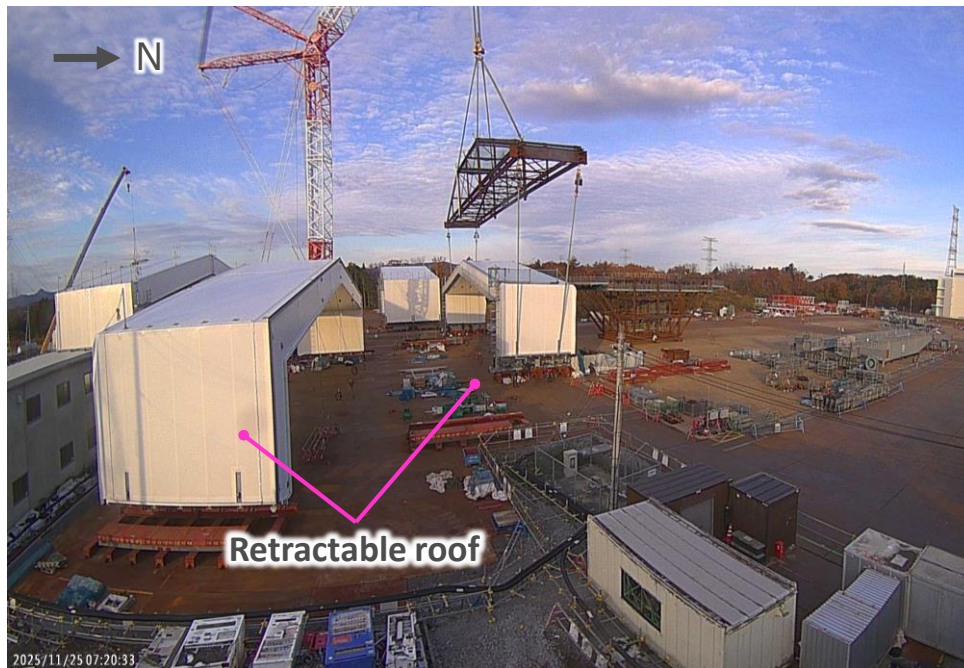
- Pre-assembly of all of the retractable roof blocks was completed on October 10, 2025.

Off-site west gate yard (photographed on November 25, 2025)

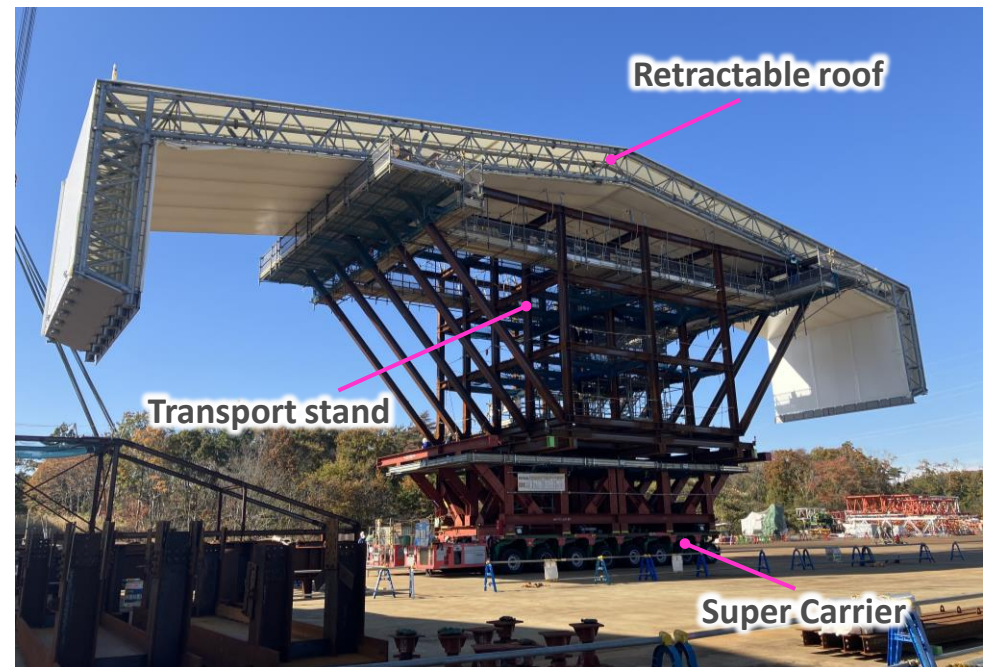
Status of retractable roof during loading
(Photographed on November 17, 2025)

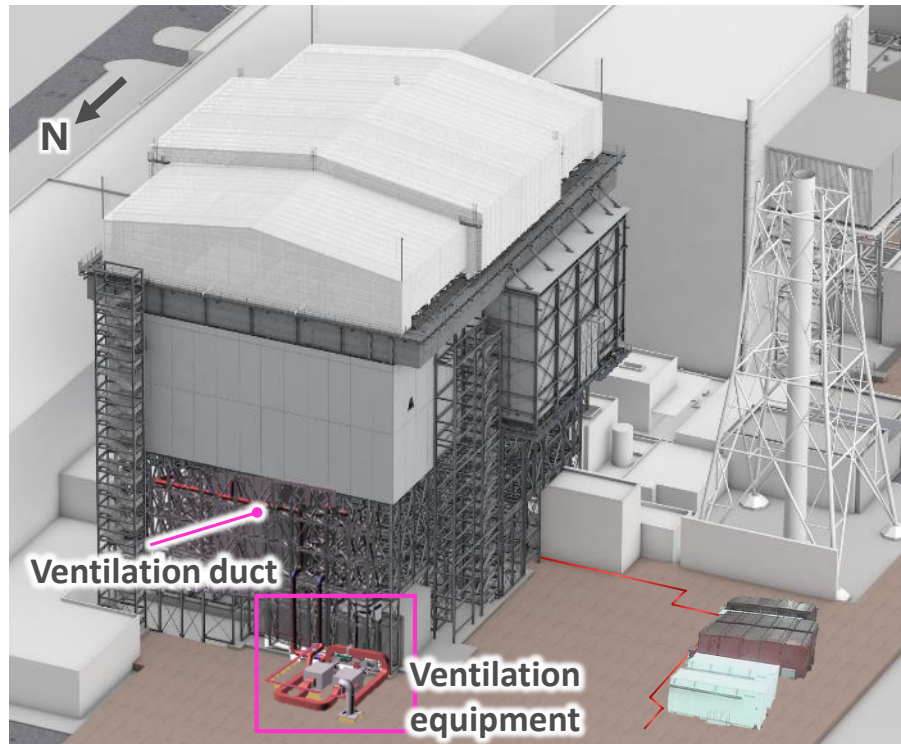
- Foundation bolt installation began on July 22, 2025. Installation of these foundation bolts was completed on November 17, 2025. Level adjustment material is now being put in place in preparation for equipment installation, and the duct, duct support installation and cable work is underway.

Overview of large cover ancillary equipment

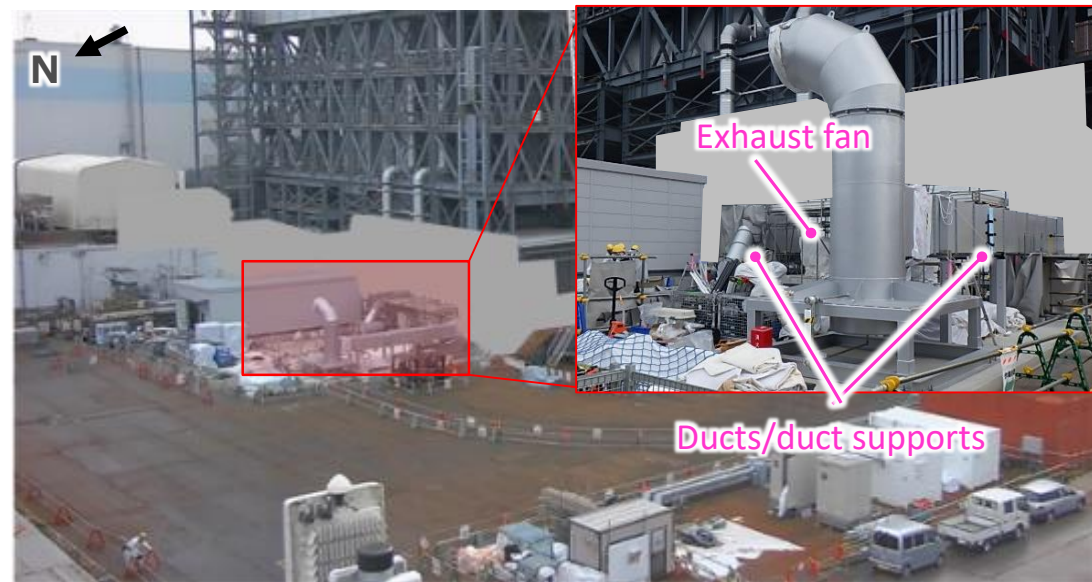
Unit 1 Reactor Building NW Yard (photographed on November 13, 2025)

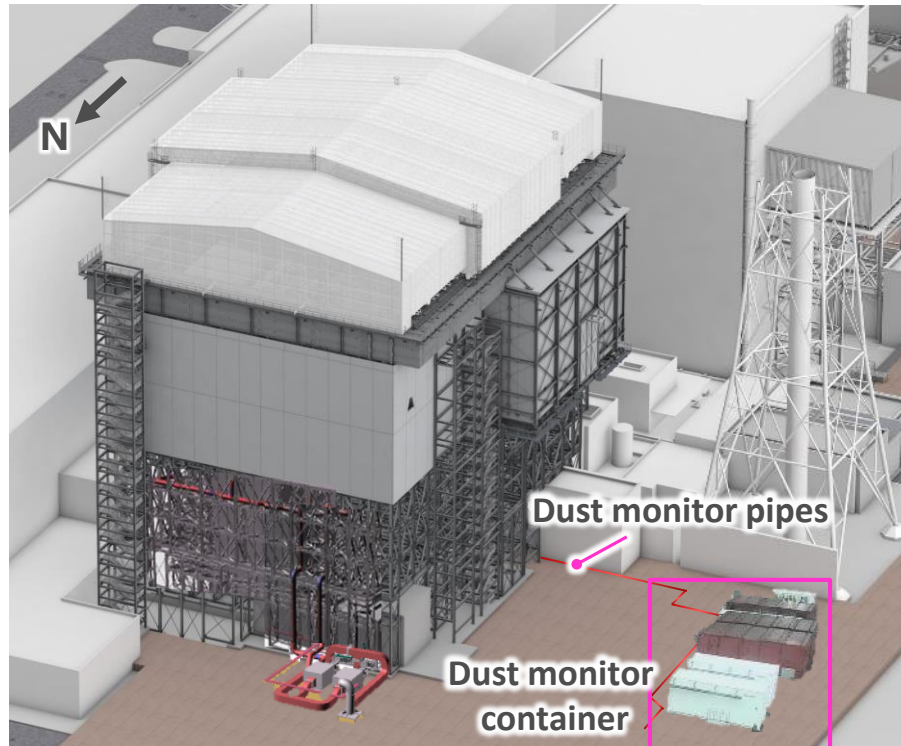
- Dust radiation monitor (hereinafter referred to as, “dust monitors”) container installation began on July 15, 2025. Dust monitor container installation was completed on July 16, 2025. Dust radiation monitor pipe laying is underway.

- Dust monitor pipe laying: 480m/1600m completed

Diagram of large cover ancillary facilities

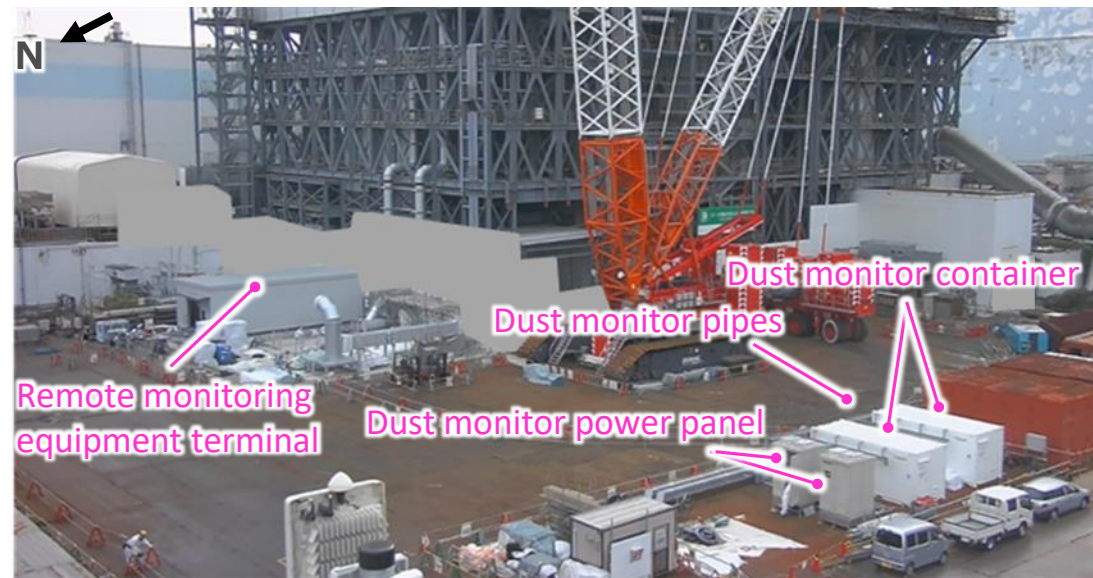
Unit 1 Reactor Building NW Yard (photographed on November 13, 2025)

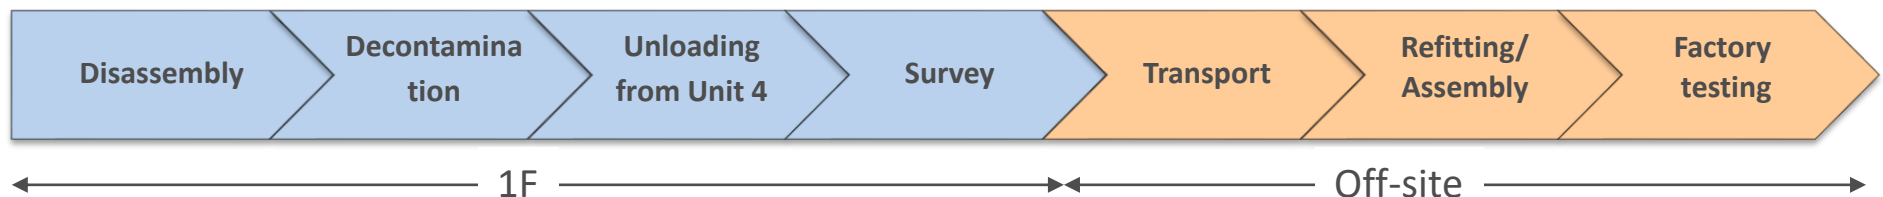
【Work flow】

- In order to reduce waste, the fuel handling machine installed at Unit 4 in 2013 will be sent back to the manufacturer to be refitted and repurposed as the fuel handling machine for Unit 1.
- The following considerations are to be made when repurposing:
 - ✓ The equipment transports in accordance with law.※
 - ✓ All equipment taken out resend back to 1F from the manufacturer's factory.
 - ✓ All electrical components instruments, and fuel handling machines, etc. not to be repurposed shall not be transported and stored on site.

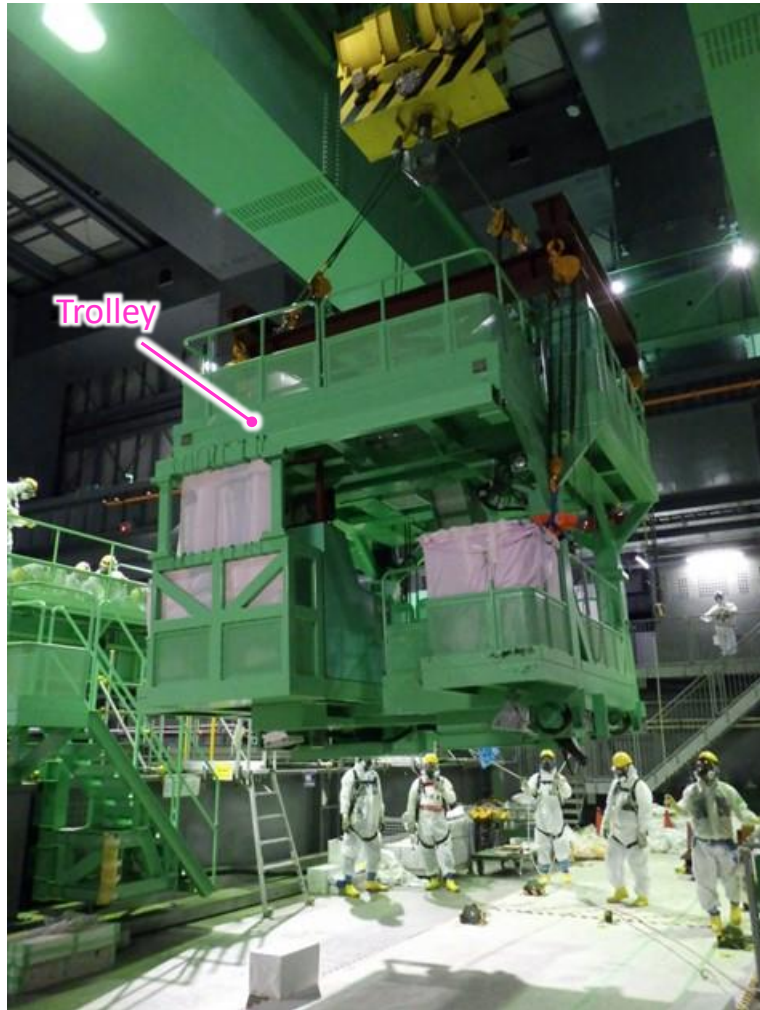
- On November 4, 2025, we began disassembling and unloading the Unit 4 fuel handling machine.
- We will finish transporting all of the parts and materials to the factory during FY2025.

Hoisting the trolley (photographed on November 12, 2025)

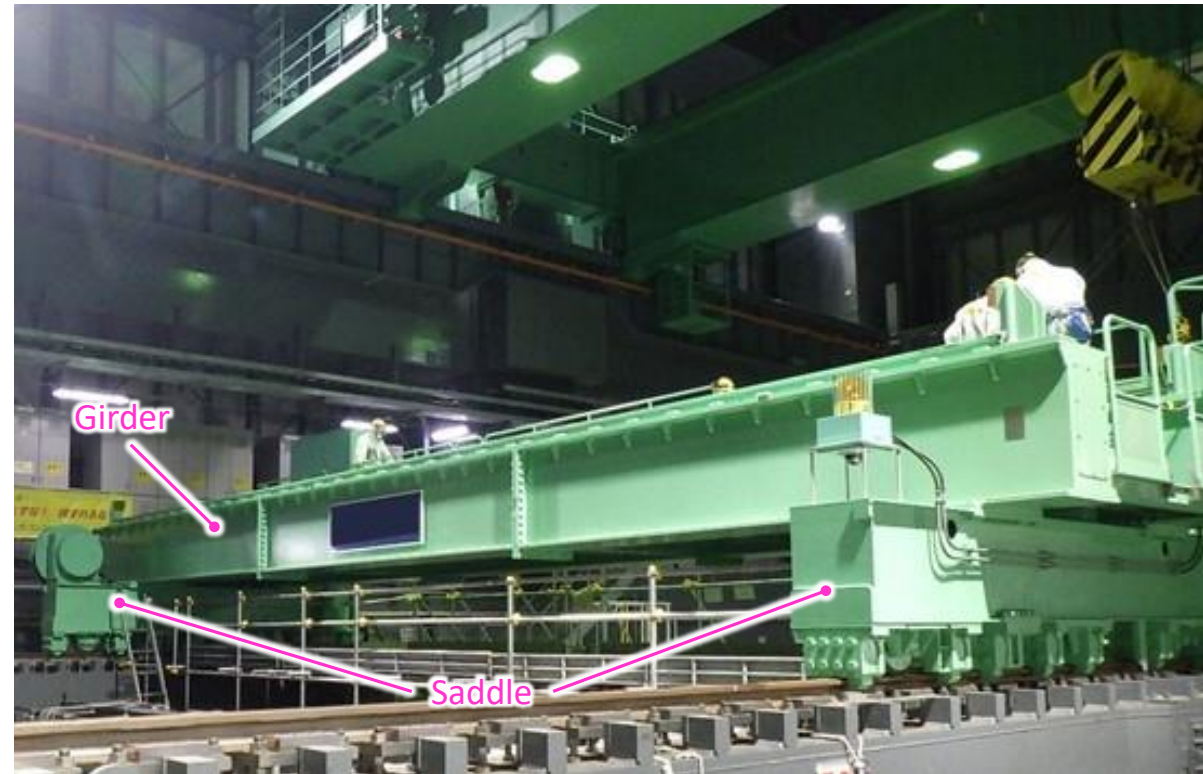
After removal of the trolley (photographed on November 12, 2025)

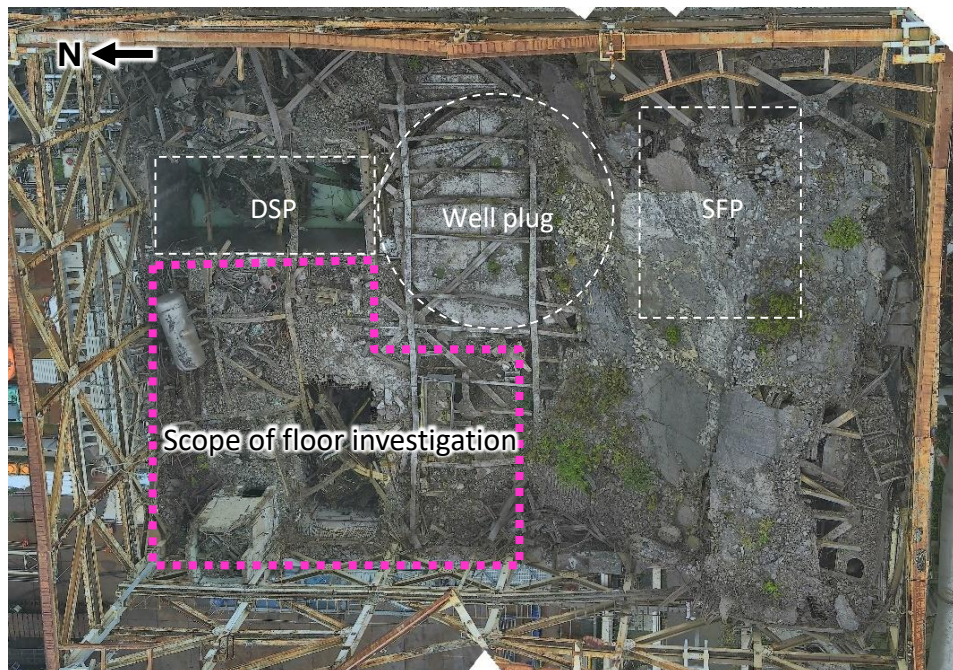
- A rubble processing platform and heavy machinery will need to be placed on the north side of the operating floor, but the condition of the floor at this time is unknown. Therefore, to prevent having to backtrack, the rubble will be removed and an investigation of the floor will be conducted so that the condition of the floor can be fully inspected.

The scope of floor investigation on the north side of the operating floor

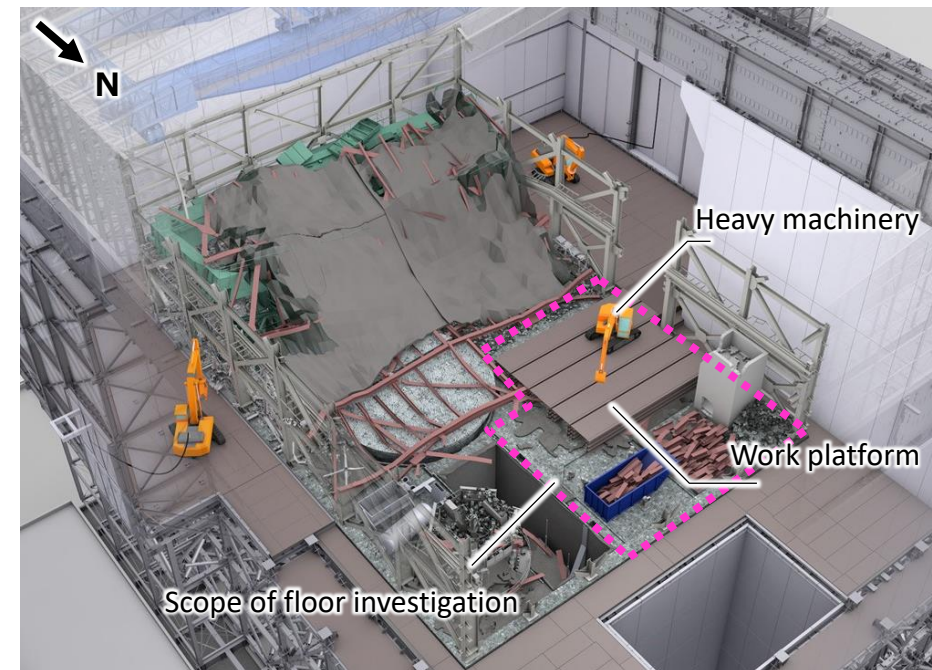
Concept diagram of work platform construction

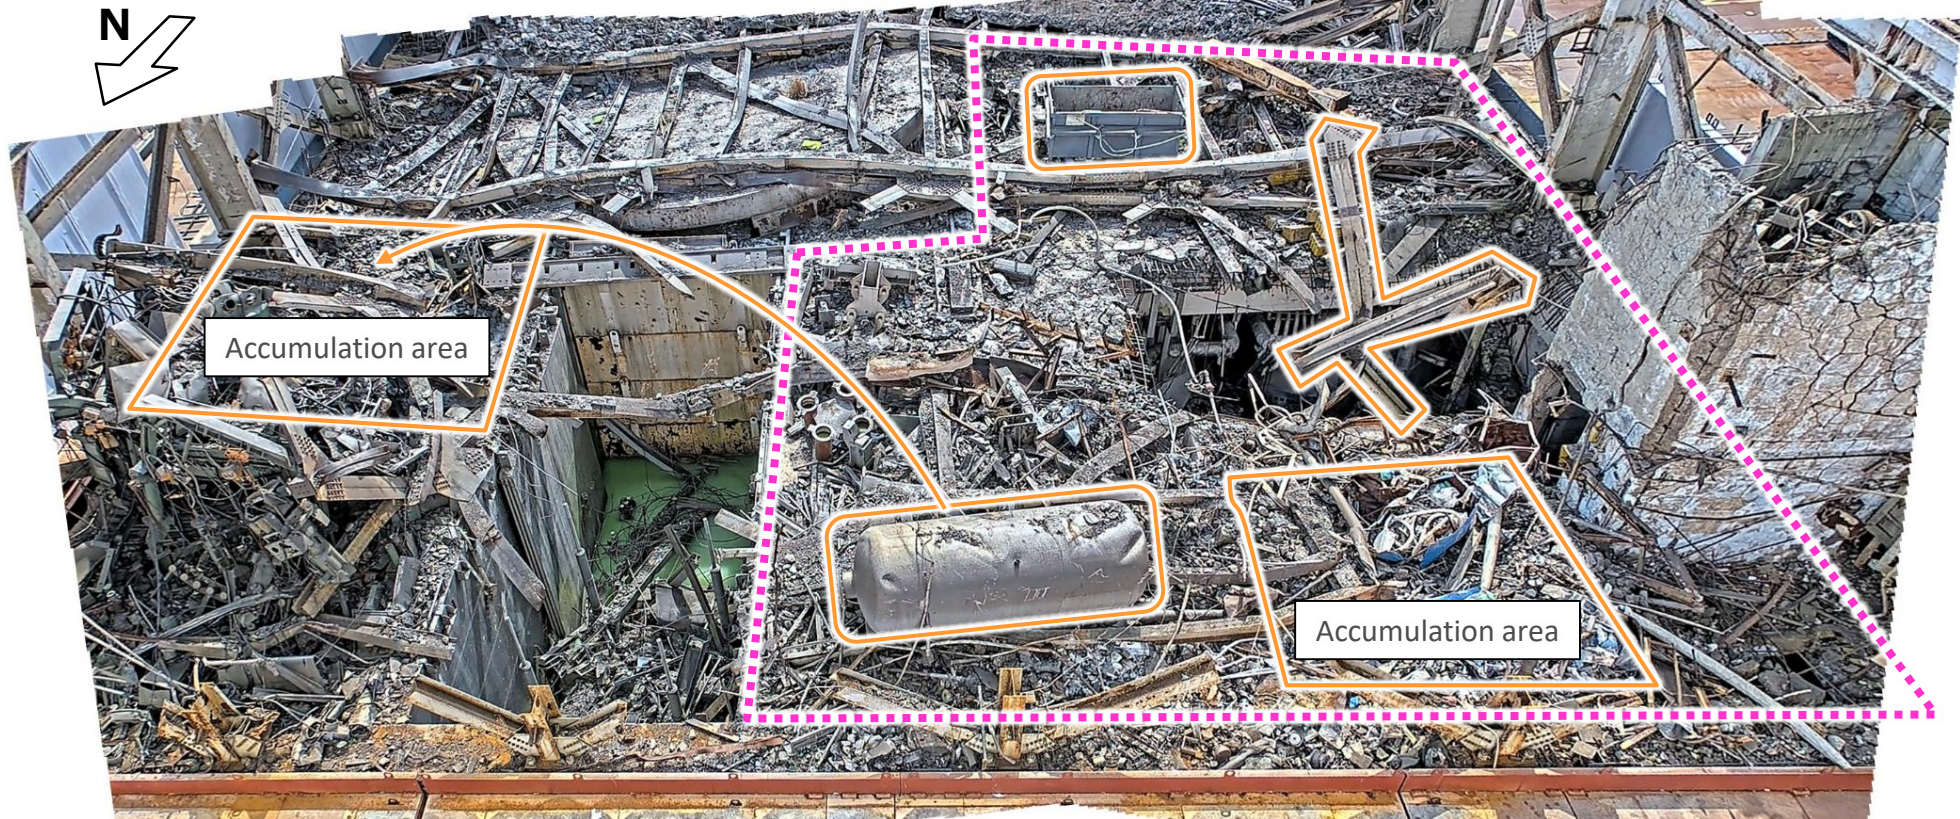
- In order to conduct a floor investigation, rubble in the investigation area shall be relocated to specific accumulation areas underneath the large cover.
- Rubble shall only be moved under the large cover and shall not be taken outside the boundaries of the cover. Work shall entail grasping/cutting/accumulating, which disperses little dust.
- After the rubble has been moved out of the way, visual inspections using cameras etc. will be conducted to determine if there has been significant structural damage to the floor.

Floor investigation on the north side of the operating floor

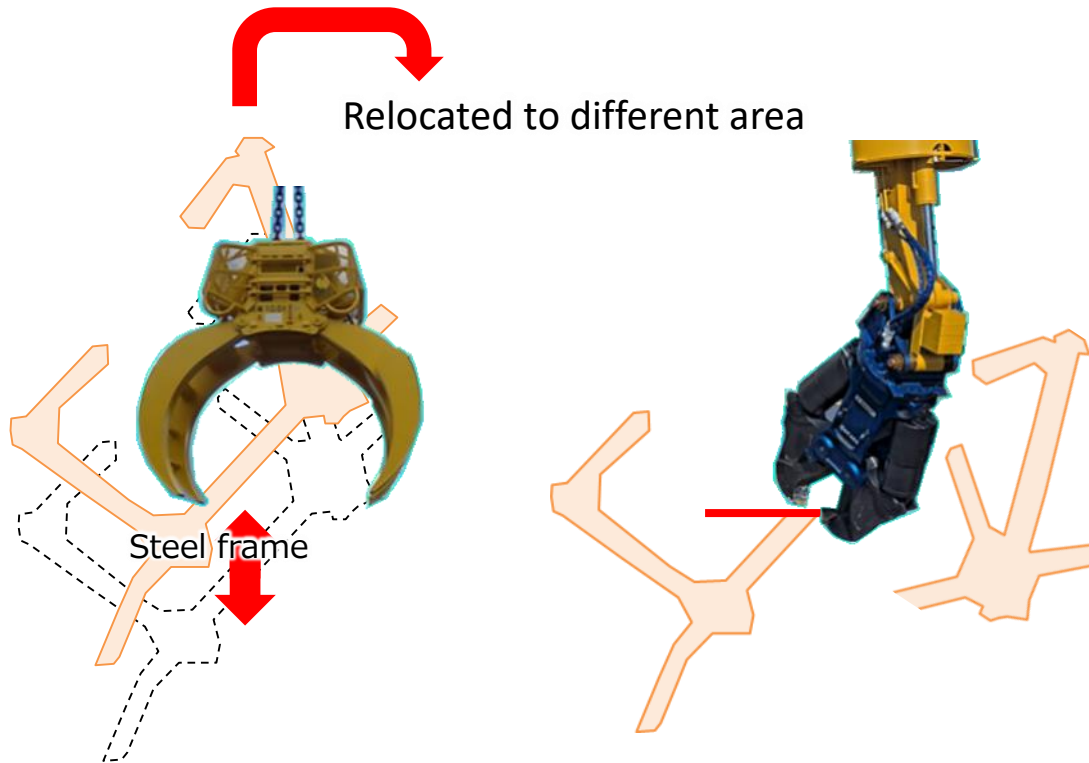
Grasping

A fork grab, etc. will be used to pick up material and relocate it after confirming other pieces of rubble are not stuck to it or hanging off of it.

Cutting

If the connection is not severed, attachments like cutters etc. will be used to cut the frame into pieces.

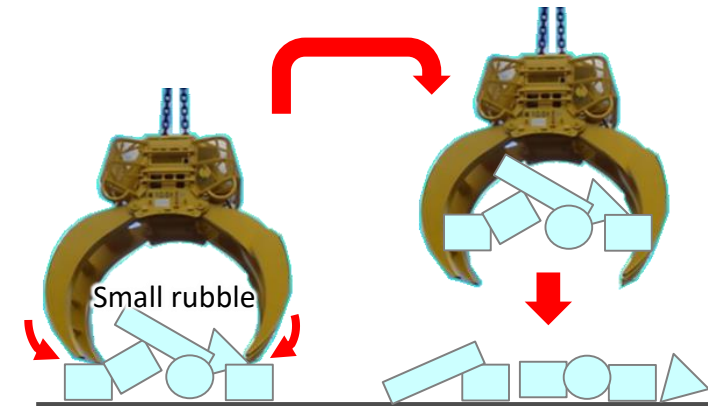
Accumulation (small rubble)

Small rubble will be grabbed with a bucket or grab fork, etc. and moved to accumulation areas so that the condition of the floor can be inspected.

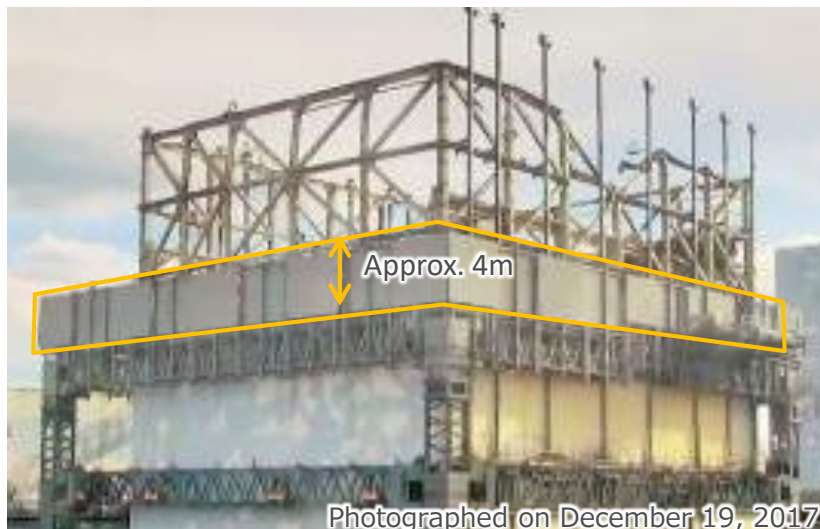
Wind prevention fence construction

Objective	Dust dispersion prevention	Wind prevention	Dust dispersion prevention
Countermeasures implemented this time	Spraying of dust prevention agents (once a month)	Large cover wall (operating floor + 25m)	Spraying of water (when alarm is sounded)
Conventional countermeasures	Spraying of dust prevention agents (once a month)	Wind prevention fence (operating floor + 4m)	Spraying of water (when alarm is sounded)

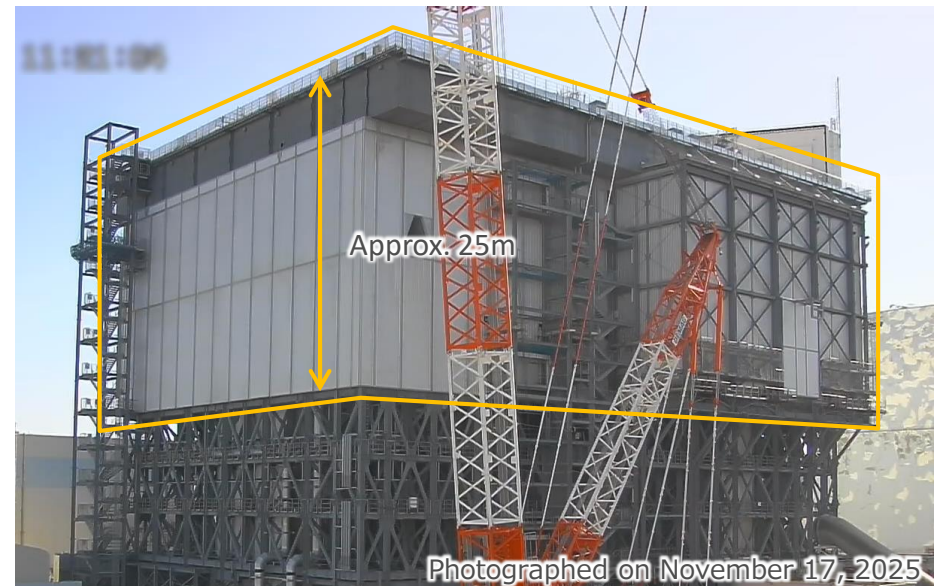
- Between 2018 and 2020 some of the rubble on the Unit 1 operating floor was already removed, and no significant changes in dust concentrations were detected during this work.
- The same countermeasures will be implemented during this investigation when handling rubble on the operating floor. Furthermore, in lieu of a wind prevention fence (operating floor + 4 meters) that is typically erected to prevent wind from coming in, the wall of the large cover will now provide 25 meters of wind barrier for the operating floor.

Large cover construction

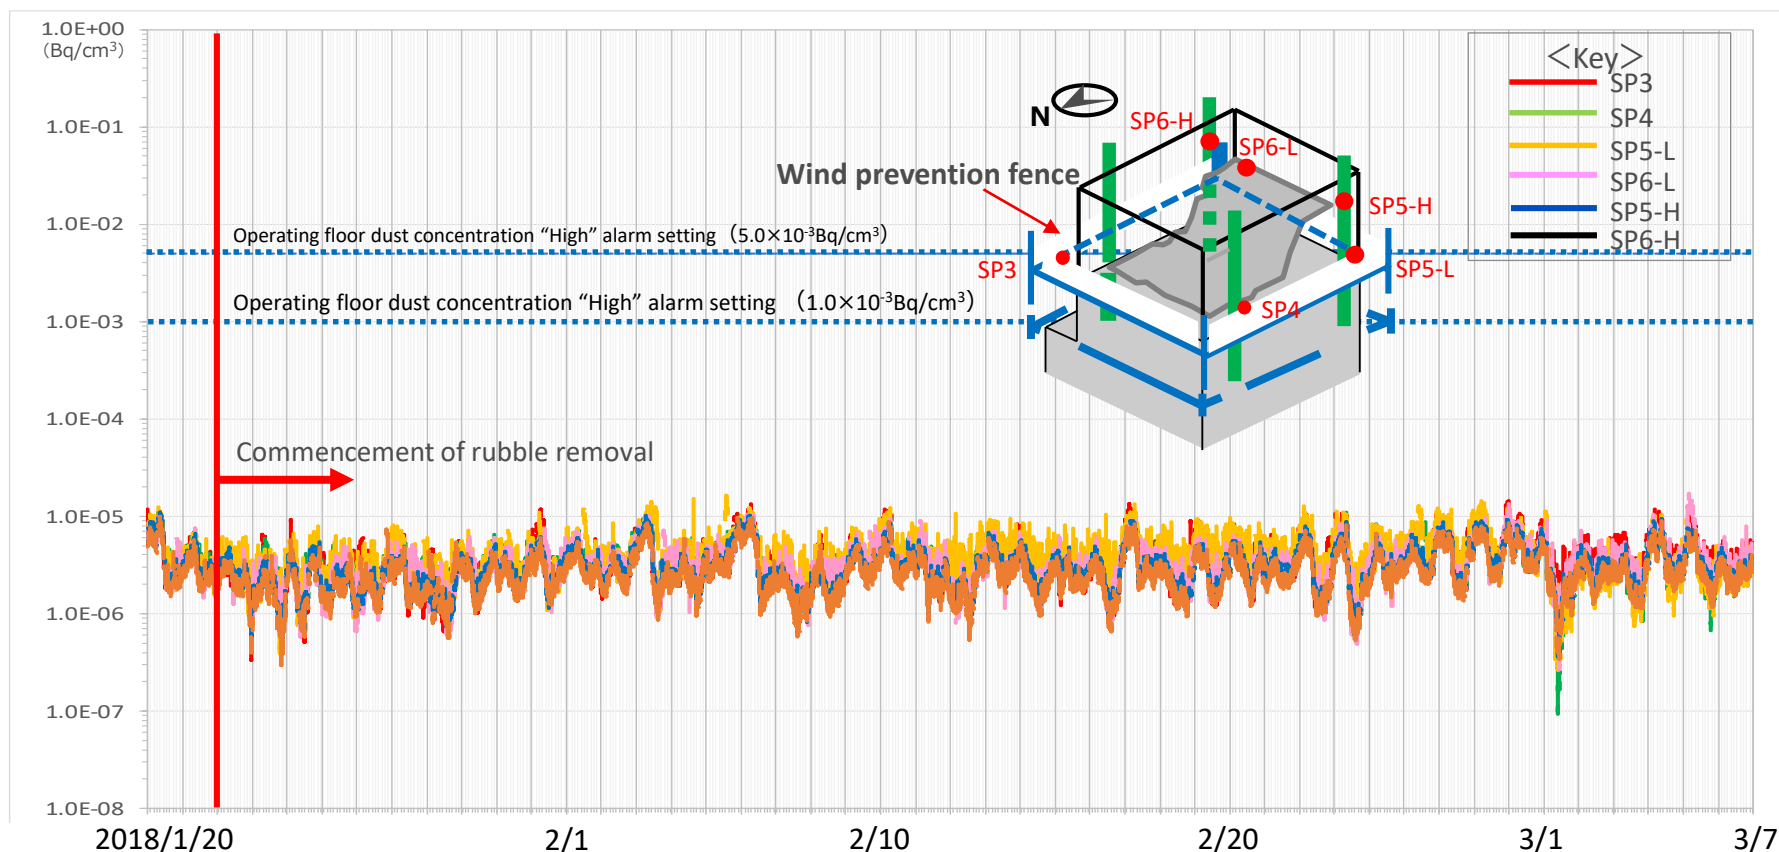
- The following chart shows the representative operating floor dust concentrations recorded during past rubble removal work.
- There were no significant changes in dust concentration, and concentrations trended below the “High” alarm setting ($1.0 \times 10^{-3} \text{ Bq/cm}^3$).

Concentrations of radioactive substances in the air on the operating floor

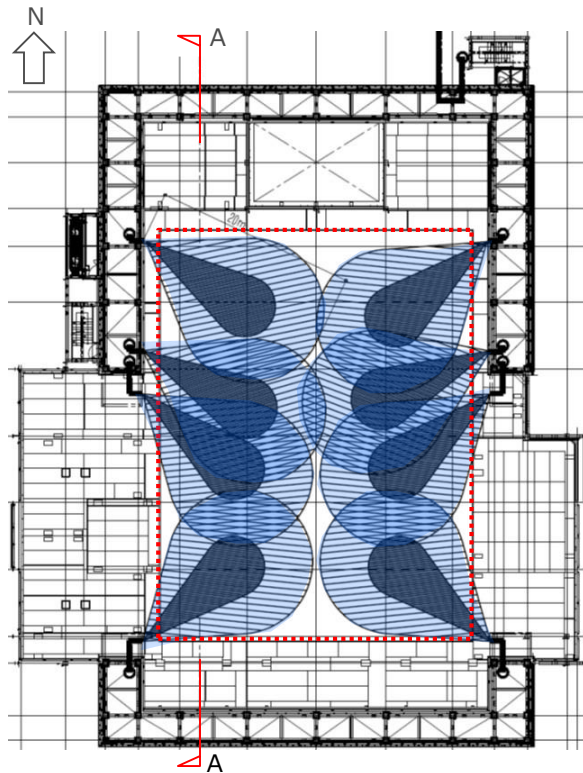
- If an operating floor dust monitor alarm sounds during investigation of the floor on the north side of the operating floor, work will immediately be halted, water sprayed. After completion of construction of the retractable roof, in addition to spraying, the retractable roof closed.
- In addition to spraying water as mentioned above, if there is the fear of dust dispersion, water sprinklers will also be used to wet the rubble directly.

A floor plan of dispersion area of the water sprinkler system

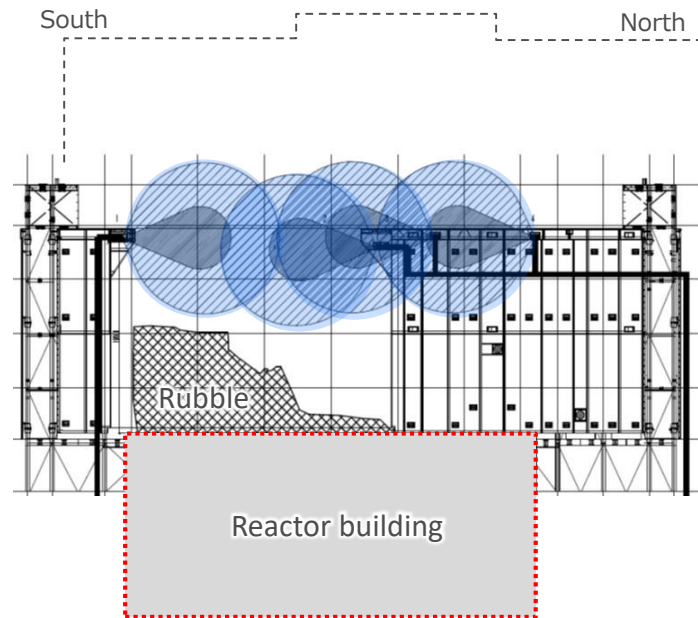
Cross section(A-A) of dispersion area of the water sprinkler system

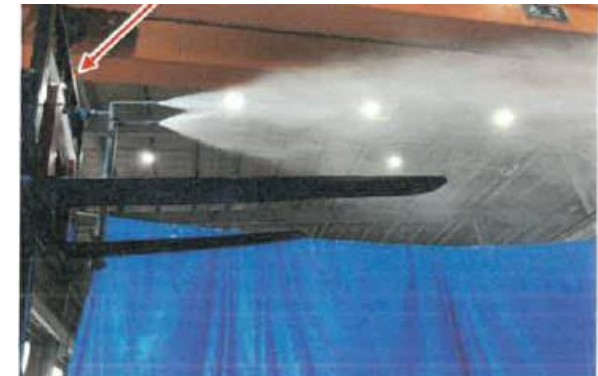
Status of the water sprinkler system dispersing water and mist

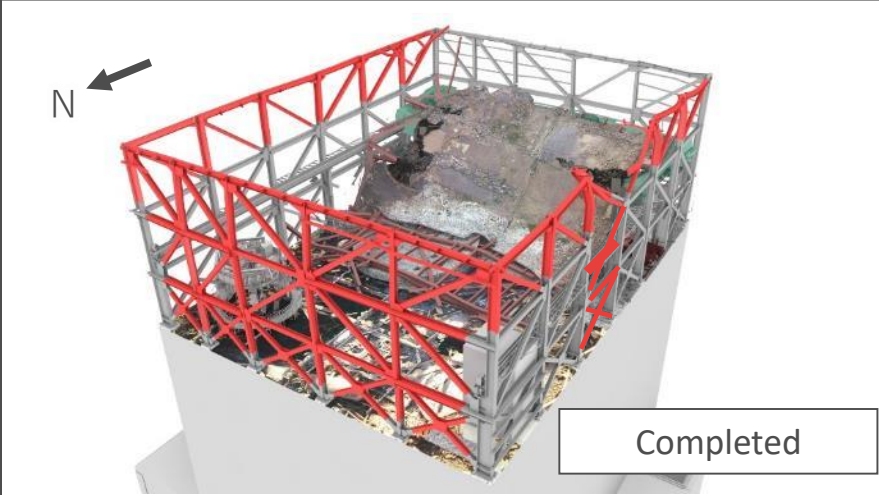
<p>STEP1: Removal of outer steel frame</p>

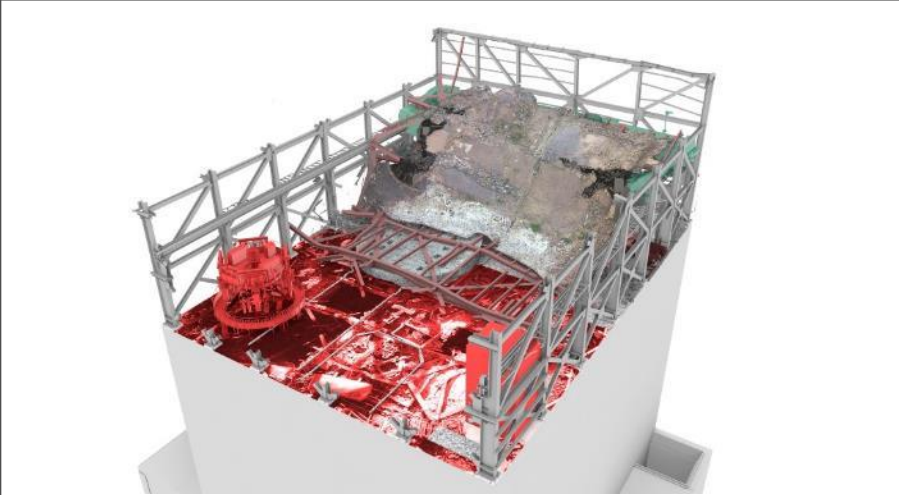
<p>Completed</p>	<p>STEP2: Operating floor north side preparations</p>

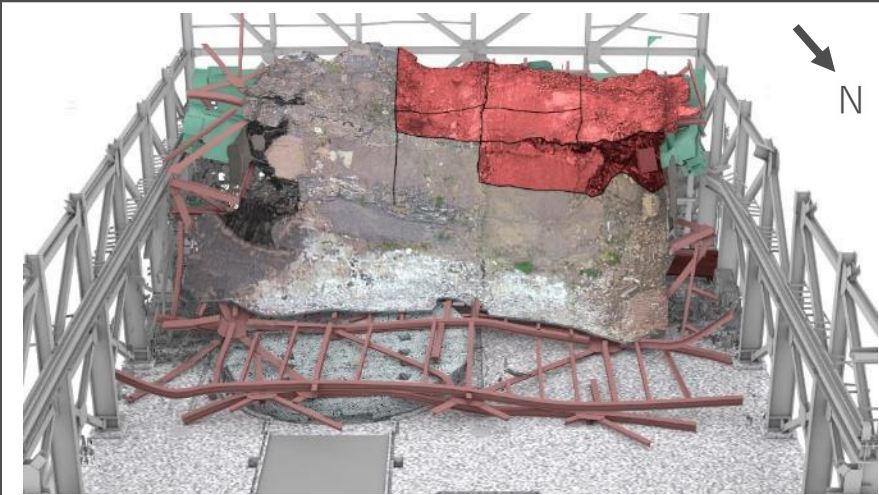
<p>STEP3: Roof slab removal (pieces on top of trolley)</p>

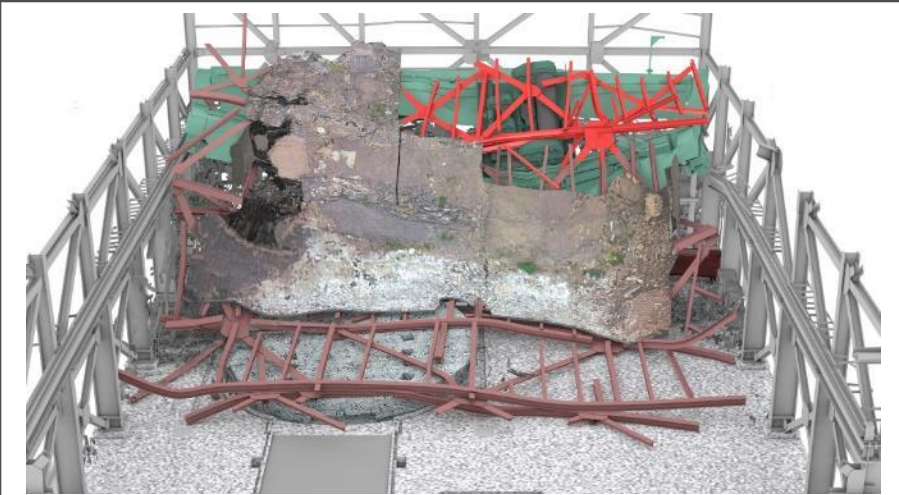
<p>STEP4: Roof frame removal (pieces on top of trolley)</p>

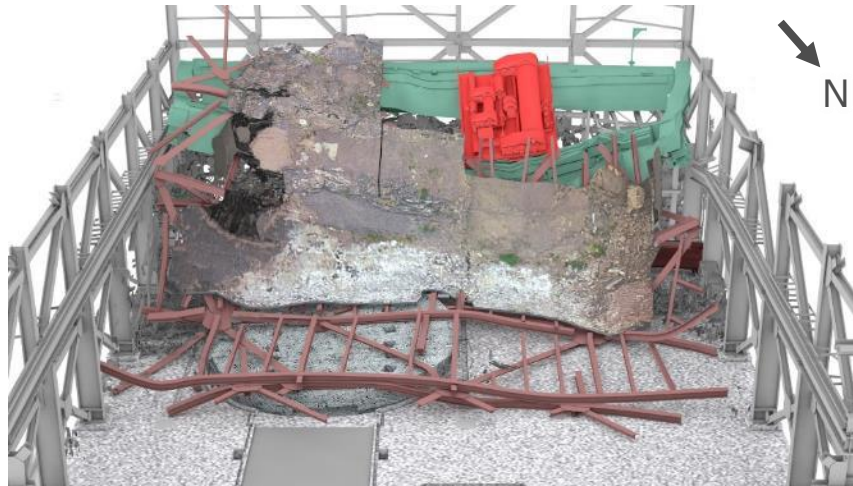
STEP5: Overhead crane trolley removal

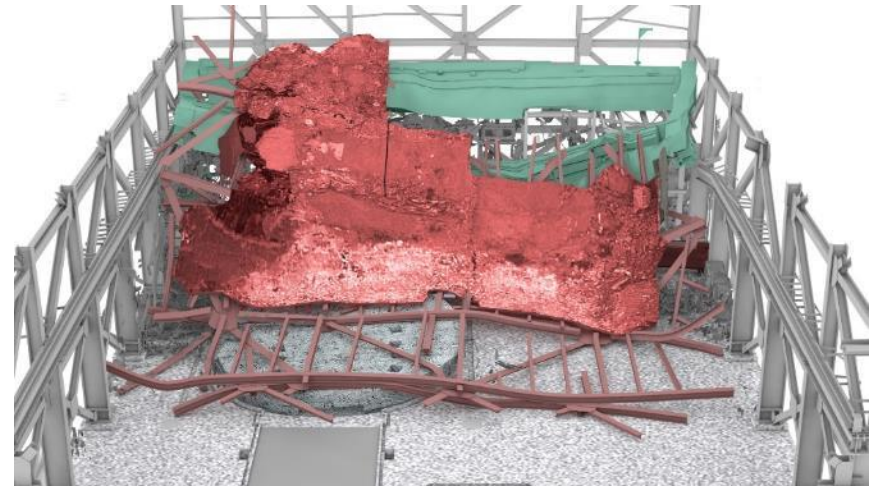
STEP6: Roof slab removal (entire)

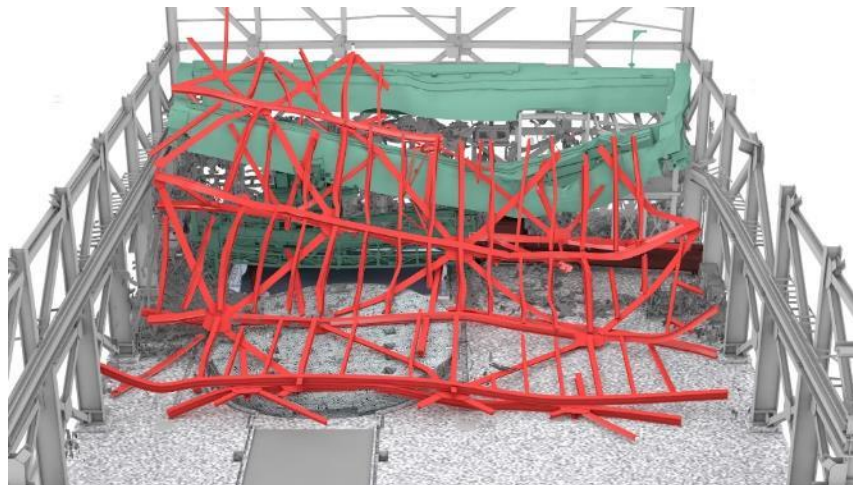
STEP7: Roof frame removal (entire)

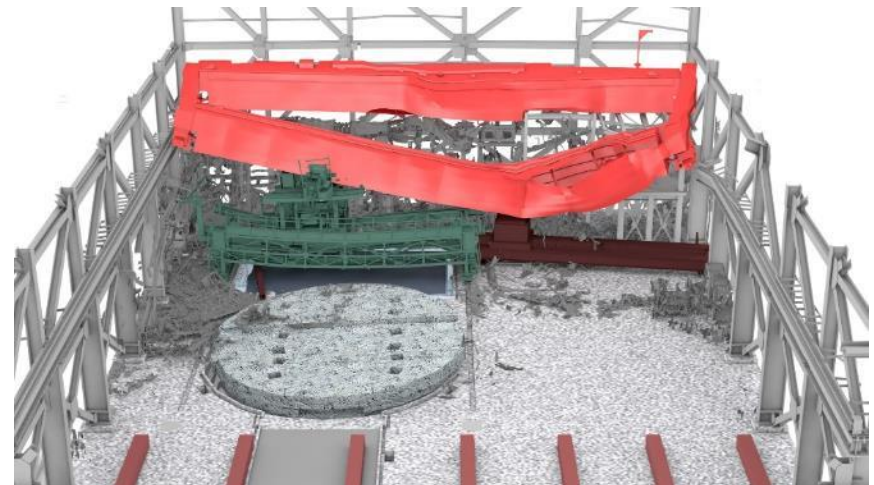
STEP8: Overhead crane girder removal
