Fukushima Daiichi Nuclear Power Station Unit 2 PCV Internal Investigation/ Status of Fuel Debris Trial Retrieval

December 25, 2025

International Research Institute for Nuclear Decommissioning
Tokyo Electric Power Company Holdings, Inc.

1. PCV internal investigation and trial retrieval plan overview

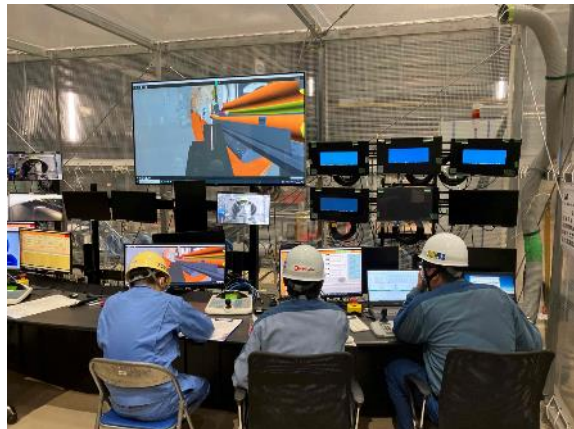
Performing operation from the remote operations room (simulated)

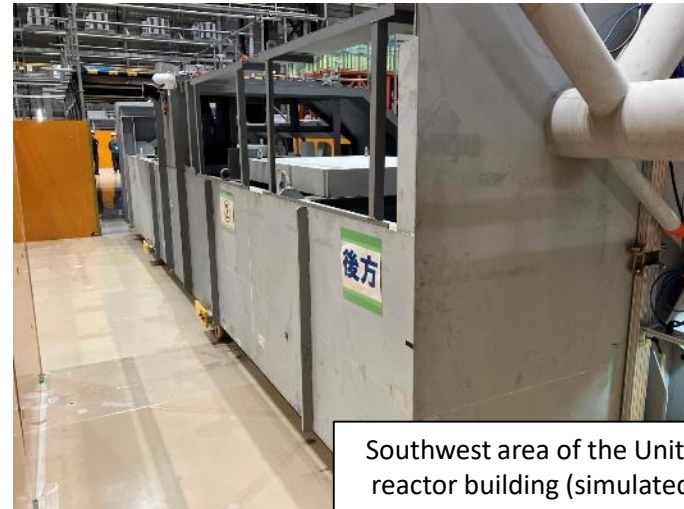
Southwest area of the Unit 2
reactor building (simulated)

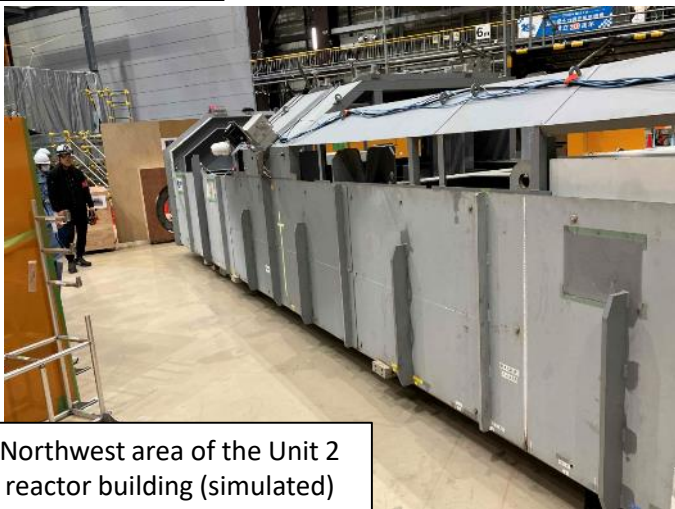
Northwest area of the Unit 2
reactor building (simulated)

X-6 penetration
connection
(simulated)

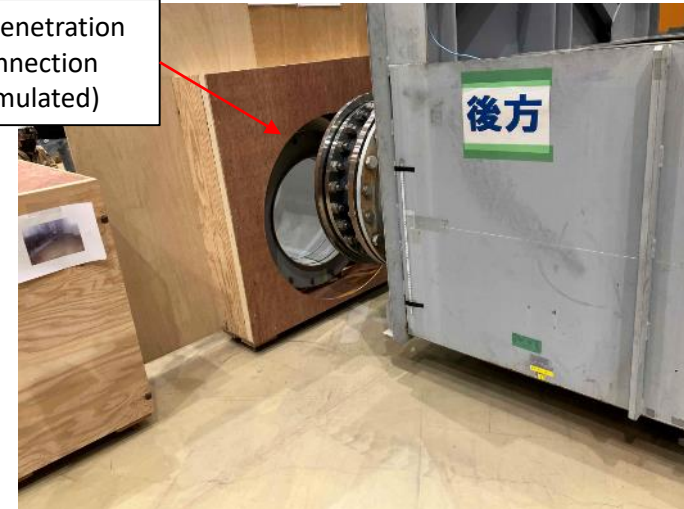
Inspecting enclosure (simulated) transport

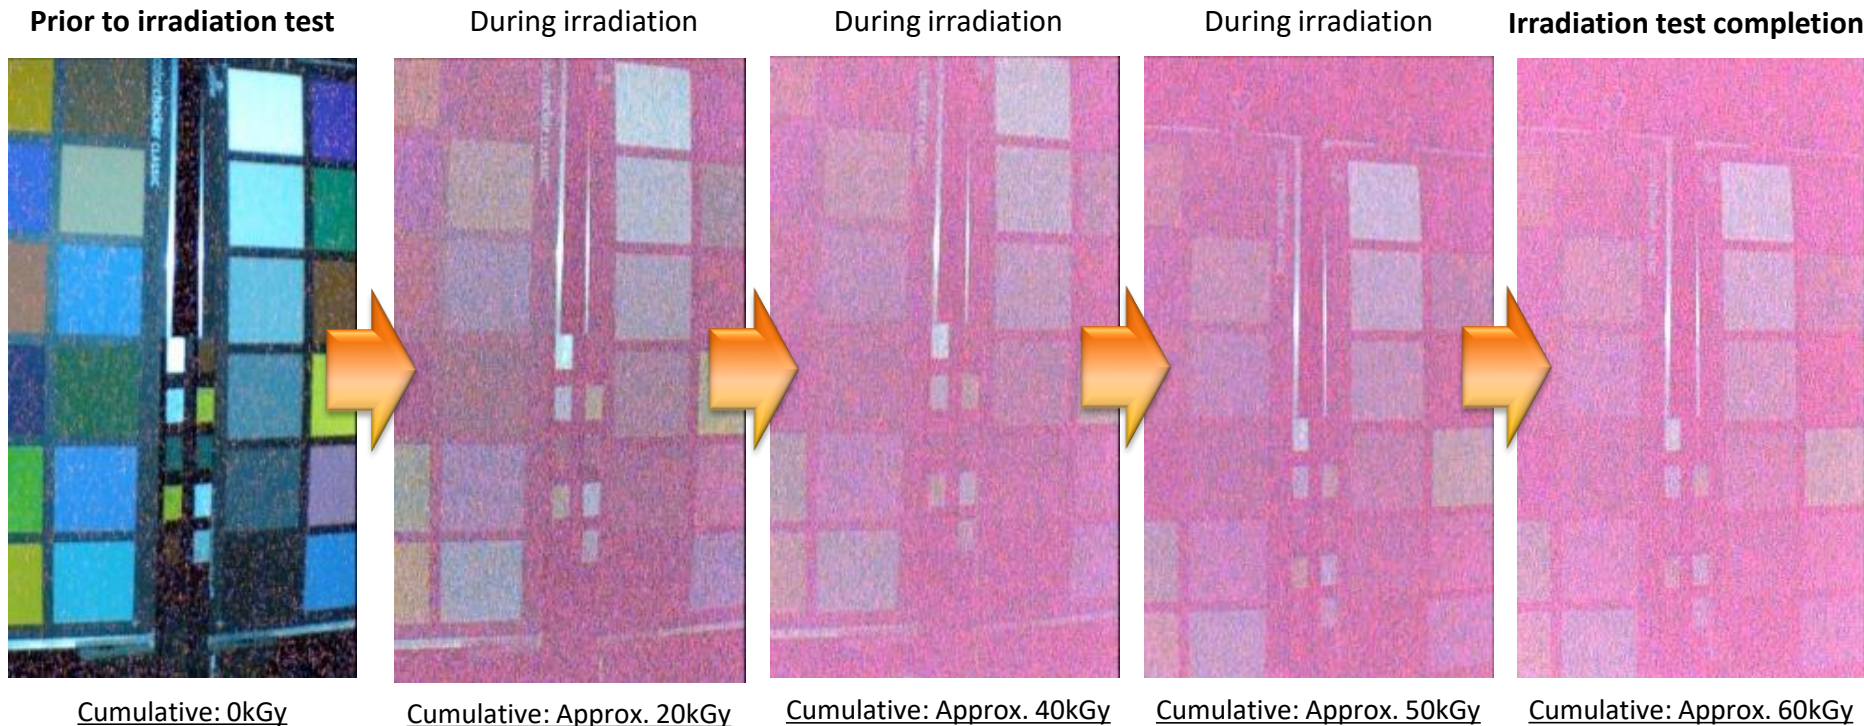
- Irradiation tests of the new cameras are underway using the on-site environment conditions (inside the PCV).
- During work in the field, deterioration of the video feeds will be monitored and the manipulator will be remotely operated to switch out cameras when necessary in order to continue operations.

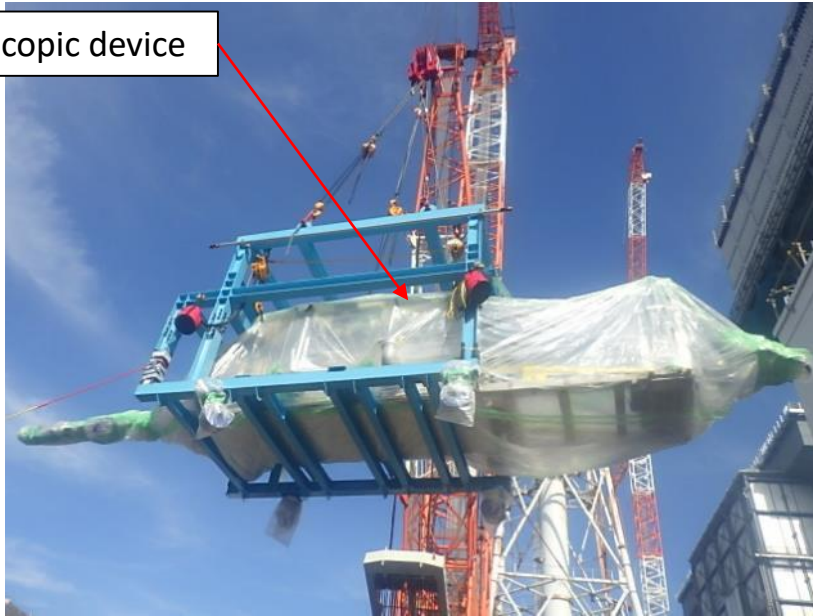
- The telescopic device was disconnected from the X-6 penetration connection structure and connection pipe, removed from the Unit 2 reactor building and transported to a storage location on site at Fukushima Daiichi Nuclear Power Station.
- Training on transport work was conducted in advance in a simulated environment prior to actual transport on-site.

Removing the telescopic device from the reactor building
(November 5)

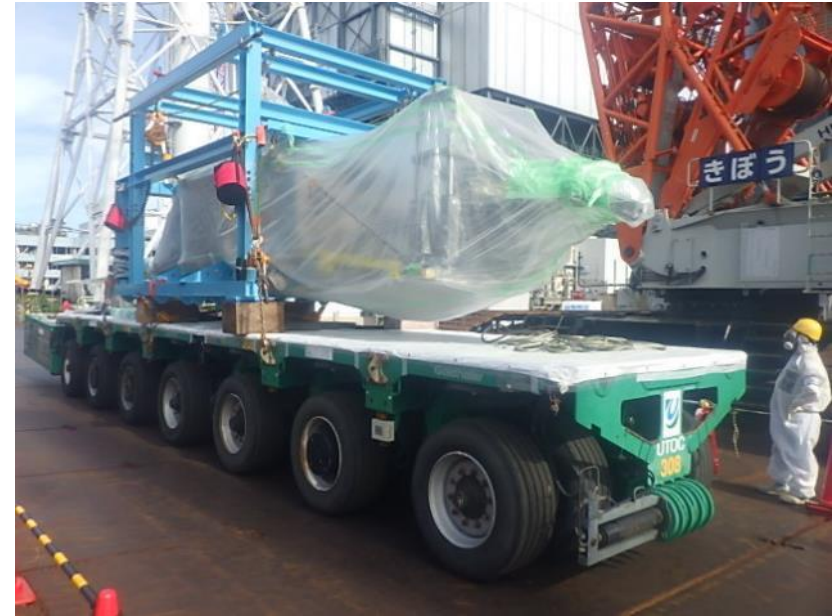
Loading the telescope device onto a vehicle for transport
(November 5)
