Fukushima Daiichi Nuclear Power Station Unit 2 PCV Internal Investigation/ Status of Fuel Debris Trial Retrieval

April 23, 2026

International Research Institute for Nuclear Decommissioning
Tokyo Electric Power Company Holdings, Inc.

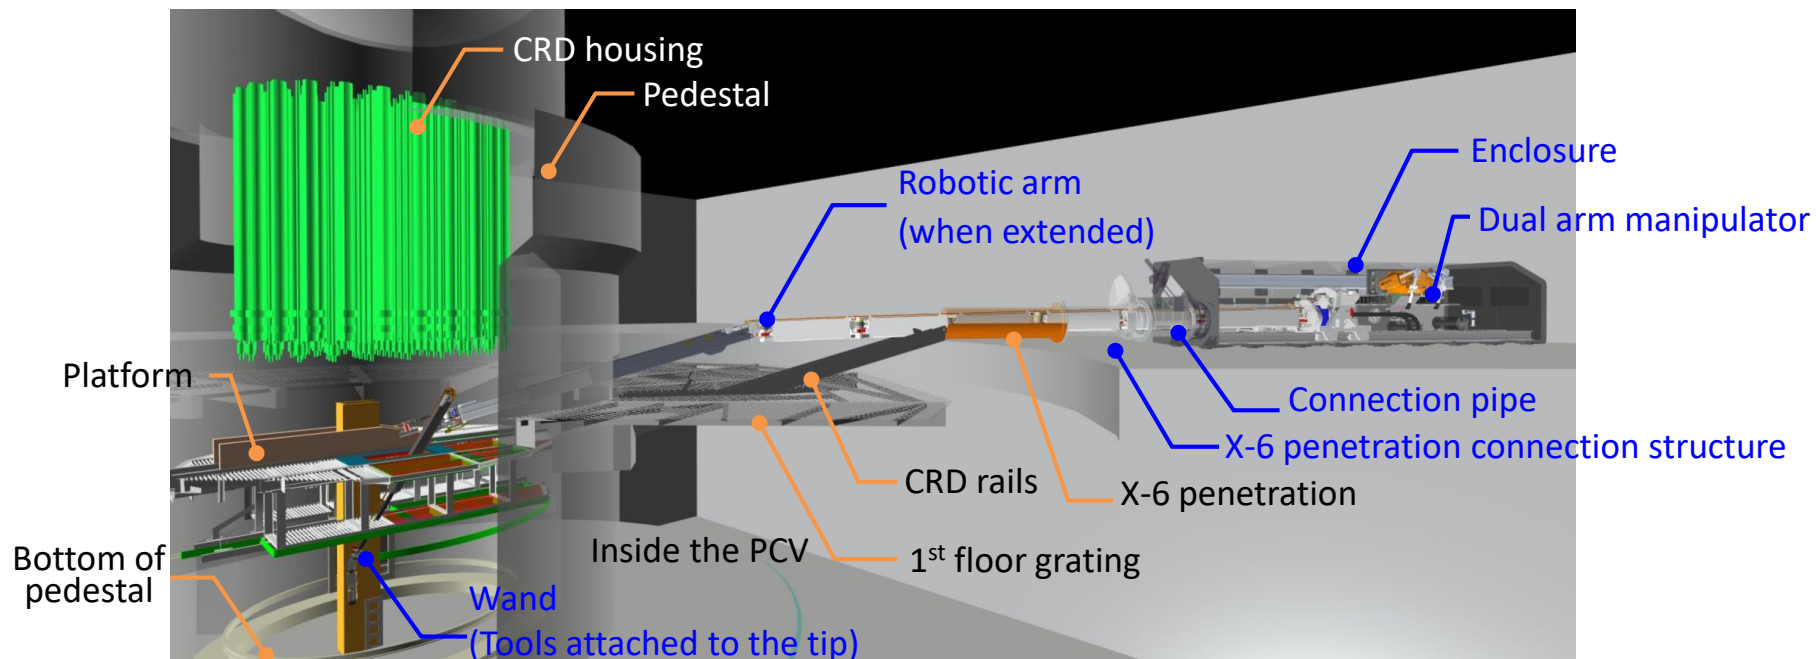
Unit 2 internal investigation/trial retrieval plan overview

- In order to guarantee work safety and prevent the spread of contamination, the following equipment will be installed at the penetration to the Unit 2 primary containment vessel (hereinafter referred to as, "X-6 penetration") that will be used for the PCV internal investigation and also as a preparatory stage of trial retrieval.
 - < Already installed >
 - The X-6 Penetration connection structure isolates the inside of the PCV from the outside
 - The connection pipe shields radiation
 - < To be installed going forward >
 - A metal box that contains the robotic arm (enclosure)
- After installation of the aforementioned equipment, the robotic arm shall be fed into the PCV through the X-6 penetration to remove obstacles inside the PCV while also conducting internal investigations and moving forward with the trial retrieval of fuel debris.

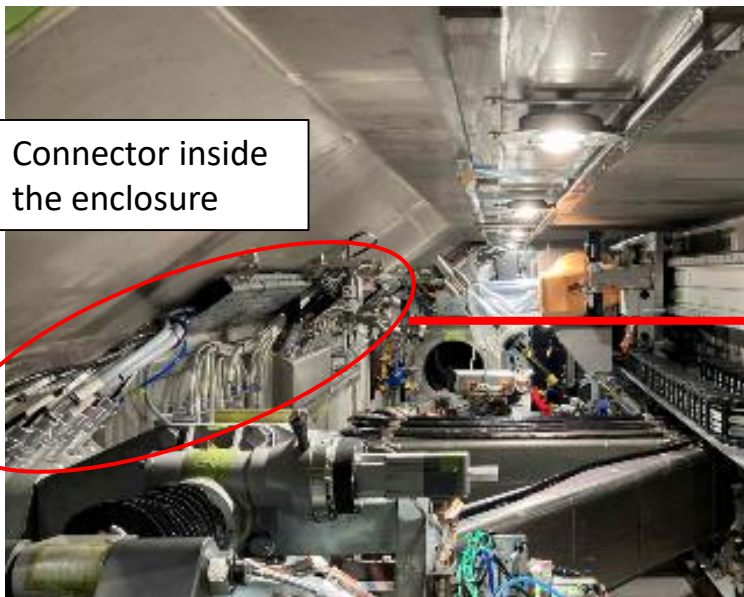
Connector inside the enclosure

Inside the enclosure

※ Photographed from the back of the enclosure

- Condensation countermeasures were examined considering the fact that condensation occurs inside the enclosure when the telescopic device is being used.
- As the last part of the test, water was sprayed inside the enclosure to test water resistance. When this was conducted a communications error occurred.
- An investigation into the cause revealed that water seeping inside the connector was the reason for the communications error so caulking was applied to improve water resistance.
- A verification test was performed again after the caulking was applied and the effectiveness of the water resistance countermeasure was confirmed.

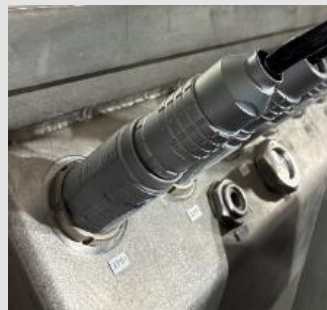
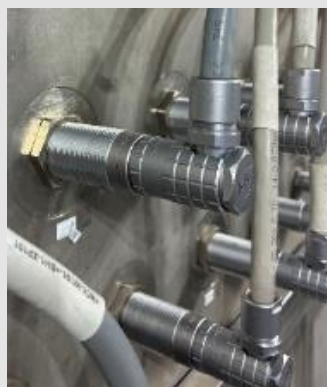
Prior to caulking

Connector condition

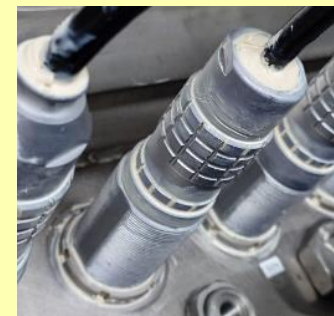
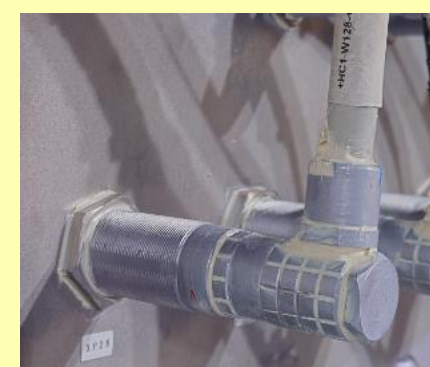
After caulking

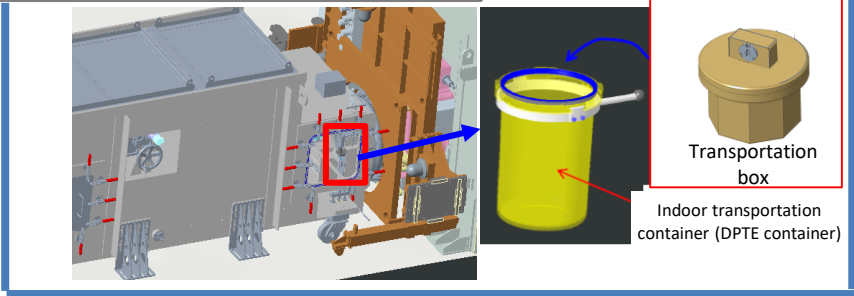
9-1. Collection of fuel debris

End of fuel debris recovery device
<Metal brush> <Vacuum chamber>

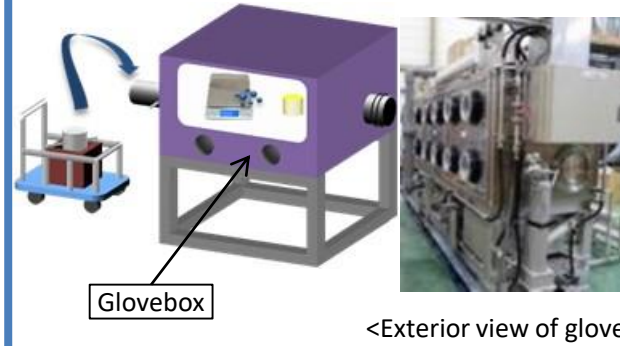
10. Insertion into glovebox/Measurement

- The collected samples will be put into a negative pressure glovebox
- The samples will be subjected to various measurements inside the glovebox and then put into a container
